**ALBERTA TRANSPORTATION AND  
ECONOMIC CORRIDORS GRMP  
NORTH CENTRAL (ATHABASCA AND FORT  
McMURRAY DISTRICTS)  
2025 SITE INSPECTION**

| Site Number | Location | Name | Hwy | km |
|---|---|---|---|---|
| NC097 | Fort McMurray | Parsons Road Overpass/Hwy 63 | 686:20 | |

NC097: HWY 686 (PARSONS ROAD OVERPASS) / HWY 63  
SITE INSPECTION PLAN

FIGURE 1

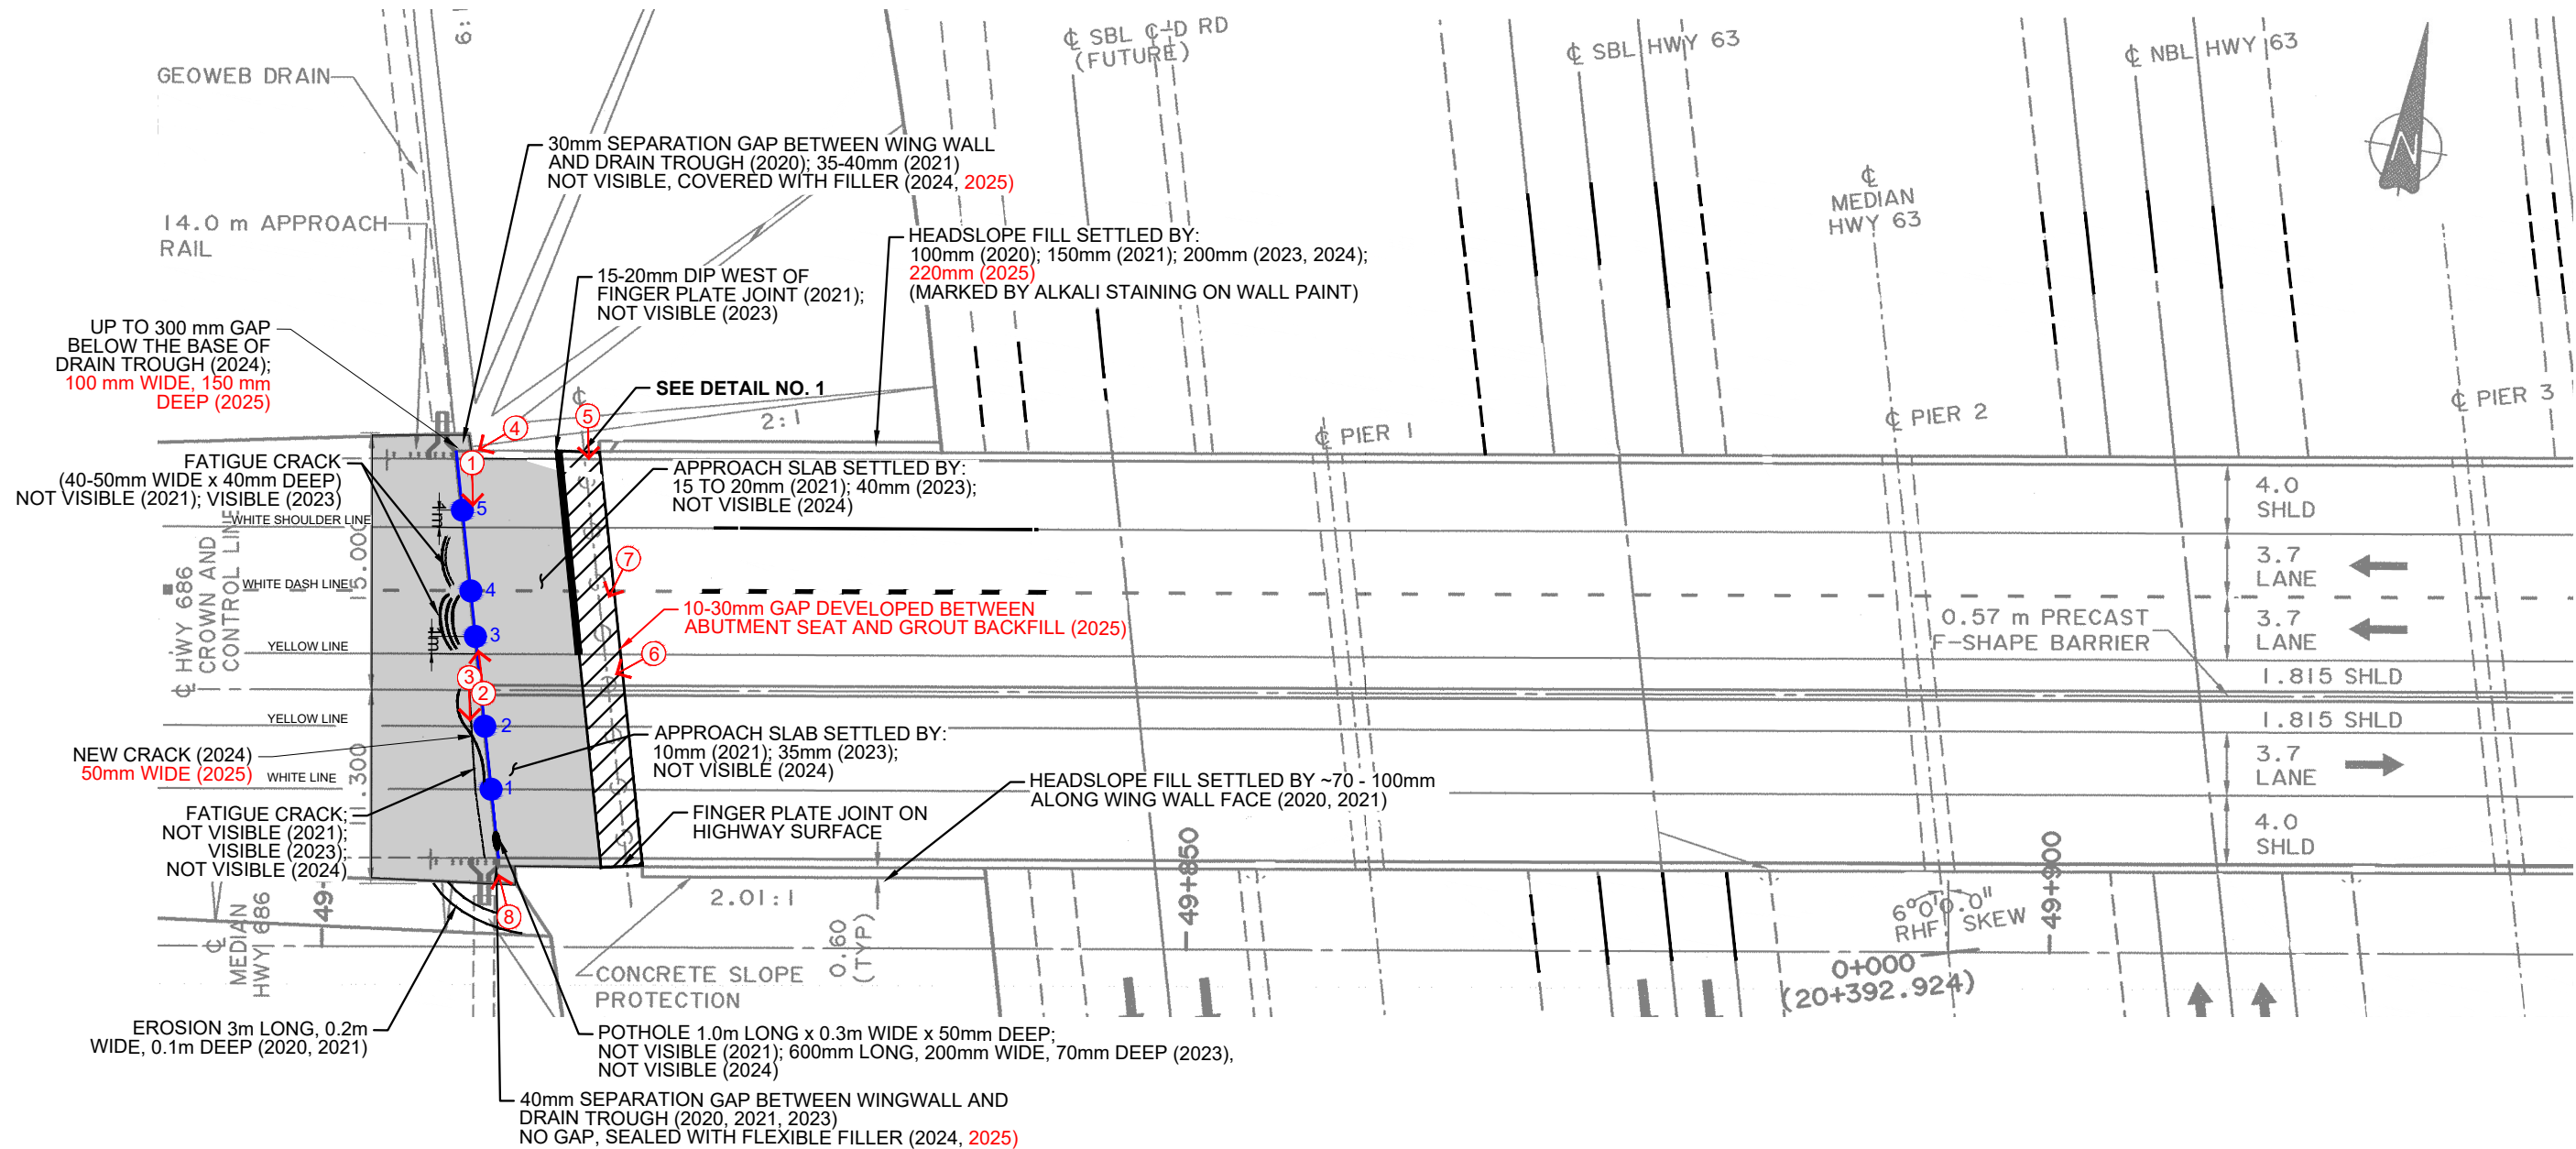
| Observations: | Description | Worse? |
|---|---|---|
| <input checked="" type="checkbox"/> Pavement Distress | Up to 70 mm wide x 200 mm deep x 26 m long crack reflected through the patch along the western edge of the west approach slab, about 6 m west of the west abutment; previously noted dip on the eastbound and westbound lanes west of the finger plate joint were not visible in the 2025 site inspection. | <input checked="" type="checkbox"/> |
| <input checked="" type="checkbox"/> Slope Movement | Bridge head slope was noted to have moved laterally and vertically by up to 300 in 2023. In 2024, additional movements of about 10 mm (lateral) and about 20 mm (vertical) were noted. A further 50 mm shift eastward was noted during the current inspection. A 10-30 mm drop has developed between the abutment seat and the grout fill placed after the 2023 inspection. | <input checked="" type="checkbox"/> |
| <input checked="" type="checkbox"/> Bridge/Culvert Distress | 200 to 300 mm of head slope movement; no visible cracks on abutment walls, wing walls, and abutment slope concrete facing; bridge bearing plates movement maxed out | <input checked="" type="checkbox"/> |

The site observations and instrumentation monitoring results indicate “excessive” vertical and lateral movements of the west approach fill. The cracks and the dips noted on the driving lanes are reflections of the ongoing slope movement of the approach fill. The movement of the fill appears to have created voids below the approach slab.

| CRACK LOCATION | JUNE 5, 2024 | | | MAY 14, 2025 | | |
| | WIDTH (mm) | DEPTH * (mm) | DROP (mm) | WIDTH (mm) | DEPTH * (mm) | DROP (mm) |
| 1 | 60 | 90 | 0 | 30 | 10 | 0 |
| 2 | 60 | 90 | 0 | 40 | 30 | 0 |
| 3 | 20 | 10 | 0 | 30 | 30 | 0 |
| 4 | 40 | 40 | 0 | 70 | 200 | 0 |
| 5 | 30 | 20 | 0 | 60 | 70 | 0 |

\* SAND AND SALT WERE NOTED WITHIN BOTTOM OF CRACK.

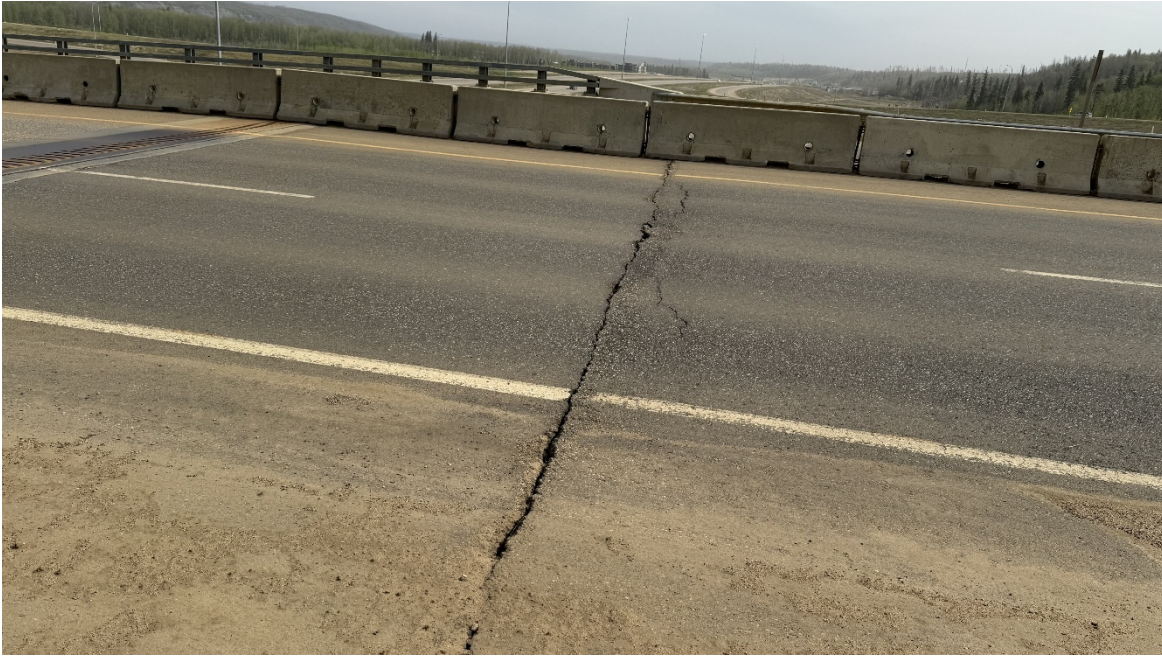
**Photo 1. Looking south at the crack developed across the westbound lanes towards the median. The main crack is 30 to 70 mm wide and 30 to 200 mm deep. The cracks are across both traffic lane directions and have formed between the approach slab and the pavement, about 6 m west of the west abutment fingerplate. Fatigue cracking is visible west of the main crack.**

The cracks on the highway should be sealed, and ACP patch should also be placed if a significant dip occurs on the highway surface. As recommended in the past it is ideal to drill holes within the slab to and inject grout in the holes to fill any voids below the slab. This may lessen the frequency of milling and patching on the highway.

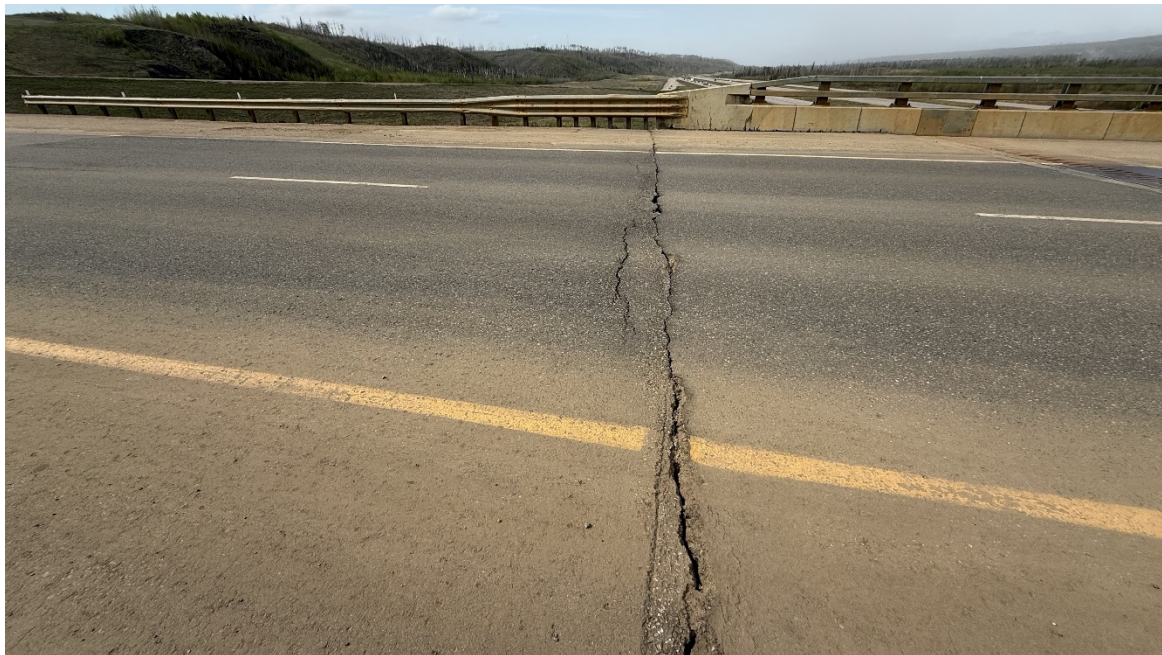
**Photo 2. Looking north at same crack from Photo 1**

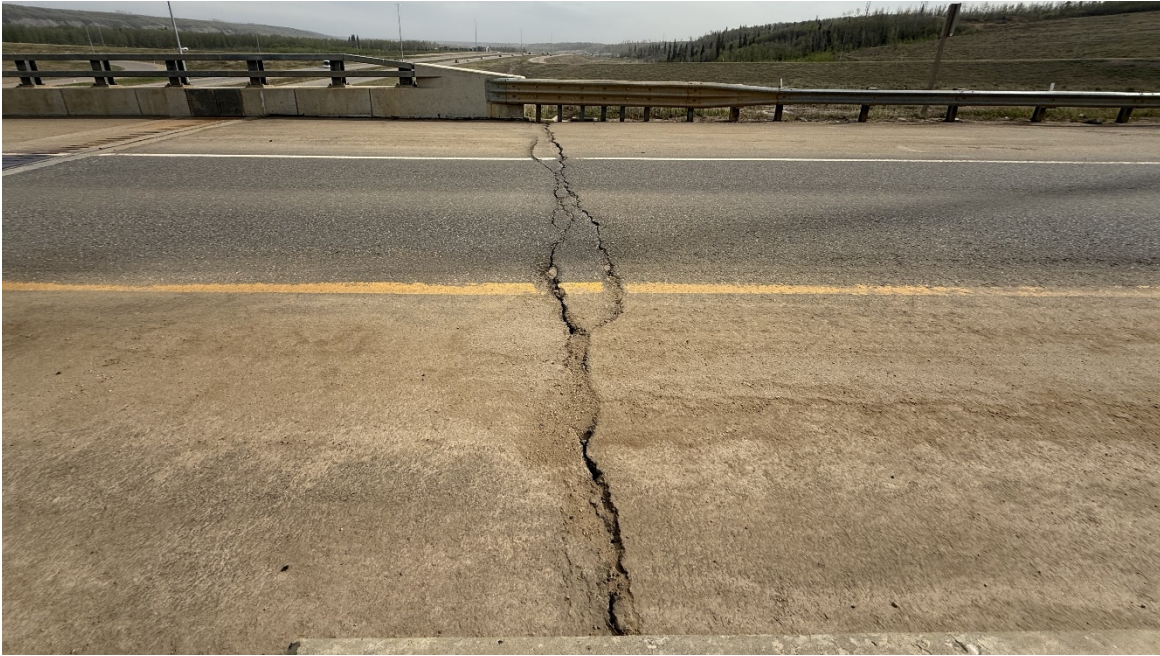
**Photo 3. Looking south at the eastbound lane. Cracks are up to 40 mm wide and 30 mm deep.**

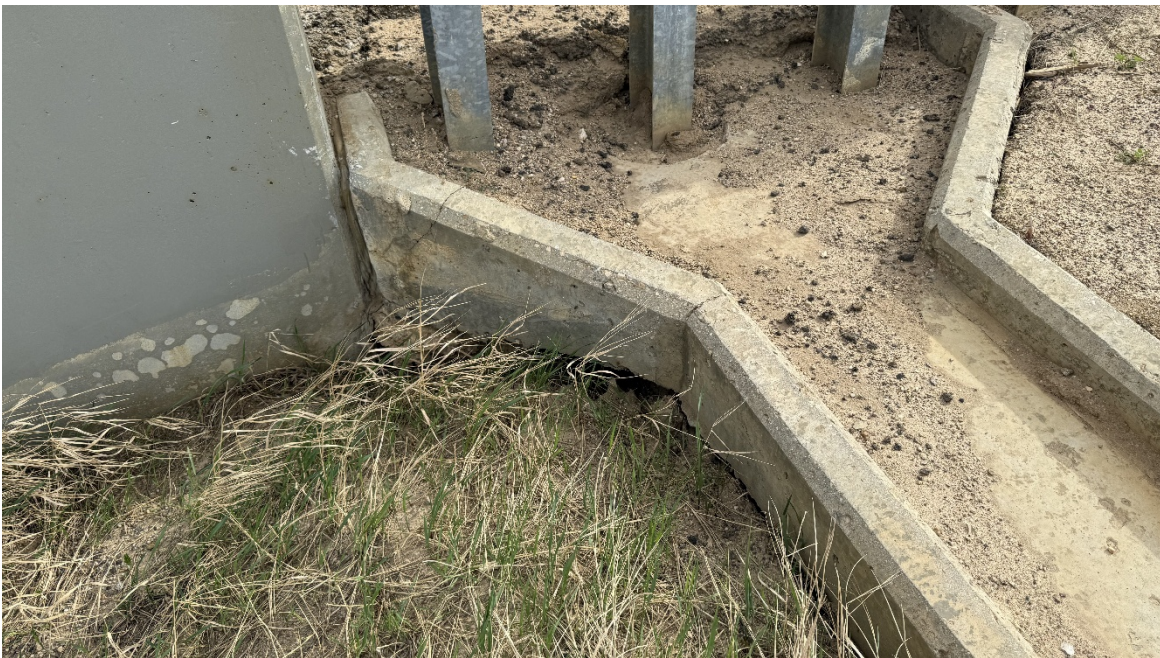
**Photo 4. View of drain trough. A flexible filler was placed in 2024 to seal the 50 mm wide separation gap between the northwest wing wall and the drain trough. However, there is a gap beneath the drain trough in response to fill settlement (up to 100 mm wide and 150 mm deep).**

Existing and future gaps (if developed) under drain troughs, between drain troughs and wingwalls, and below the abutment seat under the bridge should be filled with low strength fillcrete.

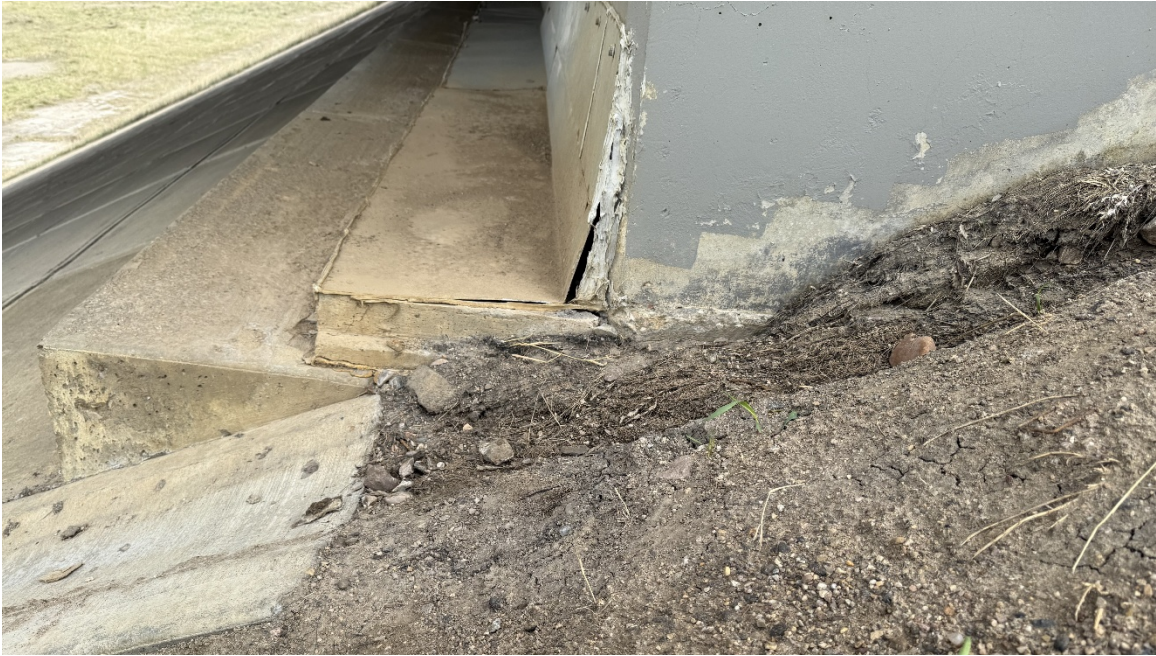
**Photo 5. Looking south at north end of abutment seat. Grout was placed between the 2023 and 2024 inspections to fill a void that had developed under the abutment seat.**

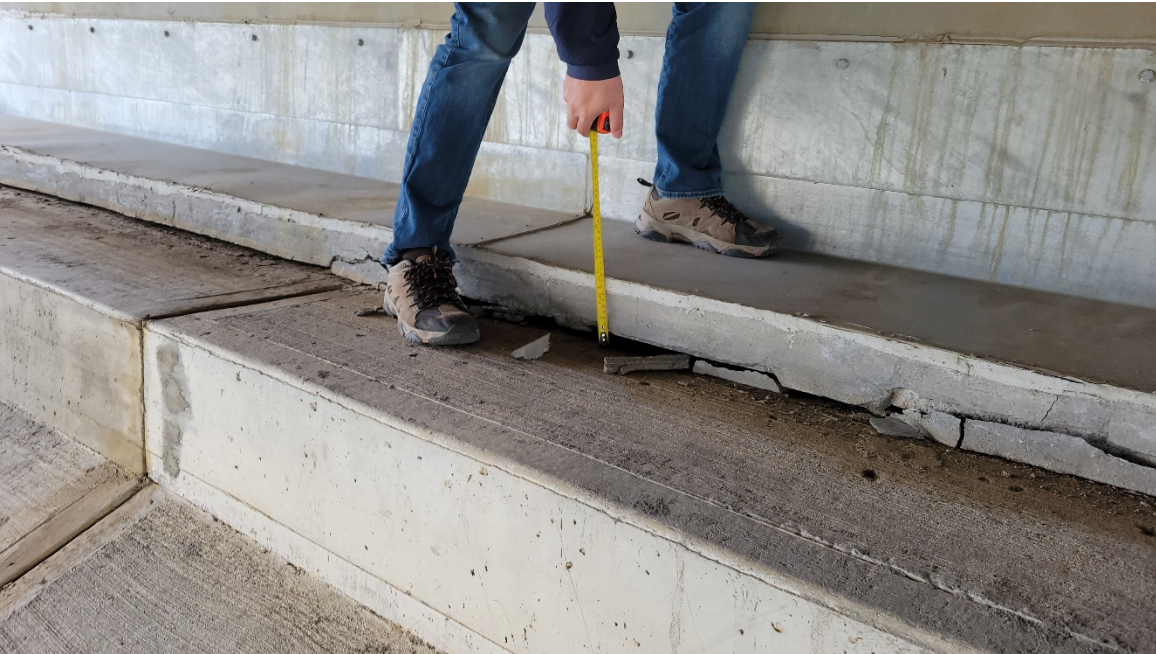
**Photo 6. Gap of up to 30 mm has developed between abutment seat and grout fill that was placed between 2024 and 2025 inspections.**

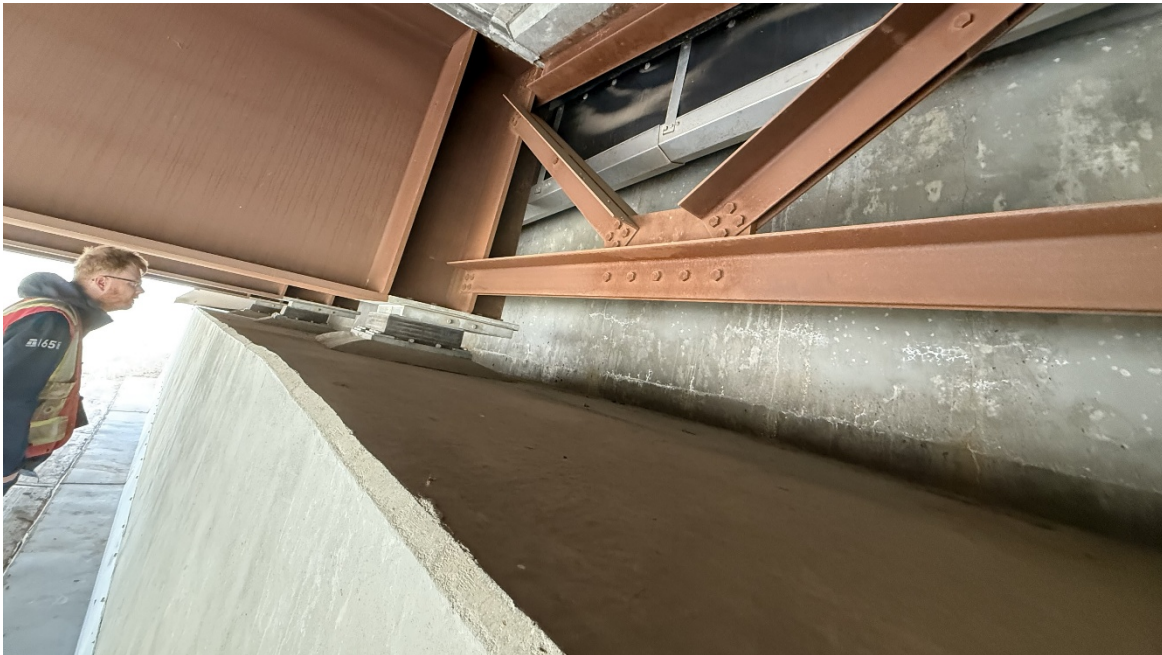
**Photo 7. Bridge bearings appear to be maxed out.**

A structural engineer should be consulted in the near future to (a) examine the condition of the bridge and assess whether the structure is performing as per the original design, and (b) provide recommendations for rehabilitation/repairs (if needed) and instrumentation monitoring of structural elements (if required).

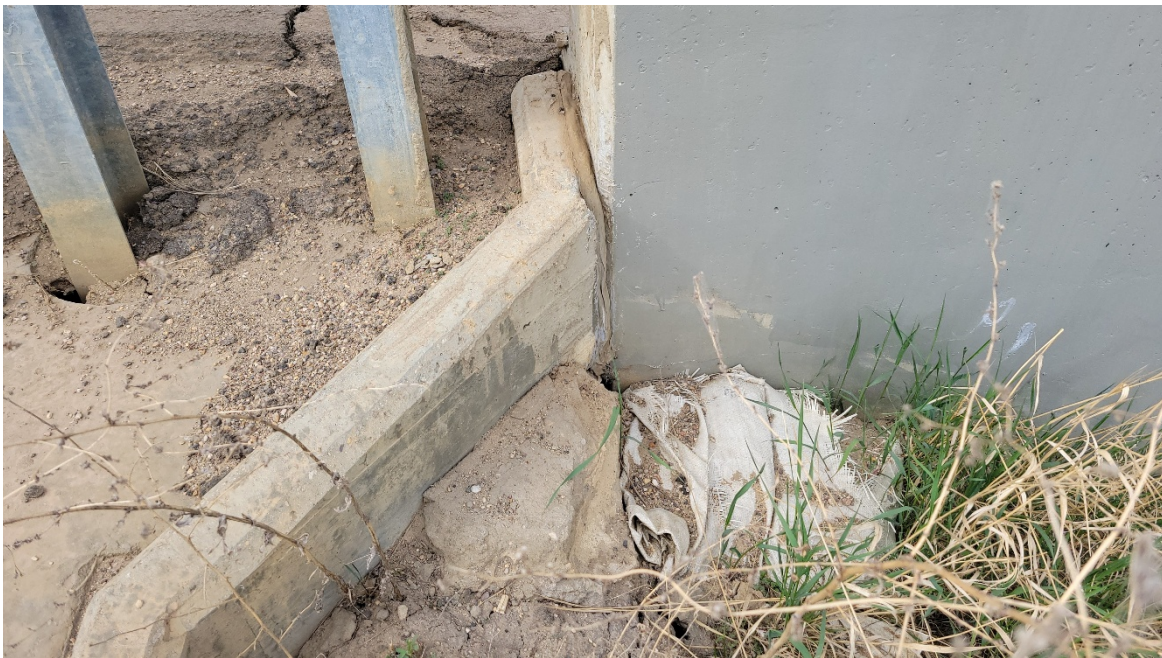
**Photo 8. South drain trough. The gap between the drain trough and wing wall was sealed with a flexible filler.**
