ALBERTA TRANSPORTATION AND  
ECONOMIC CORRIDORS GRMP  
NORTH CENTRAL (ATHABASCA AND FORT  
McMURRAY DISTRICTS)  
2025 SITE INSPECTION

| Site Number | Location | Name | Hwy | km |
|---|---|---|---|---|
| NC110 | Hamlet of Wabasca | Wabasca Lake Slip 'N Slide | 754:06 | 30.9 |

| | Date | PF | CF | Total |
|---|---|---|---|---|
| Current Inspection: | May 13, 2025 | 13 | 10 | 130 |

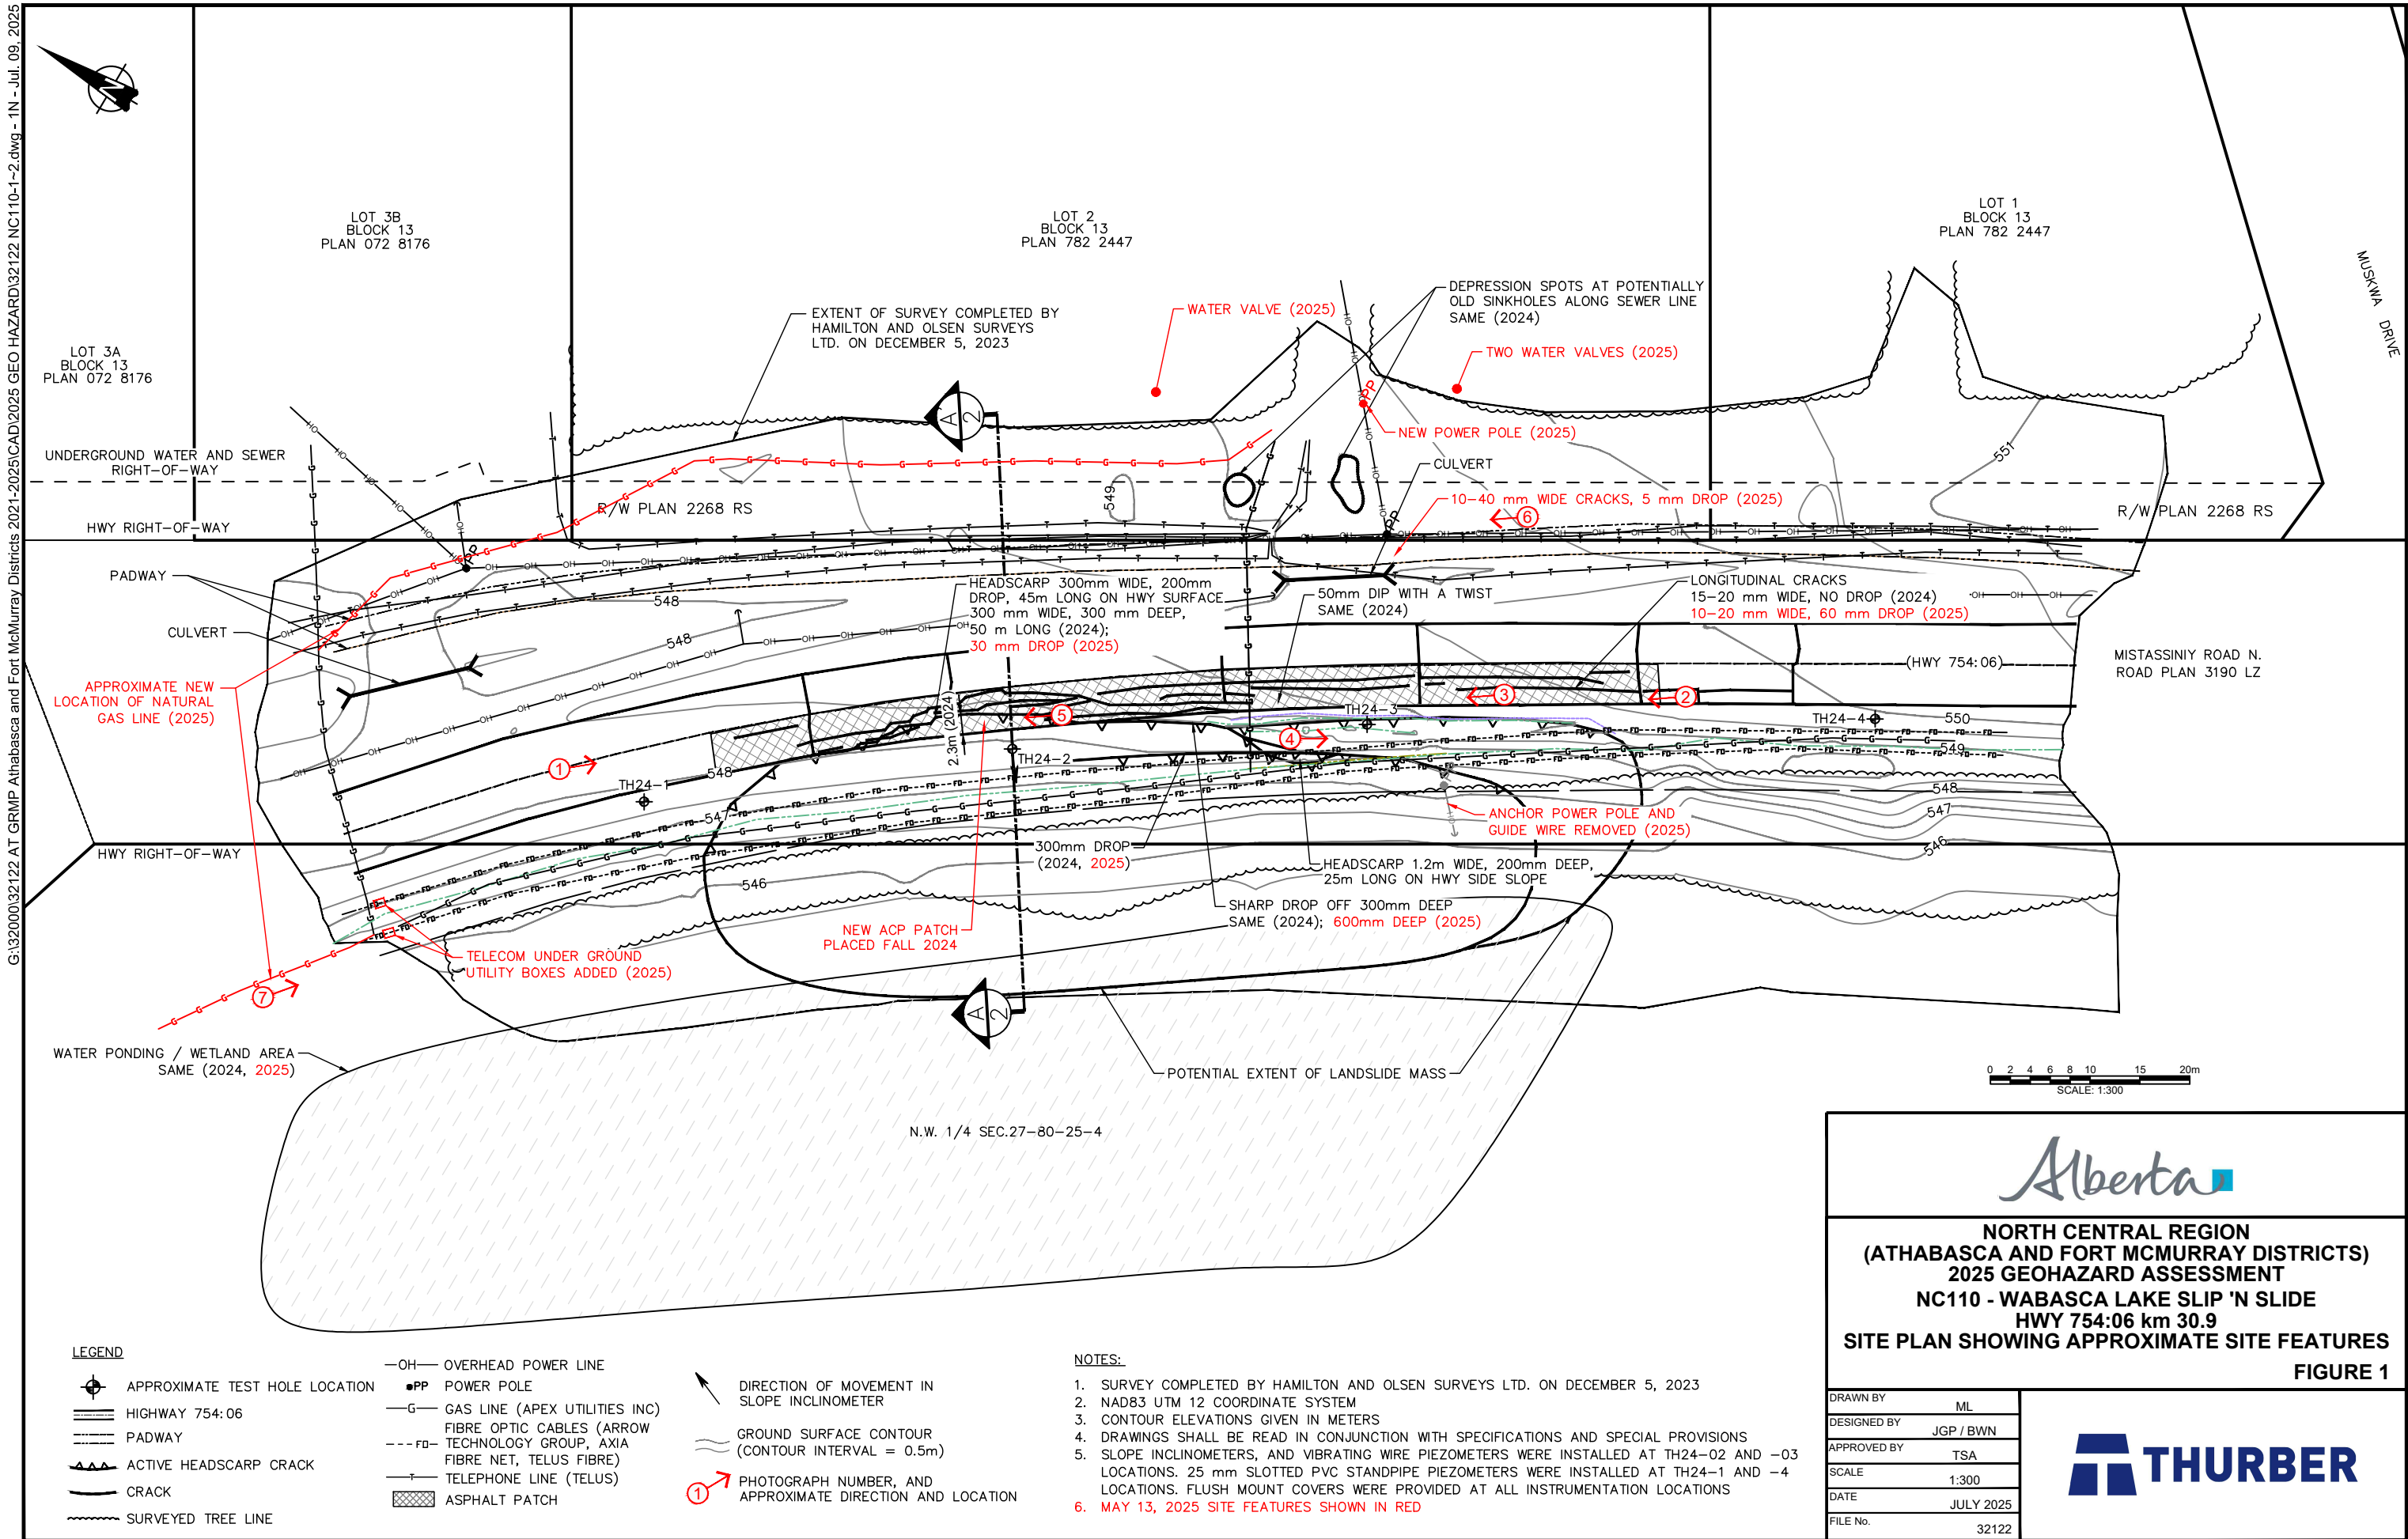
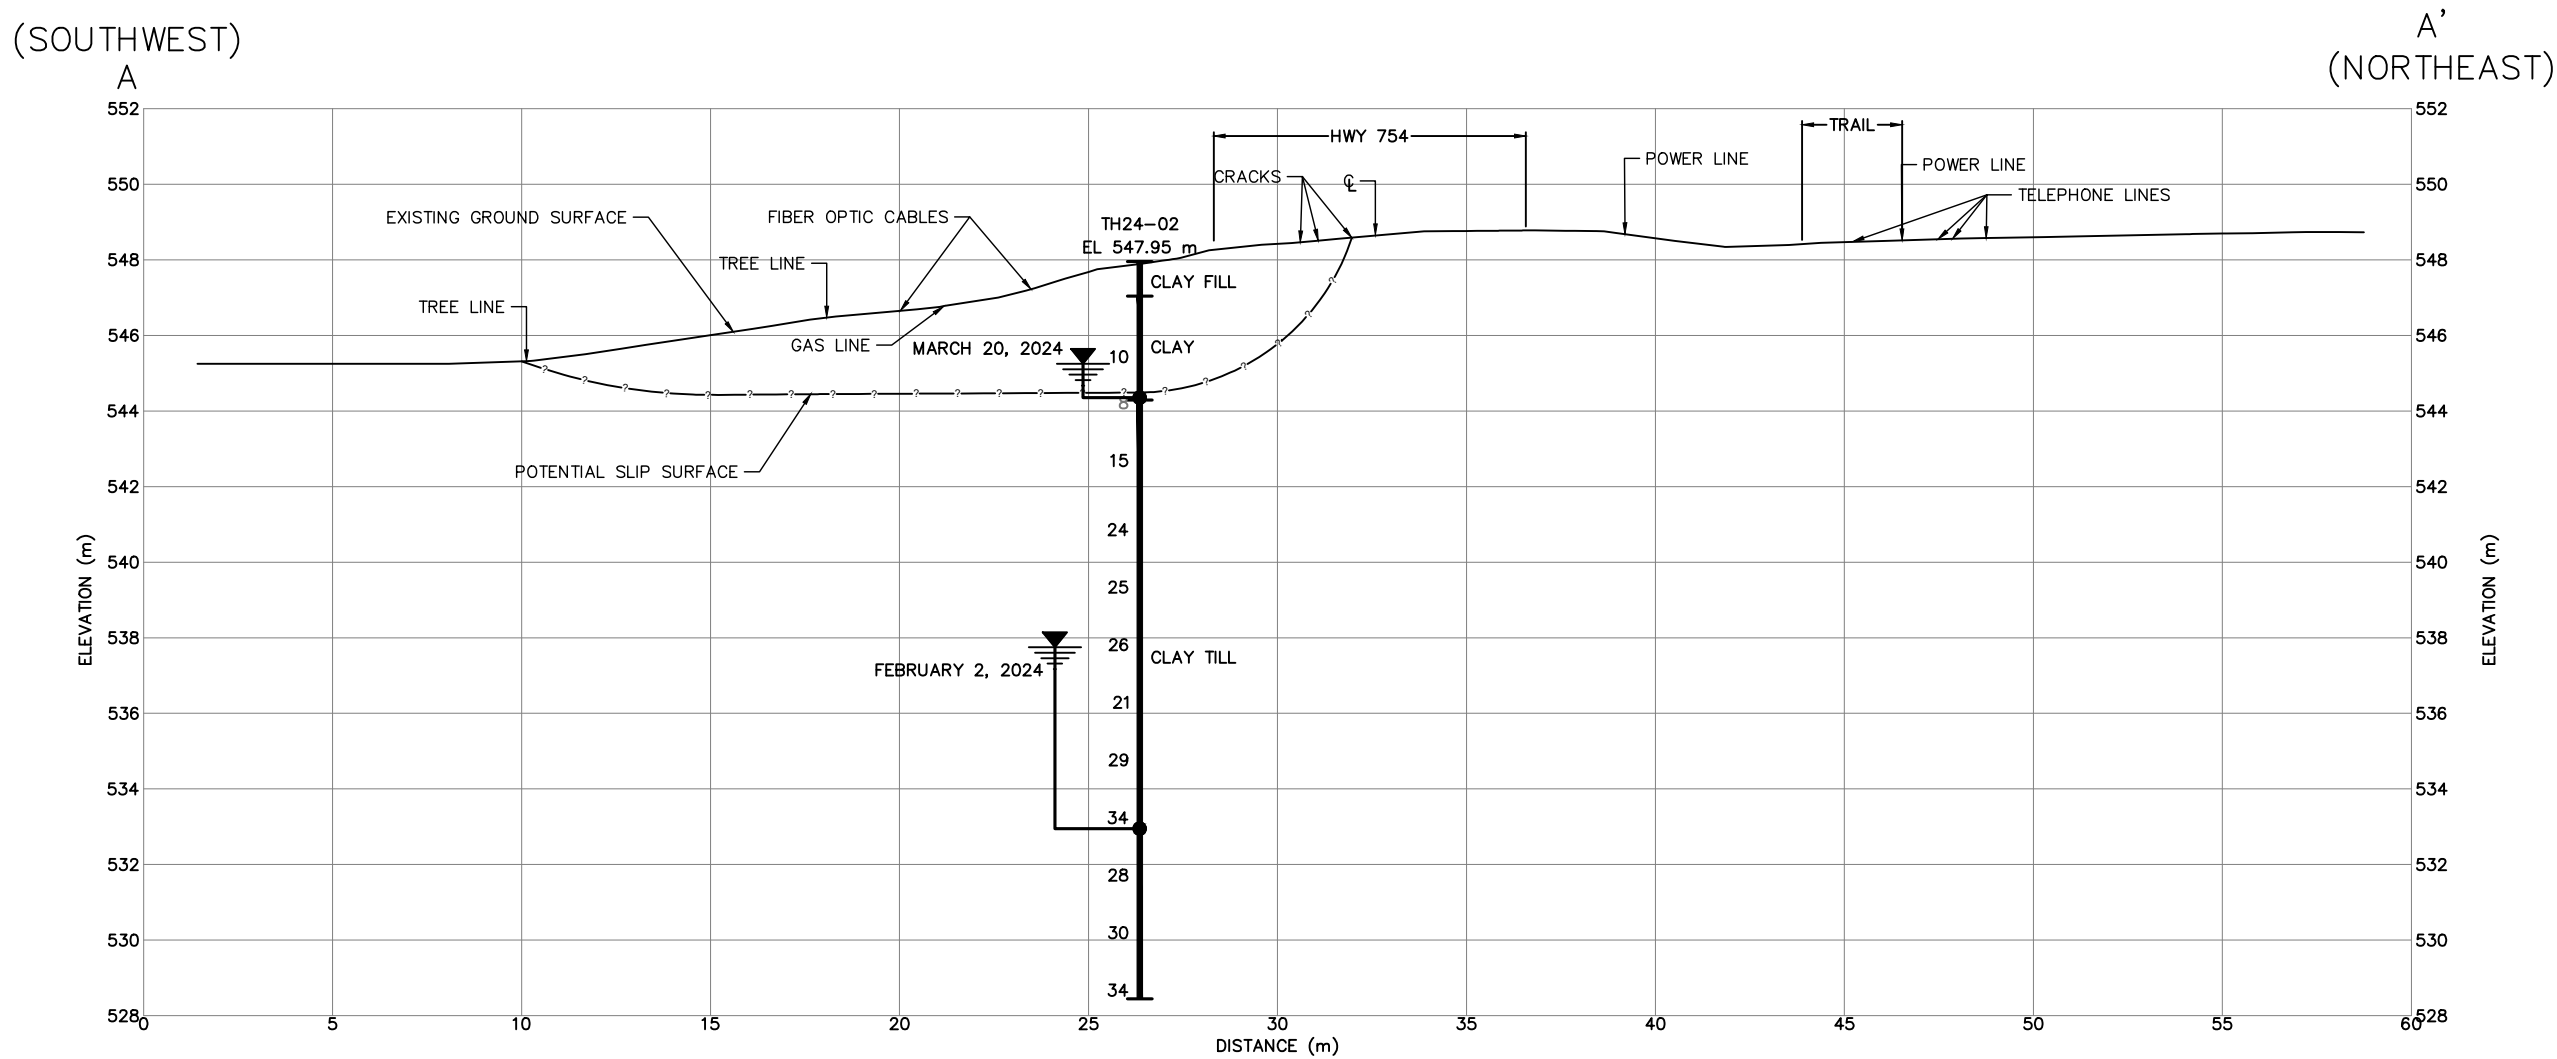
FIGURE 2

NORTH CENTRAL REGION  
(ATHABASCA AND FORT MCMURRAY DISTRICTS)  
2025 GEOHAZARD ASSESSMENT  
NC110 - WABASCA LAKE SLIP 'N SLIDE  
HWY 754:06 km 30.9  
SITE PLAN SHOWING APPROXIMATE SITE FEATURES

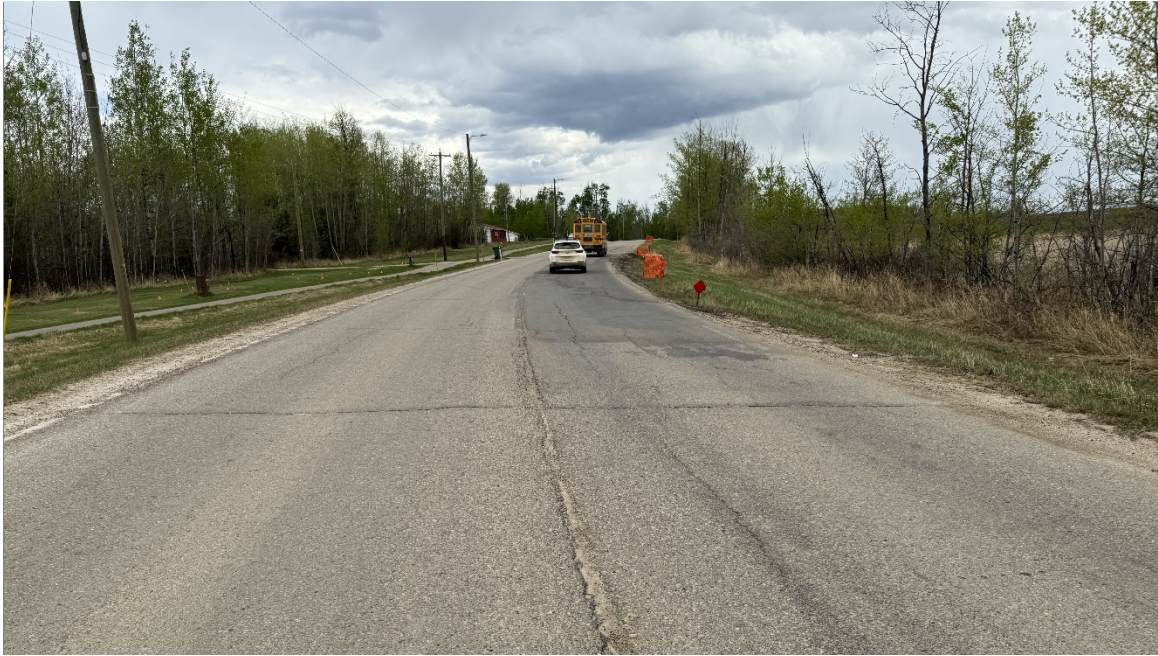
**Photo 1. Northern flank of landslide. Head scarp open cracks were filled with ACP in early Spring 2024.**

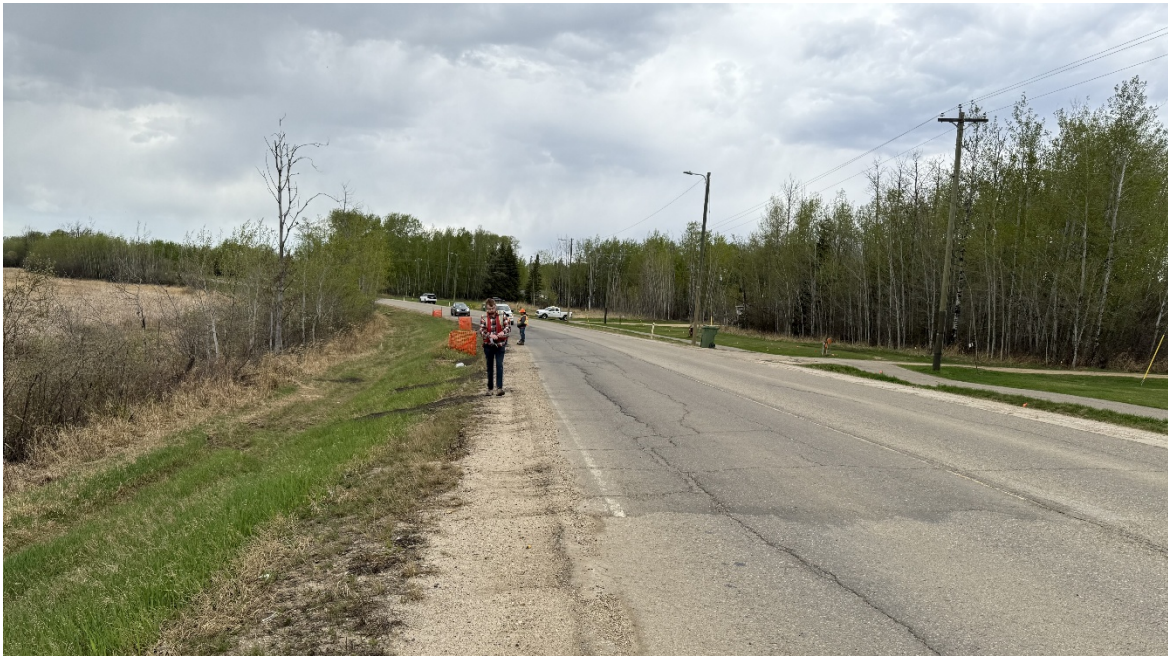
**Photo 2. Looking north at the landslide area. Note that Anchor Power Pole No. 3 on the west side of the highway has been removed since the 2024 inspection.**

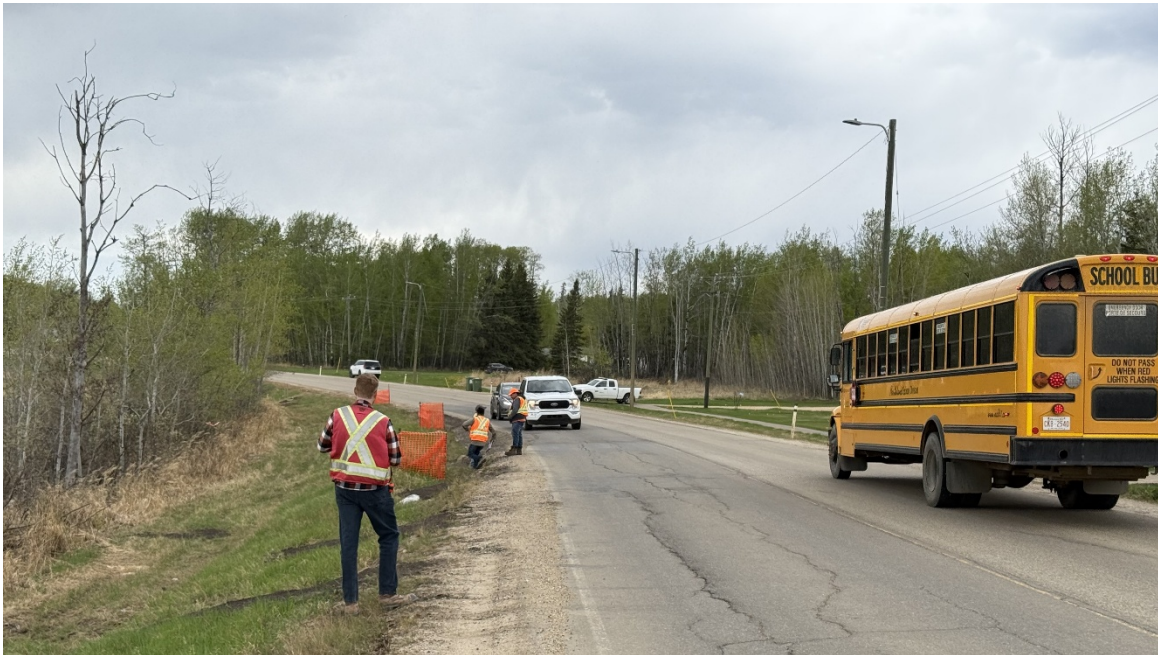
| Observations: | Description | Worse? |
|---|---|---|
| <input checked="" type="checkbox"/> Pavement Distress | 30 mm drop within the SBL bounded by landslide scarp cracks for a distance of about 50 m within the northern section of the landslide; Drop of 60 mm in pavement near the southern flank of the slide. Overall dip in pavement has reduced since previous inspection due to recent ACP patch. | <input type="checkbox"/> |

**Photo 3. Longitudinal cracks (10-20 mm wide, 60 mm drop) within the previously patched area.**

- The MCI should monitor the highway condition on a regular basis and seal all open cracks as they re-appear on the highway surface.
- ACP patches should be placed if further drop of the pavement is observed.
- A landslide warning sign should be placed off the highway surface to warn motorists of the existing hazard.

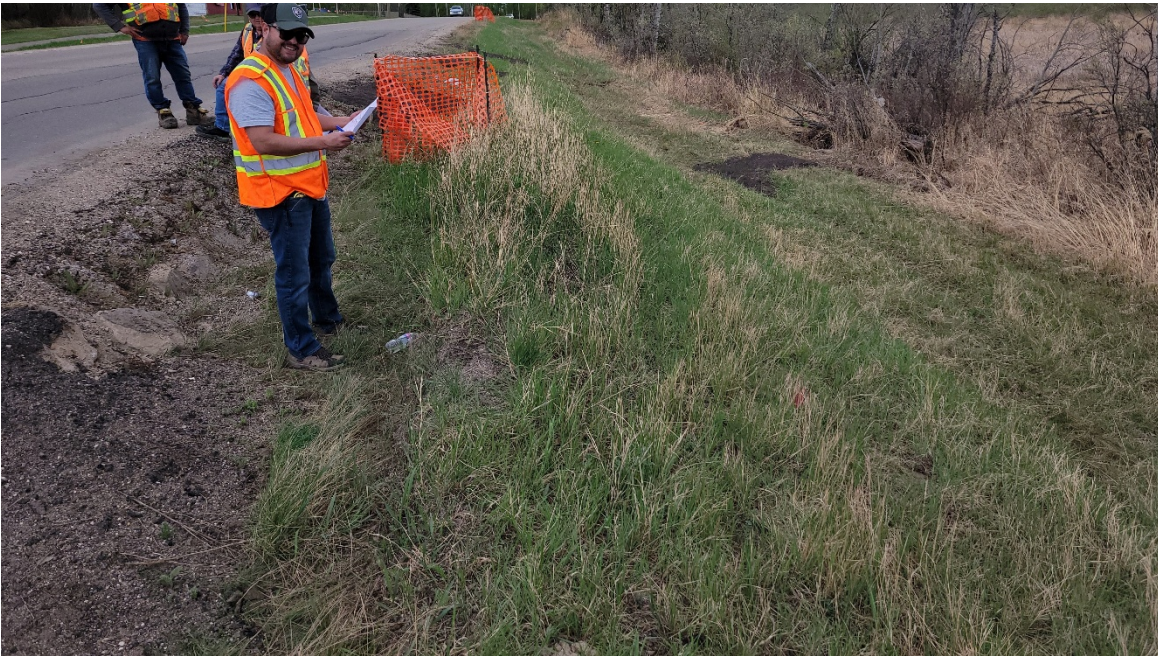
| Observations: | Description | Worse? |
|---|---|---|
| <input checked="" type="checkbox"/> Slope Movement | Cracks in pavement area are less pronounced since last inspection due to ACP patch. Sharp highway shoulder drop off between TH24-1 and TH24-3 has increased to 600 mm. | <input checked="" type="checkbox"/> |

**Photo 4. Southern flank of the landslide (looking south); 600 mm drop visible from the highway. Note the topsoil patch at the right-hand side of the photo where Anchor Power Pole No. 3 was removed after the 2024 inspection.**

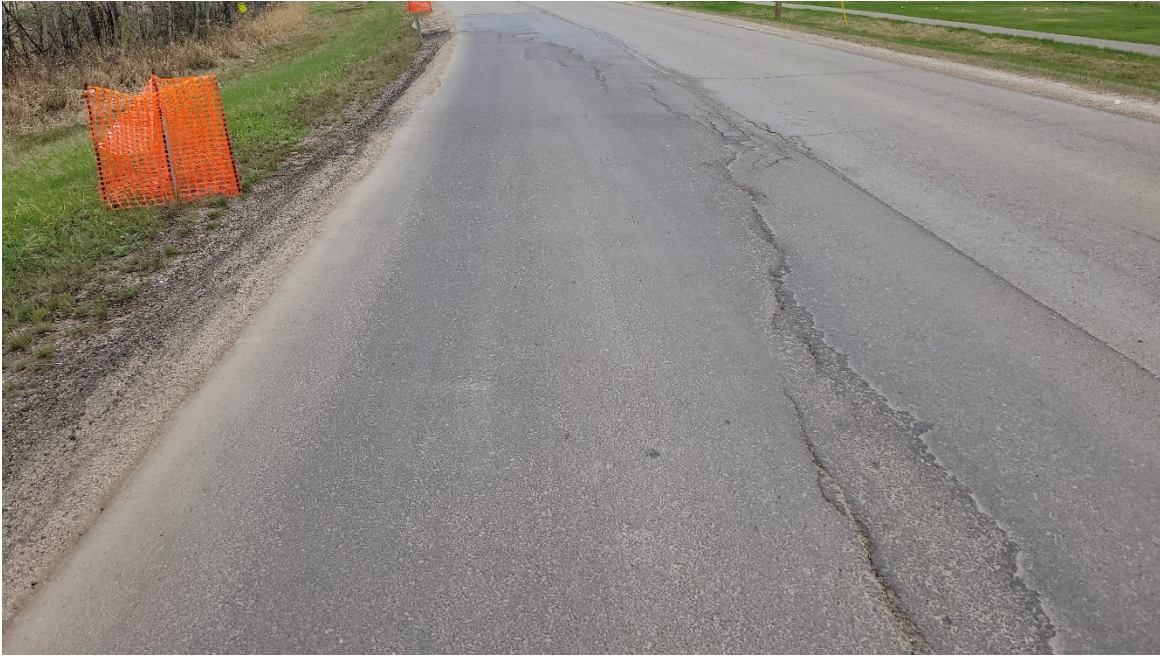
**Photo 5. Looking north at the severely impacted section of the highway by the landslide movement. Area was patched after the 2024 inspection.**

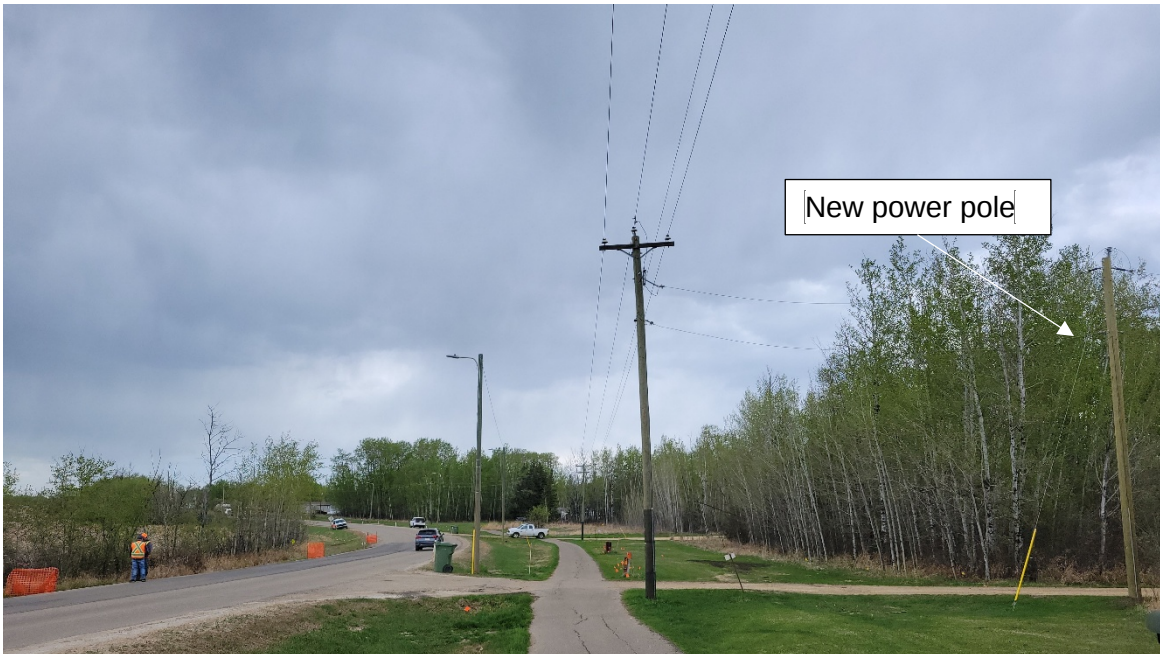
| <input checked="" type="checkbox"/> Other | Multiple underground utilities within the sliding mass; including fiber optics, Telus, gas, and overhead ATCO cables. Gas and fibre optic lines appear to have been relocated to the east of the highway around the landslide area after the 2024 inspection. The anchor power pole and guide wire connected to power pole were removed since the previous inspection – tilt in power pole no. 2 is significantly reduced as a result. | <input type="checkbox"/> |

**Photo 6. Looking north from the east side of the highway at Power Pole No. 2, which has a much less pronounced tilt since the anchor pole has been removed. Note the new power pole installed after the 2024 inspection.**

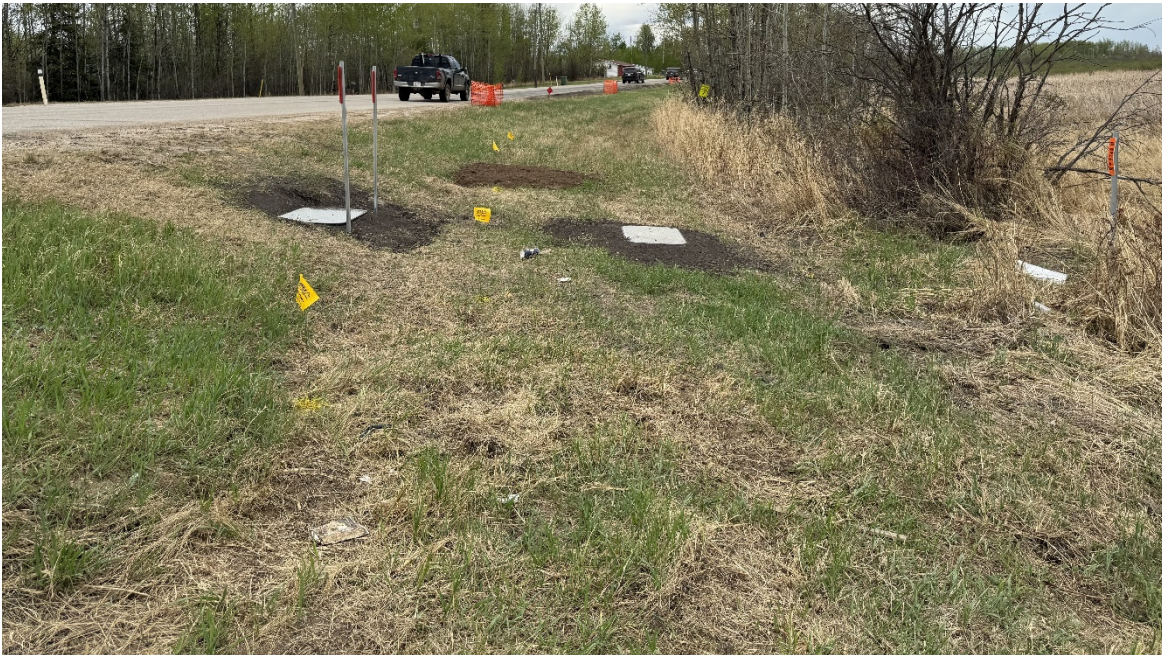
**Photo 7. Looking south from the west side of the highway. Two utility boxes are visible where the fibre optic lines have been rerouted to the west side of the highway. The Apex Utilities gas line has also appear to have been rerouted across the highway at this location. |**

We have no records to confirm the relocation of all utility lines away from the landslide area. TEC should confirm if all utility relocations have been conducted and if so, the risk rating at this site may be reduced to 65 (PF of 13 x CF of 5).
