**ALBERTA TRANSPORTATION AND  
ECONOMIC CORRIDORS GRMP  
NORTH CENTRAL (ATHABASCA AND FORT  
McMURRAY DISTRICTS)  
2025 SITE INSPECTION**

| Site Number | Location | Name | Hwy | km |
|---|---|---|---|---|
| NC093 | 22 Km north of Calling Lake | Rock Island Bridge (79692) Landslide | 813:06 | 4.70 |

| <b>Primary Site Issue</b> | Landslide within the NW approach fill of Bridge File (BF) 79692, impacting NW wing wall, highway and abutment supports |

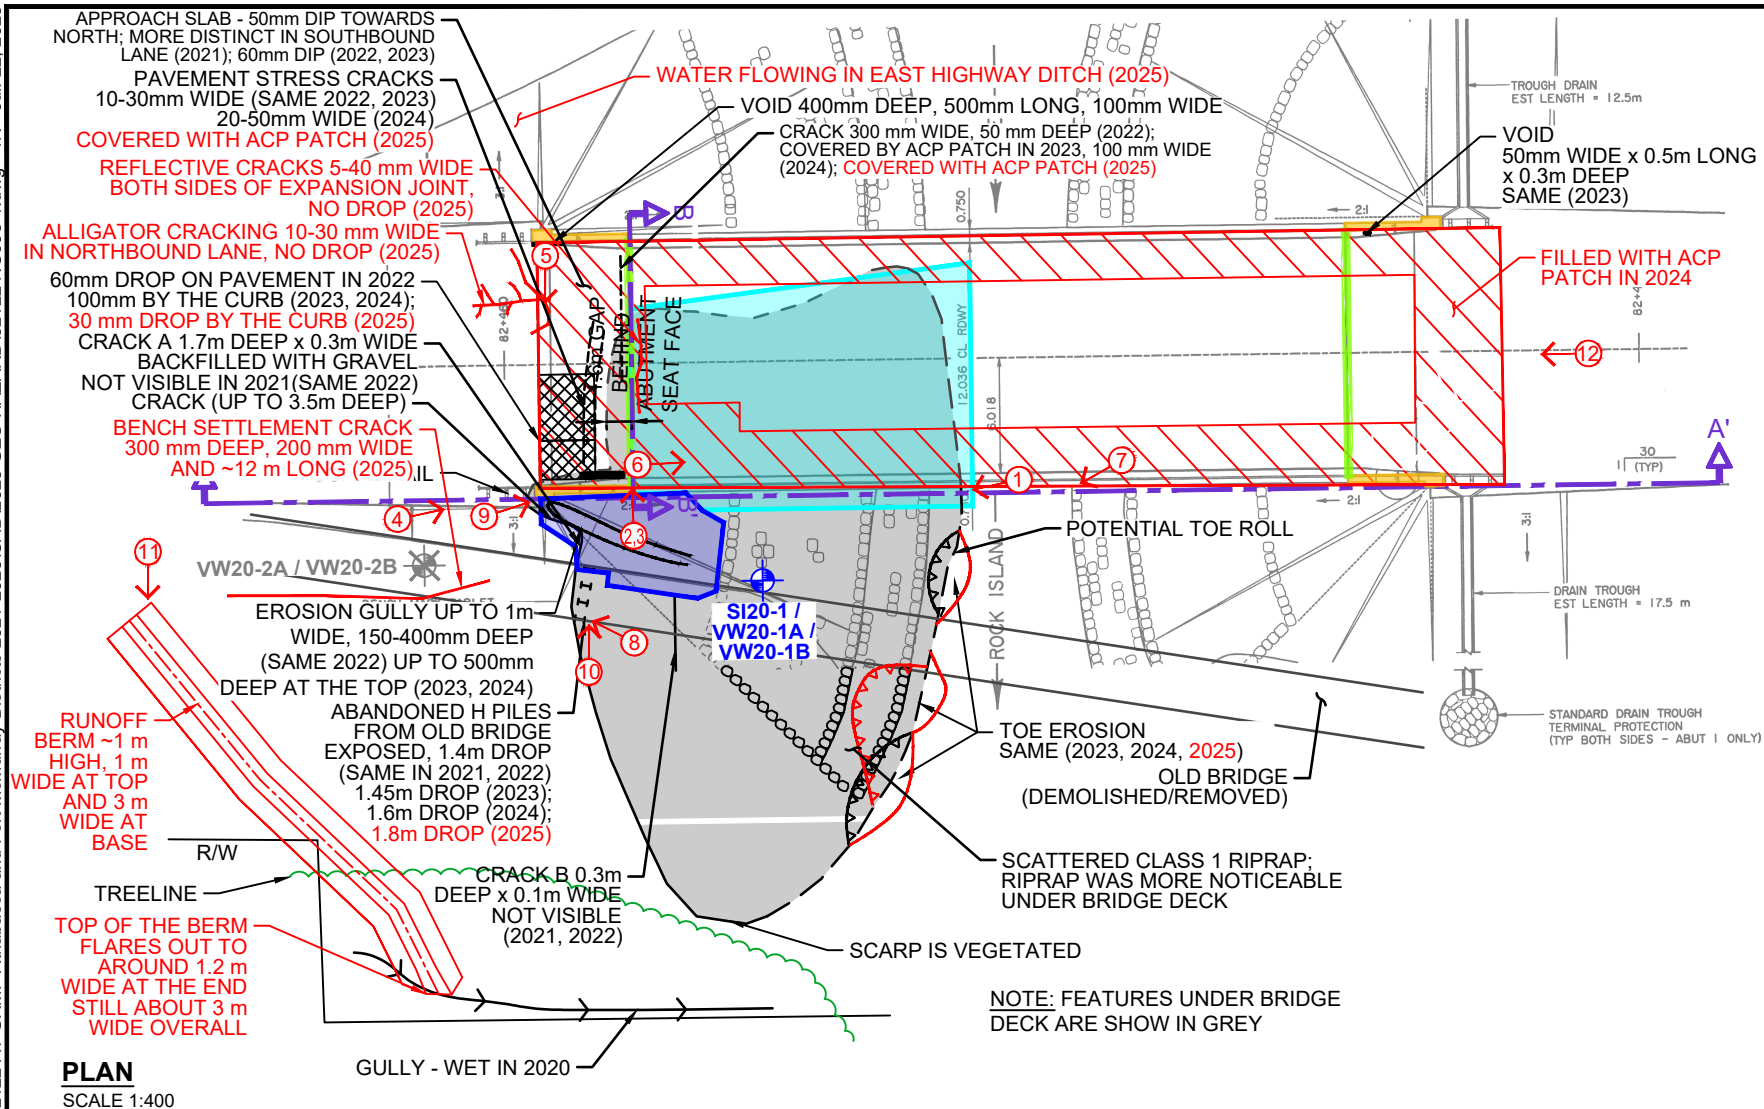
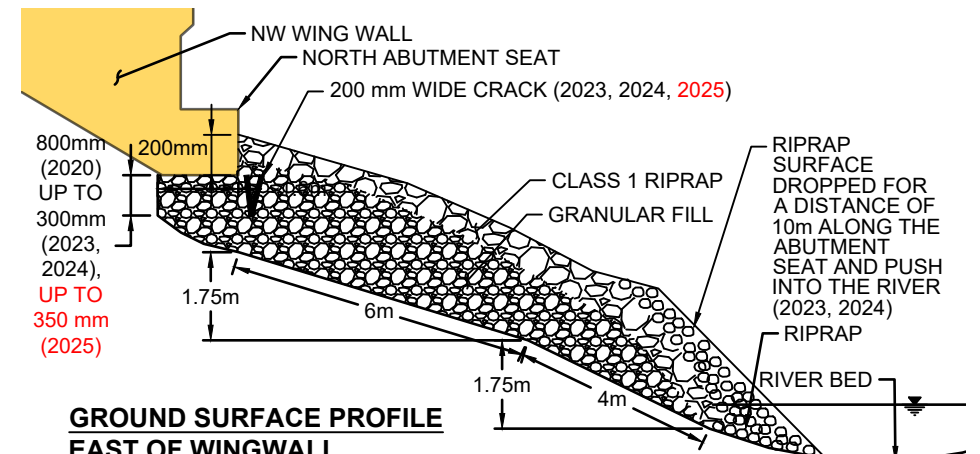
DWG NO. 32122-NC093-1

GAP BETWEEN BOTTOM OF WINGWALL AND GROUND SURFACE:  
A: 300mm  
B: 200mm  
C: 800mm

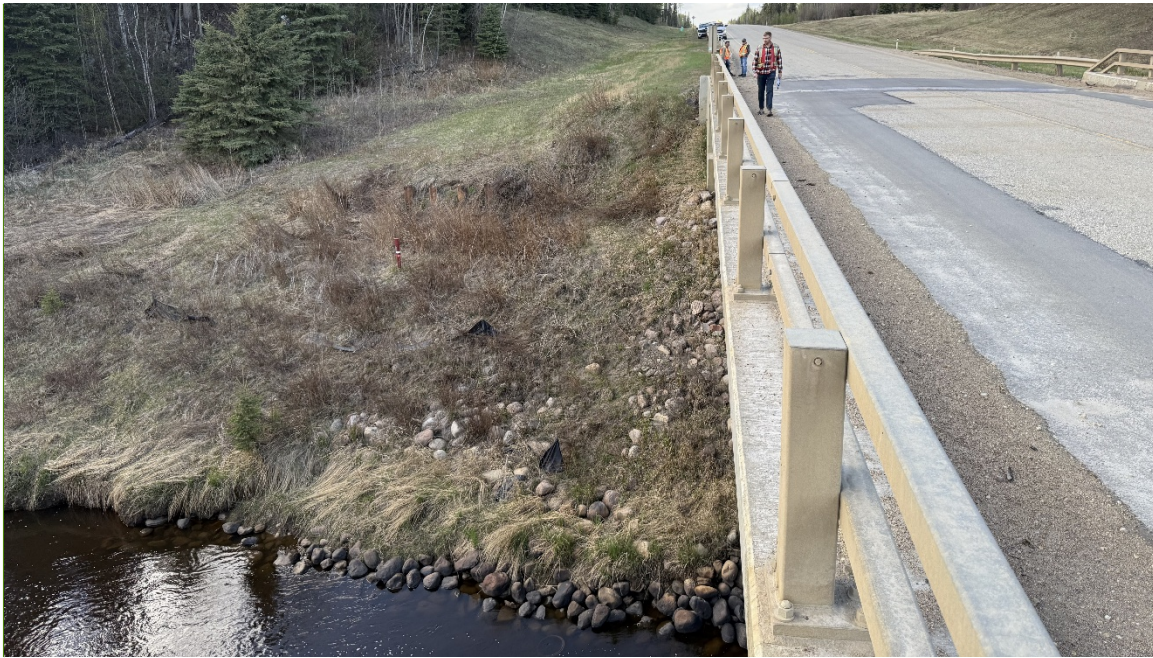
**Photo 1. Landslide area viewed from bridge (looking north).**

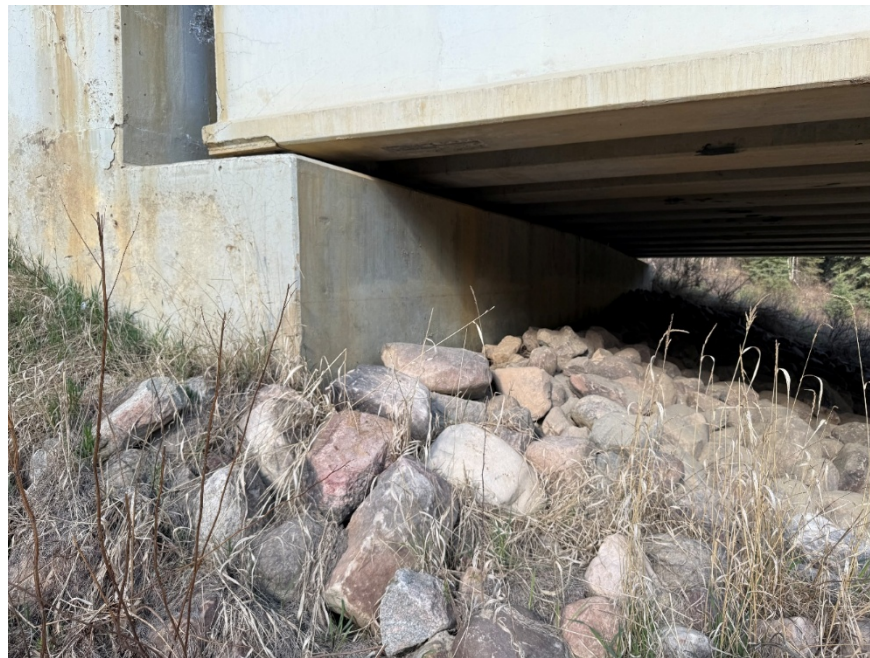
The temporary repairs completed by TEC have performed relatively well to date. However, the landslide is still active as evidenced from the existing vertical and lateral movements of the riprap within the bridge headslope, and the existing drop along the approach slab. The gap formed along and below the abutment seat will continue to get bigger unless repaired and may result in the exposure of a few of the abutment supports.

**Photo 2. North Abutment (looking east) showing riprap placed by TEC in 2021; The riprap top surface appears to have dropped for a distance of about 10 m along the face of the abutment seat and the riprap along this zone shifted laterally towards the river.**

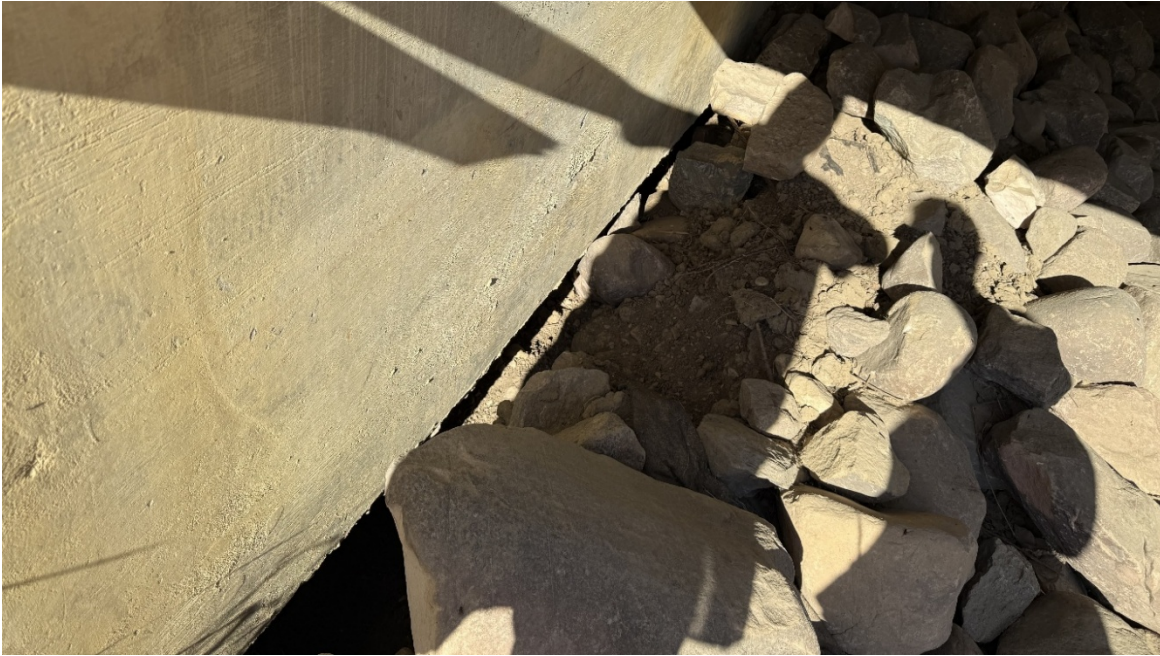
| <input checked="" type="checkbox"/> Slope Movement | The landslide exposed the upper 1.8 m of four of the old bridge piles; riprap placed on the bridge headslope dropped and shifted laterally towards the river; 2.7 m long crack along the face of the abutment seat (crack is about 2.7 m long (parallel to the abutment seat, 200 mm wide, and up to 350 mm deep below the abutment seat). | <input checked="" type="checkbox"/> |

**Photo 3. A closer look at the NW corner of the abutment seat. There is a 2.9 m long gap formed along the face of the abutment seat.**

- Place additional gravel or low strength fillcrete to fill the gap formed along the face of the abutment seat.
- Consider placing sandbags or extending the NW concrete curb further north to ensure that runoff is diverted away from the landslide area. Consideration may also be given to installing a half CSP pipe along the highway NW side slope to direct surface water away from the landslide area and the northern edge of the wingwall.
- Add granular fill or riprap to backfill the erosion gully developed near the NW wing wall.
- Place riprap within eroded areas at the toe of the slope.

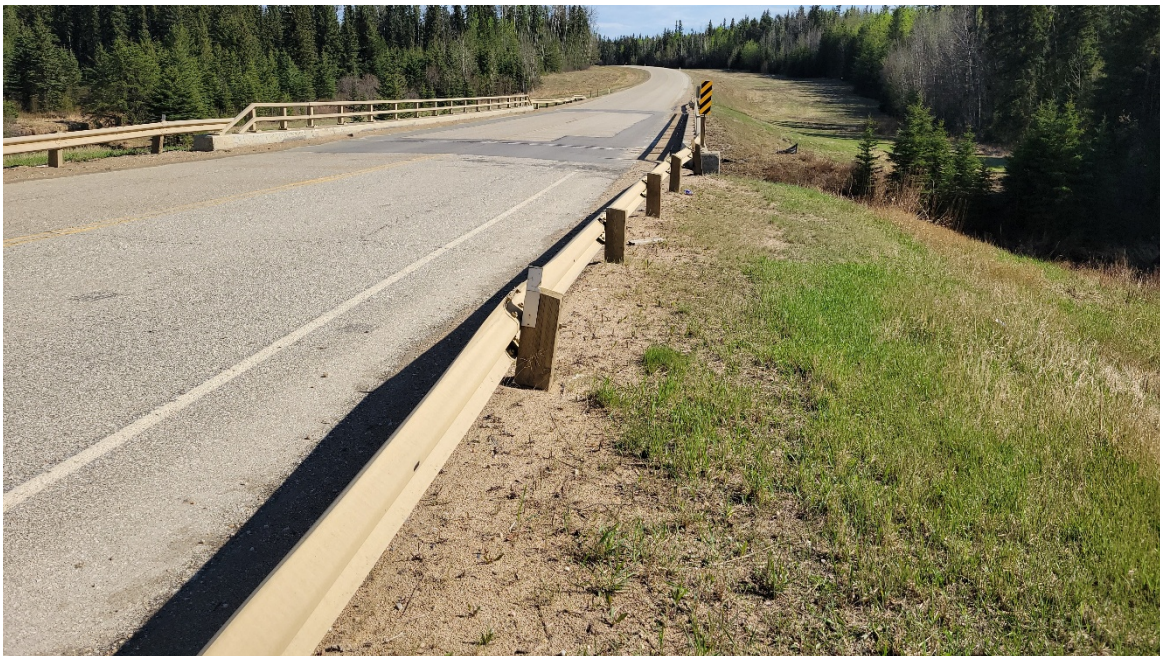
**Photo 4. Bridge deck and highway surface condition (looking north at the south expansion joint). The previously distressed pavement area has been patched since the 2024 inspection.**

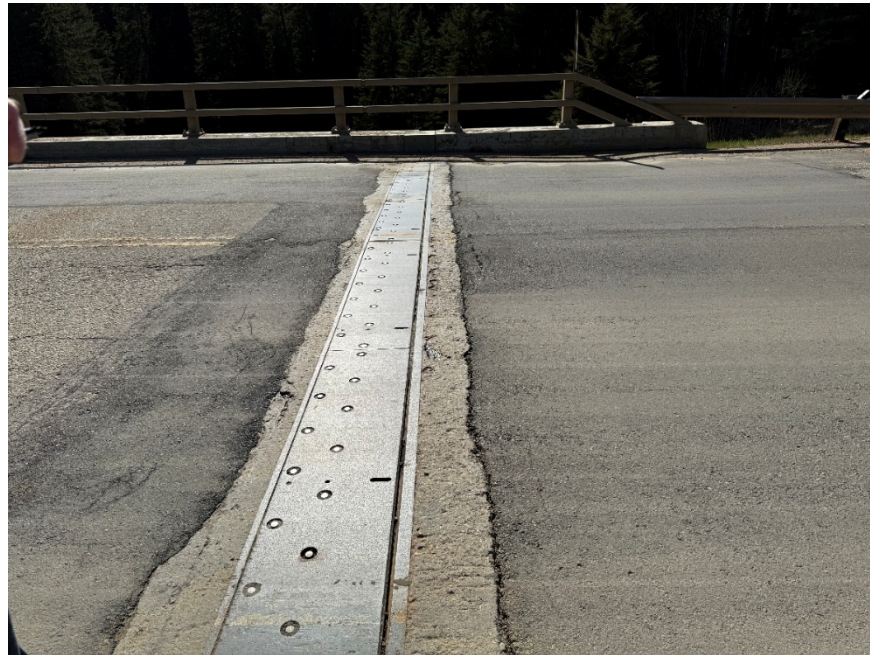
**Photo 5. Looking at the north expansion joint. The area of distressed pavement area around the expansion joint has been patched since the 2024 inspection.**

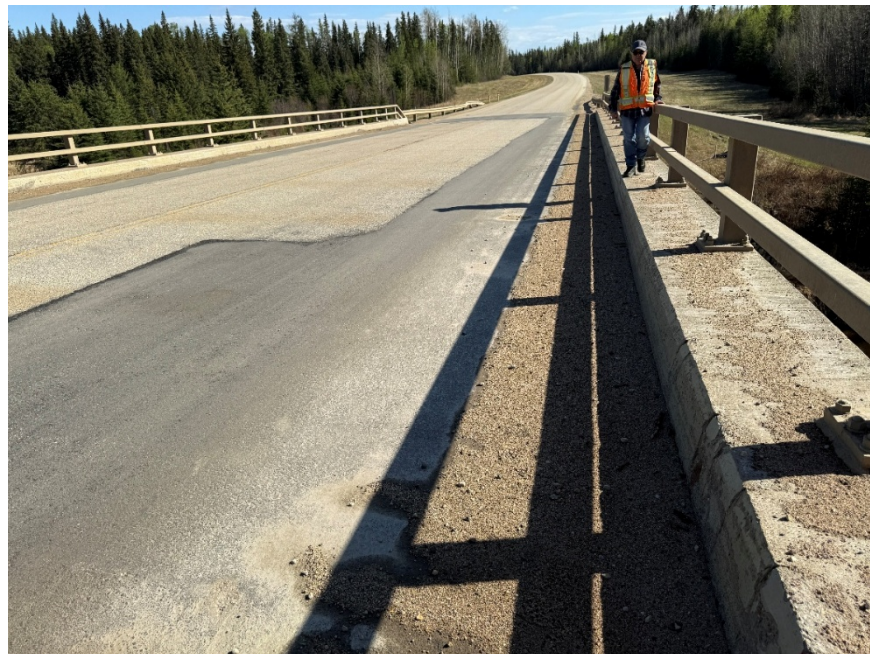
**Photo 6. Patched area of previously failed pavement on bridge deck (looking south)**

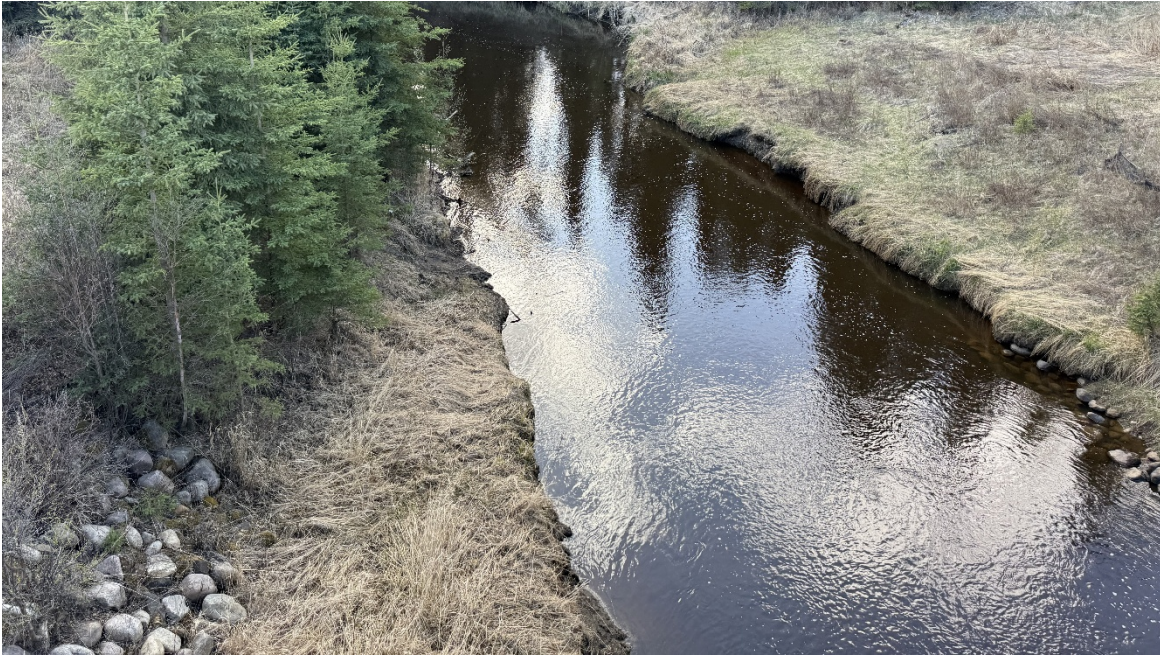
Ongoing toe erosion by the river resulted in the development of two distinct slumps immediately above the stream level. These slumps may get bigger in size and result in a significant loss of toe support at the base of the slope and hence an accelerated movement of the landslide.

**Photo 7. Toe of NW head slope and river channel.**

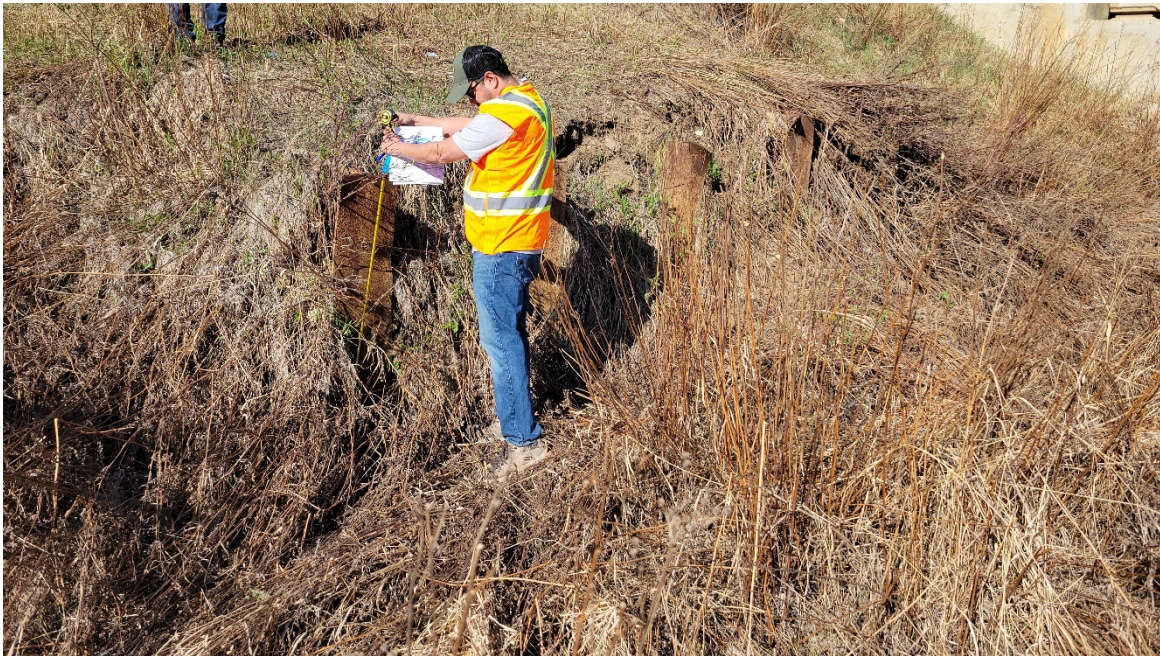
The site condition did not change significantly since the 2024 site inspection, with the exception of the ACP patch completed on the bridge deck and approach slabs. The drop within the landslide measured by the old bridge piles has also increased by 0.2 m to 1.8 m overall.

**Photo 8. Exposed old bridge H piles within the active landslide mass. The landslide has a 1.8 m drop at this location.**

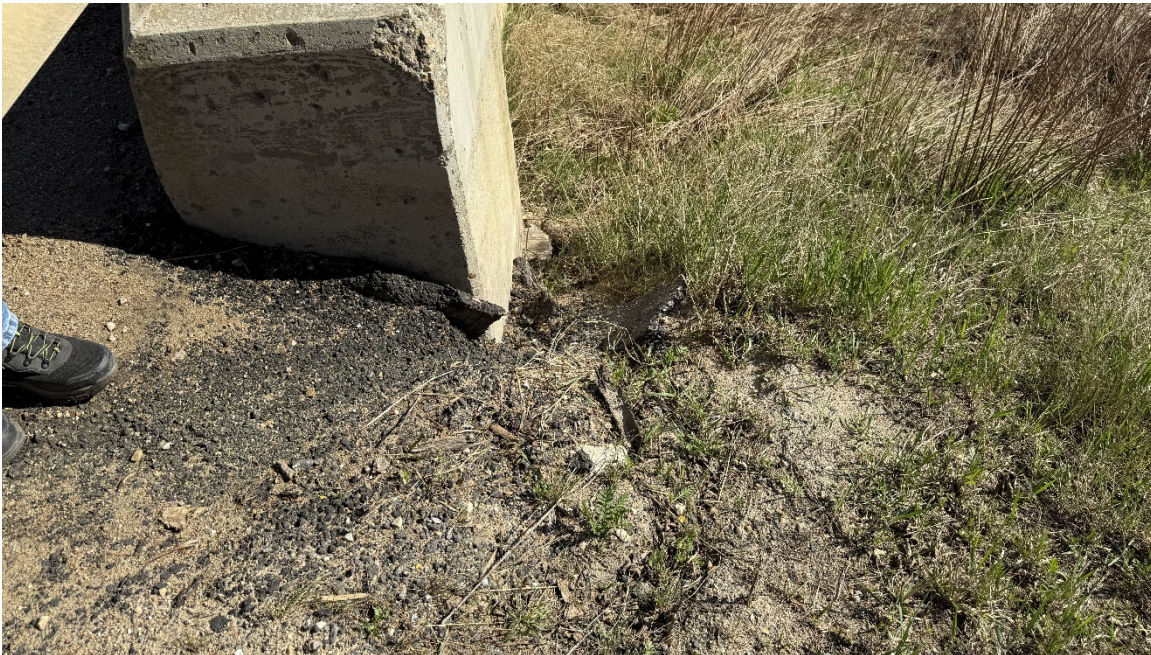
**Photo 9. Void that had formed between the highway side slope and the top edge of the NE wingwall has been filled with ACP since the 2024 inspection.**

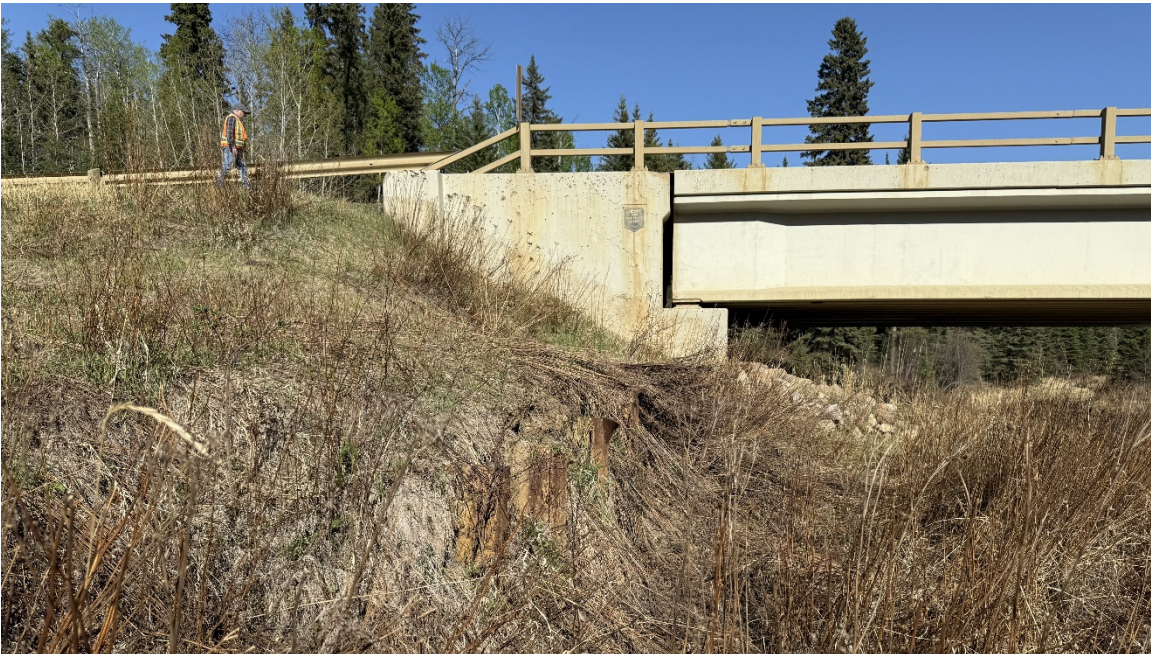
The settlement of the approach slab created a low spot at the north edge of the NW wing wall (on highway side) and hence surface drainage from the highway is currently directed towards the NW approach fill side slope rather than to the south side of the bridge as per the original design. The erosion gully developed within the recently placed gravel fill is a direct consequence of concentrated surface water runoff along the face of the NW wing wall. The erosion gully will likely continue to grow bigger in size, and this may result in future exposure of the underside of the wing wall.

**Photo 10. Northwest wingwall: soil staining on the wall face shows original design elevation of fill; approximately 1 m of gravel was placed in 2020 to buttress/cover the gap formed below the wing wall; vegetation has grown within the backfilled area since 2020; erosion up to 500 mm at the top developed within new fill placed against the wing wall (area with erosion had been filled with ACP).**

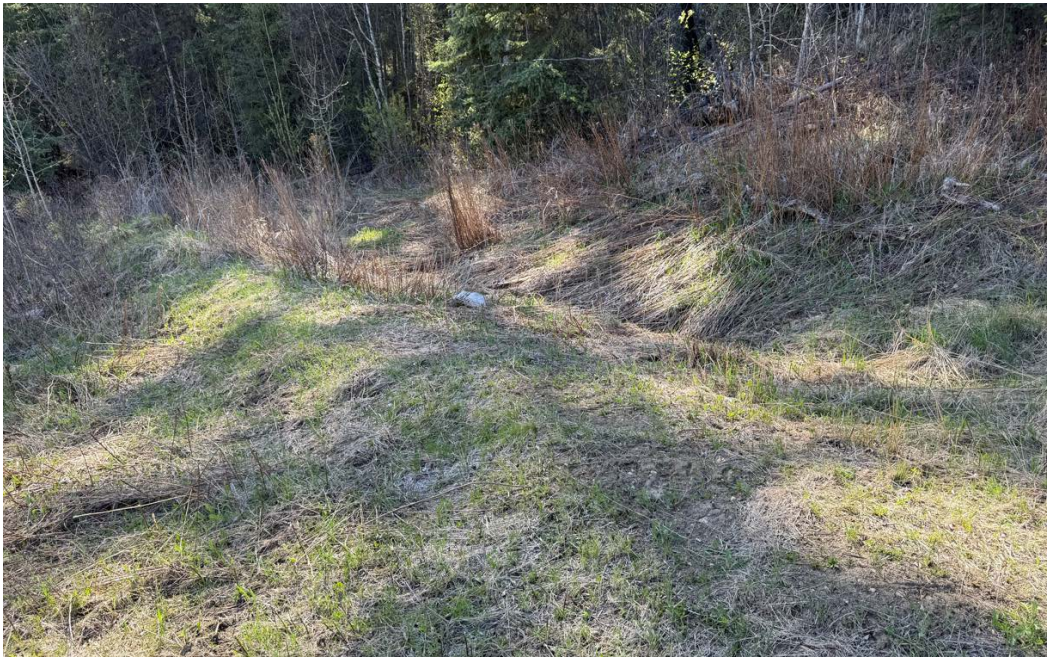
**Photo 11. Ditch Runoff Berm – Well vegetated, no flow noted in 2025.**

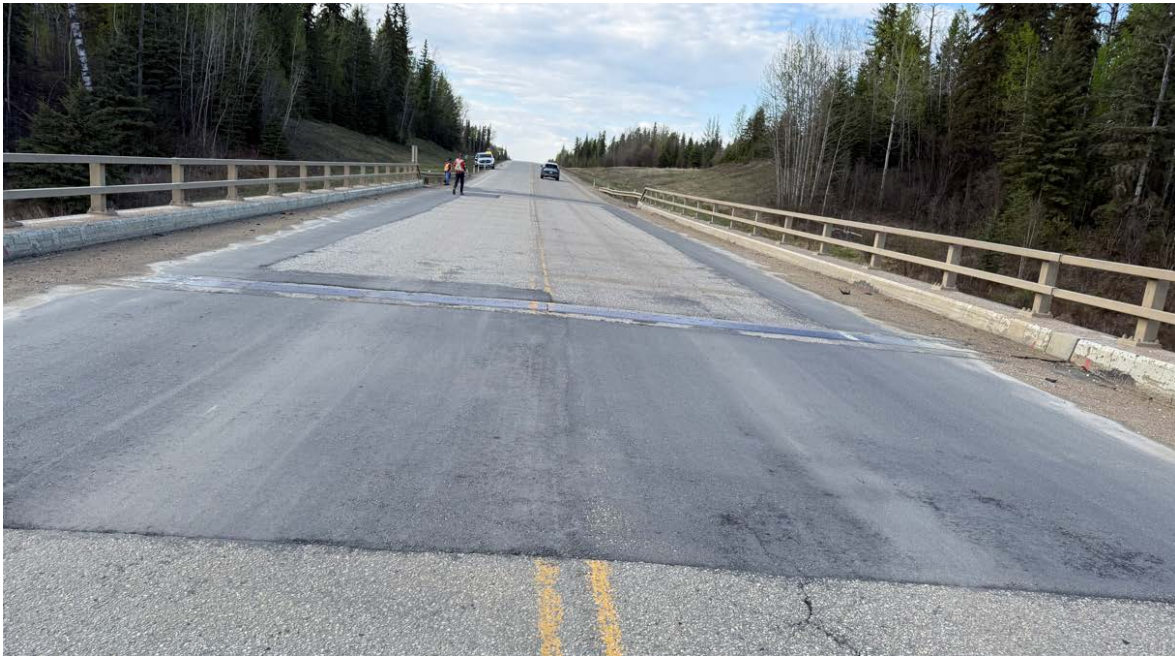
**Photo 12. Looking north at the overall bridge deck surface condition. Note new ACP patch placed in 2024.**
