ALBERTA TRANSPORTATION AND  
ECONOMIC CORRIDORS GRMP  
NORTH CENTRAL (ATHABASCA AND FORT  
McMURRAY DISTRICTS)  
INSTRUMENTATION MONITORING - SPRING 2025

| Site Number | Location | Name | Hwy | km |
|---|---|---|---|---|
| NC093 | HWY 813:06, C1 4.631 | Rock Island Bridge | 813:06 | km 4.6 |

**SITE NC093: HWY 813 ROCK ISLAND RIVER BRIDGE NW APPROACH FILL LANDSLIDE  
(BF79692)**

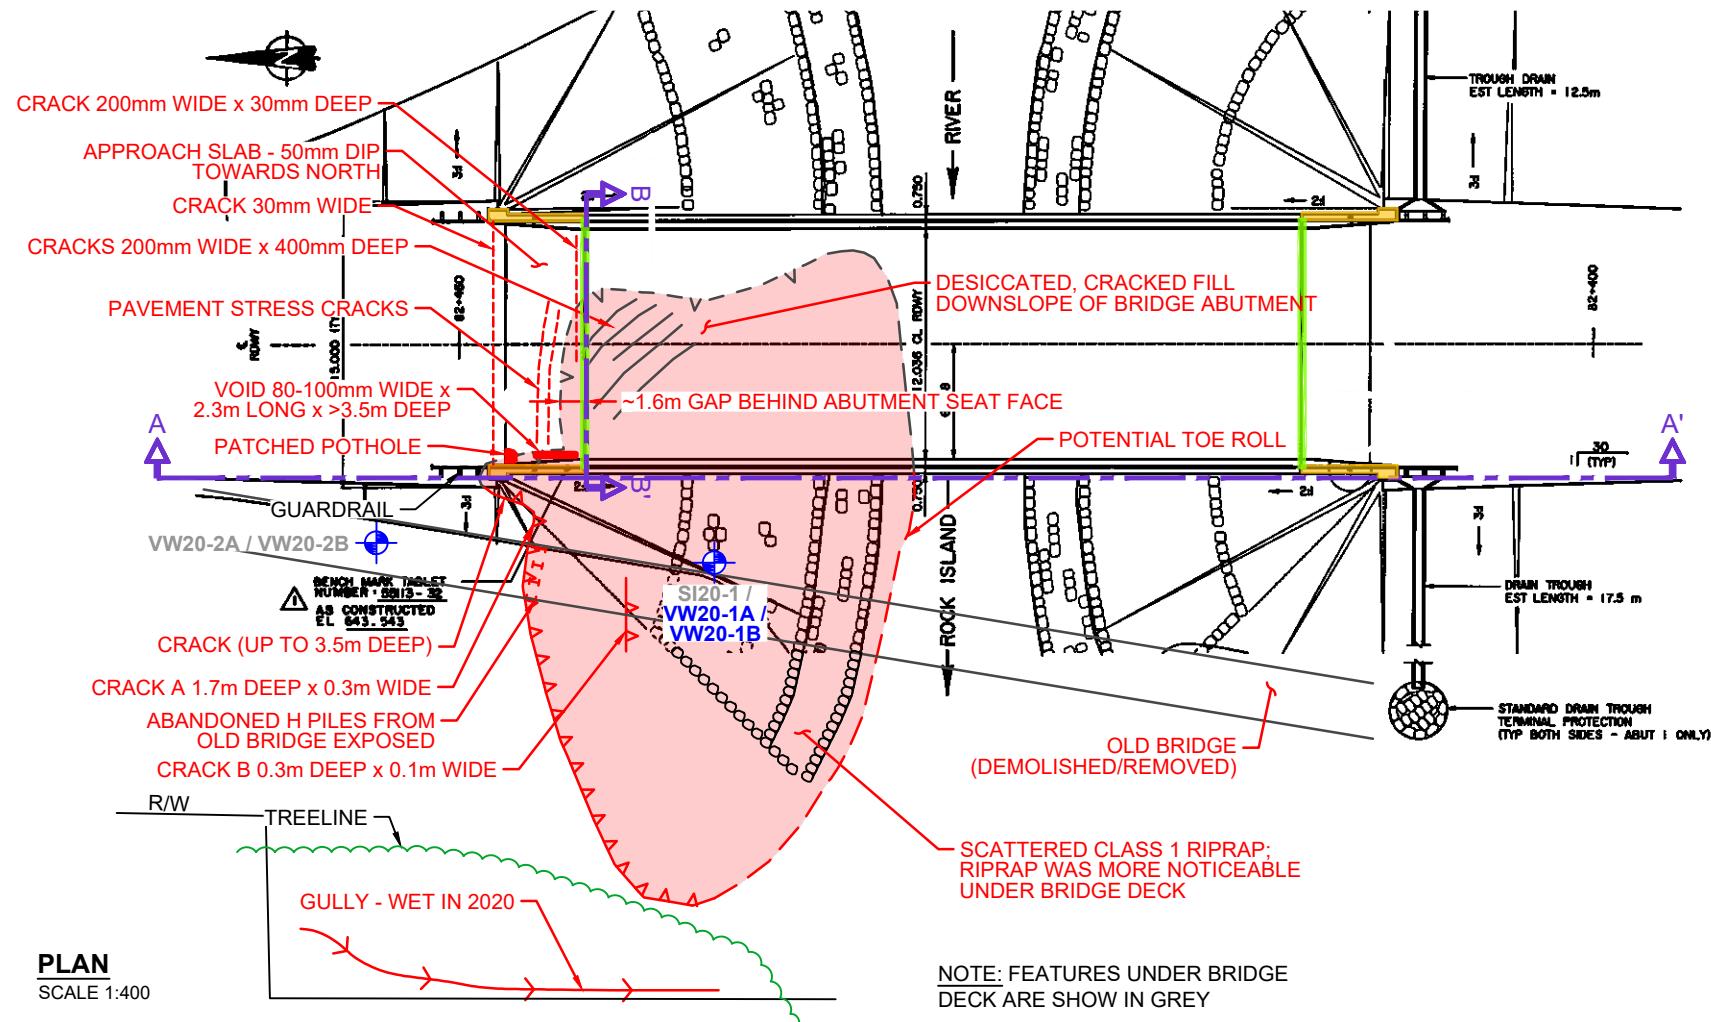
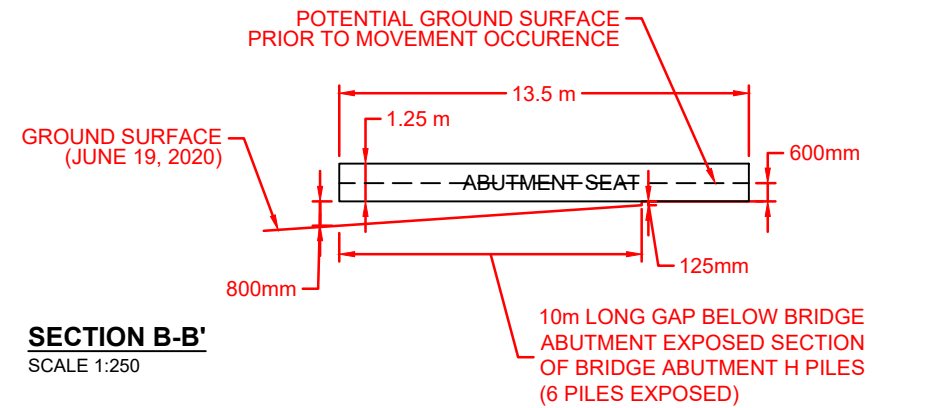
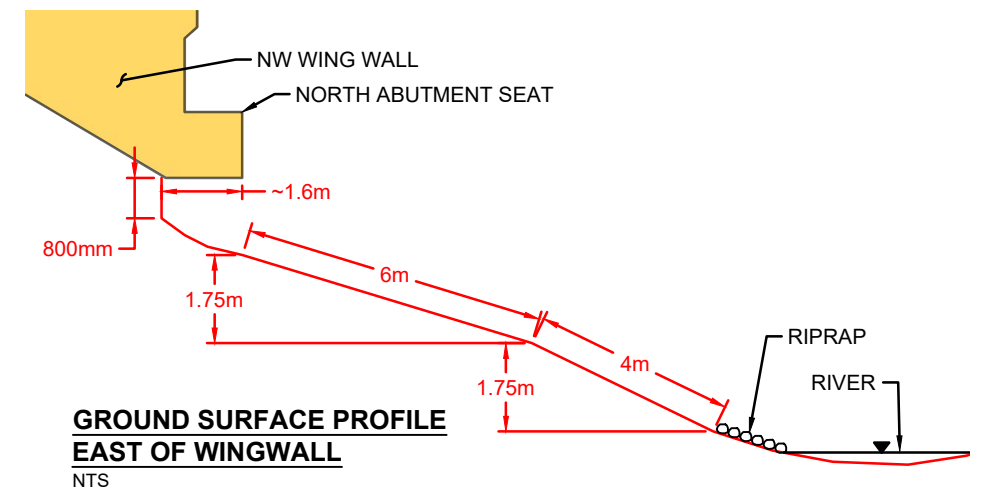
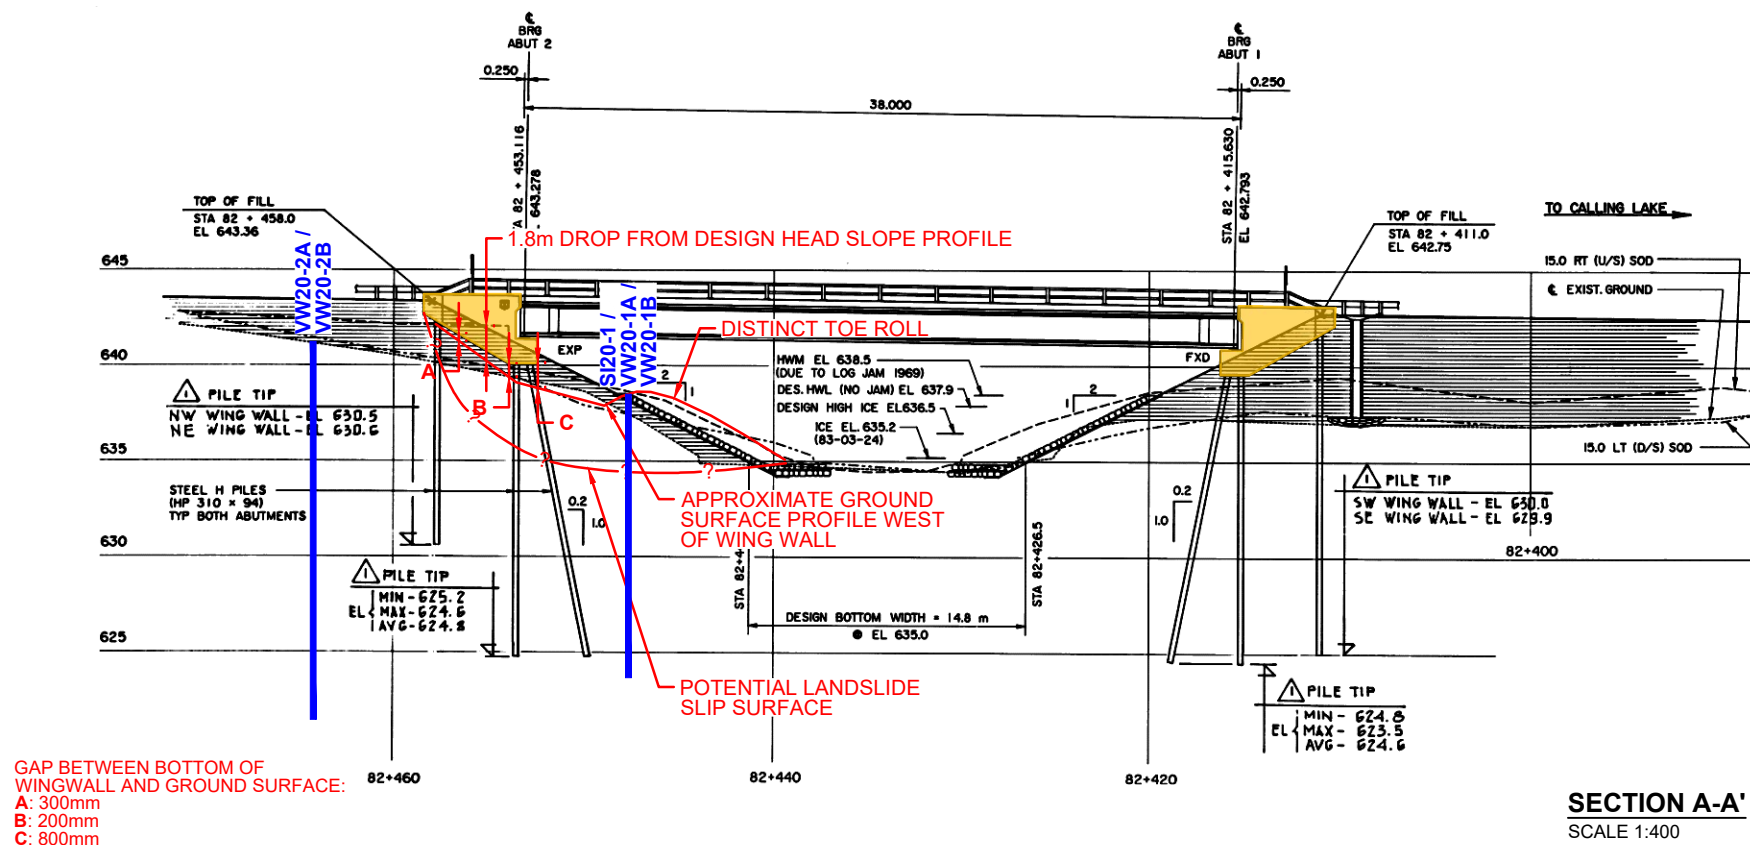
Alberta  
NORTH CENTRAL  
(ATHABASCA AND FORT McMURRAY DISTRICTS)  
NC093 HWY 813 ROCK ISLAND RIVER  
BRIDGE NW APPROACH FILL  
SITE PLAN SHOWING APPROXIMATE  
INSTRUMENT LOCATIONS  
DWG NO. 32122-NC093

Drawing 32122-NC093 in Appendix A provides a sketch of the approximate location of the monitoring instrumentation for this site.

| Discussion | |
|---|---|
| <b>Instrumentation Repairs:</b> | Consideration should be given to repairing SI20-1 to continue monitoring the landslide movement rate at this site. A mechanical or hydrovac excavation will be required to repair the SI. |

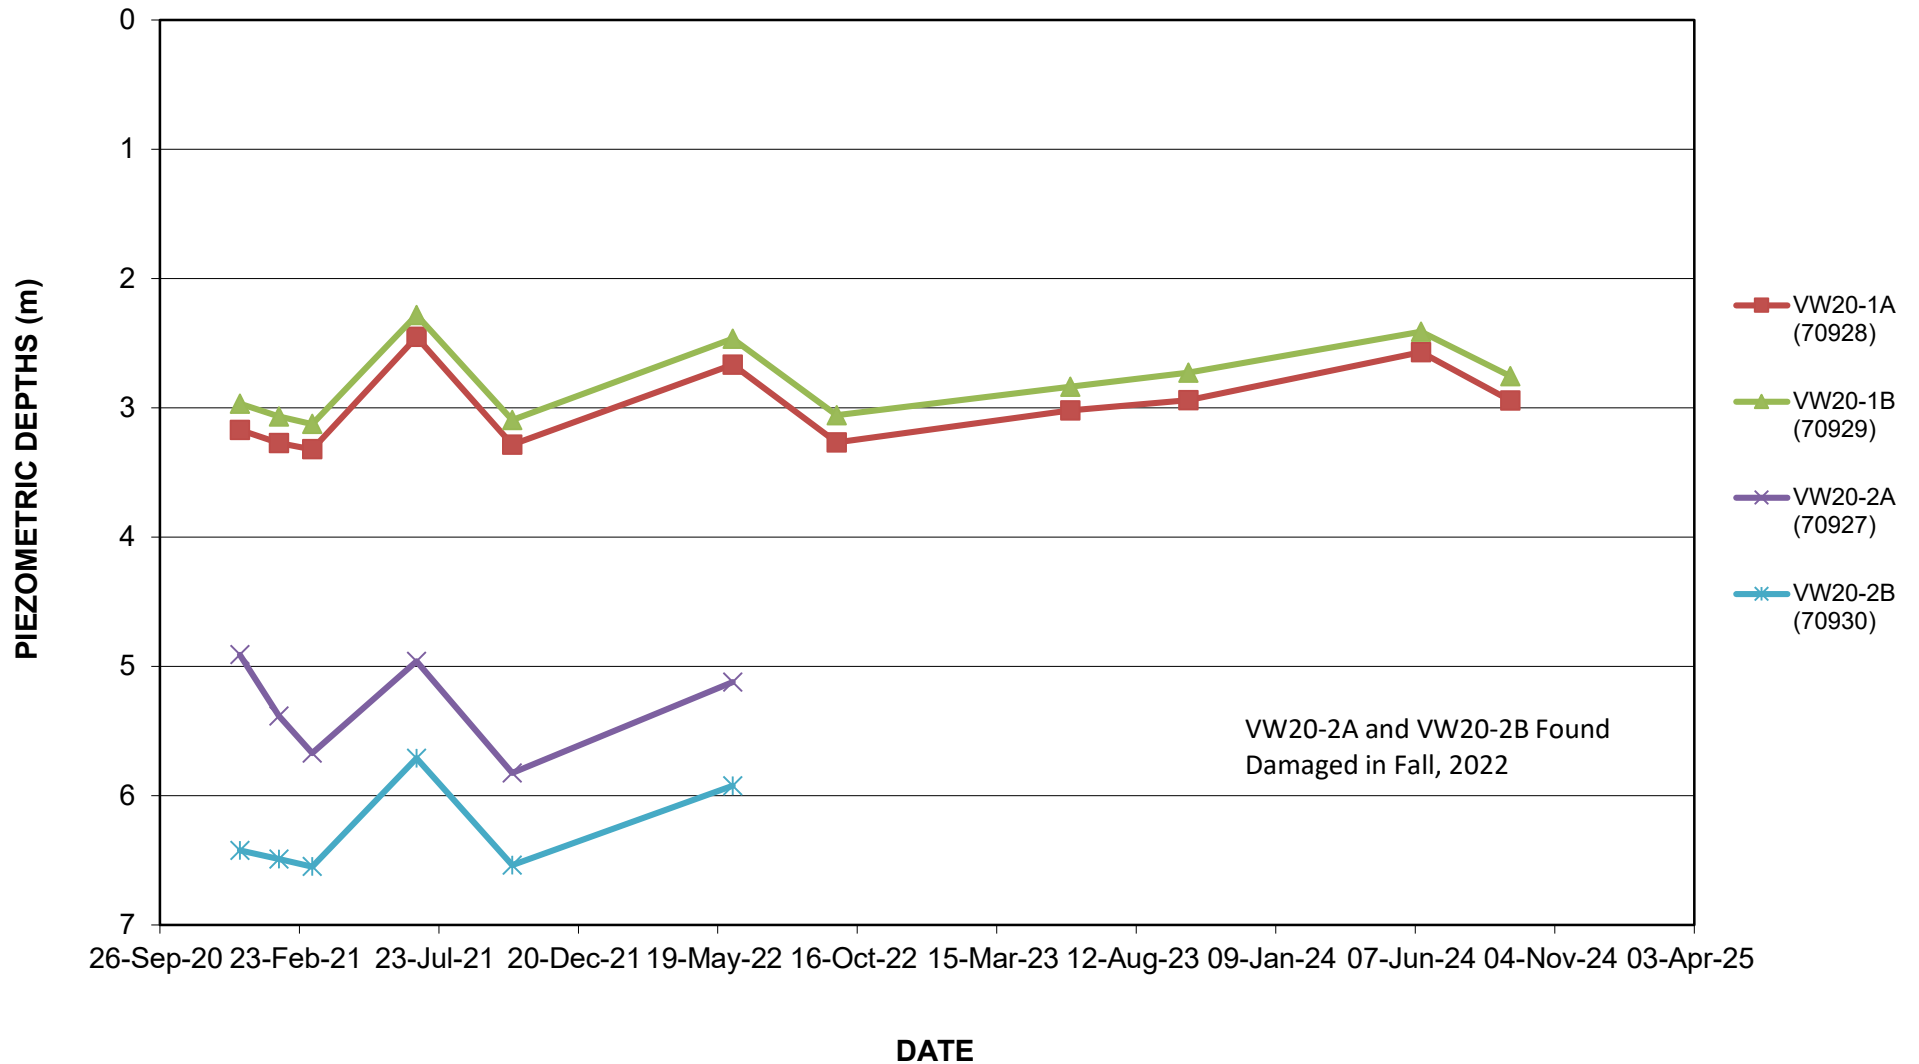
**FIGURE NC093-1**  
**HWY 813 ROCK ISLAND RIVER BRIDGE (BF79692)**  
**VIBRATING WIRE PIEZOMETER DATA**

| Discussion | |
|---|---|
| <b>Interpretation of Monitoring Results:</b> | Vibrating wire piezometers VW20-1A and VW20-1B showed increases in groundwater level of 0.17 m and 0.13 m, respectively, since the fall of 2024 readings. The current groundwater levels are within the historical levels. |

| Discussion | |
|---|---|
| <b>Future Work:</b> | The instruments should be read again in the fall of 2025. |
