ALBERTA TRANSPORTATION AND  
ECONOMIC CORRIDORS GRMP  
NORTH CENTRAL (ATHABASCA AND FORT  
McMURRAY DISTRICTS)  
INSTRUMENTATION MONITORING - SPRING 2025

| Site Number | Location | Name | Hwy | km |
|---|---|---|---|---|
| NC106 | HWY 63:08 km 27.9 | Pavement Distress | 63:08 | 27.9 |

| <b>Current Monitoring:</b> | 30-May-2025 | <b>Previous Monitoring</b> | 17-Sep-2024 |

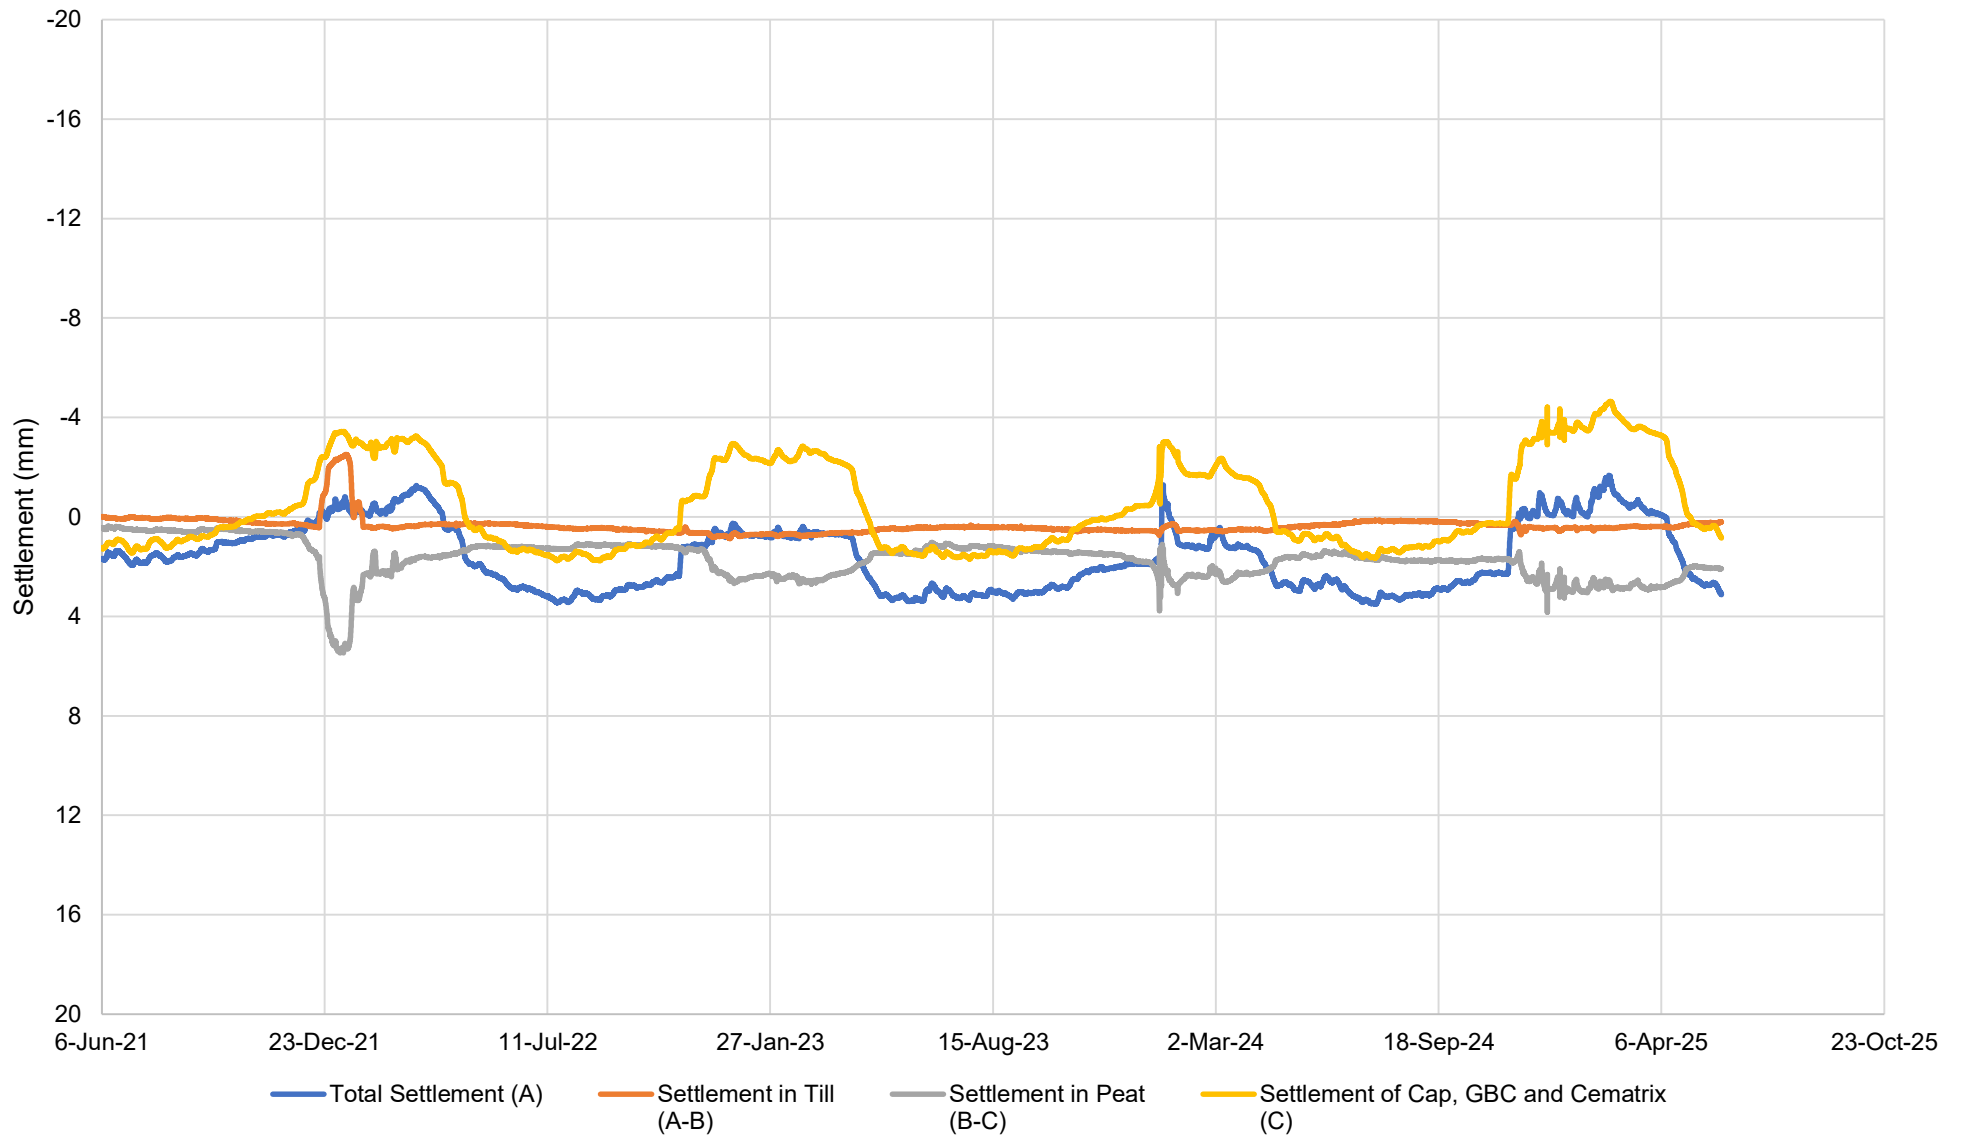
**Figure NC106-1**  
**Highway 63:08 km 27.9 Pavement Distress Near Wandering River, Alberta**  
**EXT21-1 - Displacement**

| Discussion | |
|---|---|
| <b>Interpretation of Monitoring Results:</b> | <p>The extensometer data is summarized in Table NC106-1 below and is plotted in Figures NC106-1 and NC106-2 in Appendix A. Extensometer EXT21-1, installed towards the southern end of the Cematrix repair section, shows a current total settlement of 3.1 mm. This corresponds to an overall increase in settlement of 0.2 mm since it was previously read on September 17, 2024. EXT21-2, installed towards the northern end of the Cematrix repair section, shows a current total settlement of 14.5 mm. This corresponds to an overall increase in settlement of 1 mm since it was previously read on September 17, 2024. At both locations, the majority of the settlement is occurring within the peat layer.</p> <p>The south extensometer (EXT21-1) has shown a pattern of about 4 mm of frost heave in the past four winter seasons despite no significant change in the amount of settlement during the spring and summer seasons. It will be interesting to see if this trend continues as the north extensometer (EXT21-2) has shown a different trend as the heave amount has been steadily decreasing while the amount of summer settlement has been increasing slightly. At both extensometer locations, the settlement seems to have stabilized, despite the cyclical variability, and most of this settlement occurred about 13 months after construction.</p> <p>The thermistor results from the monitoring period are summarized in Table NC106-2 and the plots are presented in Figures NC106-3 to NC106-6. The near-surface temperature nodes from each of the thermistor arrays have been compared to the ambient temperature readings, and the results are plotted in Figure NC106-7. To compare the influence of the Cematrix on temperatures at depth, the 1.1 m to 1.3 m thermistor readings from all four locations are plotted in Figure NC106-8.</p> <p>The results indicate the following:</p> <ul style="list-style-type: none"> <li>(a) THERM21-1, installed south of the Cematrix repair zone, shows highly variable temperature readings within its shallowest thermistor nodes (above 1.1 m) reflecting changes in ambient air temperatures (Figure NC106-3). The thermistor nodes below 1.1 m have generally shown less fluctuations in temperatures. The nodes at 2.1 m and 3.1 m depth have recently shown significant scatter in the readings, possibly indicating issues with the sensors. A new program was uploaded during the readings in an attempt to address this scatter.</li> </ul> <p>A similar trend of fluctuating temperatures in response to changes in ambient temperature has been noted in the nodes above 1.3 m in THERM21-2 and THERM21-3, installed within the Cematrix repair section and in THERM21-4 installed within the grass covered area (Figures NC106-4 to NC106-6). The thermistor nodes below 1.3 m at all four locations has generally shown less fluctuations in temperatures.</p> <p>At THERM21-3, installed within the Cematrix repair section, the thermistors at 0.3 m, 1.3 m, 2.3 m, and 3.3 m depth, stopped functioning after March 24, 2025.</p> <ul style="list-style-type: none"> <li>(b) As expected, the ground temperature reduces with depth at all thermistor array locations (Figures NC106-3 to NC106-6).</li> <li>(c) The near-surface temperature nodes closely follow the trend of the ambient air temperatures. In addition, the shallow temperatures measured in the paved areas are significantly</li> </ul> |

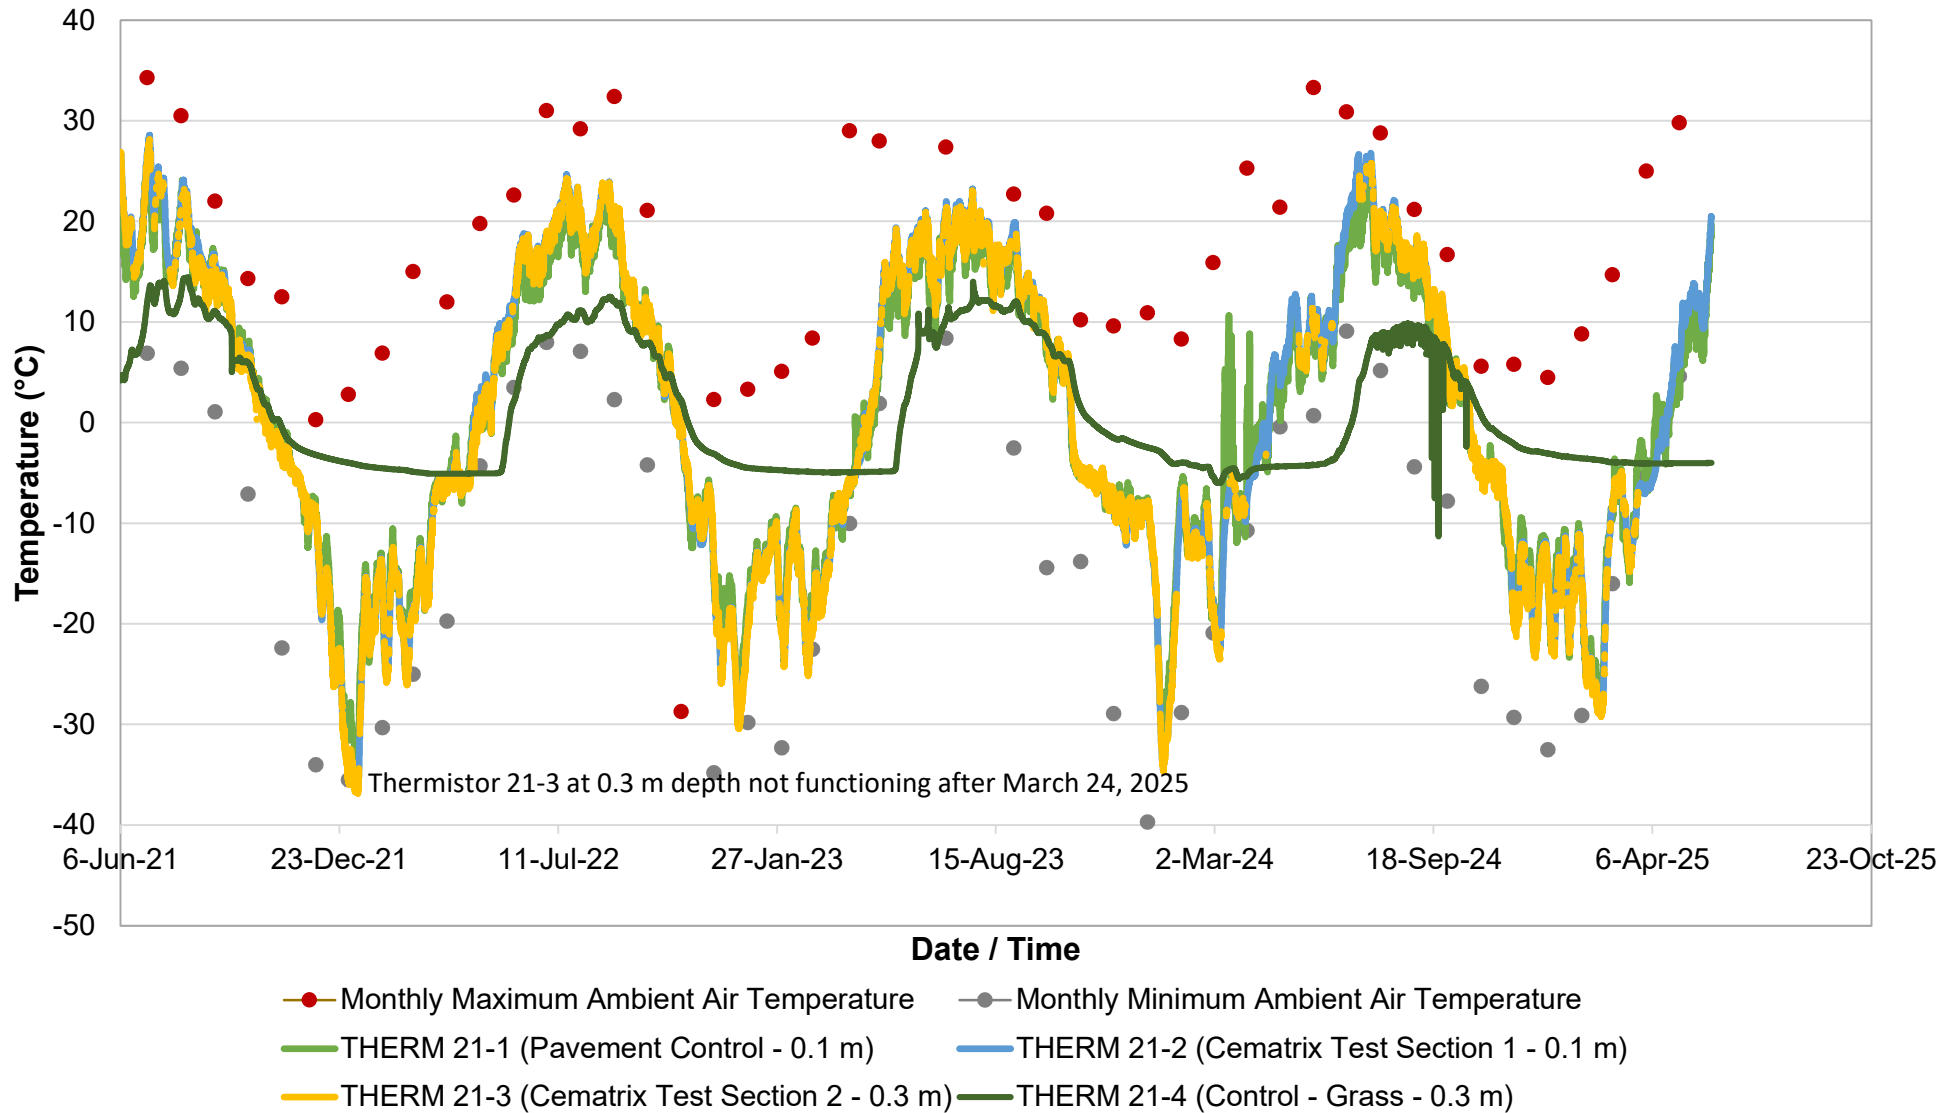
**Figure NC106-7**  
**Highway 63:08 km 27.9 Pavement Distress Near Wandering River, Alberta**  
**Surface Thermistors and Weather Data**

| | <p>higher in the summer and colder in the winter compared to the grassed area (Figure NC106-7) as the grass and accumulated snow in the winter provide more insulation.</p> <p>(d) Figure NC106-8 shows that the thermistor nodes within the upper 1.3 m in the Cematrix section are less impacted by the changes in temperature when compared to the thermistor node within the upper 1.1 m of the pavement control section due to the insulating properties of the Cematrix. The results from THERM21-2 and THERM21-3 have also demonstrated that the insulating properties of the Cematrix reduced the temperatures below 1.3 m depth, and fluctuation in temperatures between the seasons in the treated section of the highway.</p> |
