July 8, 2023

**ALBERTA TRANSPORTATION AND ECONOMIC CORRIDORS GRMP (CON0022163)  
NORTH CENTRAL (ATHABASCA AND FORT McMURRAY DISTRICTS)  
INSTRUMENTATION MONITORING RESULTS – SPRING 2023**

**SECTION C**

**SITE NC099: HWY 63:10 HANGINGSTONE RIVER BRIDGES**

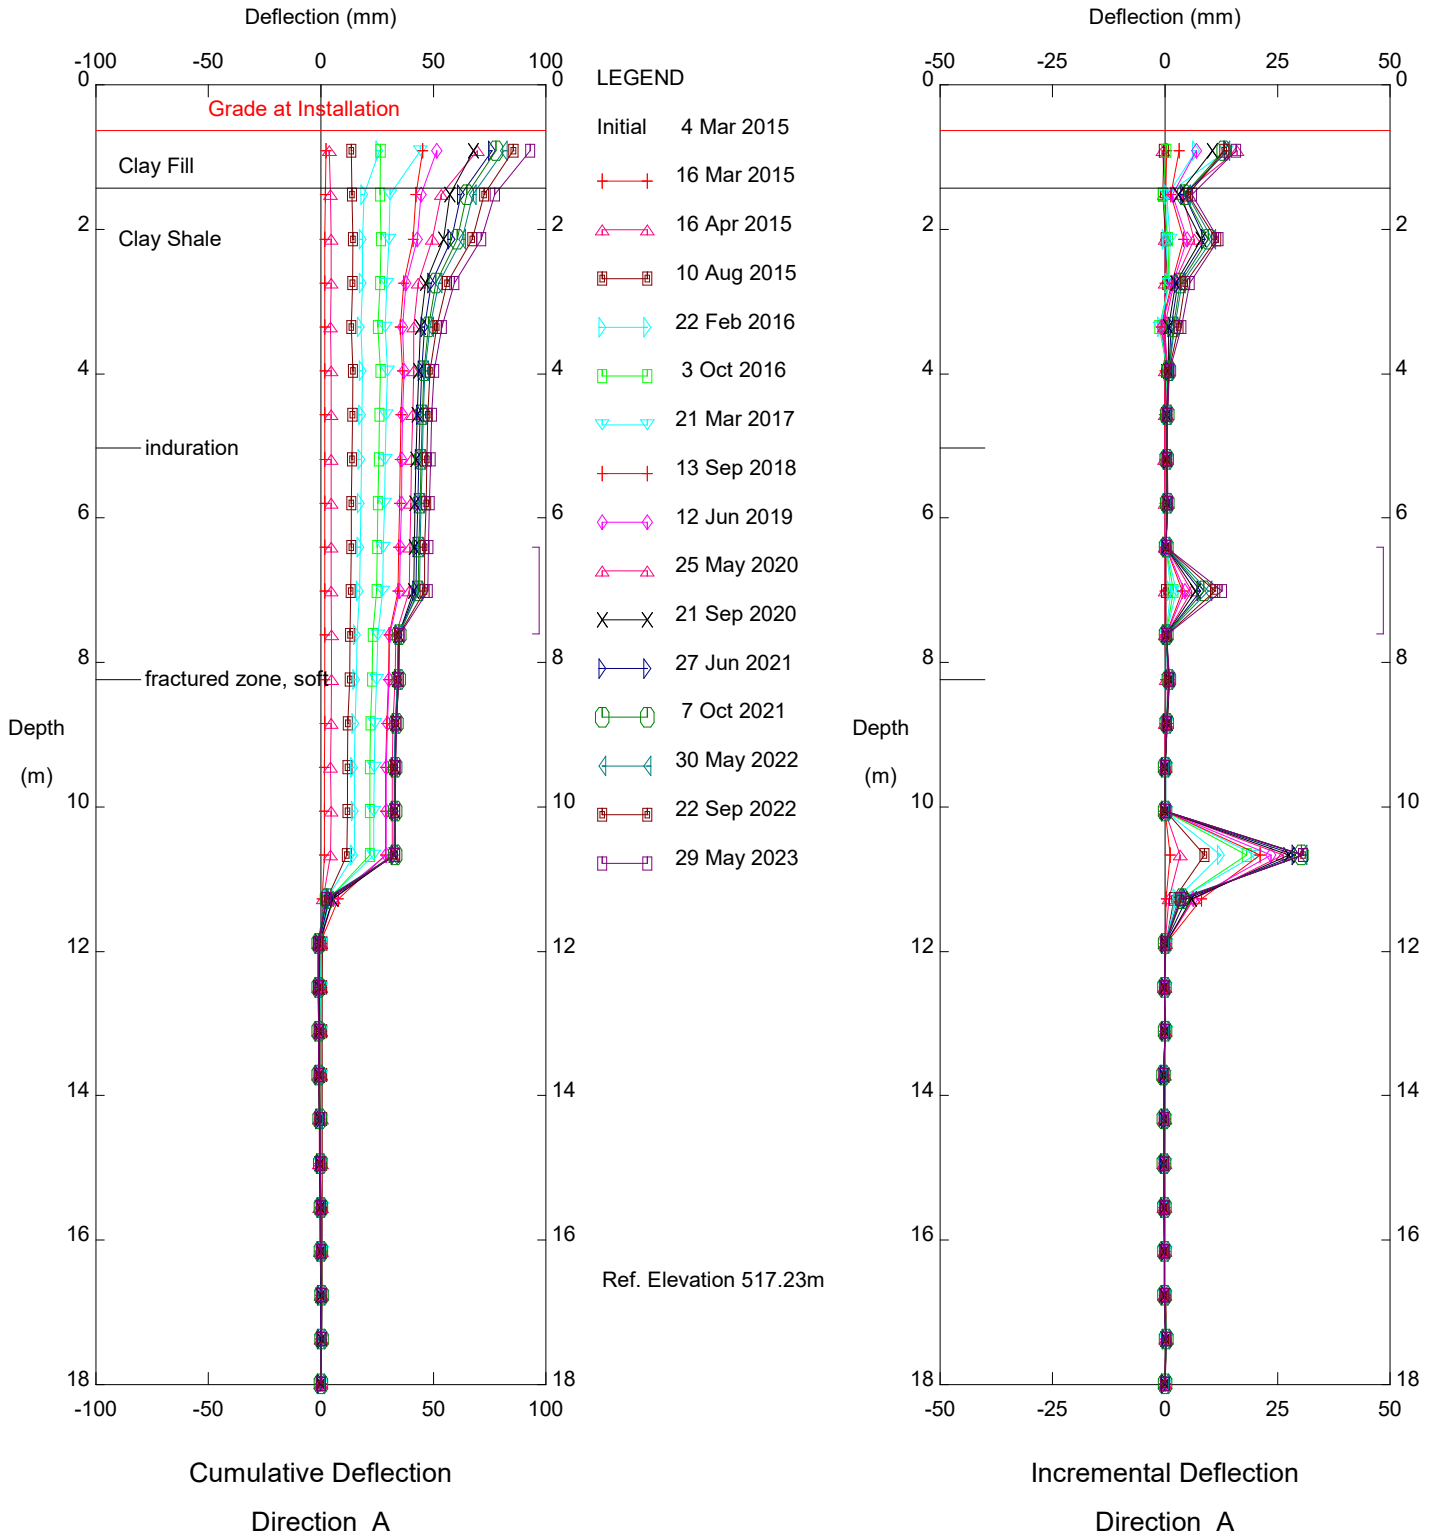
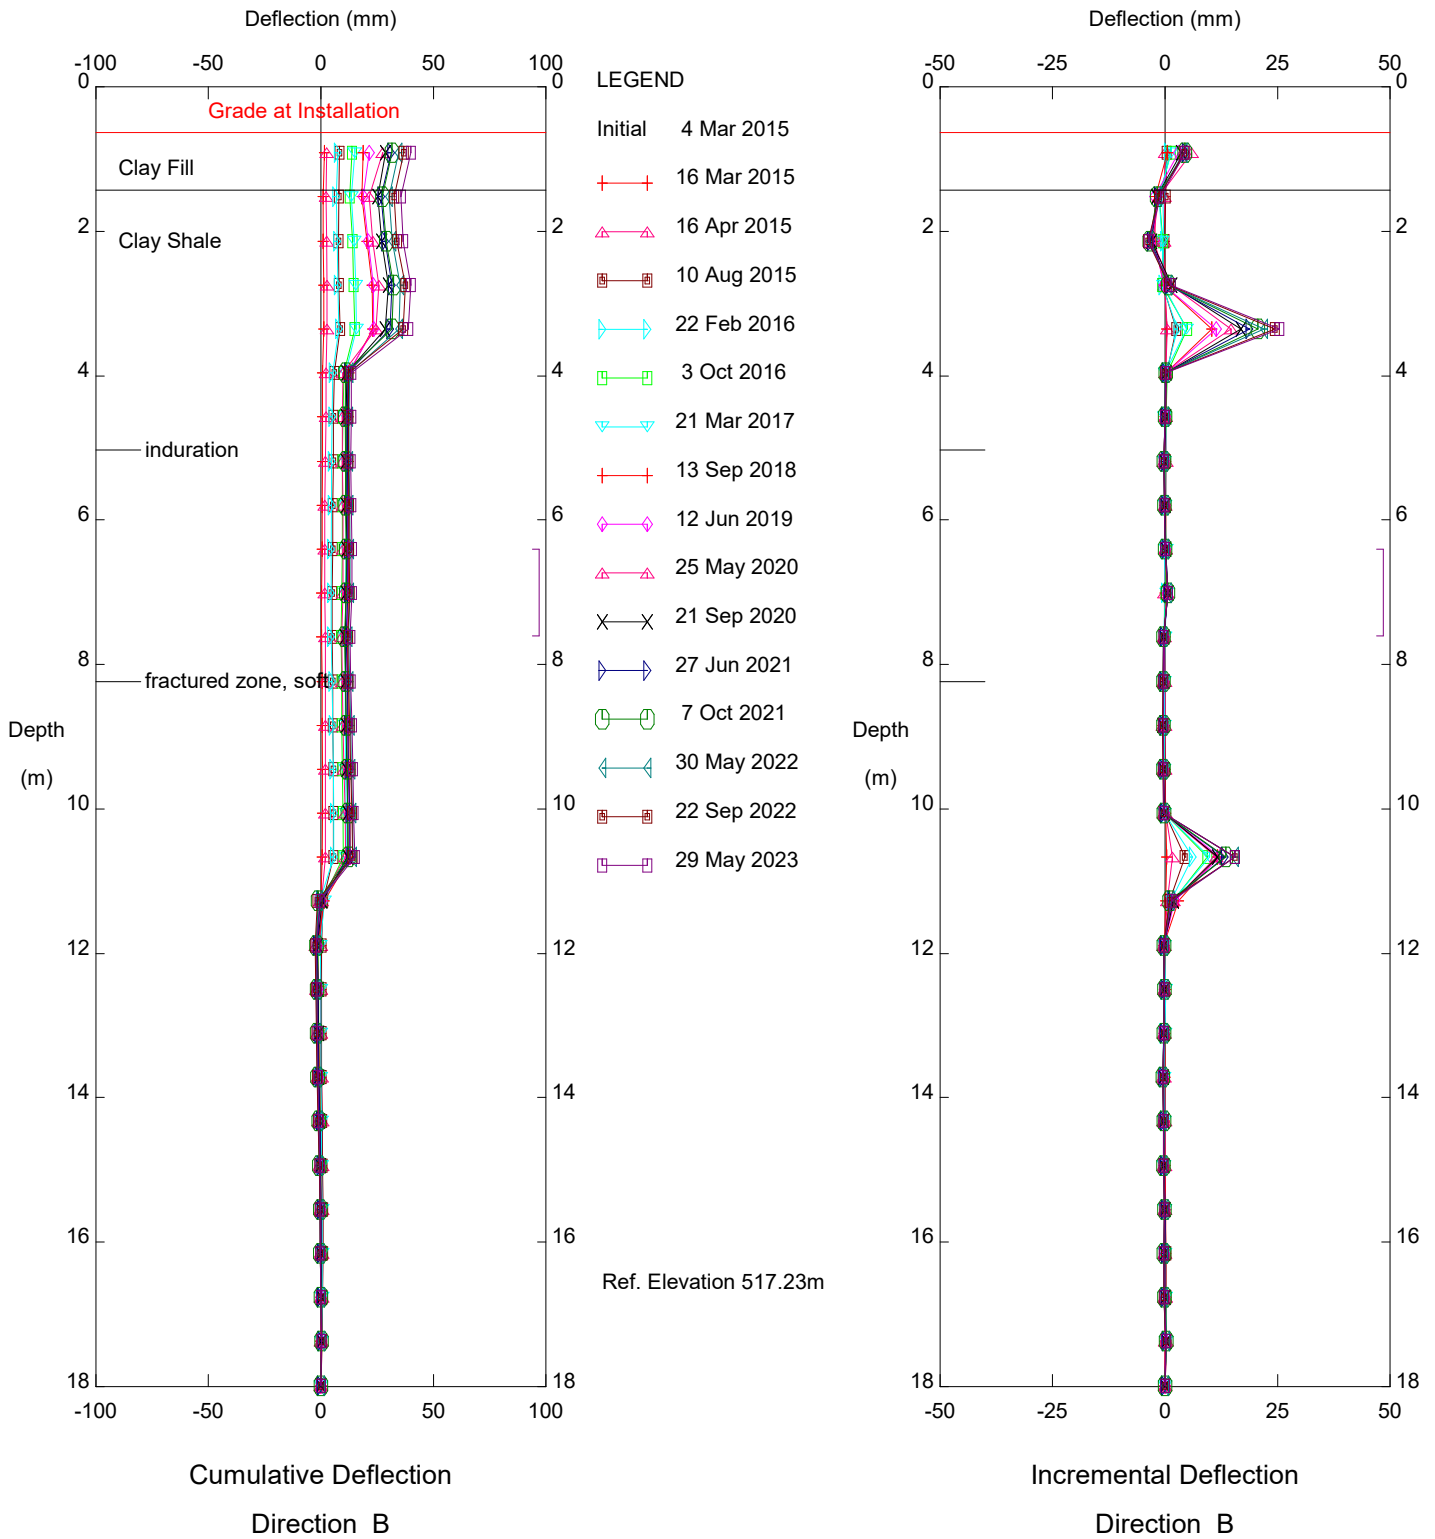
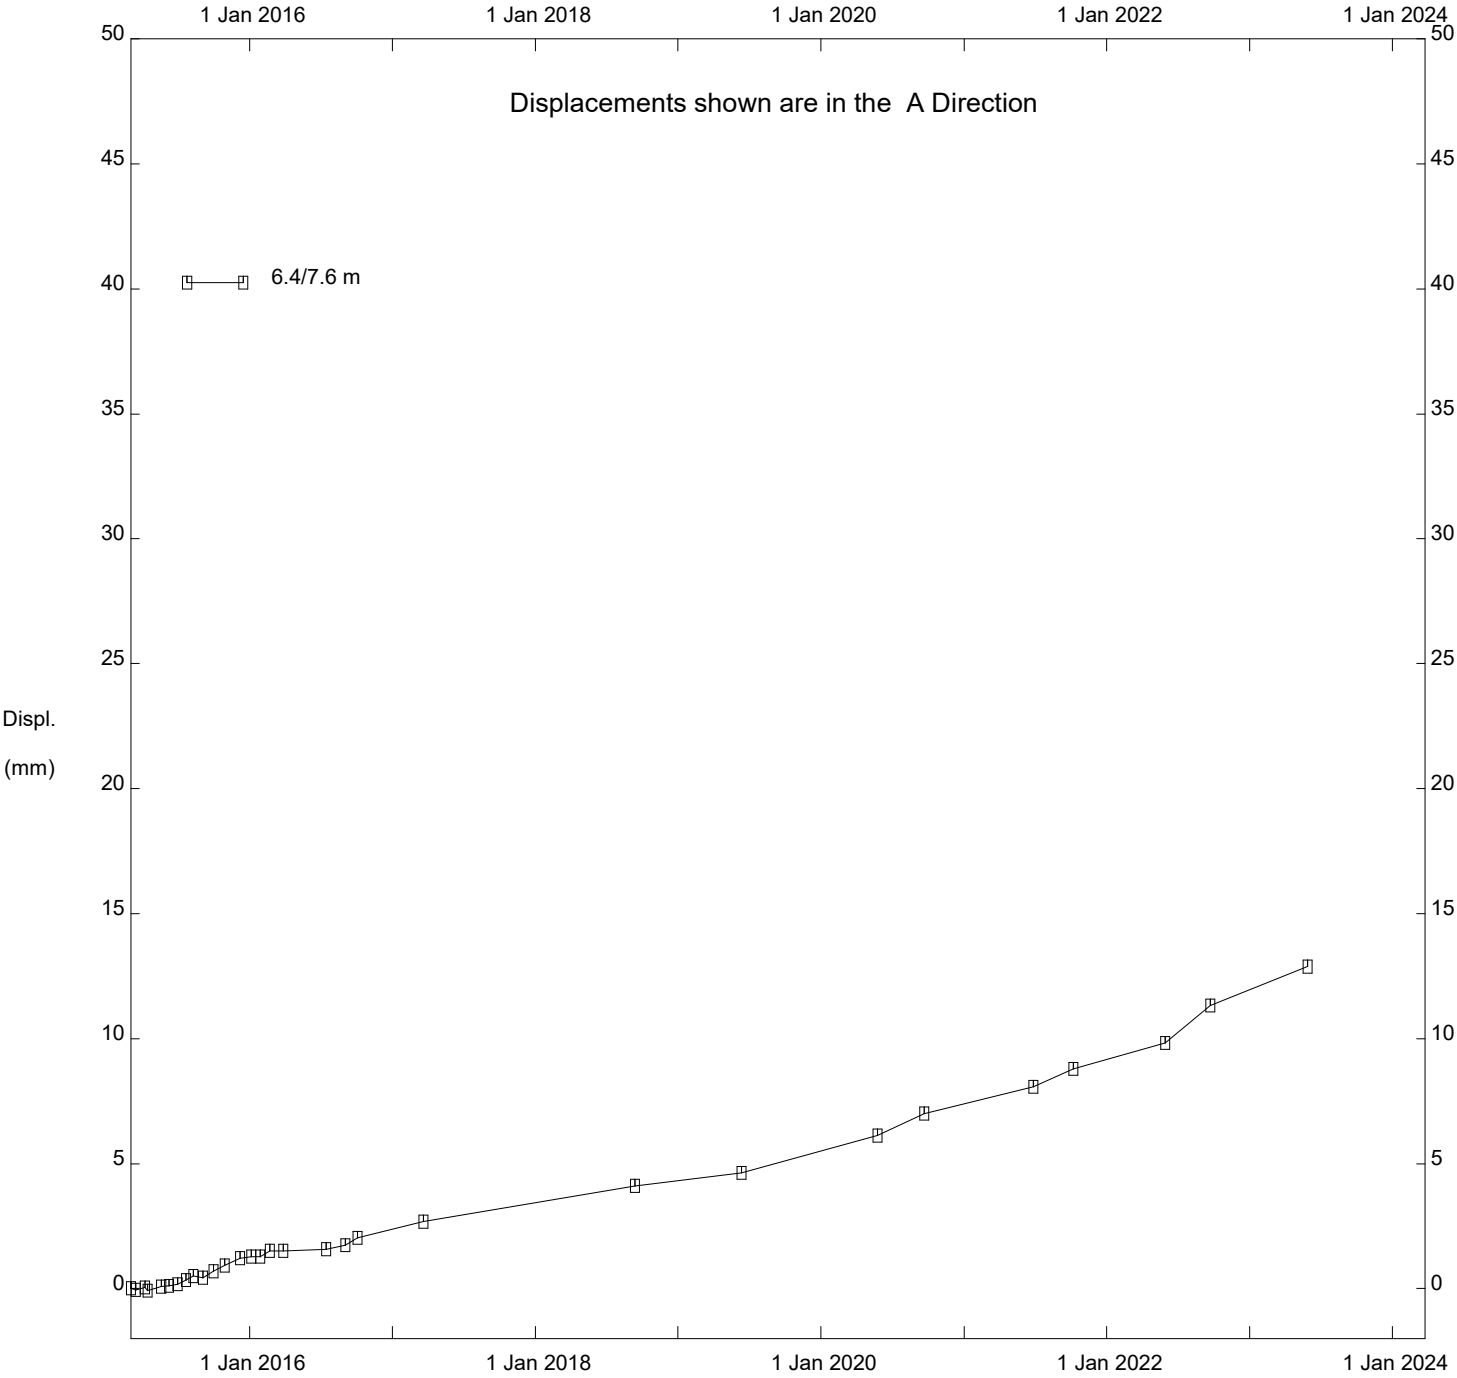
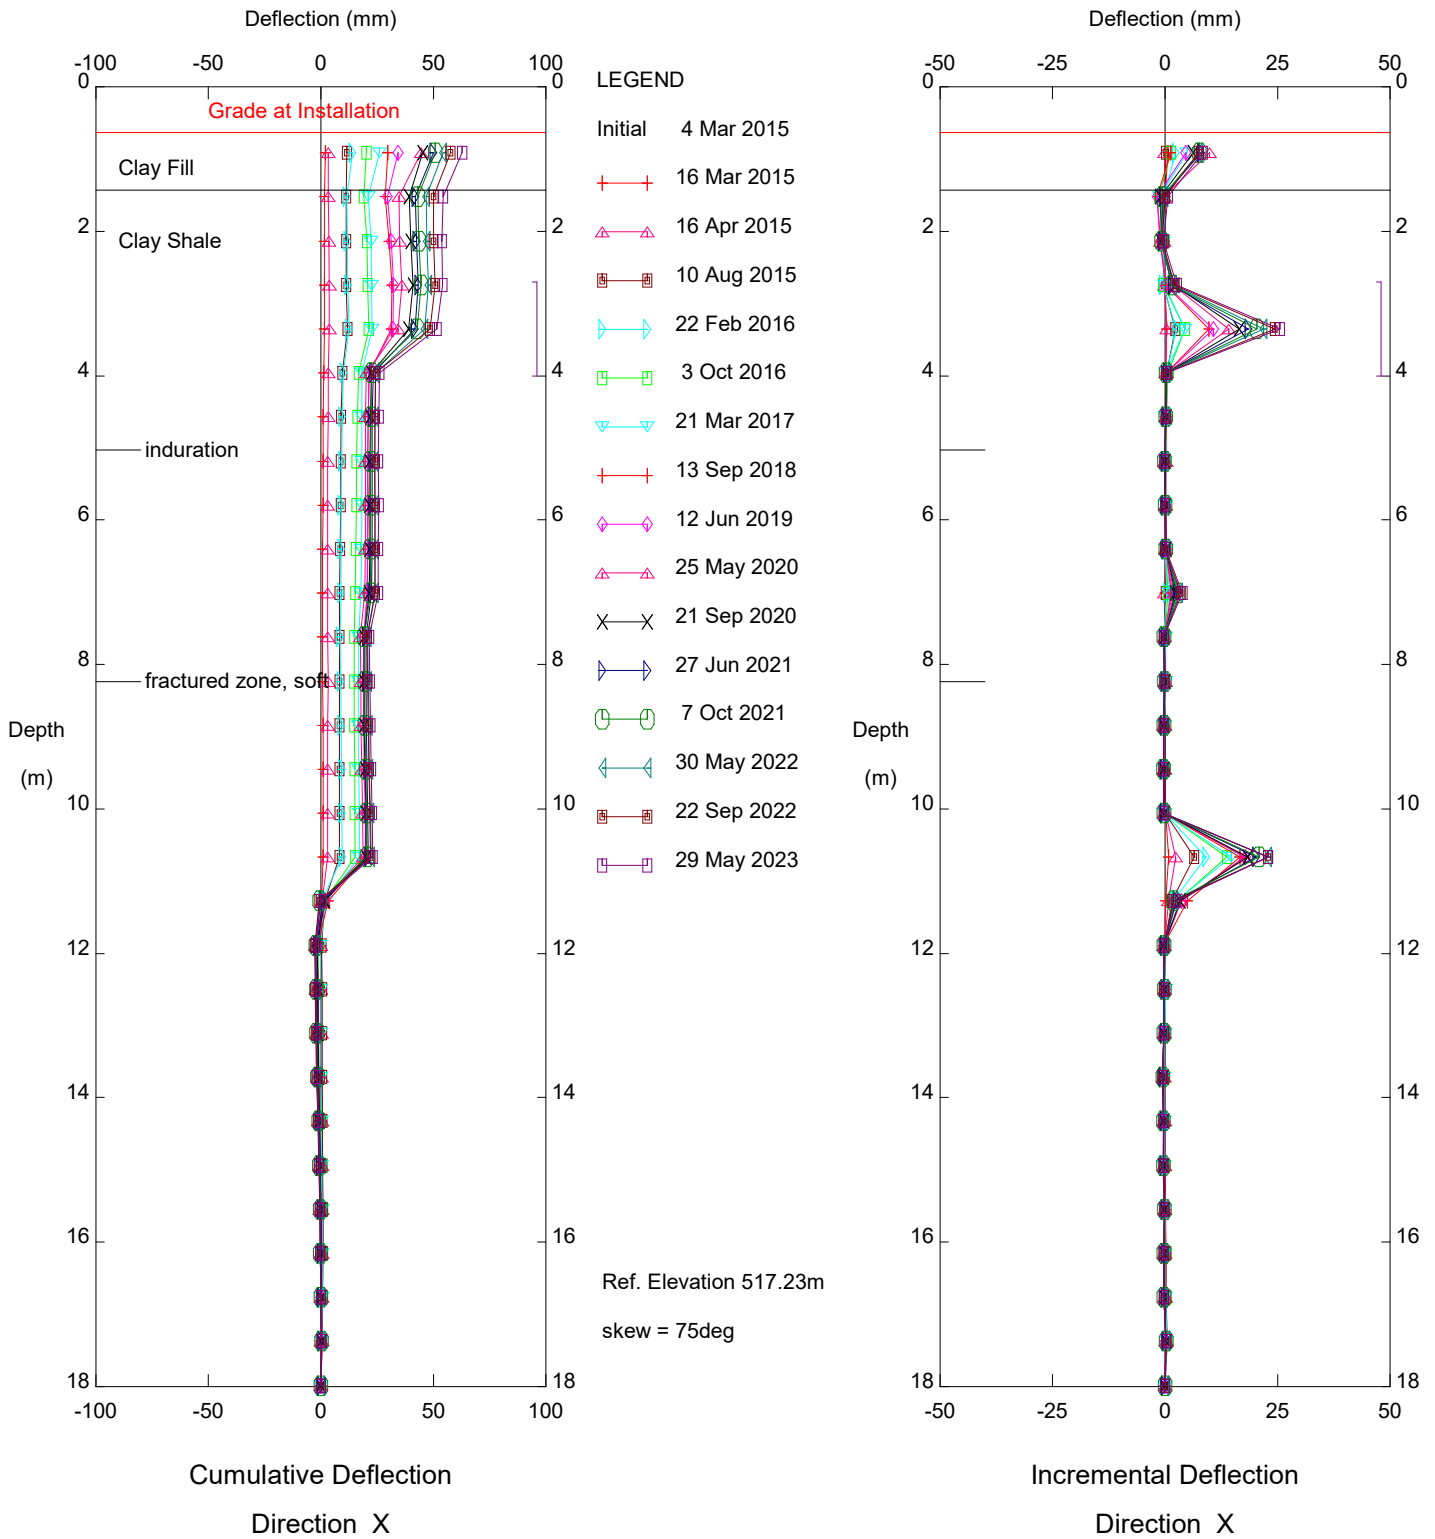
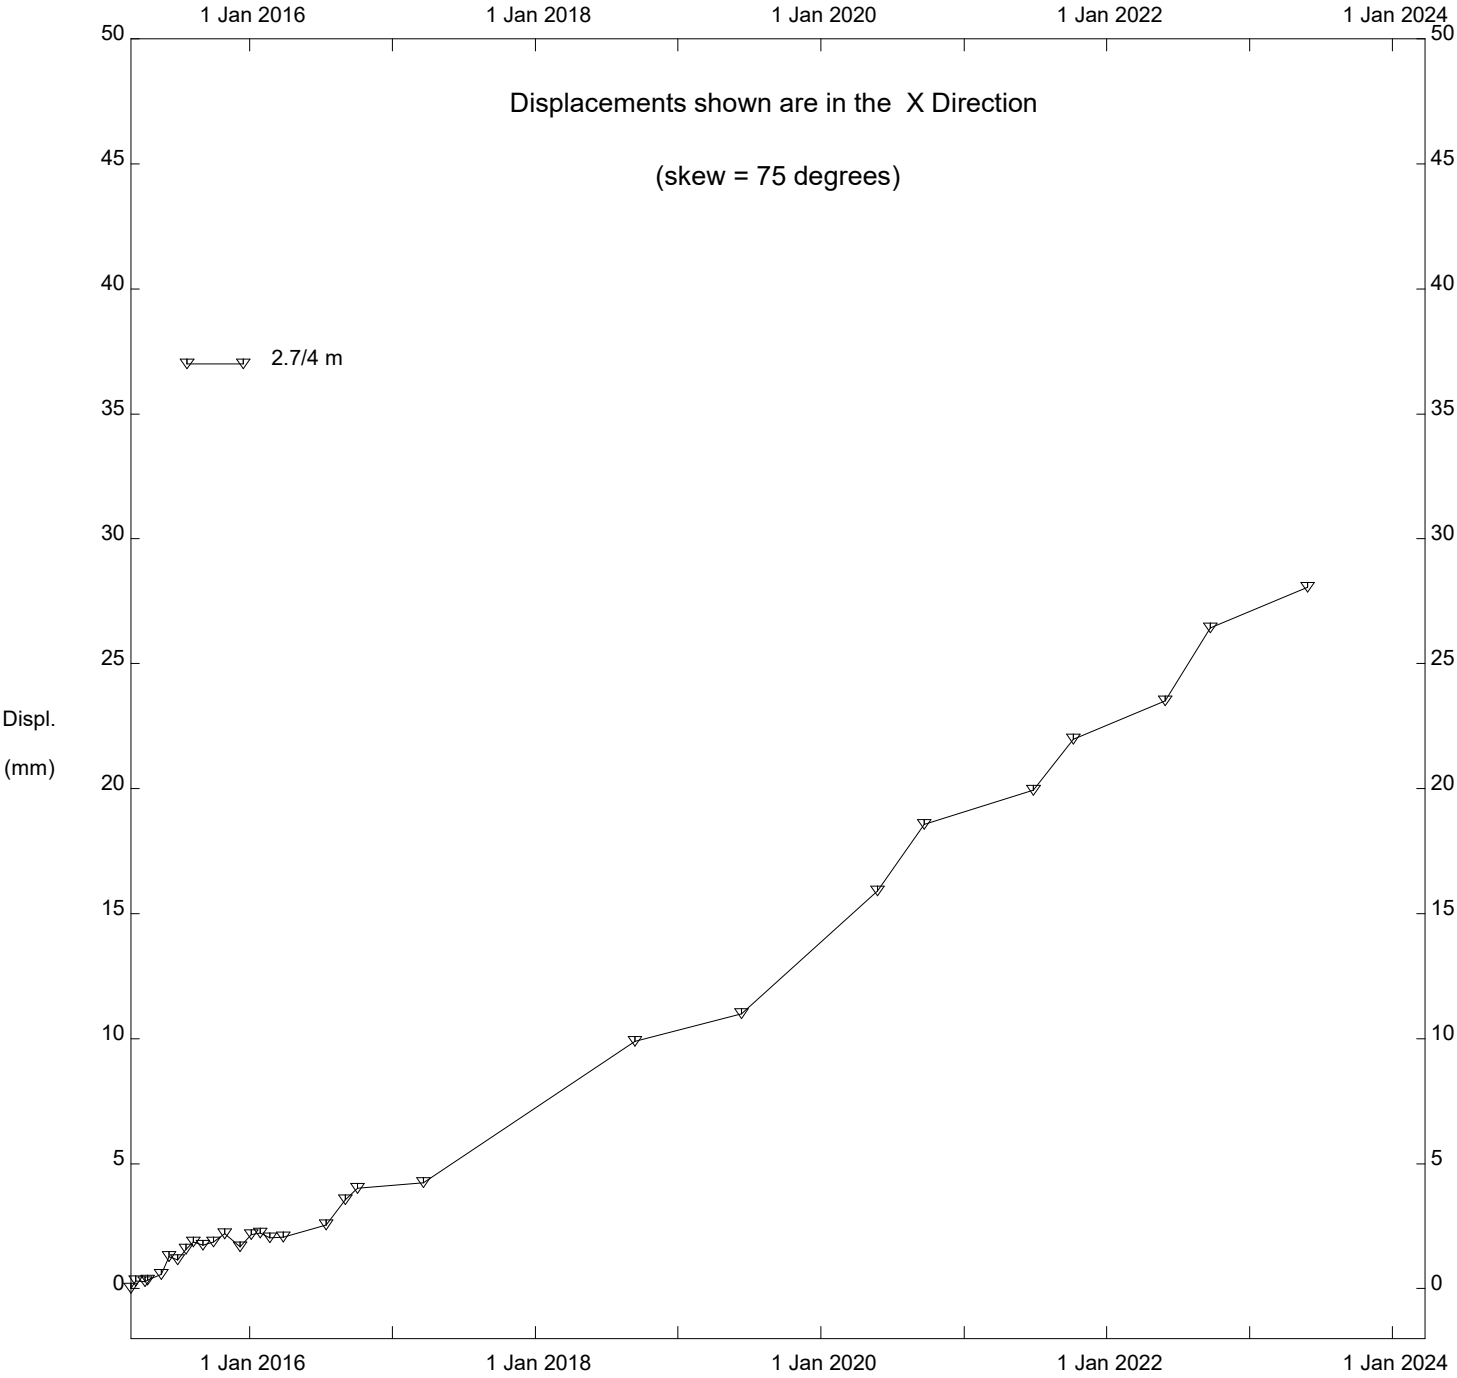
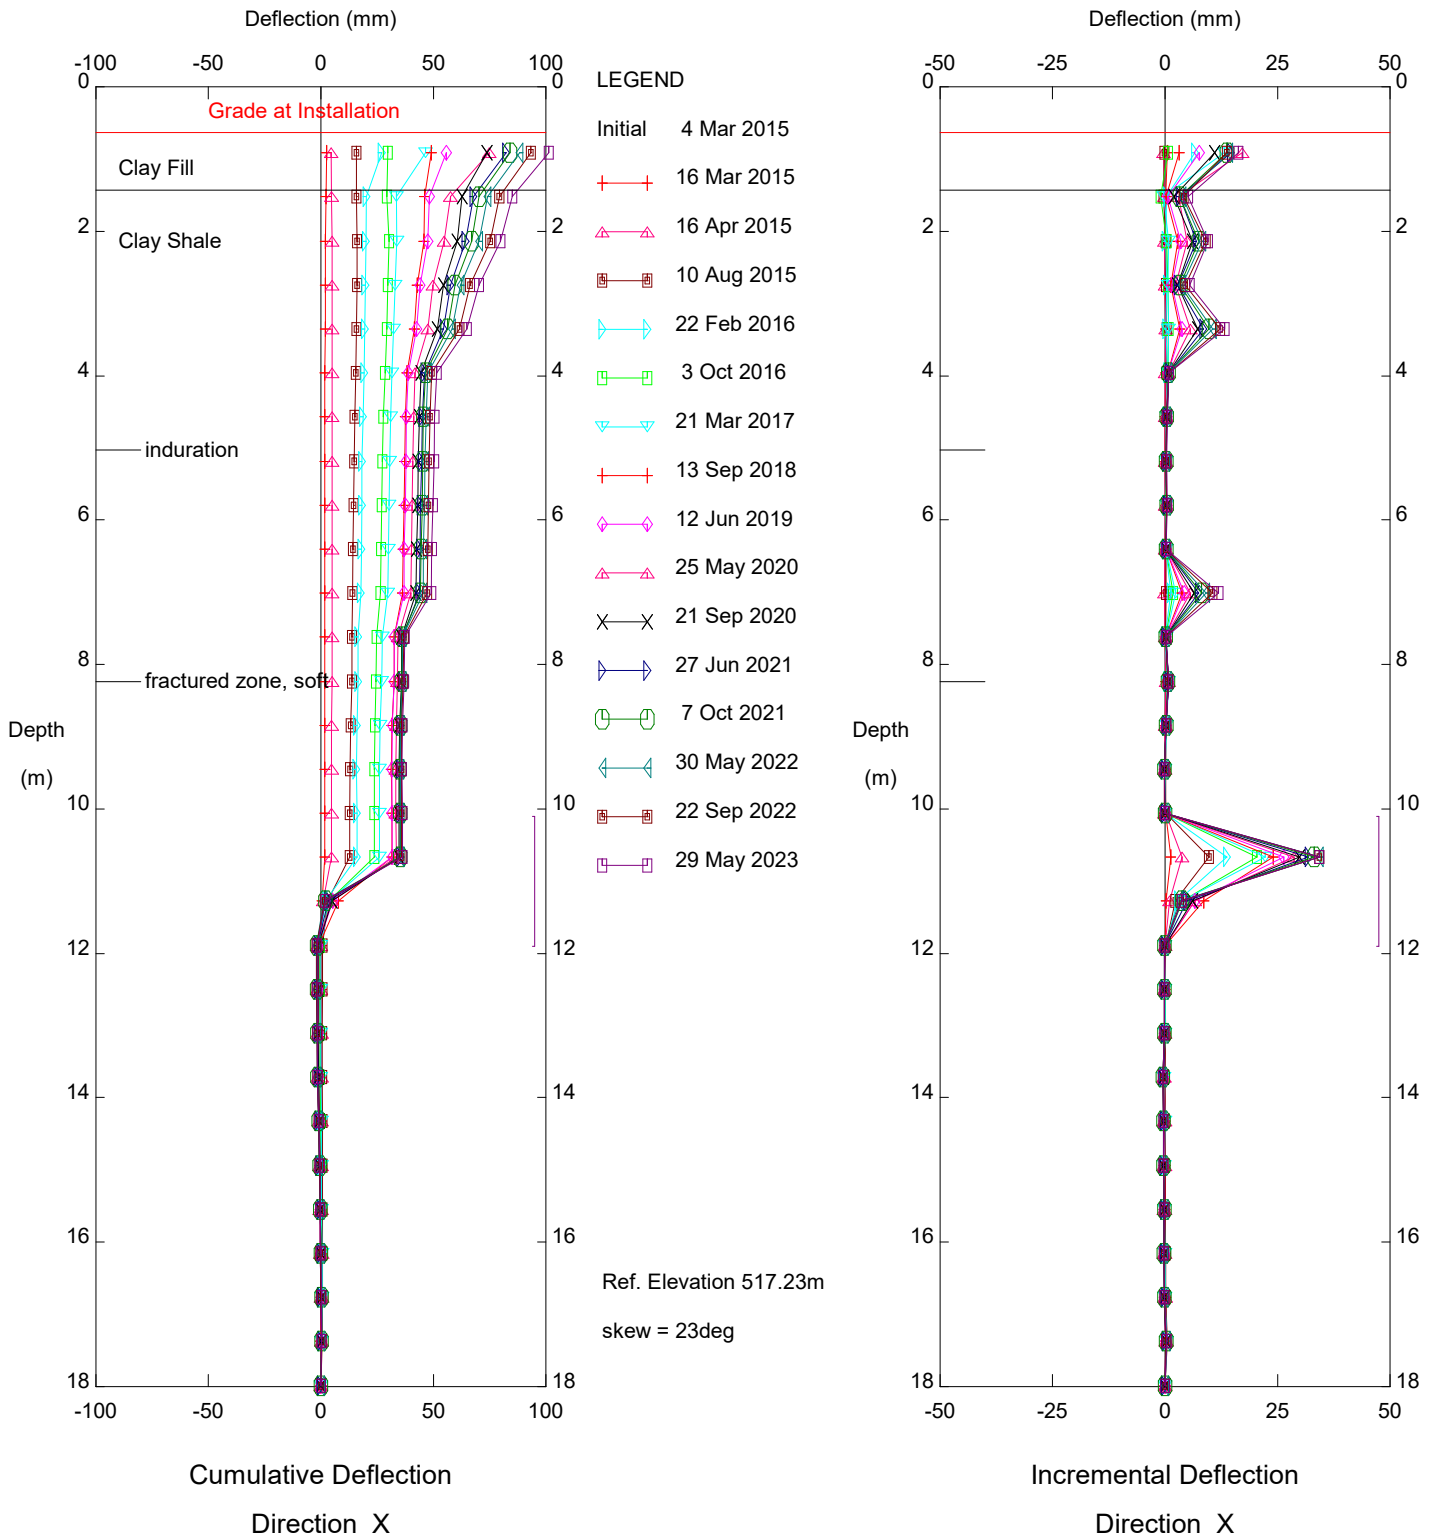
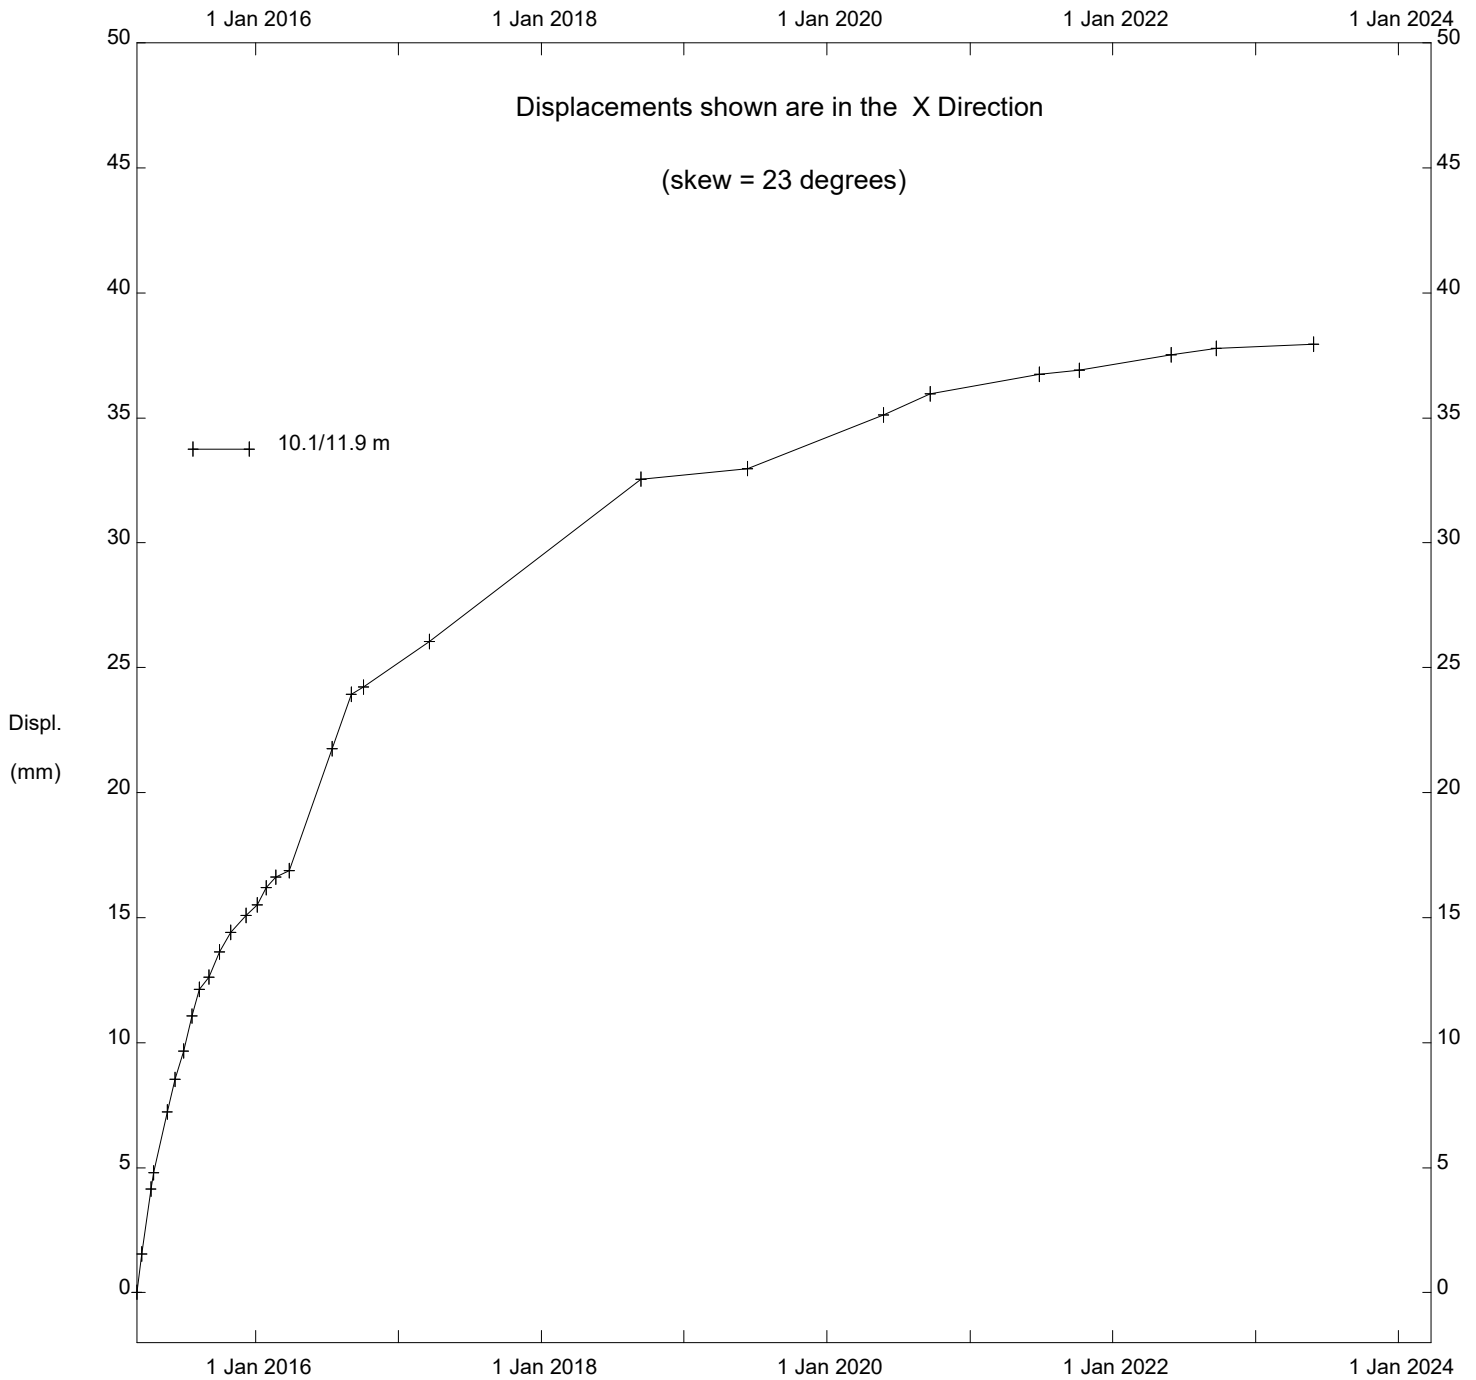
NC099 Cut Slope - Bench 1, Inclinometer 15-09

| INSTRUMENT # | DATE INITIALIZED | TOTAL CUMULATIVE RESULTANT MOVEMENT AND DEPTH OF MOVEMENT TO DATE (mm) | MAXIMUM RATE OF MOVEMENT (mm/yr) | CURRENT STATUS | DATE OF LATEST READING | DATE OF PREVIOUS READING | INCREMENTAL MOVEMENT SINCE PREVIOUS READING (mm) | CURRENT RATE OF MOVEMENT (mm/yr) | CHANGE IN RATE OF MOVEMENT SINCE PREVIOUS READING (mm/yr) |
|---|---|---|---|---|---|---|---|---|---|
| SI15-09 | March 4, 2015 | 28.1 mm over 2.7 m to 4.0 m in 24° direction | 13.0 on June 9, 2015 | Operational | May 29, 2023 | September 22, 2022 | 1.6 | 2.4 | -6.9 |
| | | 12.9 mm over 6.4 m to 7.6 m in 309° direction | 4.9 on September 22, 2022 | | | | 1.5 | 2.3 | -2.6 |
| | | 37.9 mm over 10.1 m to 11.9 m in 332° direction | 46.9 on March 16, 2015 | | | | 0.2 | 0.2 | -0.7 |
