July 8, 2023

**ALBERTA TRANSPORTATION AND ECONOMIC CORRIDORS GRMP (CON0022163)  
NORTH CENTRAL (ATHABASCA AND FORT McMURRAY DISTRICTS)  
INSTRUMENTATION MONITORING RESULTS – SPRING 2023**

**SECTION C**

**SITE NC099: HWY 63:10 HANGINGSTONE RIVER BRIDGES**

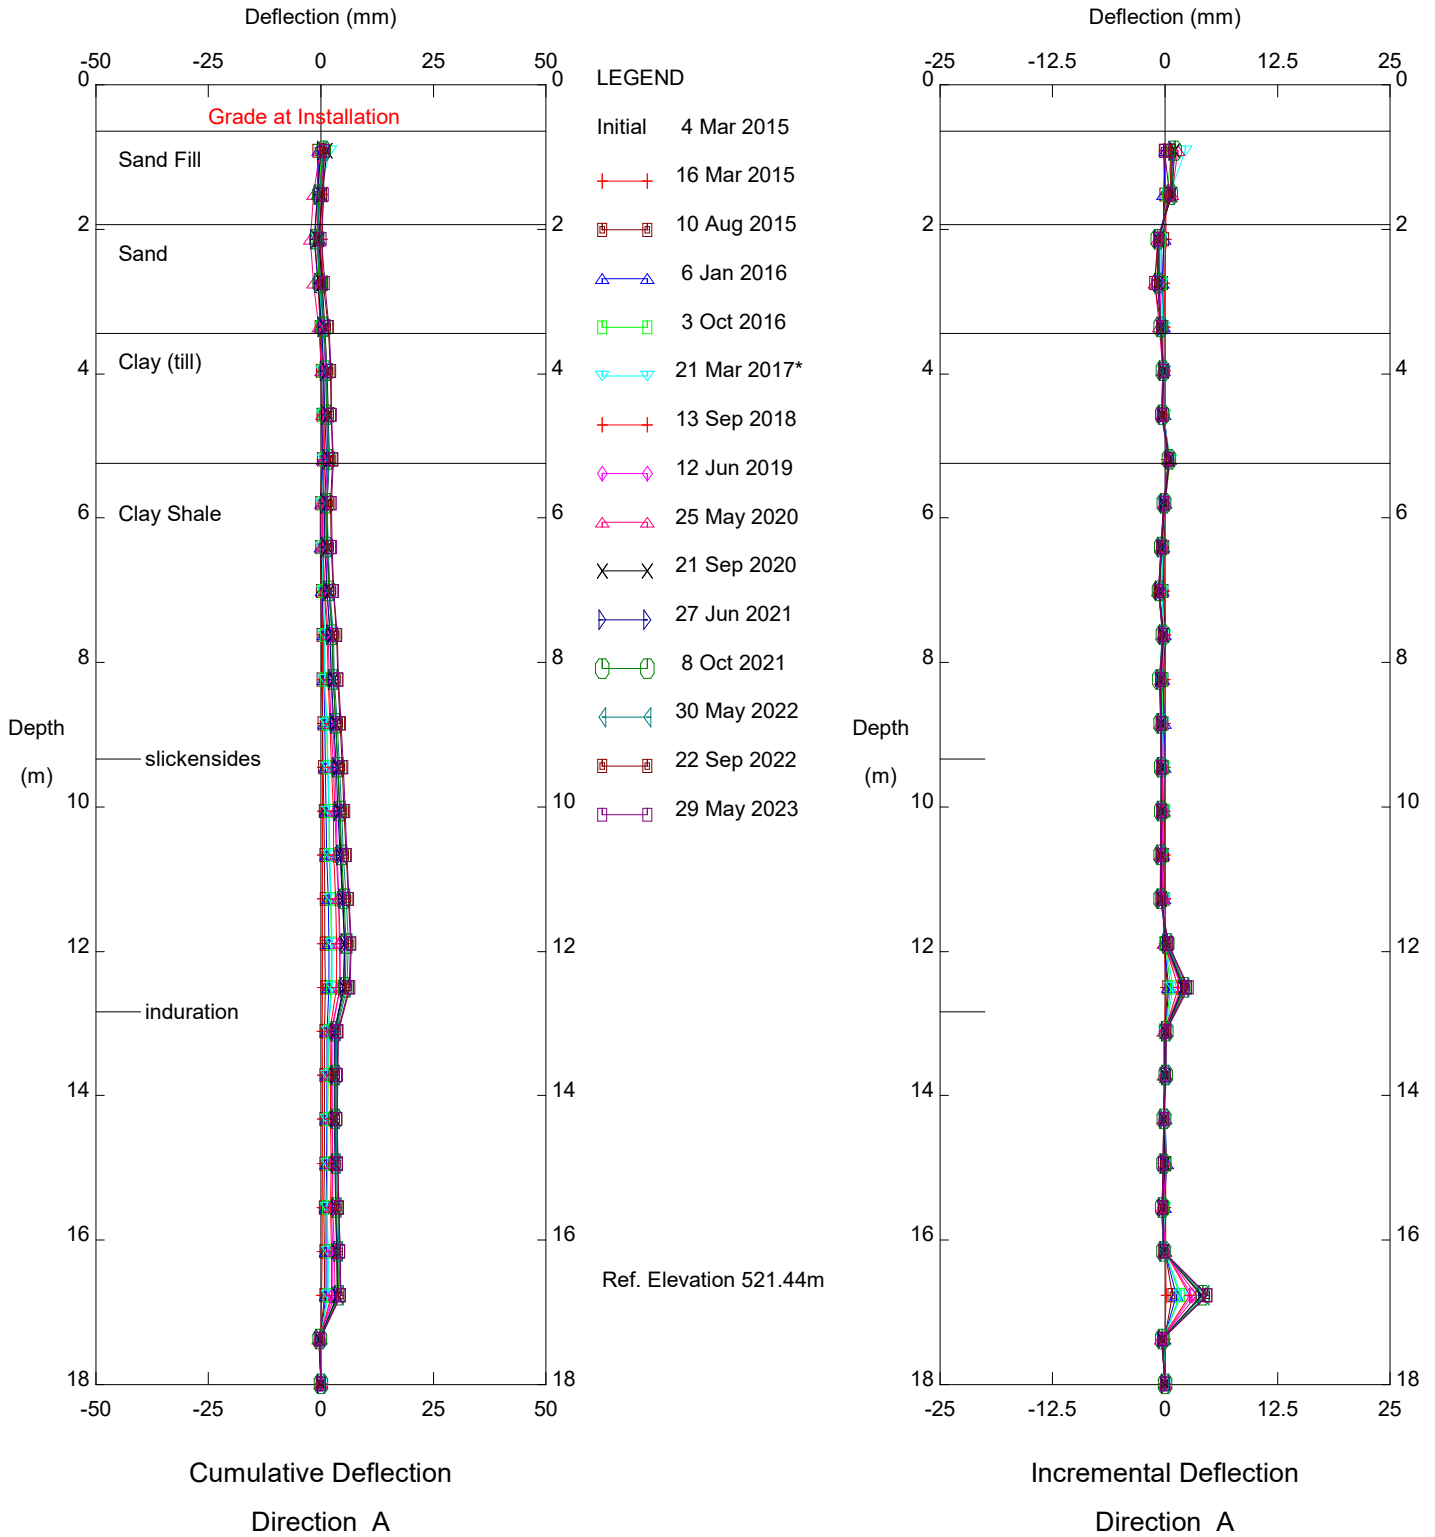
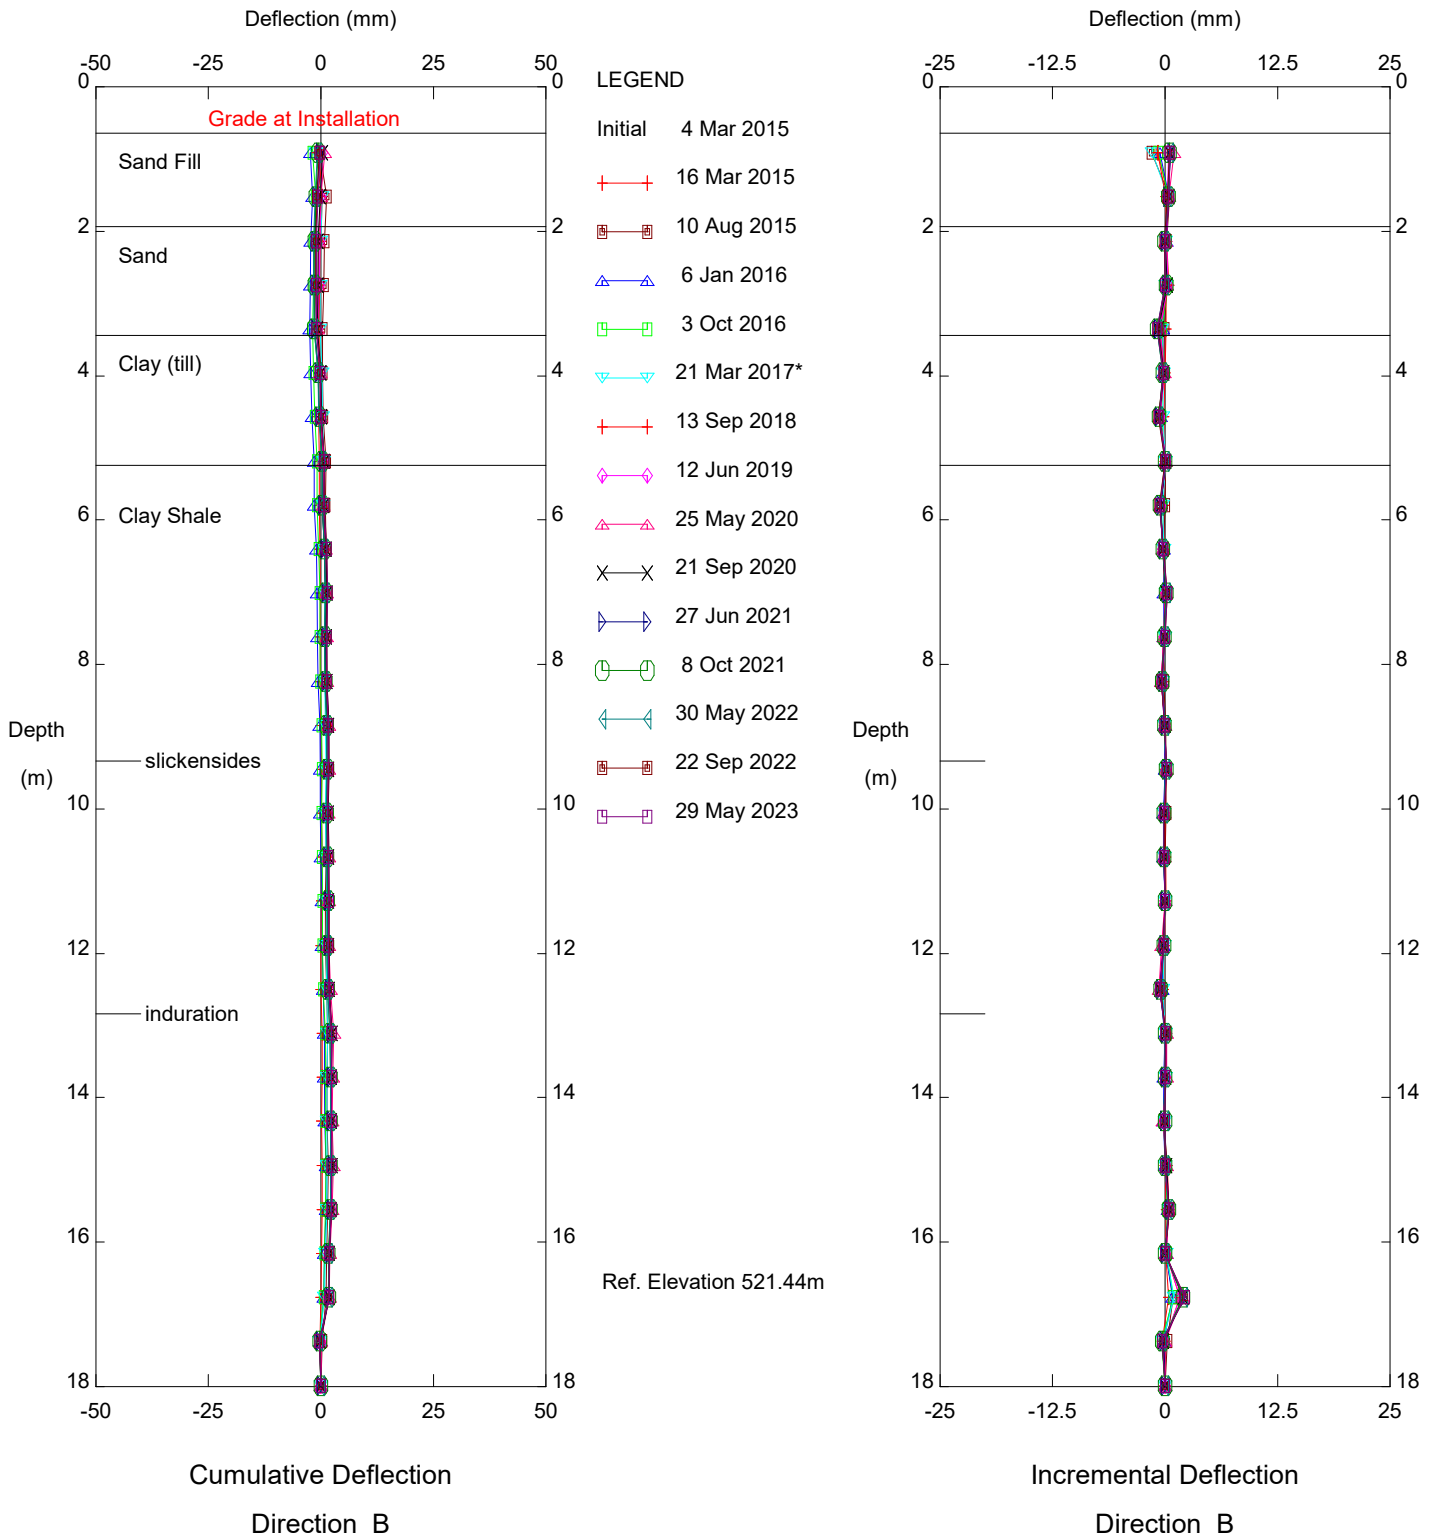
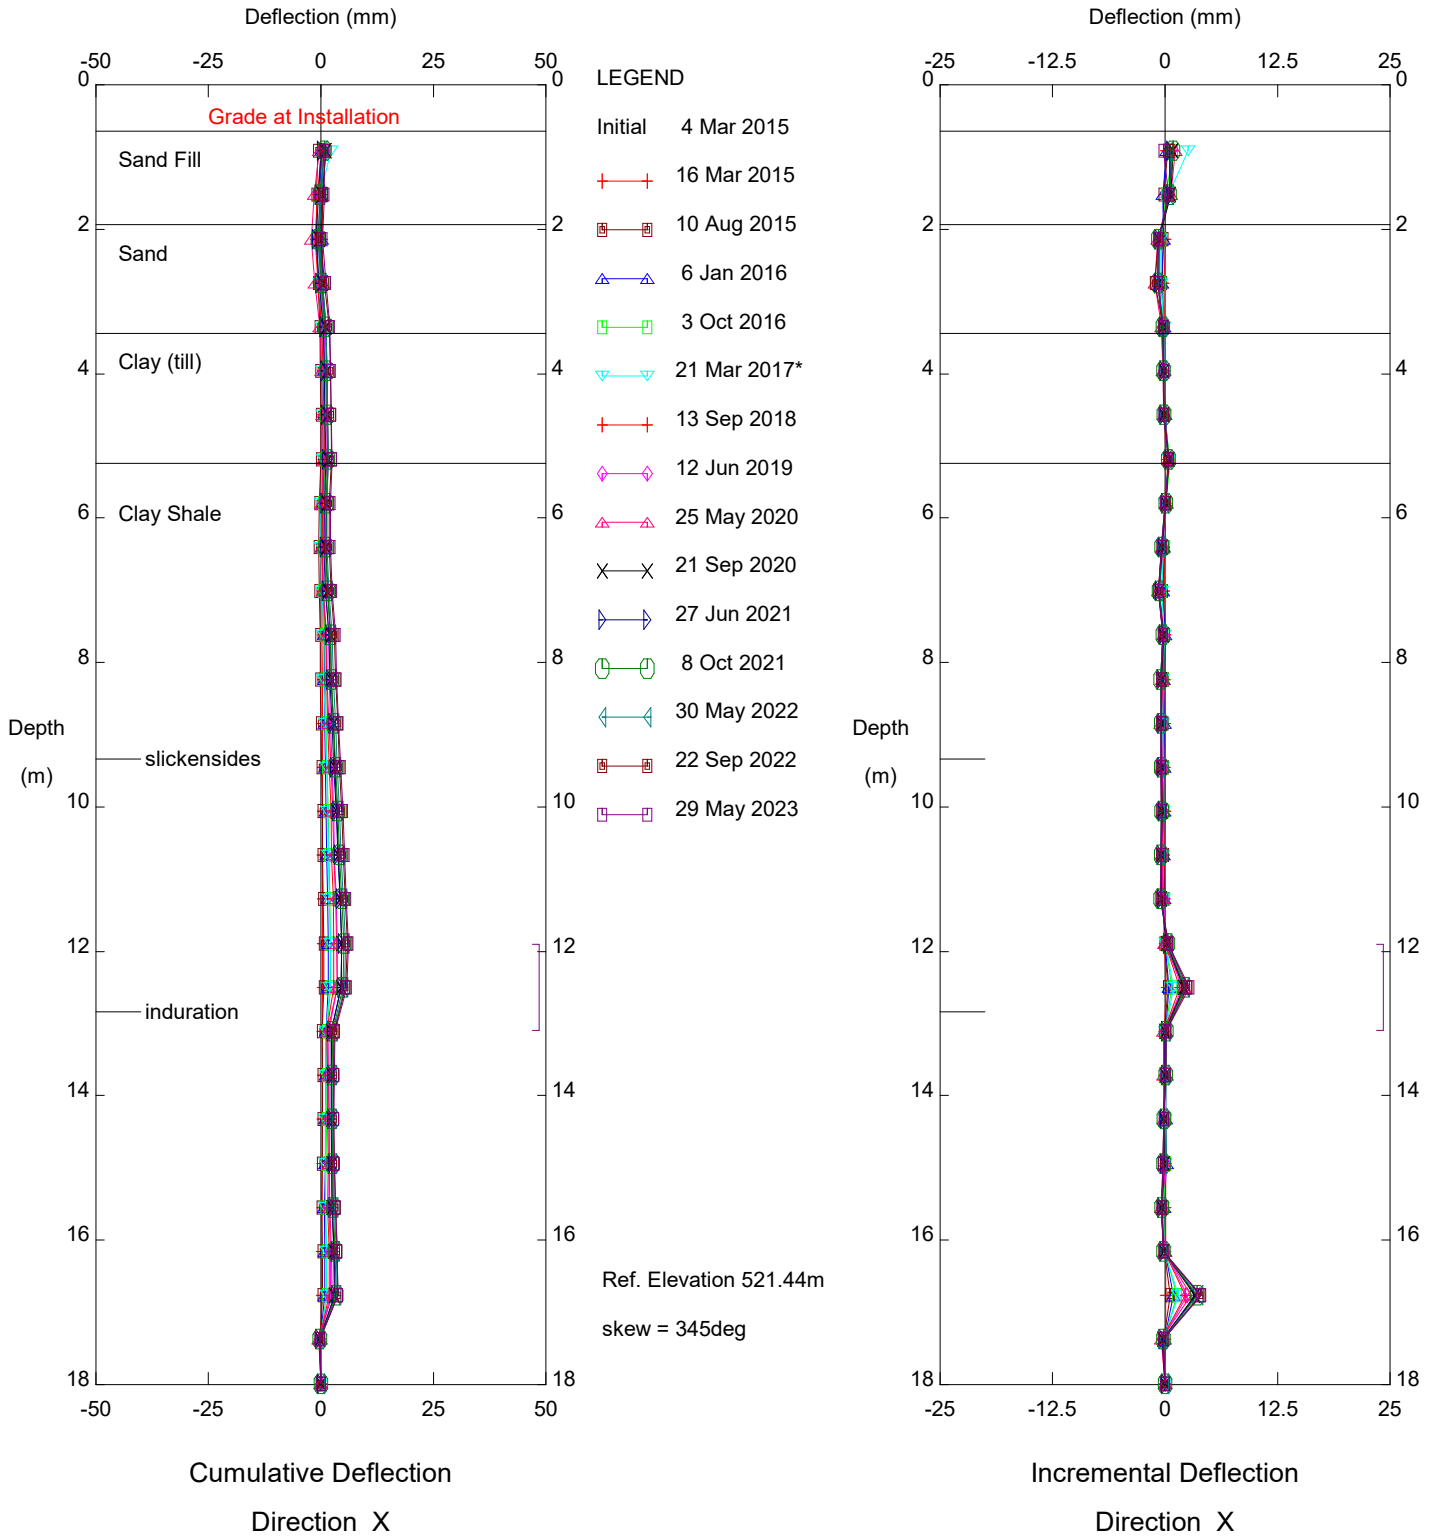
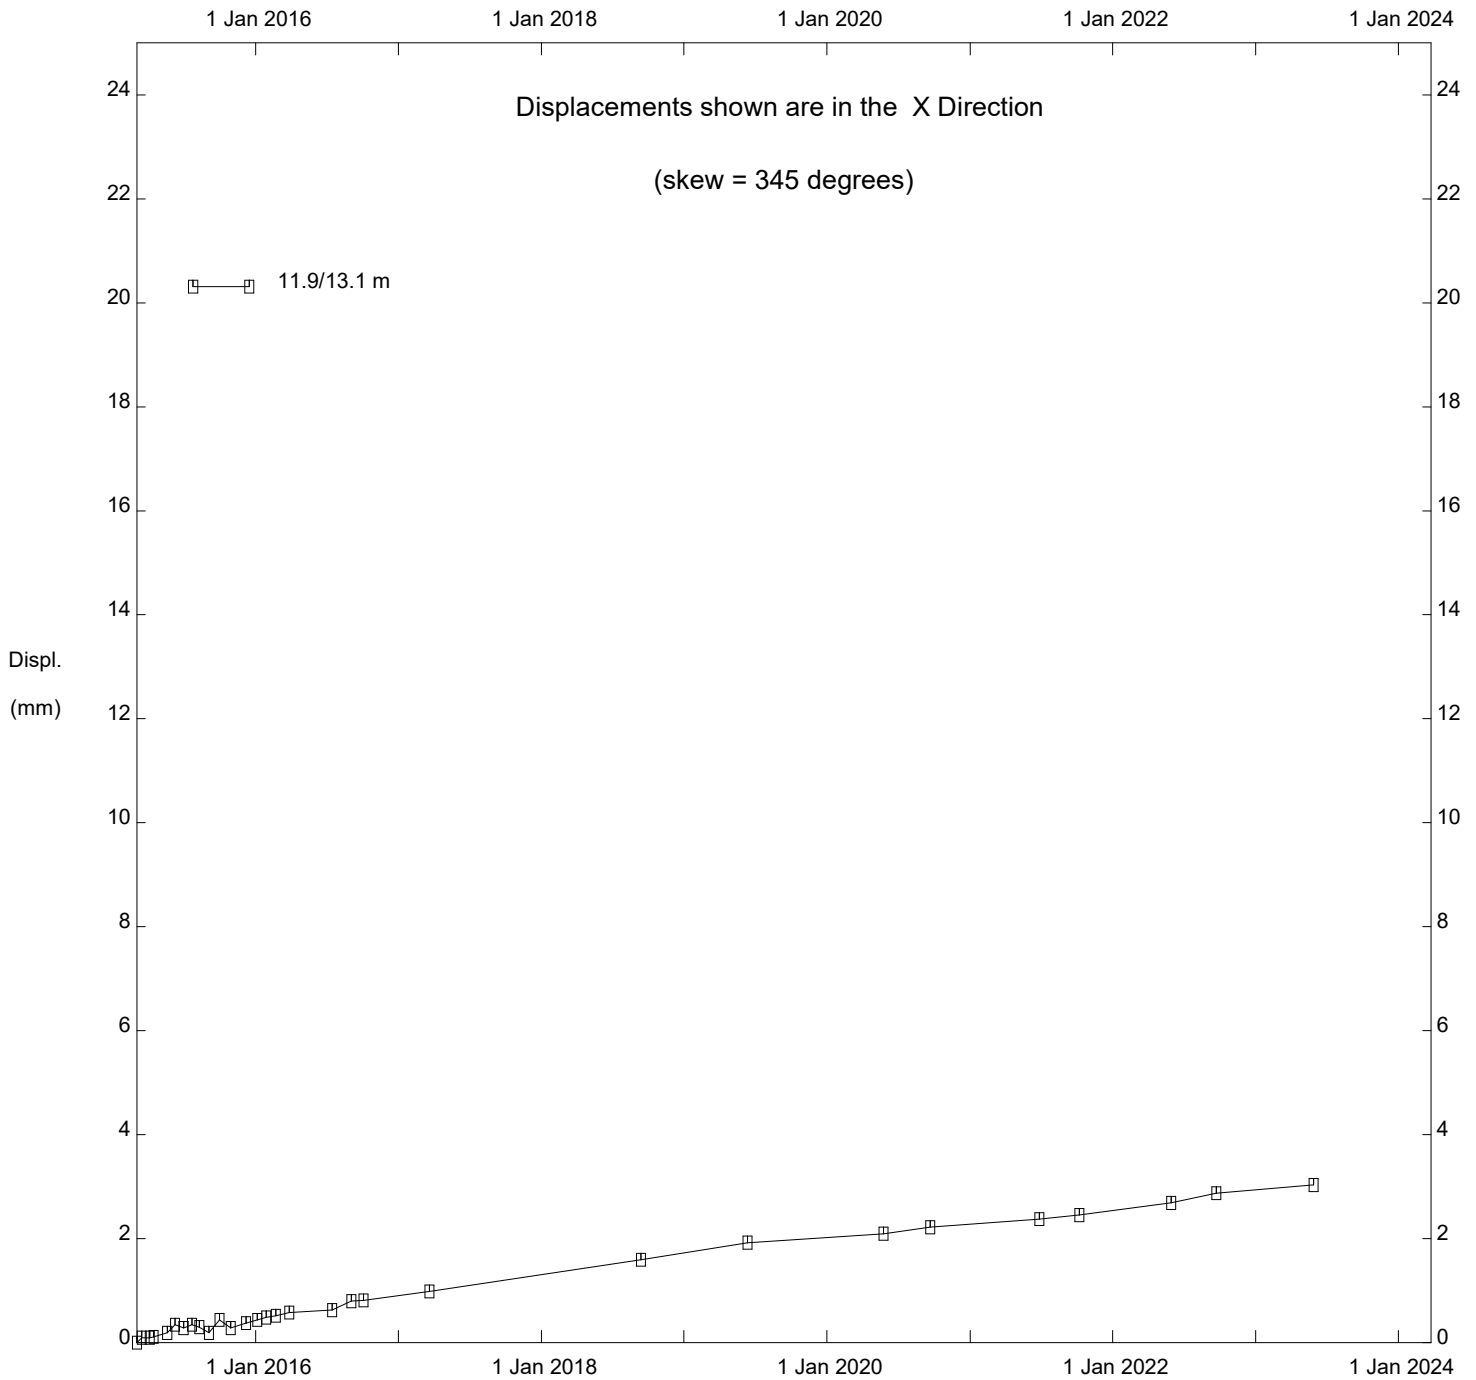
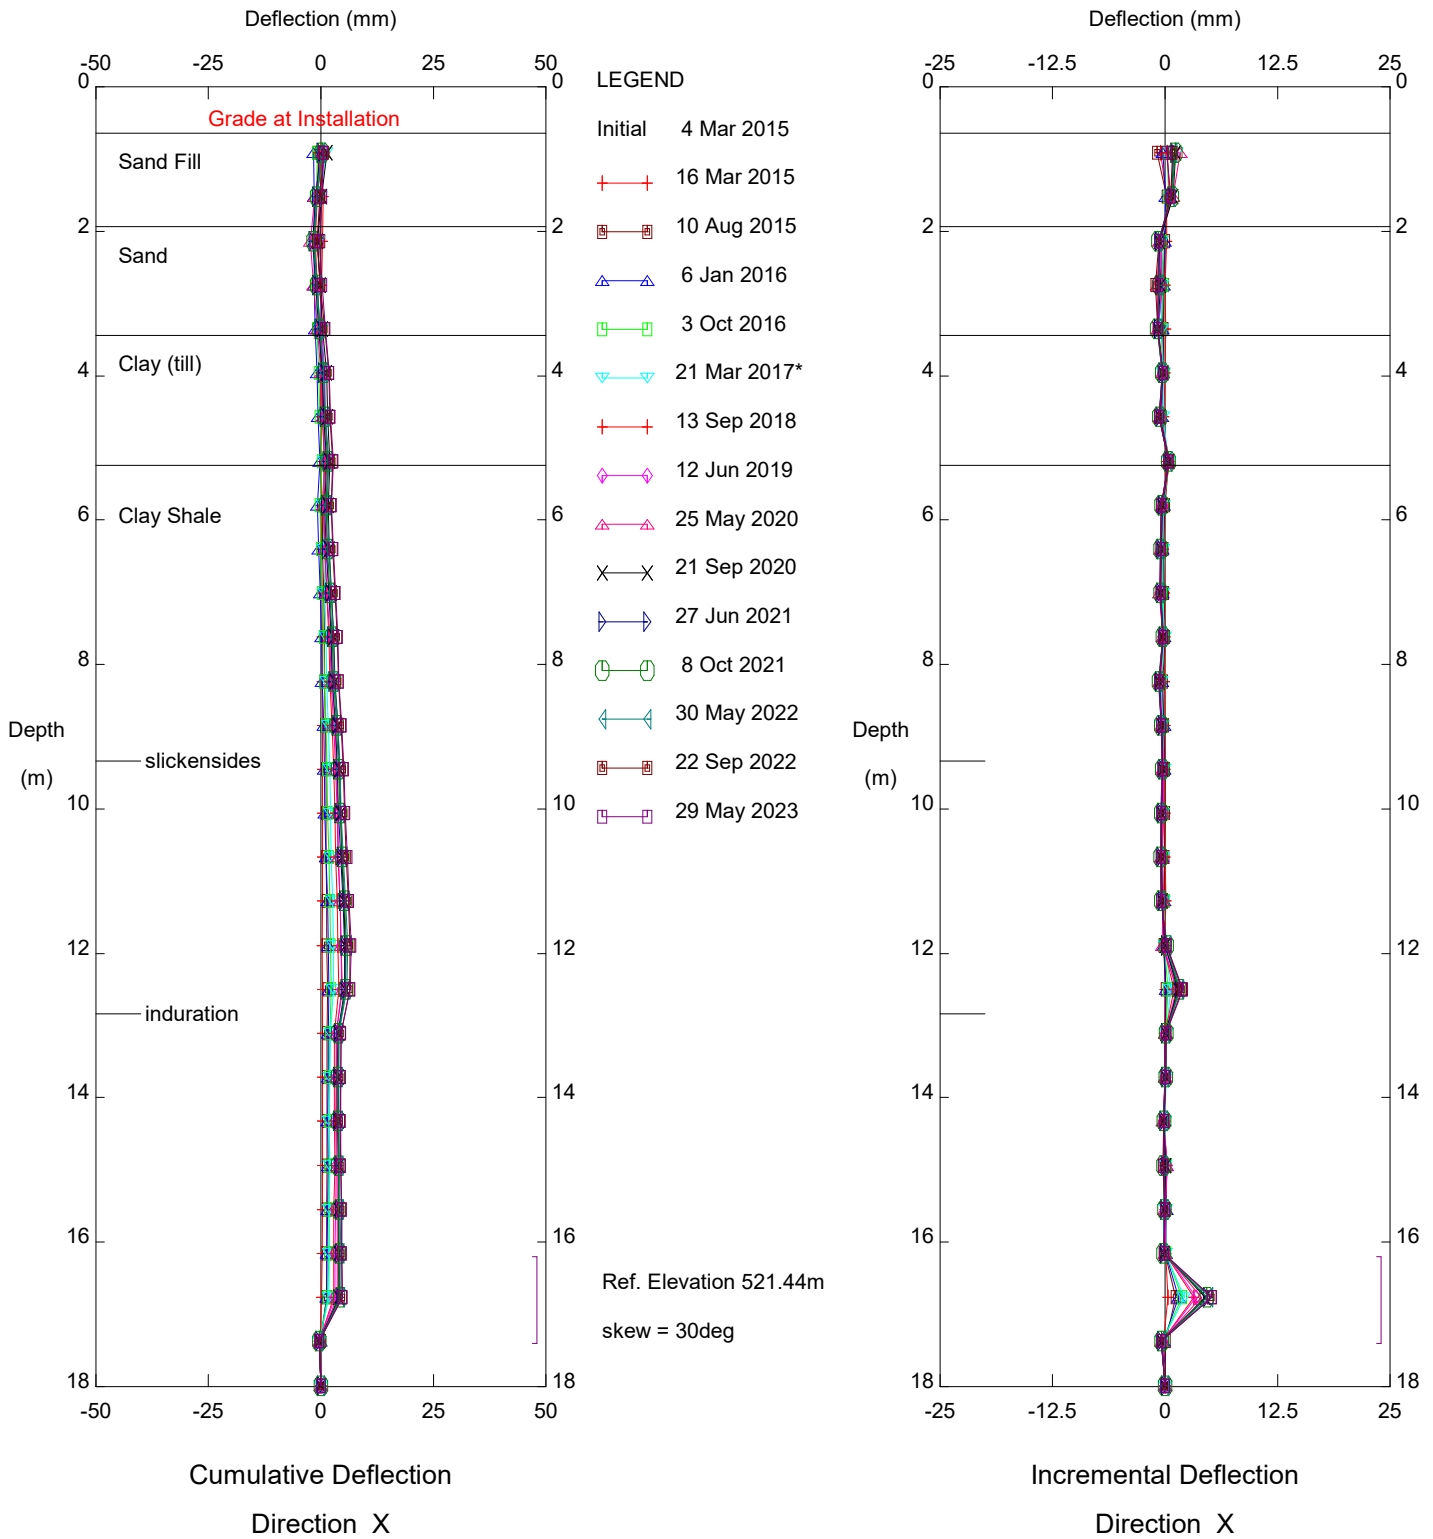
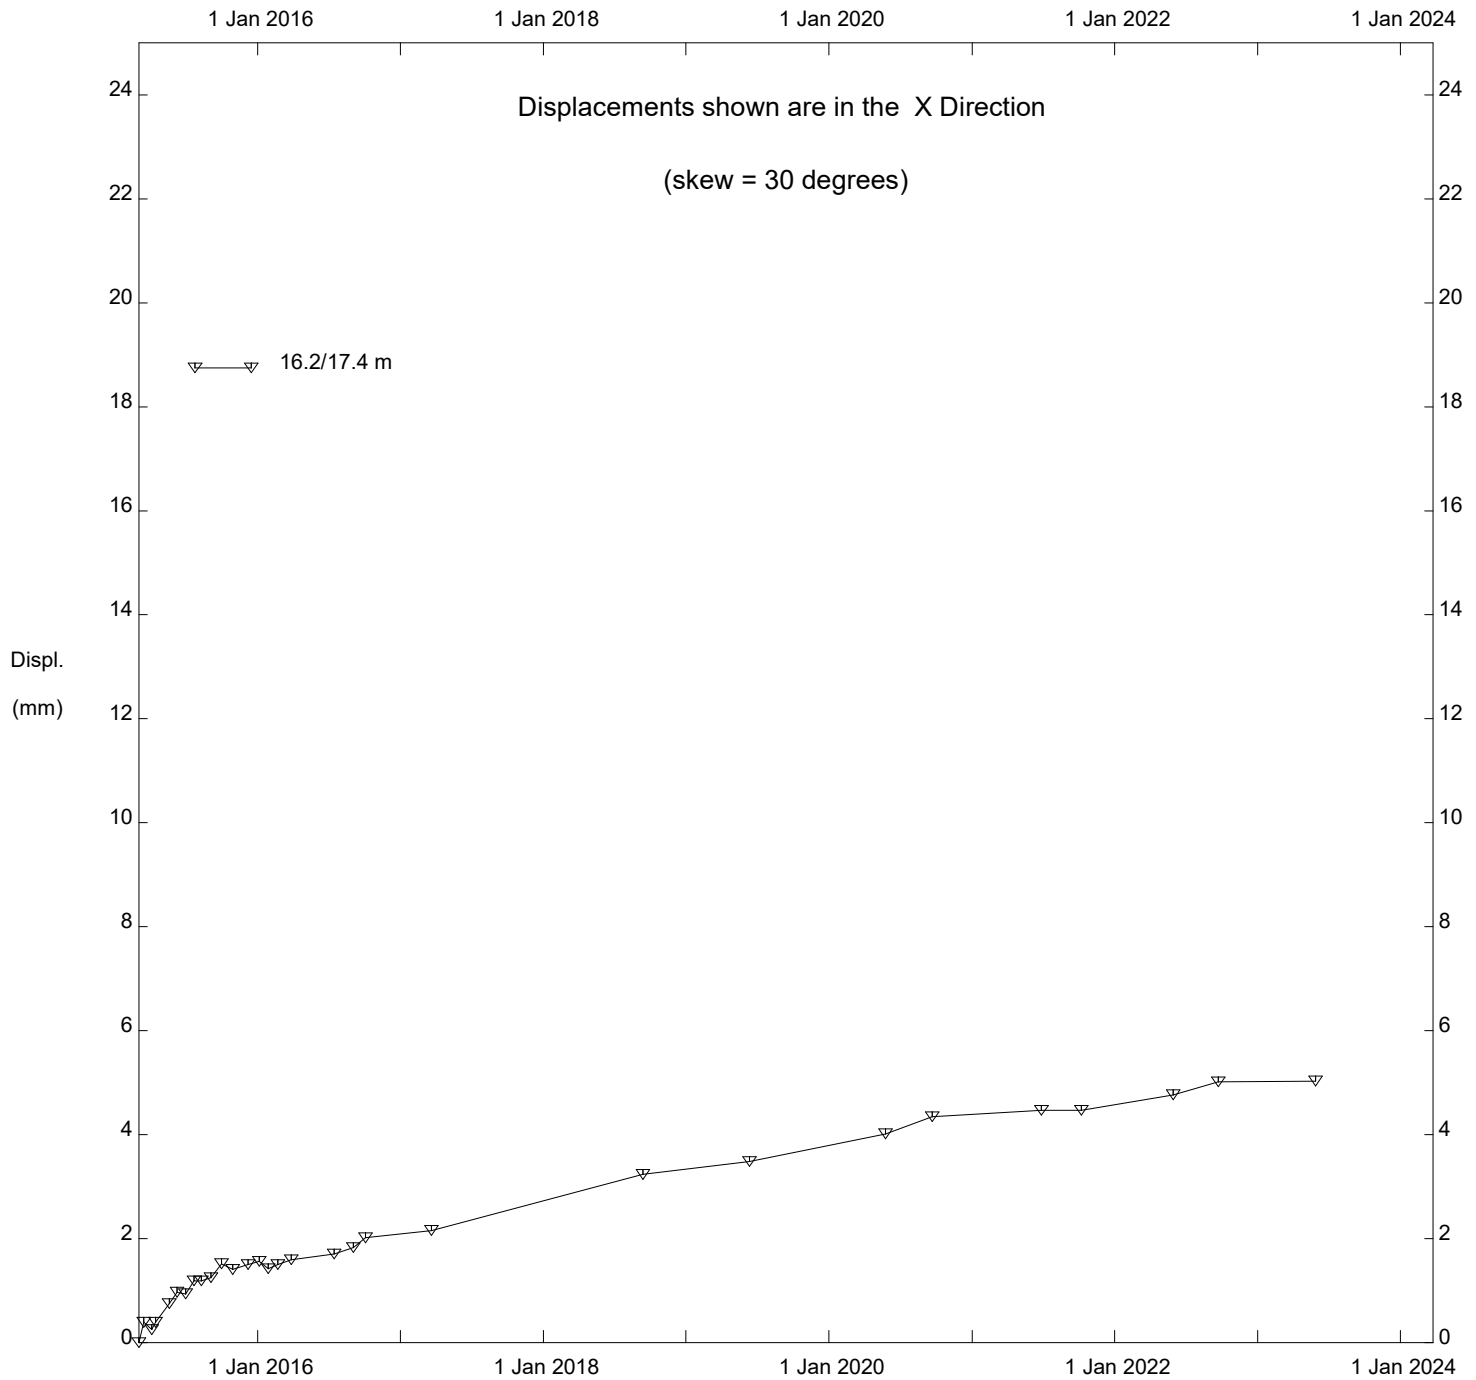
NC099 Cut Slope - Bench 1, Inclinometer 15-10

| INSTRUMENT # | DATE INITIALIZED | TOTAL CUMULATIVE RESULTANT MOVEMENT AND DEPTH OF MOVEMENT TO DATE (mm) | MAXIMUM RATE OF MOVEMENT (mm/yr) | CURRENT STATUS | DATE OF LATEST READING | DATE OF PREVIOUS READING | INCREMENTAL MOVEMENT SINCE PREVIOUS READING (mm) | CURRENT RATE OF MOVEMENT (mm/yr) | CHANGE IN RATE OF MOVEMENT SINCE PREVIOUS READING (mm/yr) |
|---|---|---|---|---|---|---|---|---|---|
| SI15-10 | March 4, 2015 | 3.0 mm over 11.9 m to 13.1 m in 303° direction | 4.3 on March 16, 2015 | Operational | May 29, 2023 | September 22, 2022 | 0.2 | 0.2 | -0.4 |
| | | 5.0 mm over 16.2 m to 17.4 m in 348° direction | 11.9 on March 16, 2015 | | | | <0.1 | 0.0 | -0.8 |

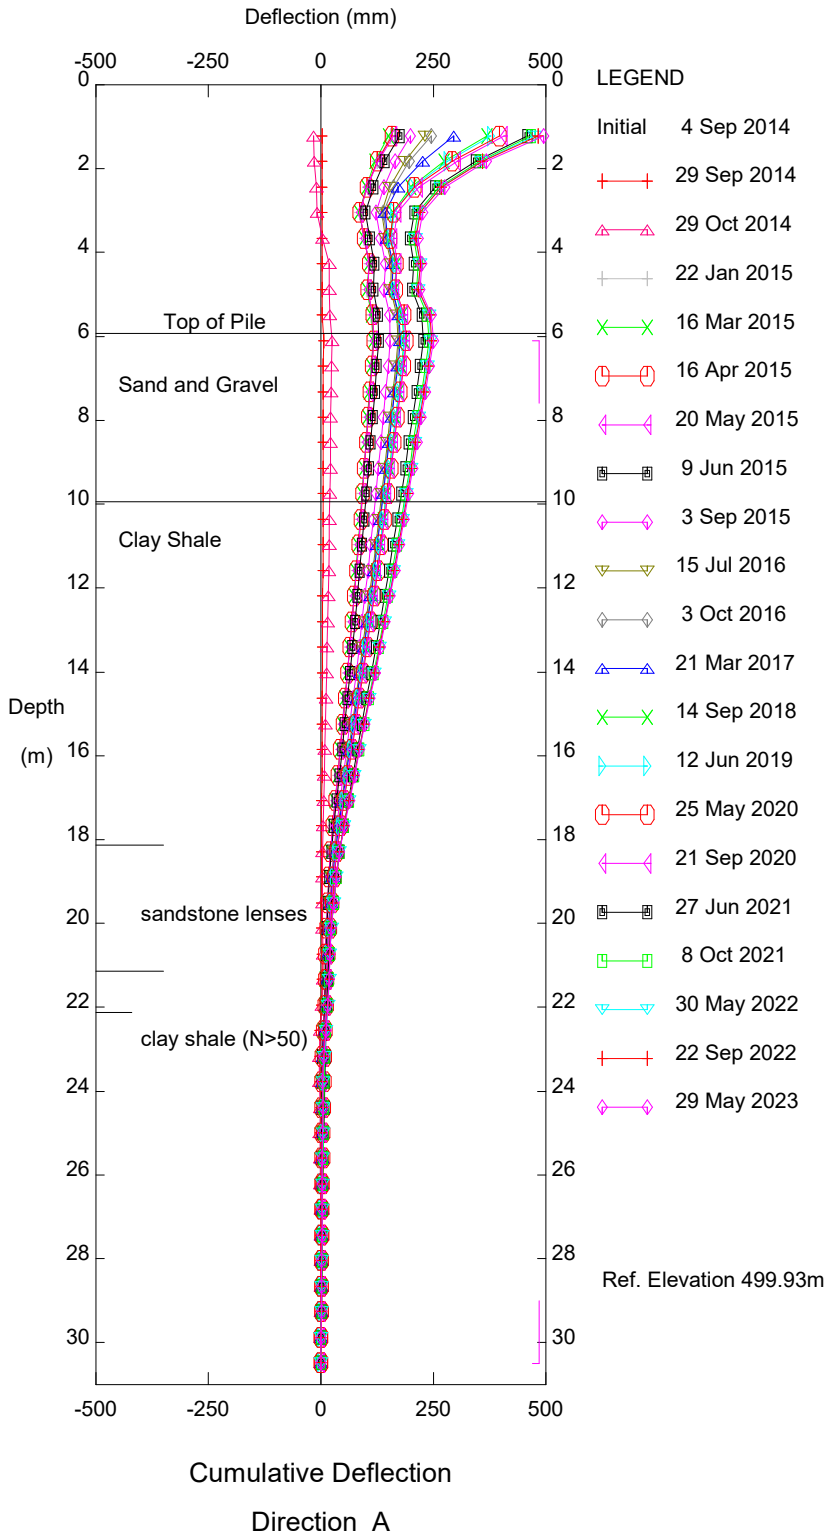
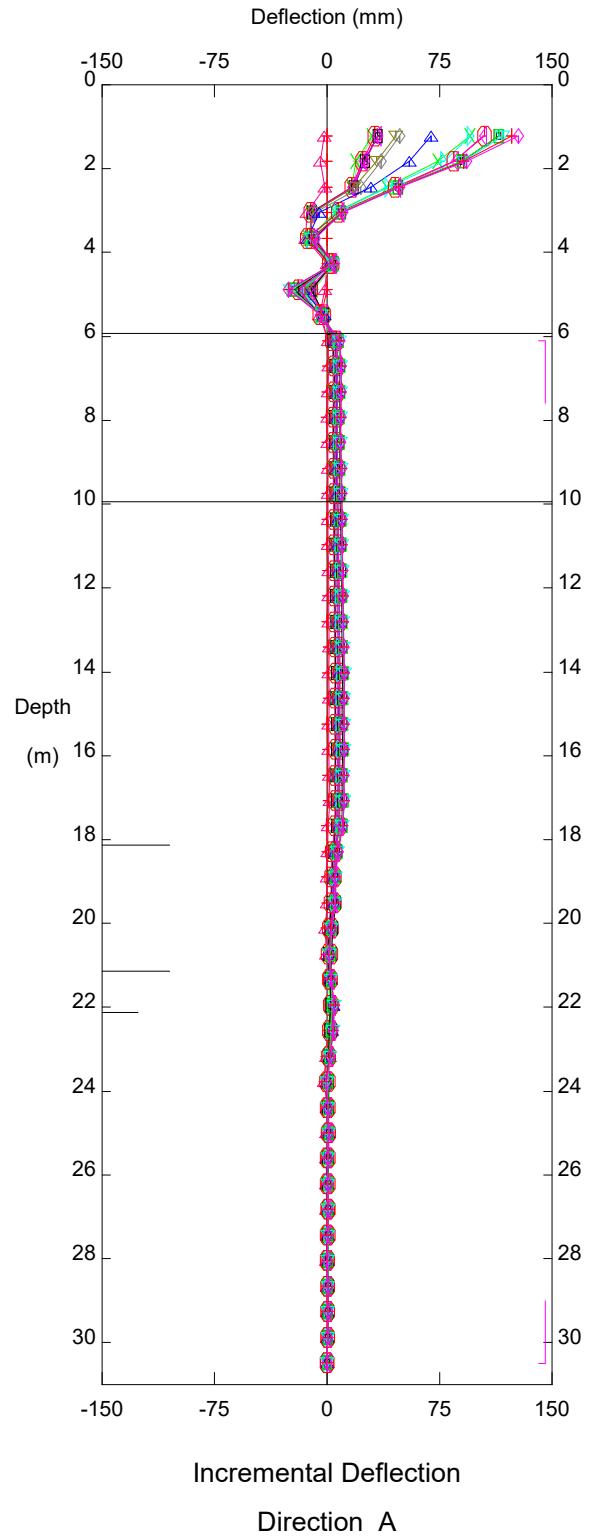
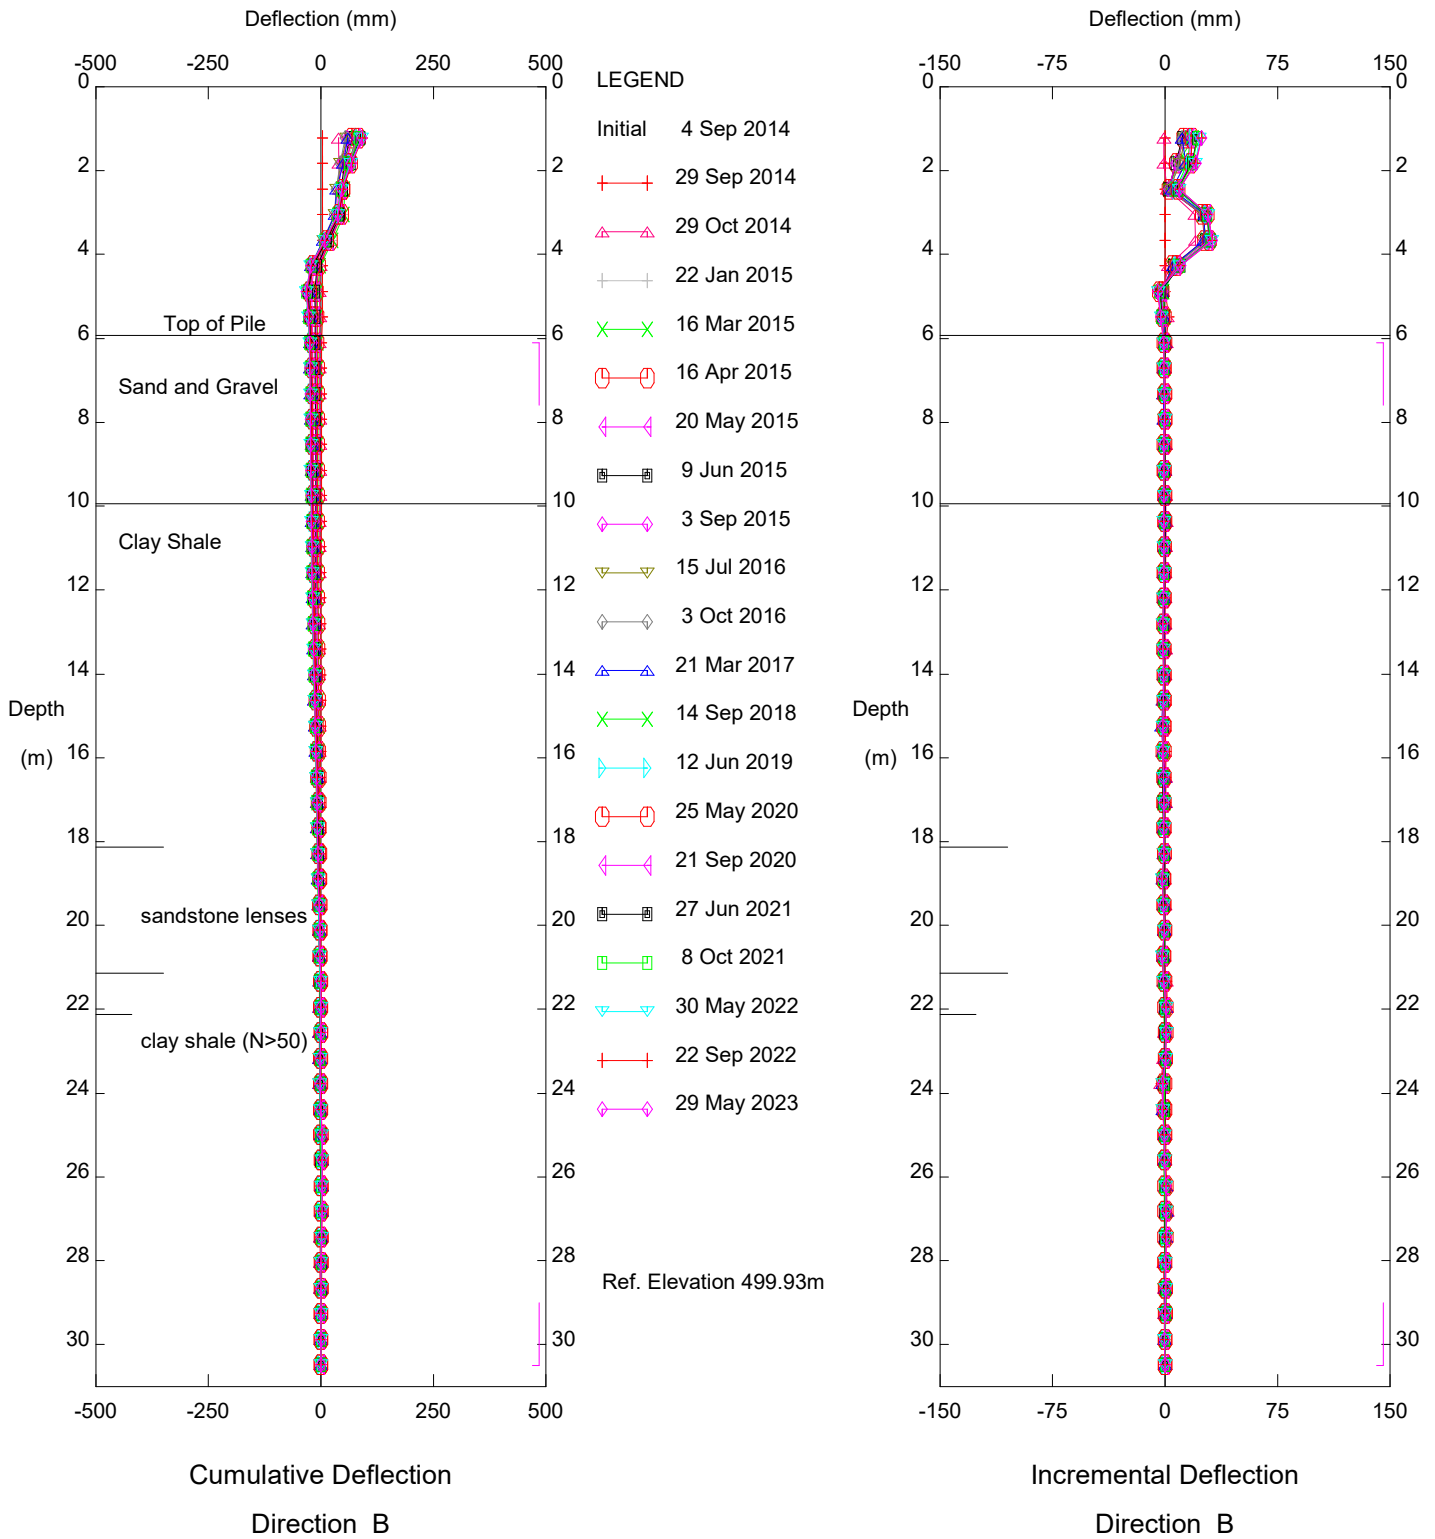
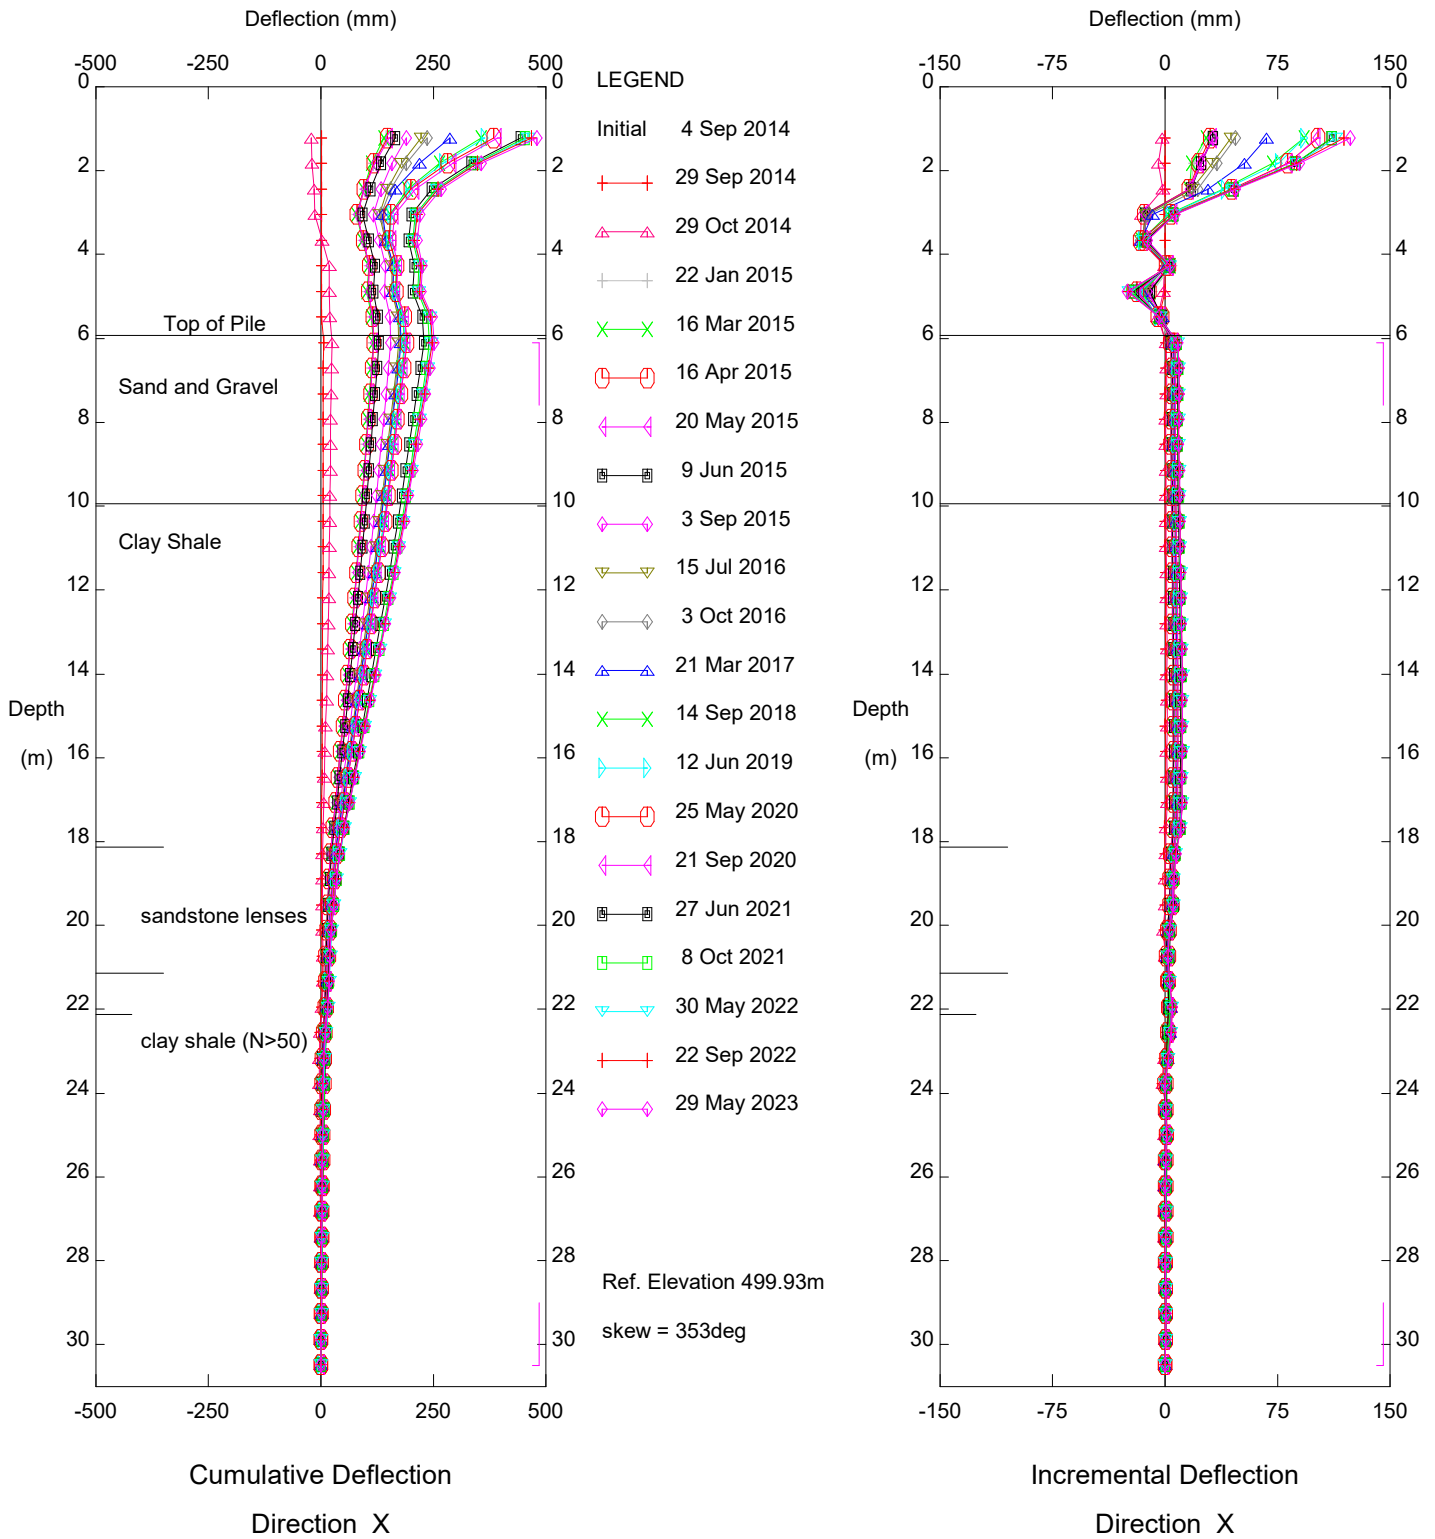
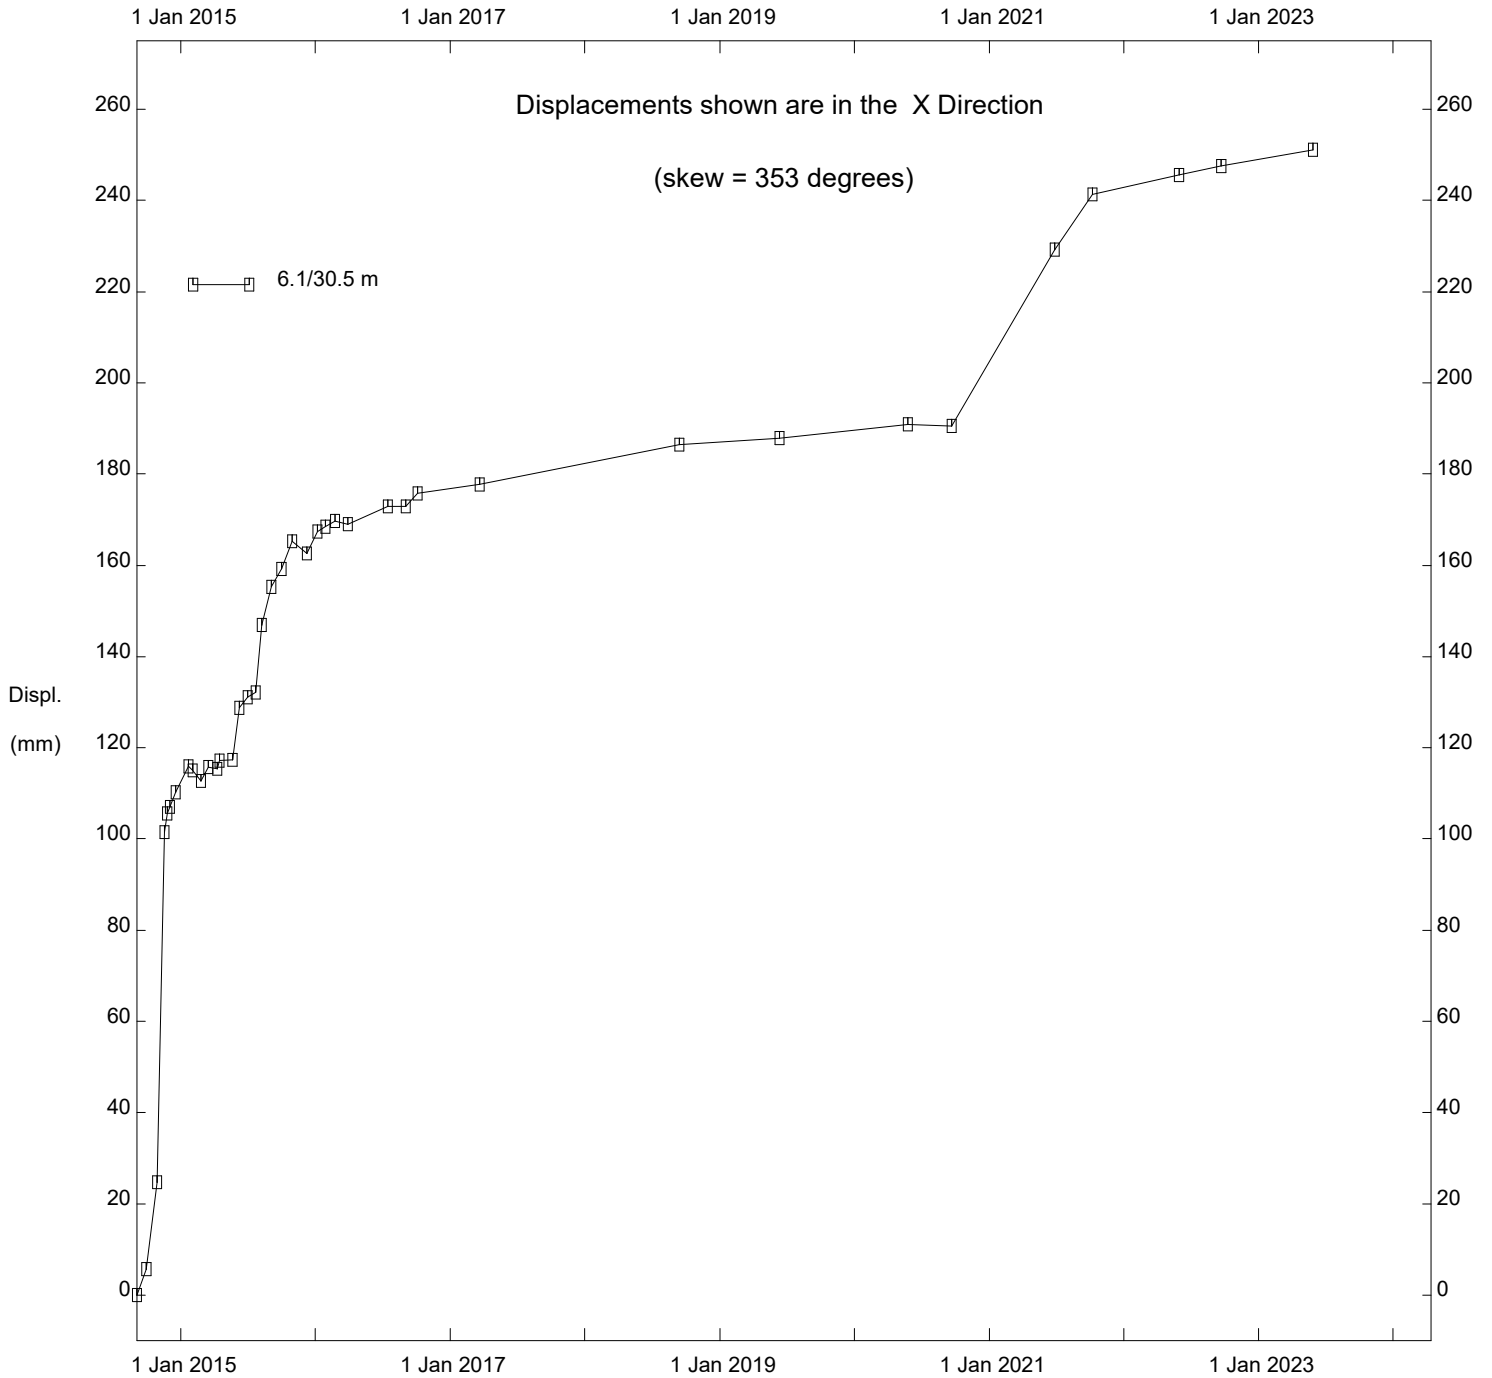
NC099 North Slope Stability Pile Wall, Inclinometer 14-01

SI14-01, located in the pile wall of the bridge north approach fill, showed a rate of movement of 5.2 mm/yr over the length of the pile from 6.1 m to 30.5 m depth, corresponding to an incremental movement of 3.5 mm since the fall of 2022 readings. SI14-02, located in the pile wall of the bridge south approach fill, shows a current rate of movement of 15.7 mm/yr over the length of the pile from 5.5 m to 31.7 m depth. Overall, SI14-01 appears to be slowing from the relatively high movement rates observed over the past several readings cycles. The rate of movement in SI14-02 increased by 10.7 mm/yr since the fall of 2022 readings, and current rate of movement in the SI is the highest recorded since October 3, 2016. The current pile head movements in SI14-01 and SI14-02 are 251.1 mm and 168.8 mm, respectively.
