July 8, 2023

**ALBERTA TRANSPORTATION AND ECONOMIC CORRIDORS GRMP (CON0022163)  
NORTH CENTRAL (ATHABASCA AND FORT McMURRAY DISTRICTS)  
INSTRUMENTATION MONITORING RESULTS – SPRING 2023**

**SECTION C**

**SITE NC099: HWY 63:10 HANGINGSTONE RIVER BRIDGES**

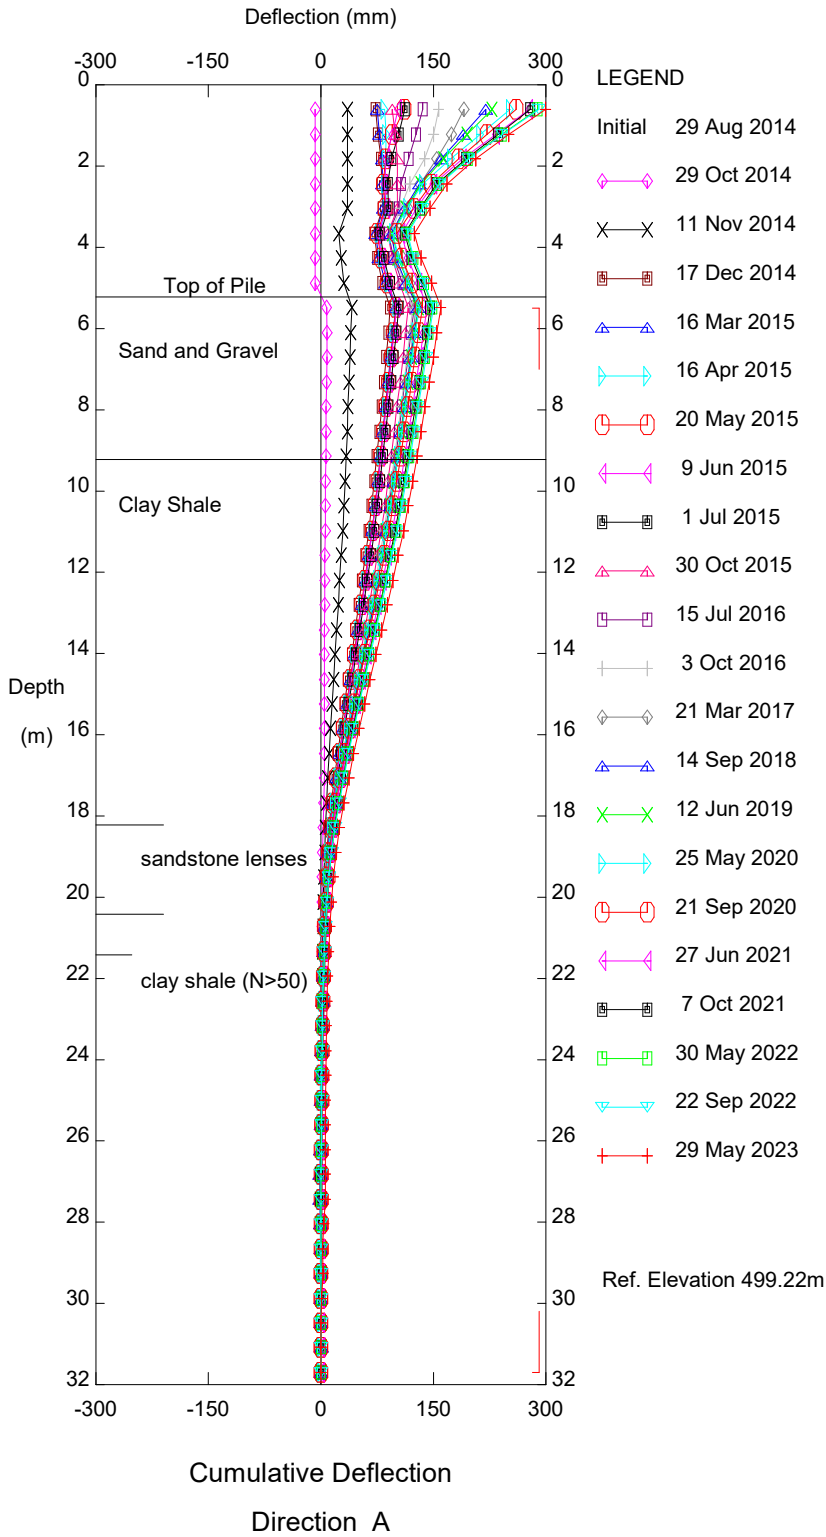
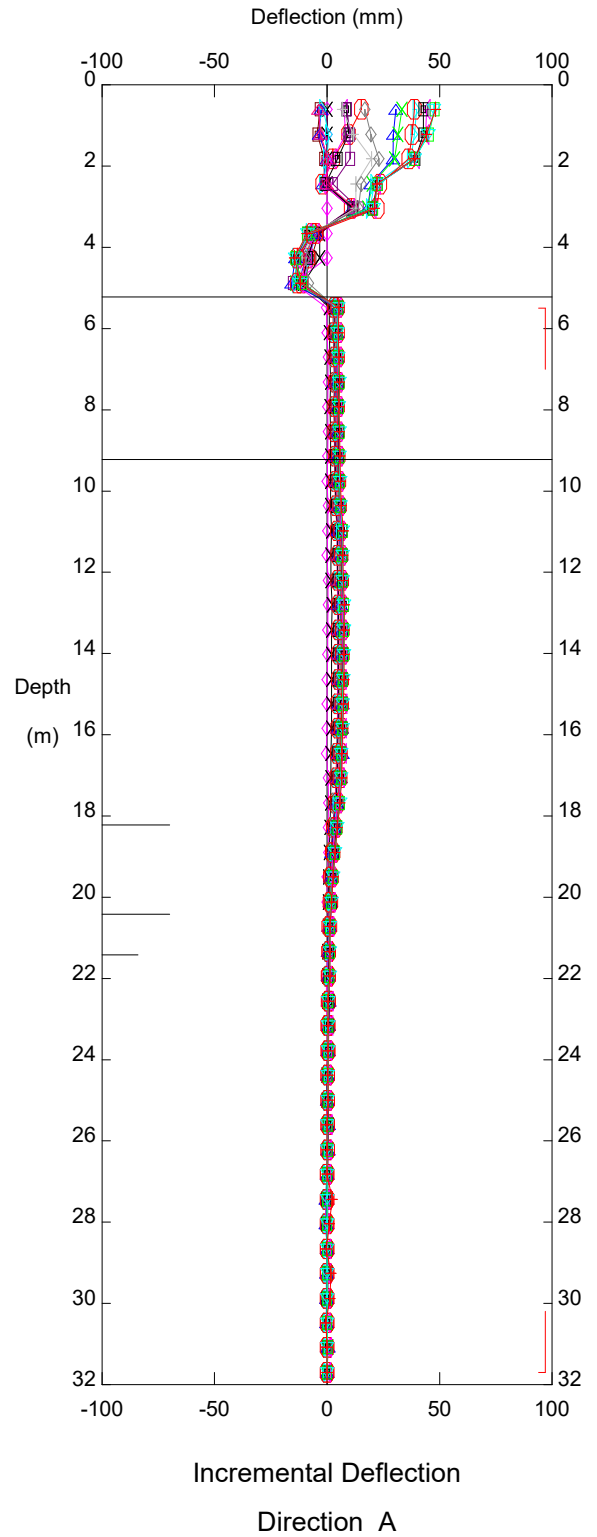
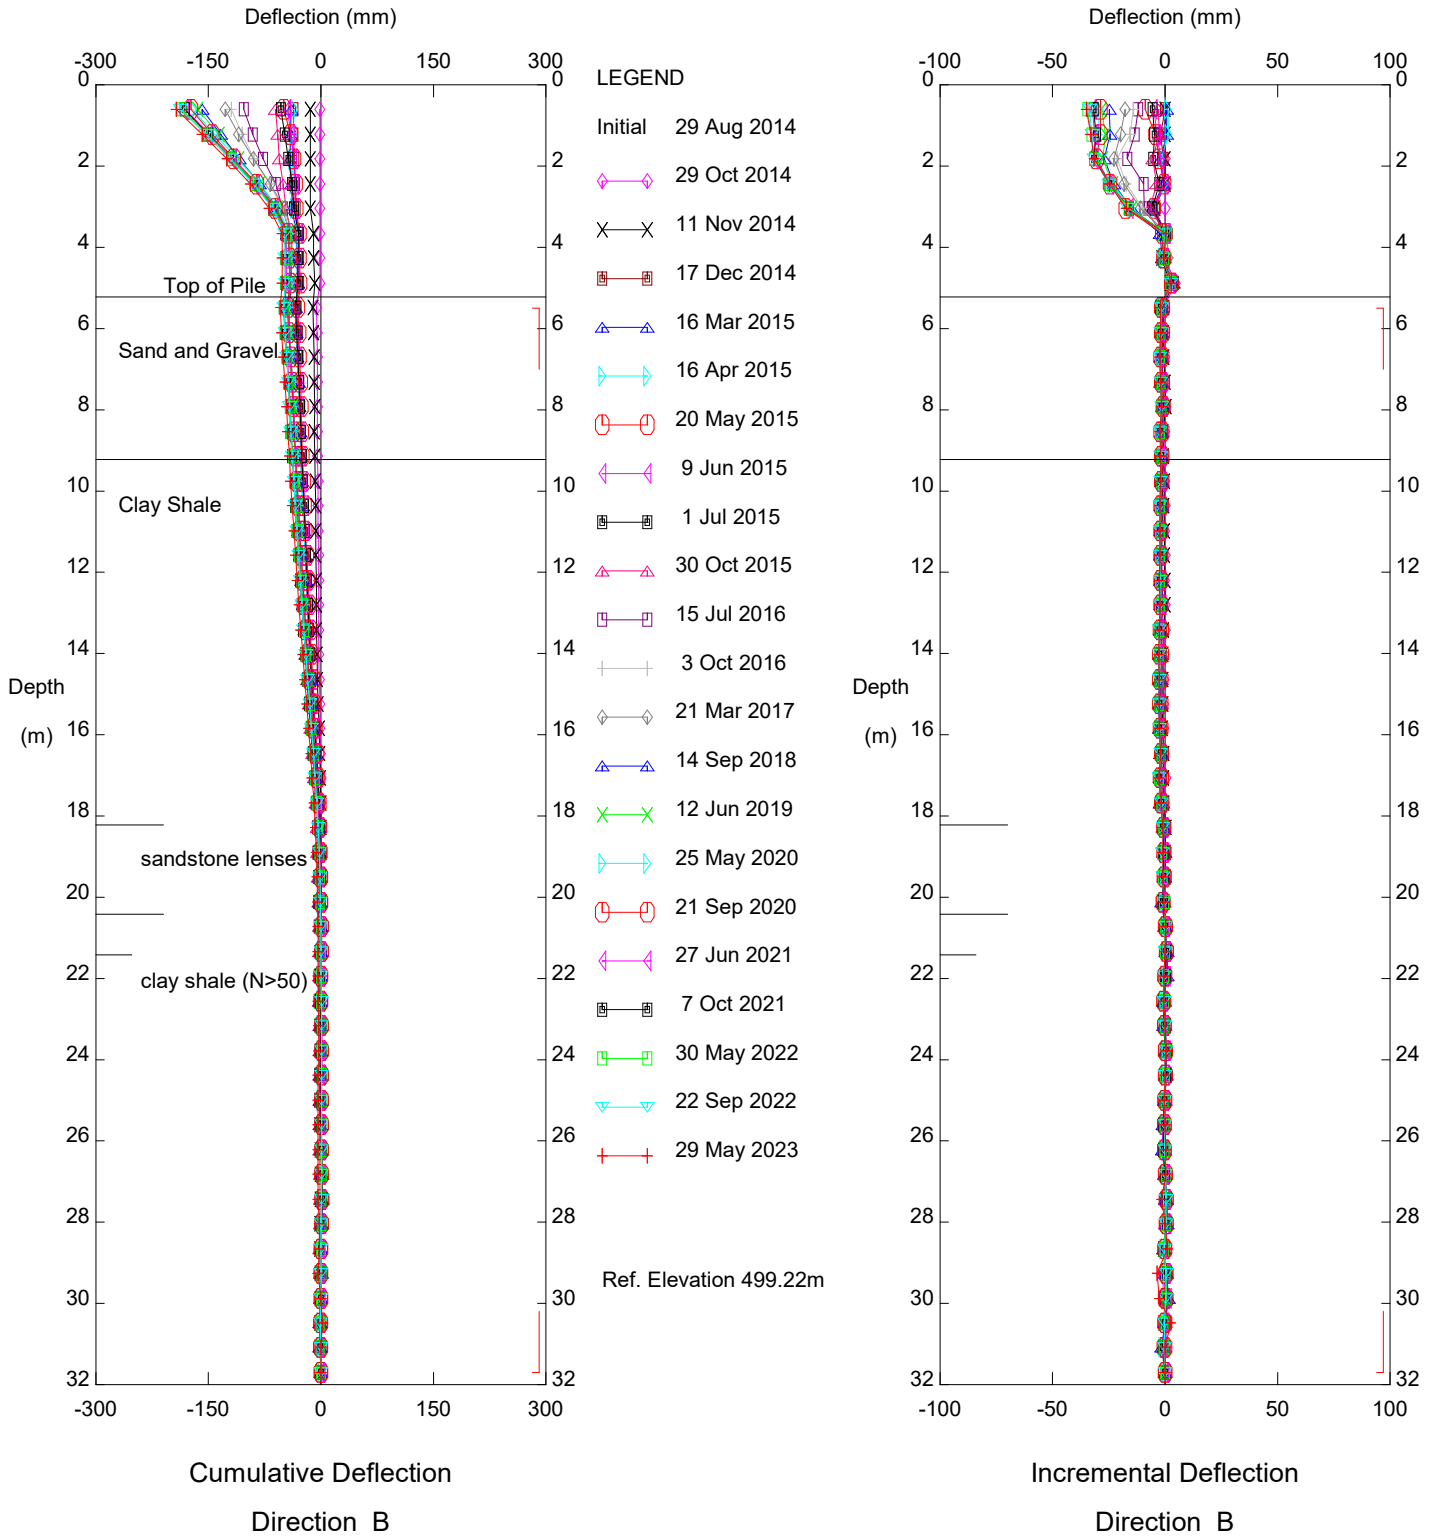
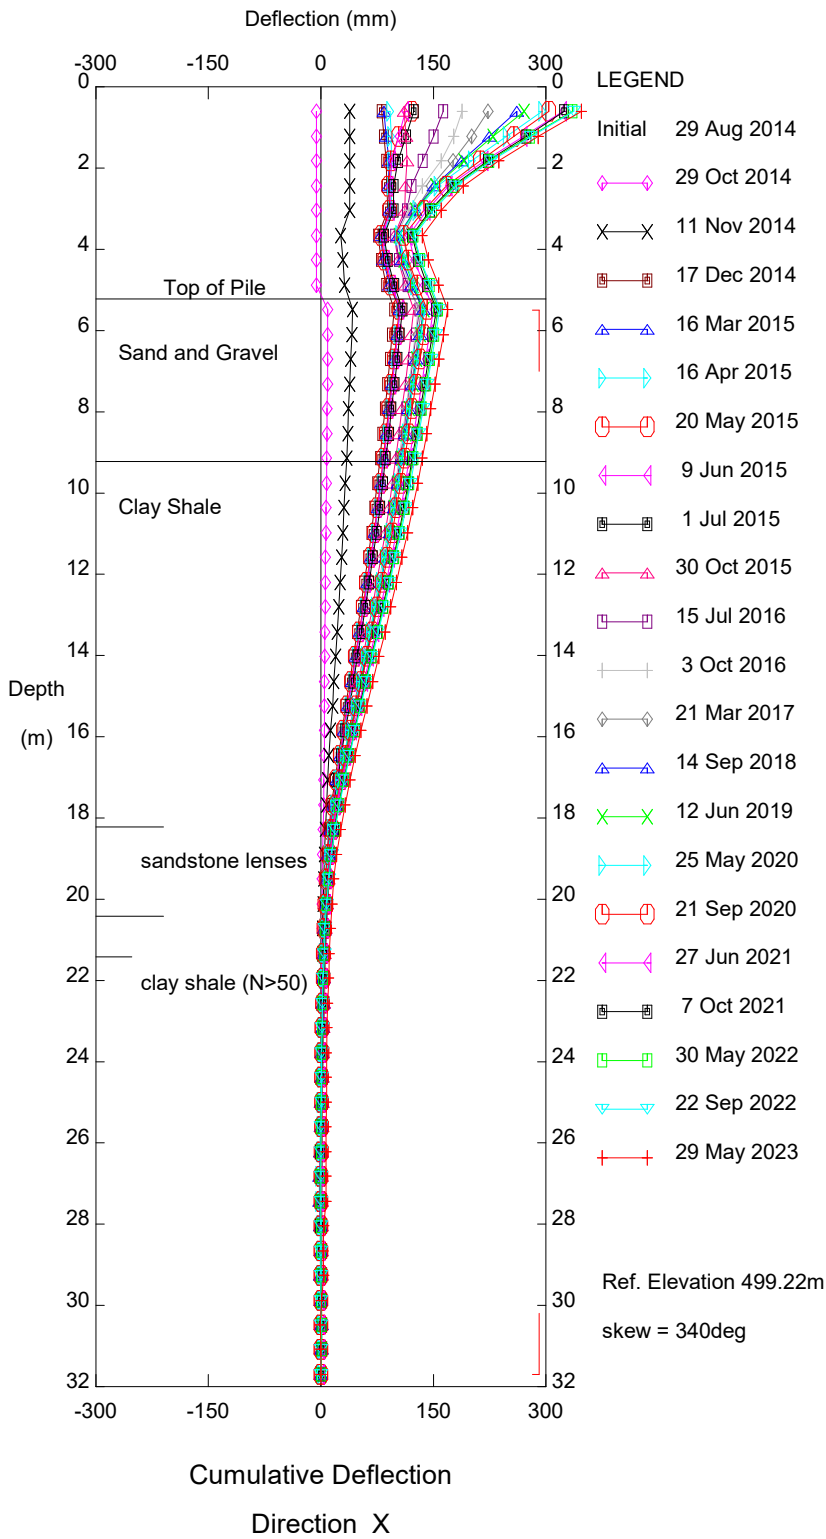
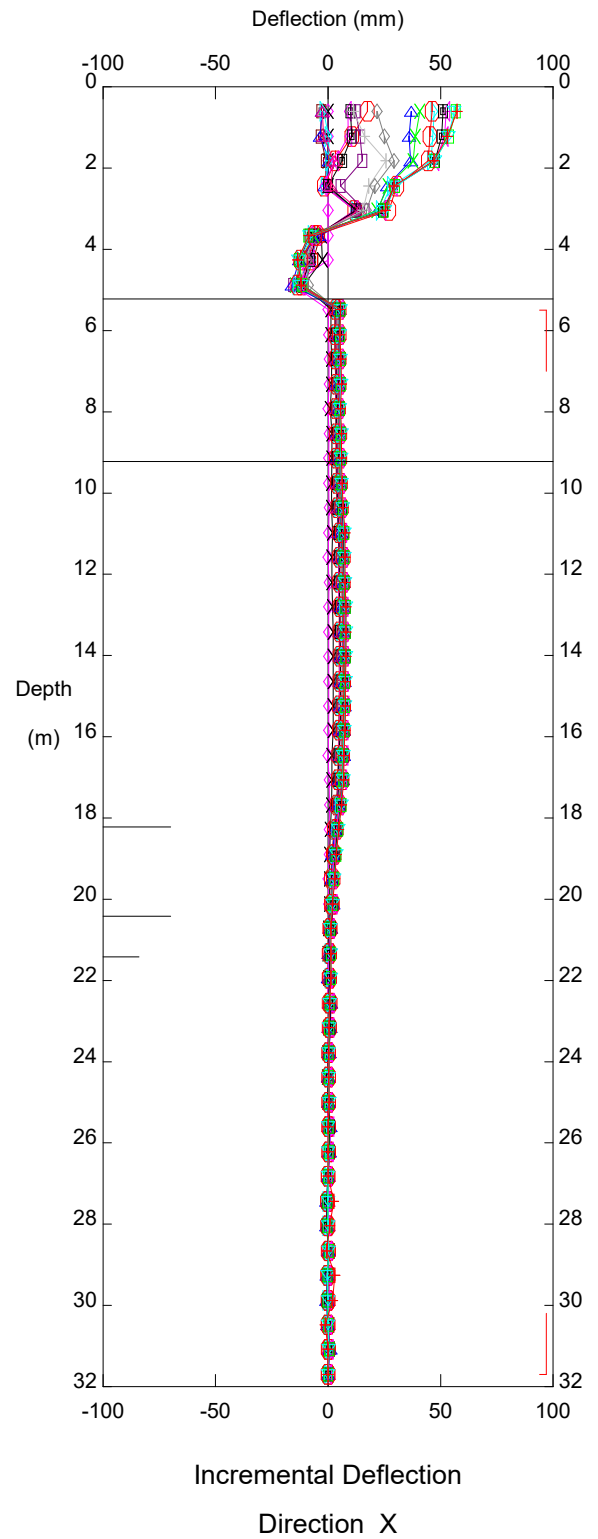
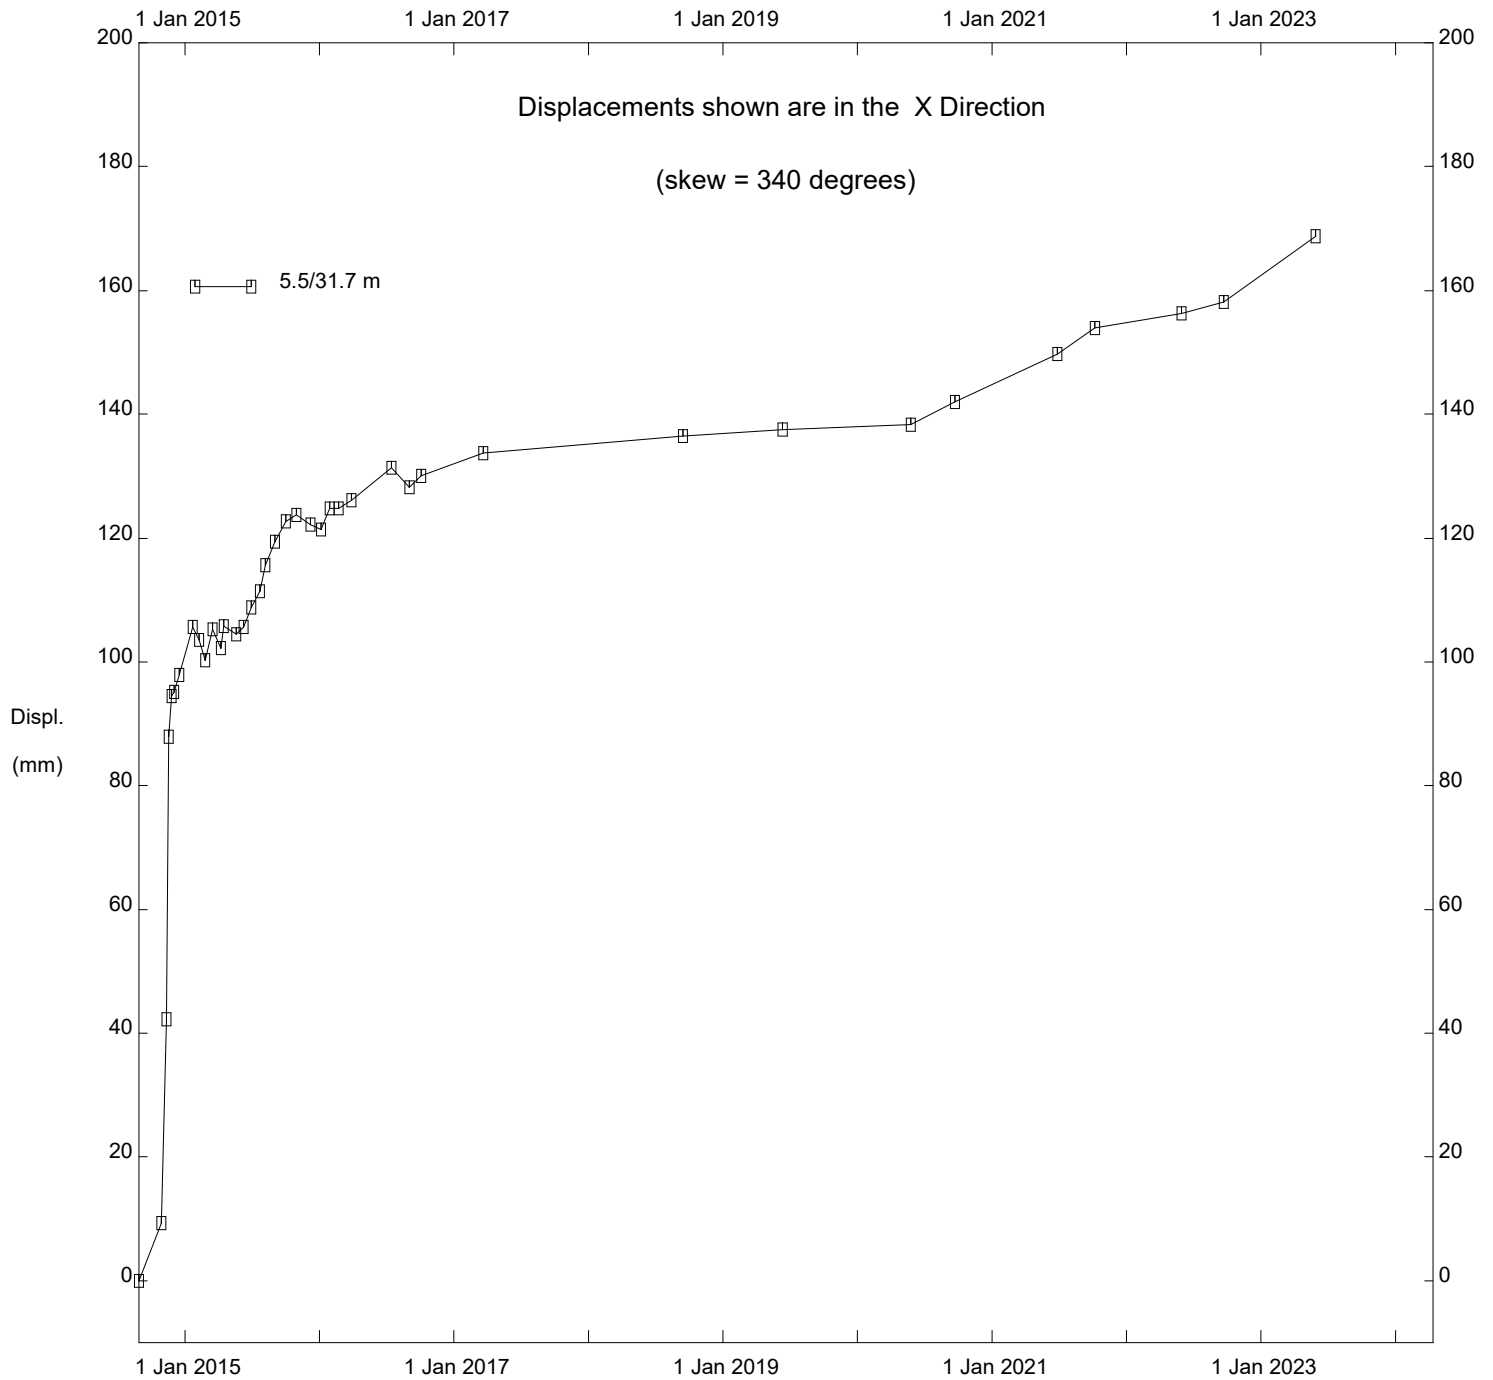
NC099 South Slope Stability Pile Wall, Inclinator 14-02

| INSTRUMENT # | DATE INITIALIZED | TOTAL CUMULATIVE RESULTANT MOVEMENT AND DEPTH OF MOVEMENT TO DATE (mm) | MAXIMUM RATE OF MOVEMENT (mm/yr) | CURRENT STATUS | DATE OF LATEST READING | DATE OF PREVIOUS READING | INCREMENTAL MOVEMENT SINCE PREVIOUS READING (mm) | CURRENT RATE OF MOVEMENT (mm/yr) | CHANGE IN RATE OF MOVEMENT SINCE PREVIOUS READING (mm/yr) |
|---|---|---|---|---|---|---|---|---|---|
| SI14-02 | August 29, 2014 | 168.8 mm over 5.5 m to 31.7 m in 54° direction | 2686.7 on November 17, 2014 | Operational | May 29, 2023 | September 22, 2022 | 10.7 | 15.7 | 10.1 |

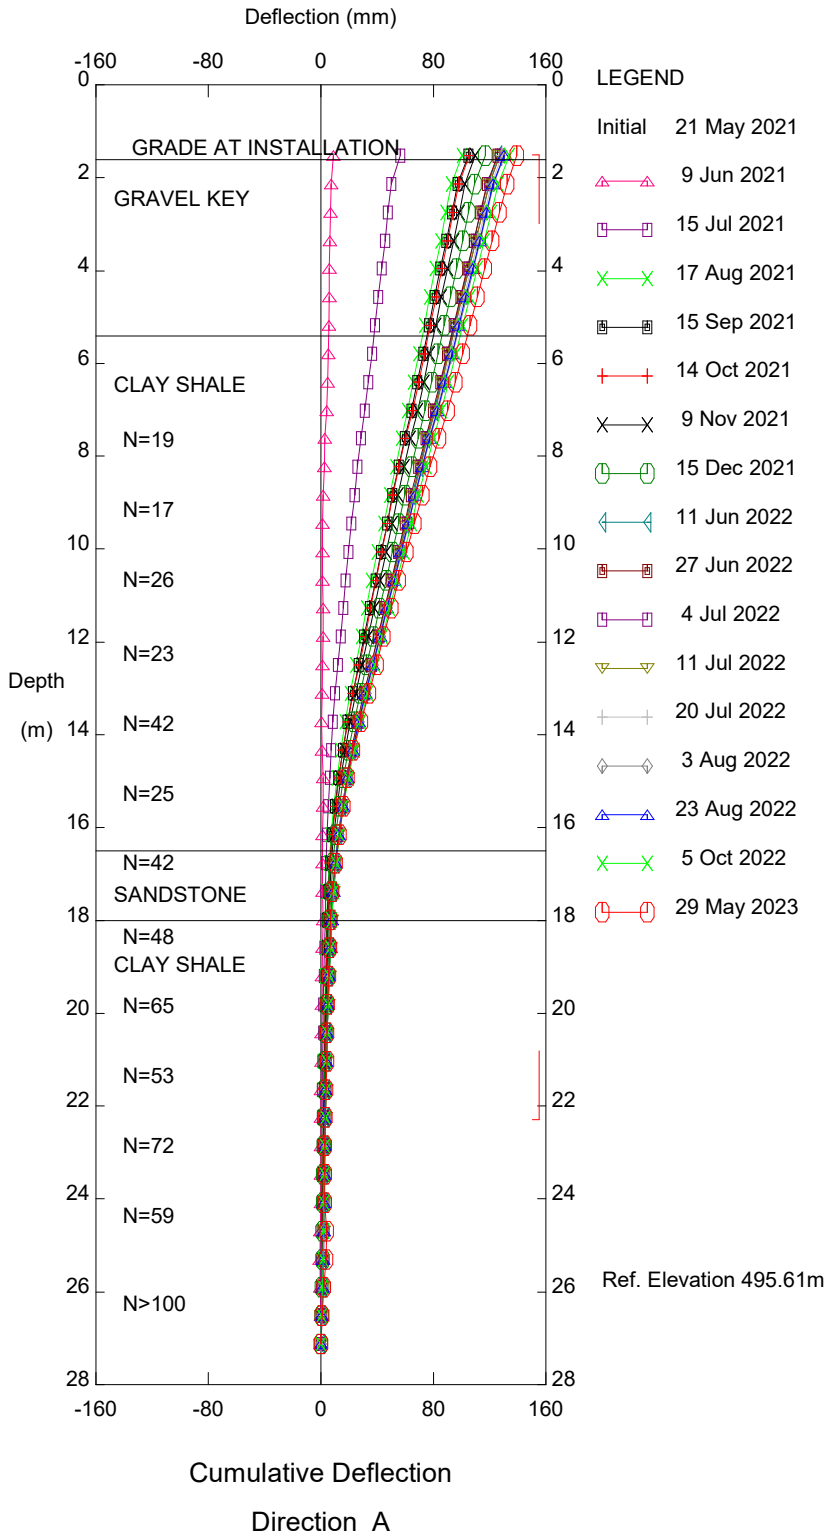
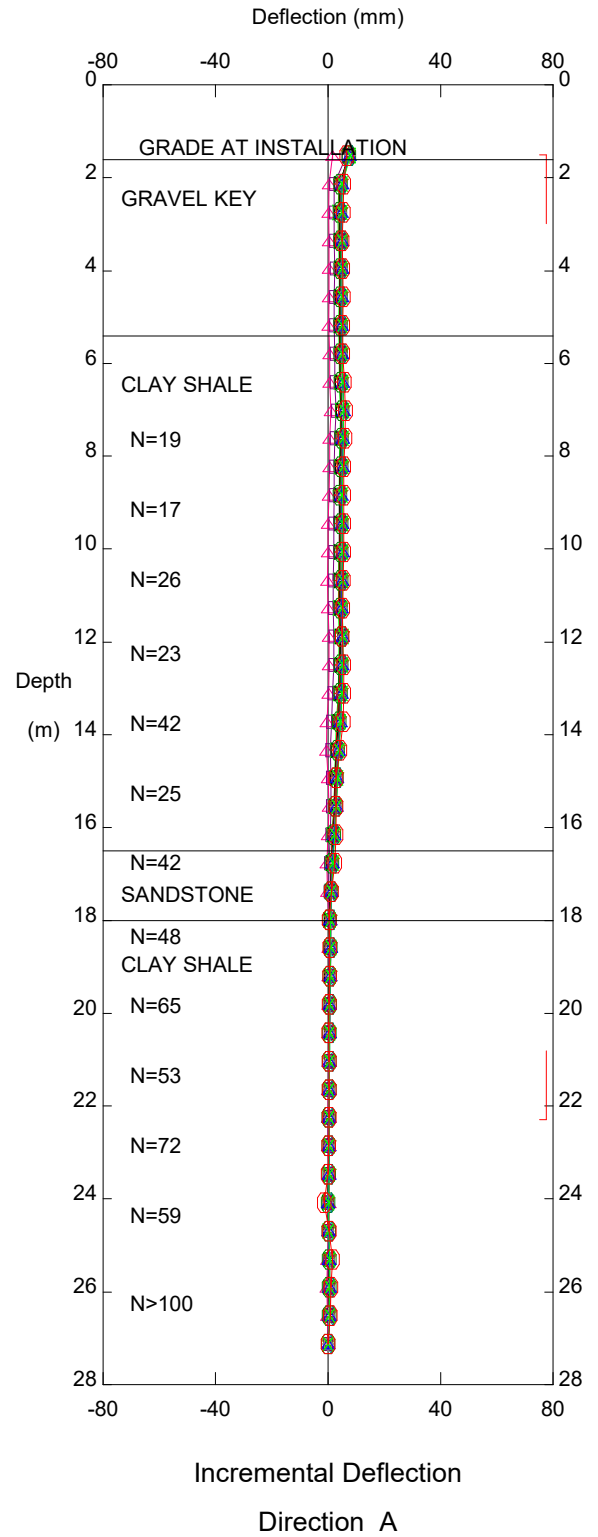
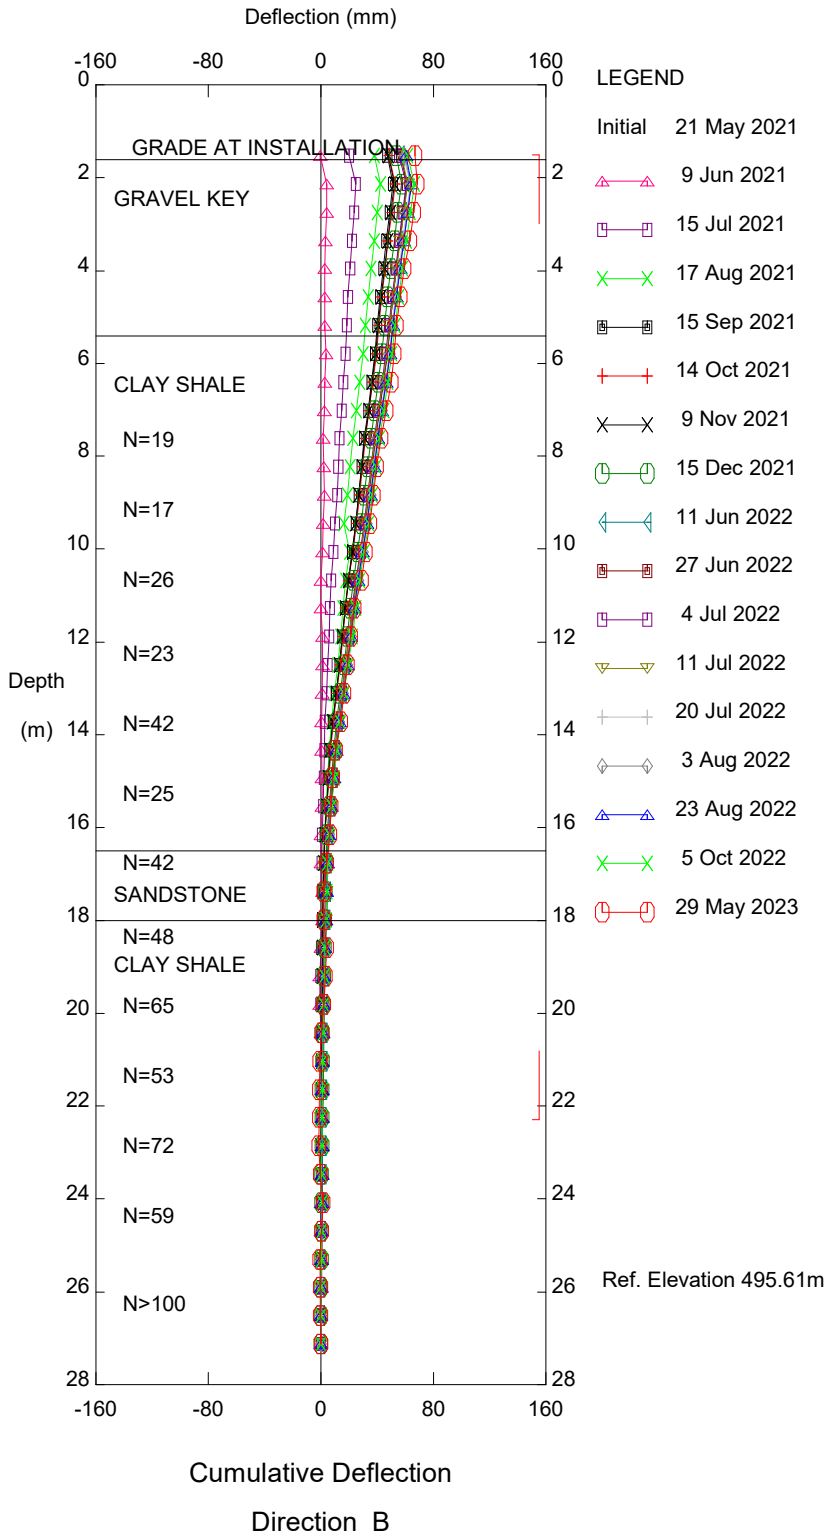
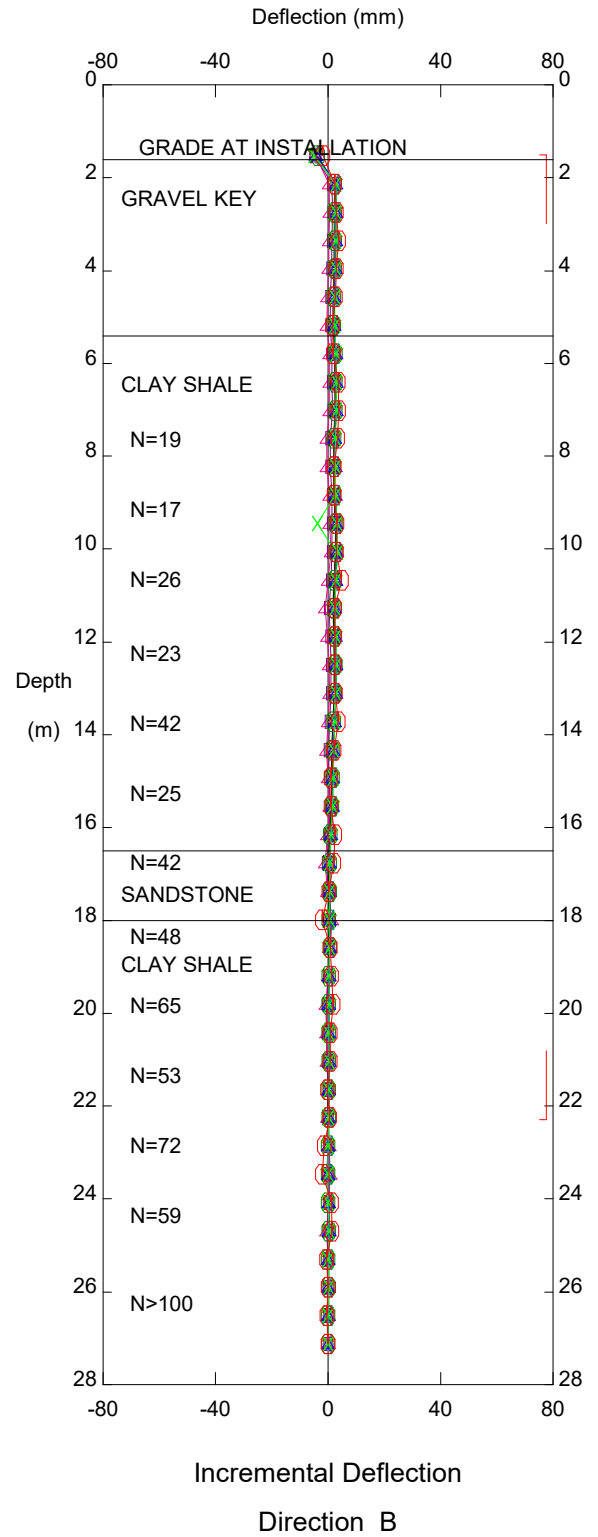
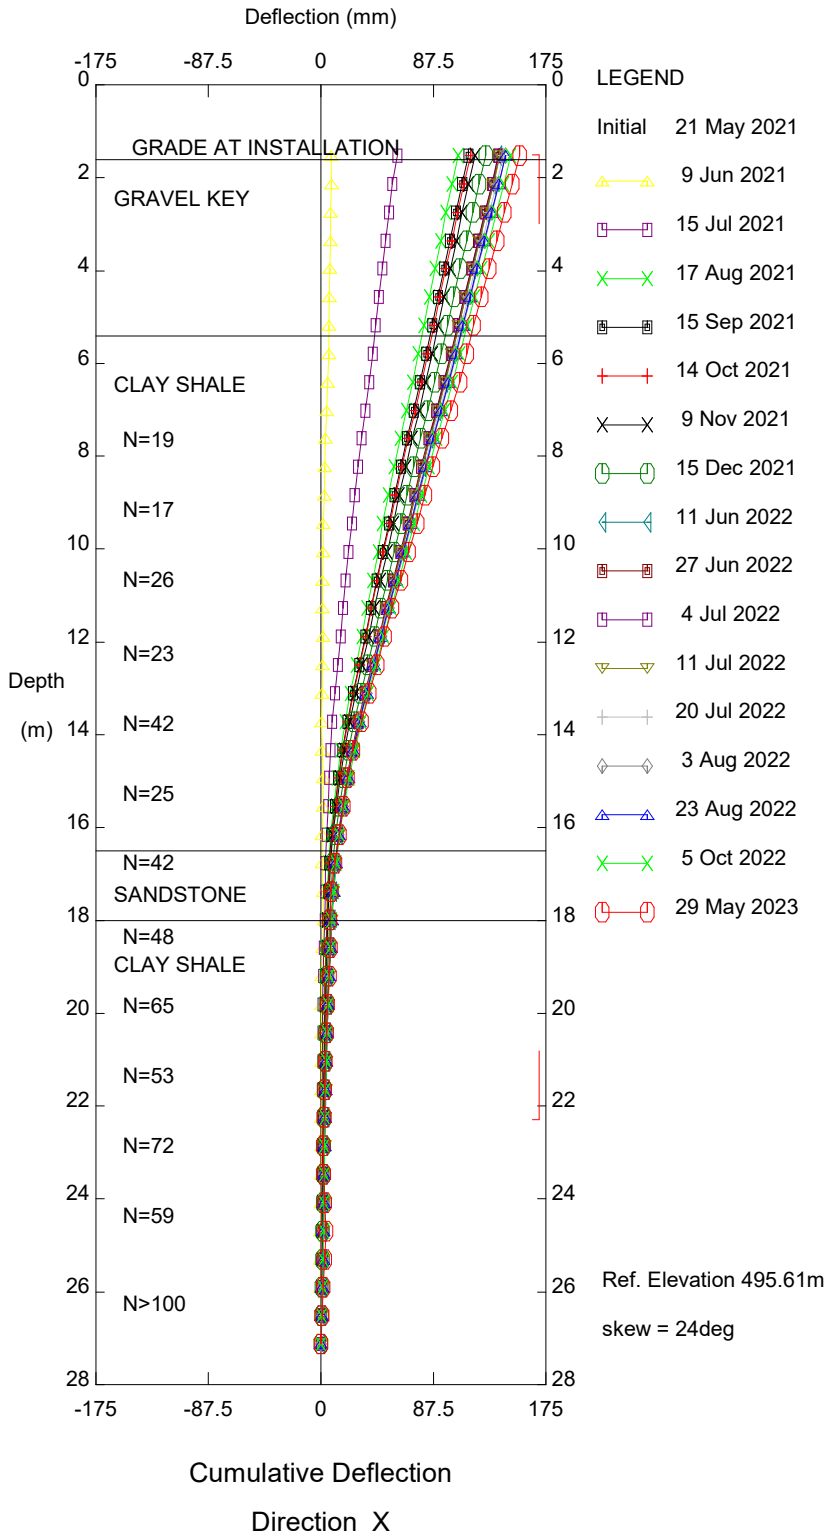
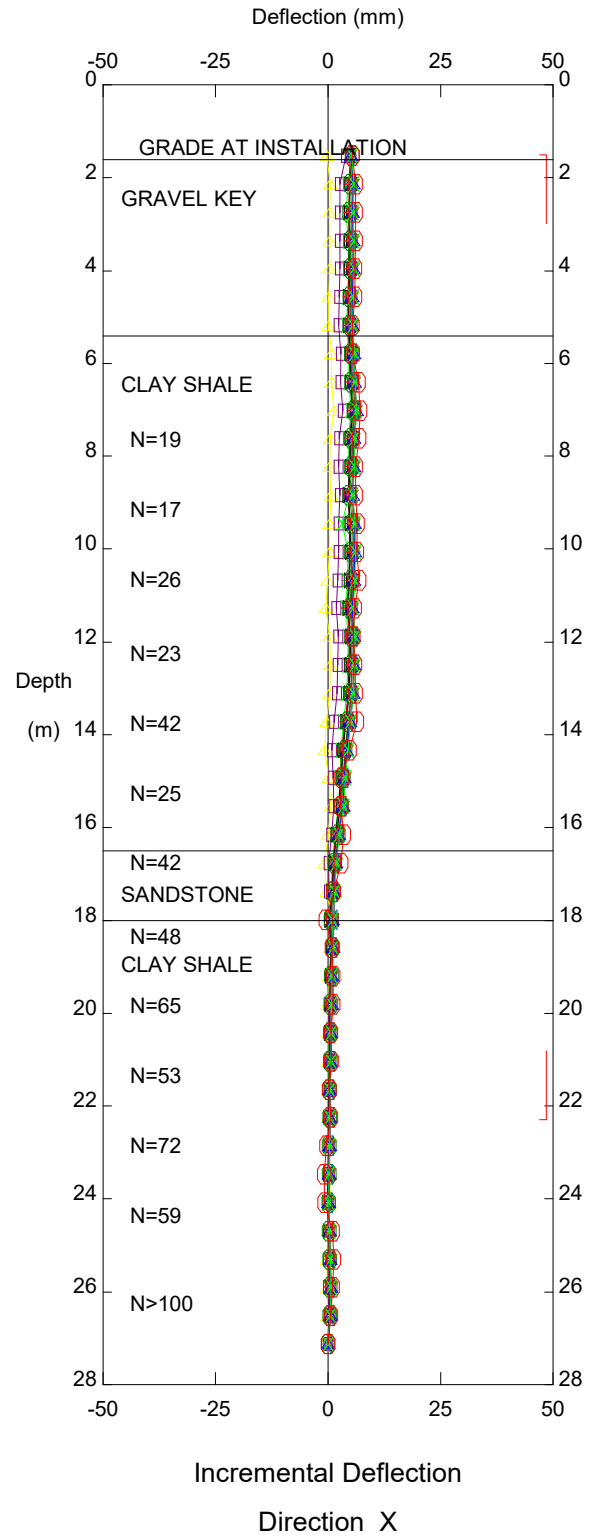
Pile Wall, Inclinator N-SI-01

| INSTRUMENT # | DATE REINITIALIZED | TOTAL CUMULATIVE RESULTANT MOVEMENT AND DEPTH OF MOVEMENT TO DATE (mm) | MAXIMUM RATE OF MOVEMENT (mm/yr) | CURRENT STATUS | DATE OF LATEST READING | DATE OF PREVIOUS READING | INCREMENTAL MOVEMENT SINCE PREVIOUS READING (mm) | CURRENT RATE OF MOVEMENT (mm/yr) | CHANGE IN RATE OF MOVEMENT SINCE PREVIOUS READING (mm/yr) |
|---|---|---|---|---|---|---|---|---|---|
| N-SI-01 | May 29, 2023 | 151.7 over 1.5 m to 22.3 m in 180° direction | 1146.4 on July 22, 2021 | Operational | May 29, 2023 | October 5, 2022 | 7.5 | 11.6 | -22.3 |

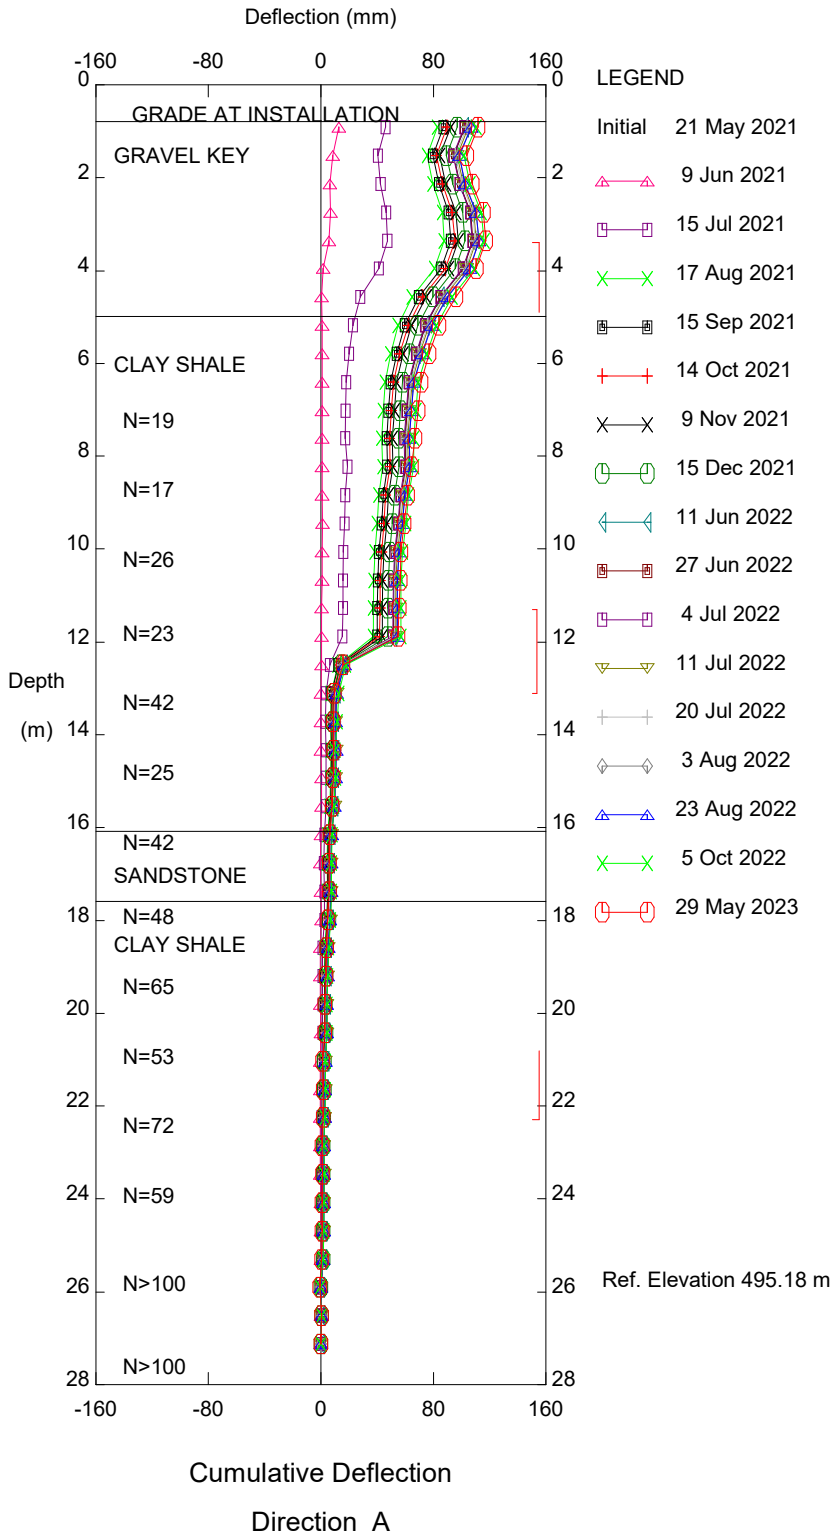
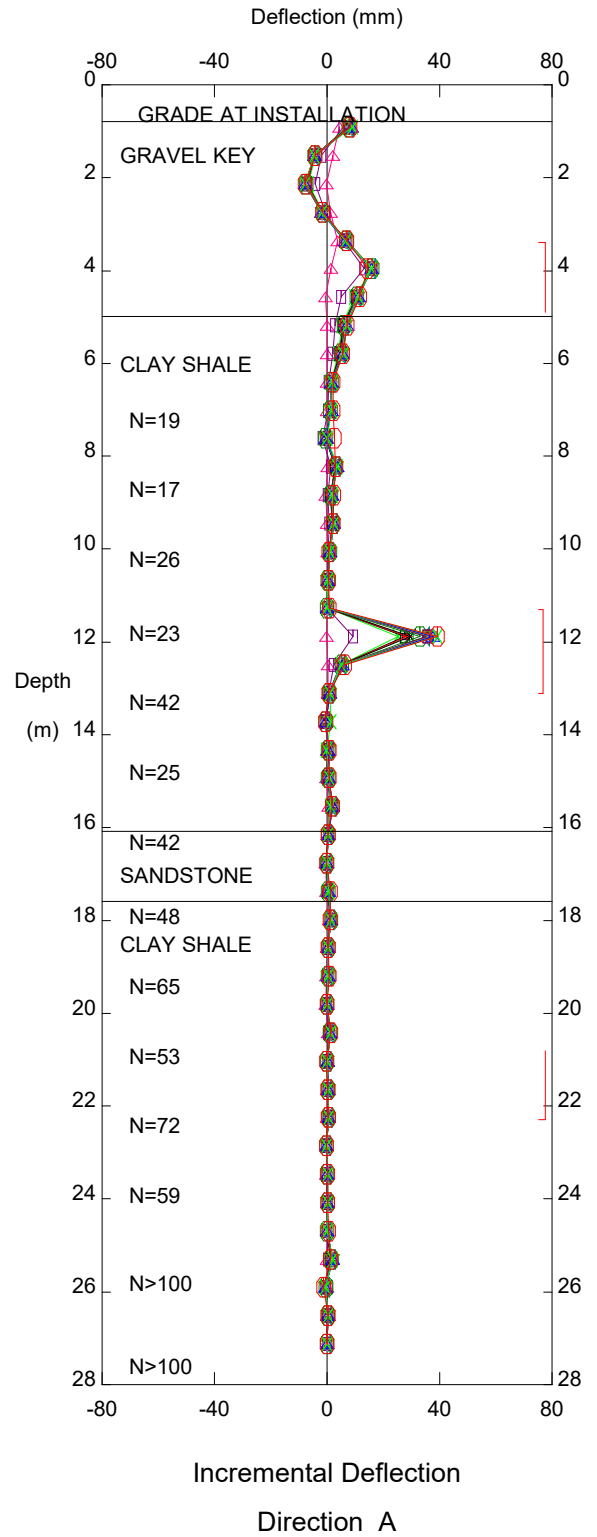
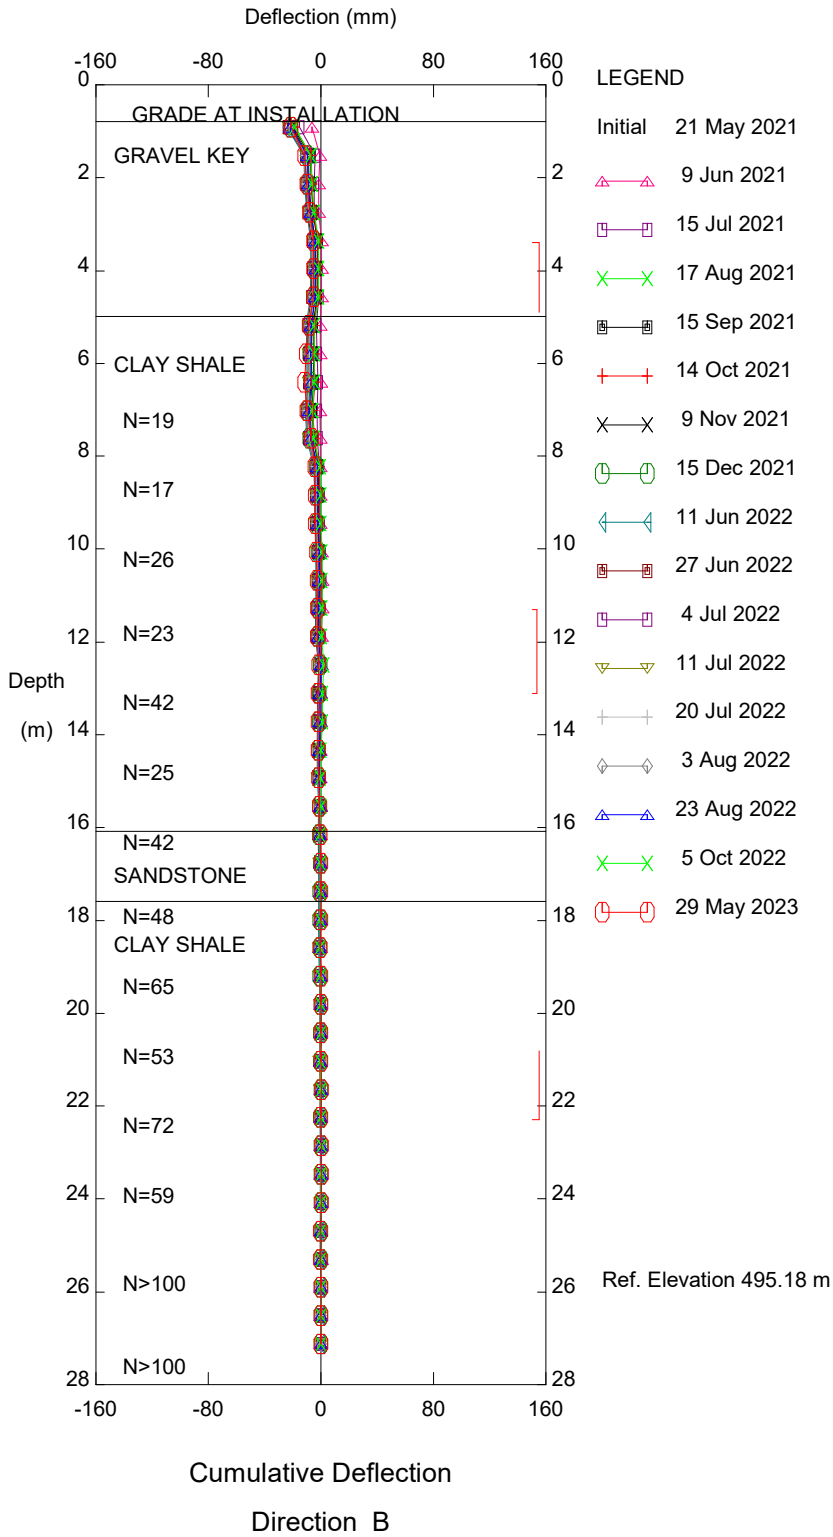
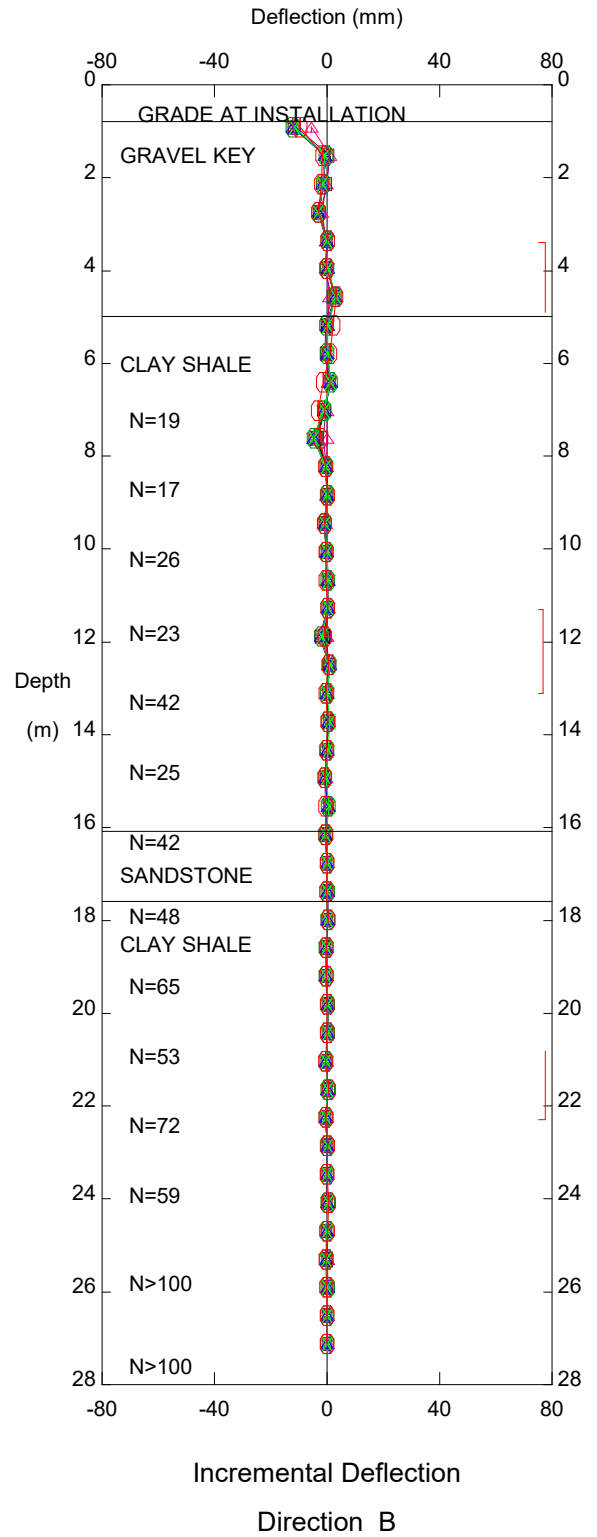
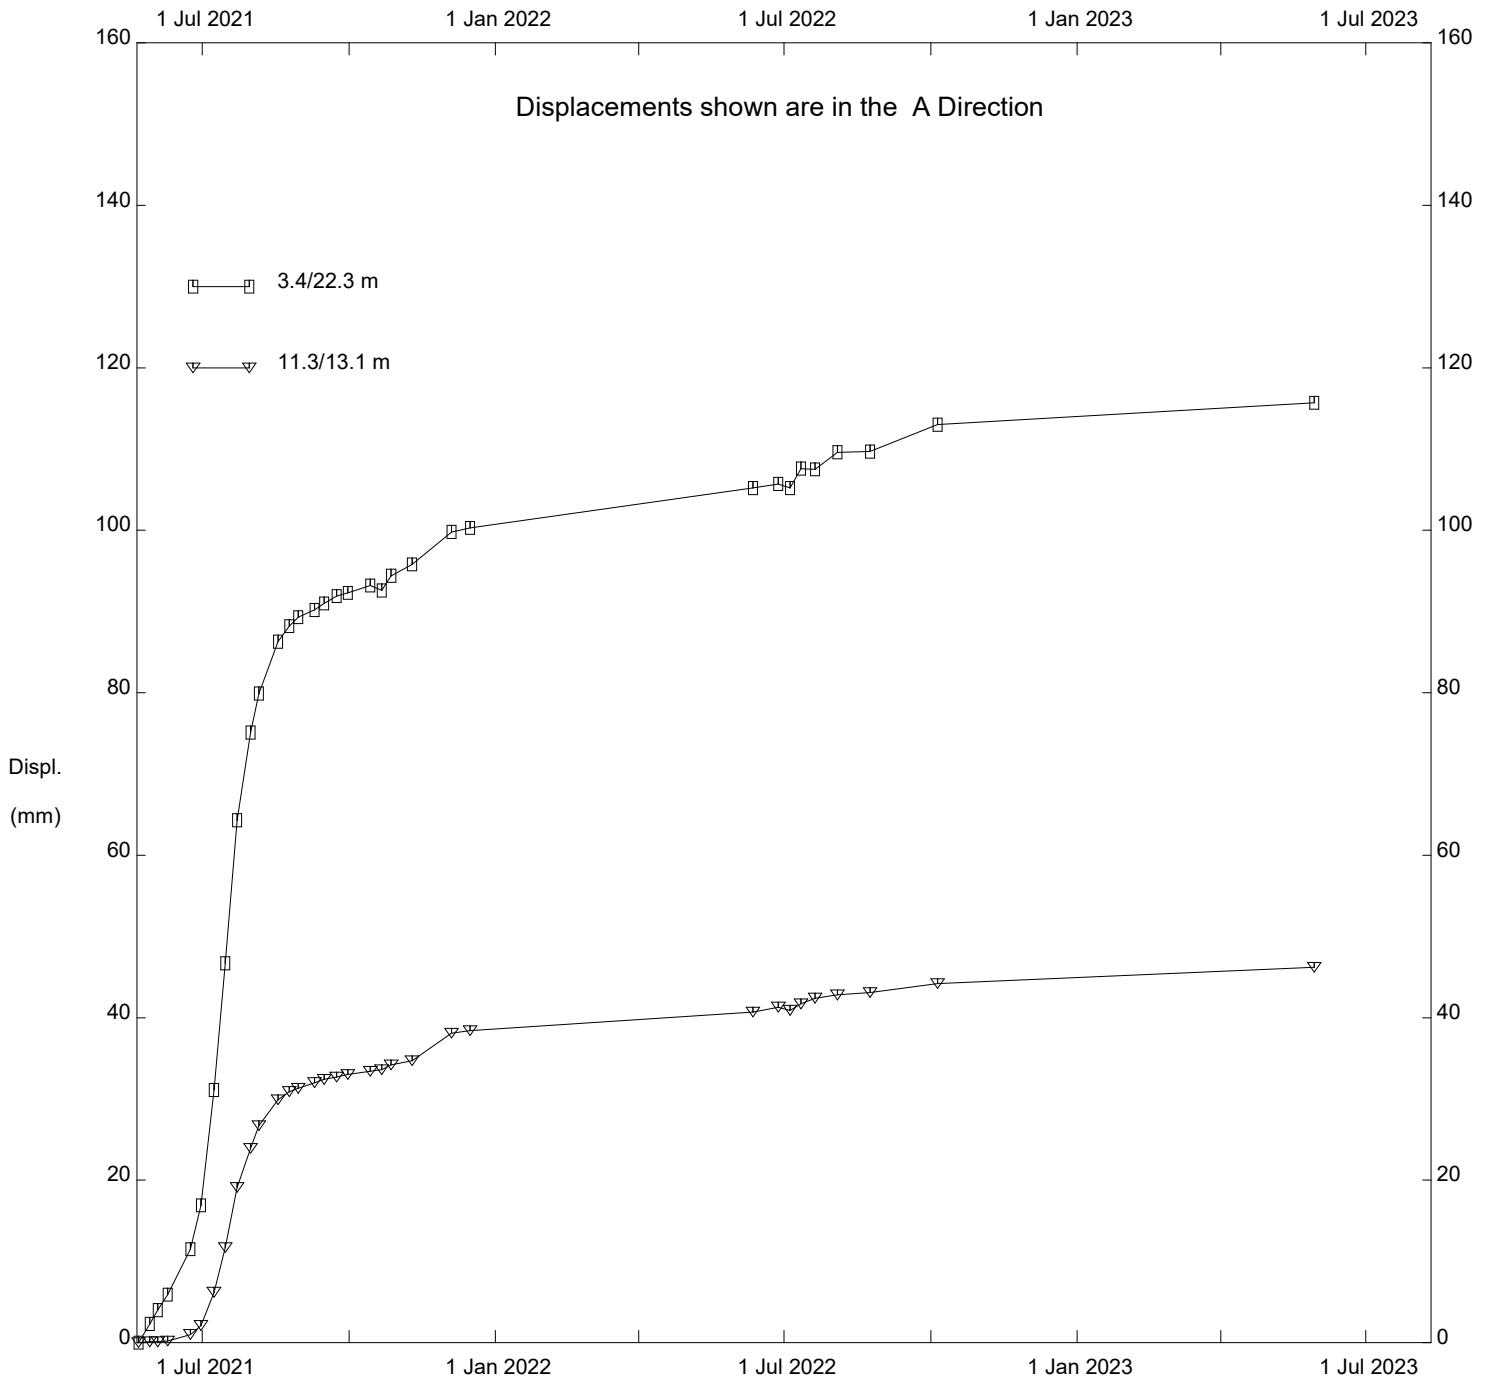
In Ground, Inclinator N-SI-02

| INSTRUMENT # | DATE REINITIALIZED | TOTAL CUMULATIVE RESULTANT MOVEMENT AND DEPTH OF MOVEMENT TO DATE (mm) | MAXIMUM RATE OF MOVEMENT (mm/yr) | CURRENT STATUS | DATE OF LATEST READING | DATE OF PREVIOUS READING | INCREMENTAL MOVEMENT SINCE PREVIOUS READING (mm) | CURRENT RATE OF MOVEMENT (mm/yr) | CHANGE IN RATE OF MOVEMENT SINCE PREVIOUS READING (mm/yr) |
|---|---|---|---|---|---|---|---|---|---|
| N-SI-02 | May 29, 2023 | 115.7 over 3.4 m to 22.3 m in 116° direction | 886.7 on July 22, 2021 | Operational | May 29, 2023 | October 5, 2022 | 2.7 | 4.1 | -23.8 |
| | | 46.2 over 11.3 to 13.1 m in 116° direction | 377.6 on July 22, 2021 | | | | 2.0 | 3.1 | -6.4 |
