July 8, 2023

**ALBERTA TRANSPORTATION AND ECONOMIC CORRIDORS GRMP (CON0022163)  
NORTH CENTRAL (ATHABASCA AND FORT McMURRAY DISTRICTS)  
INSTRUMENTATION MONITORING RESULTS – SPRING 2023**

**SECTION C**

**SITE NC099: HWY 63:10 HANGINGSTONE RIVER BRIDGES**

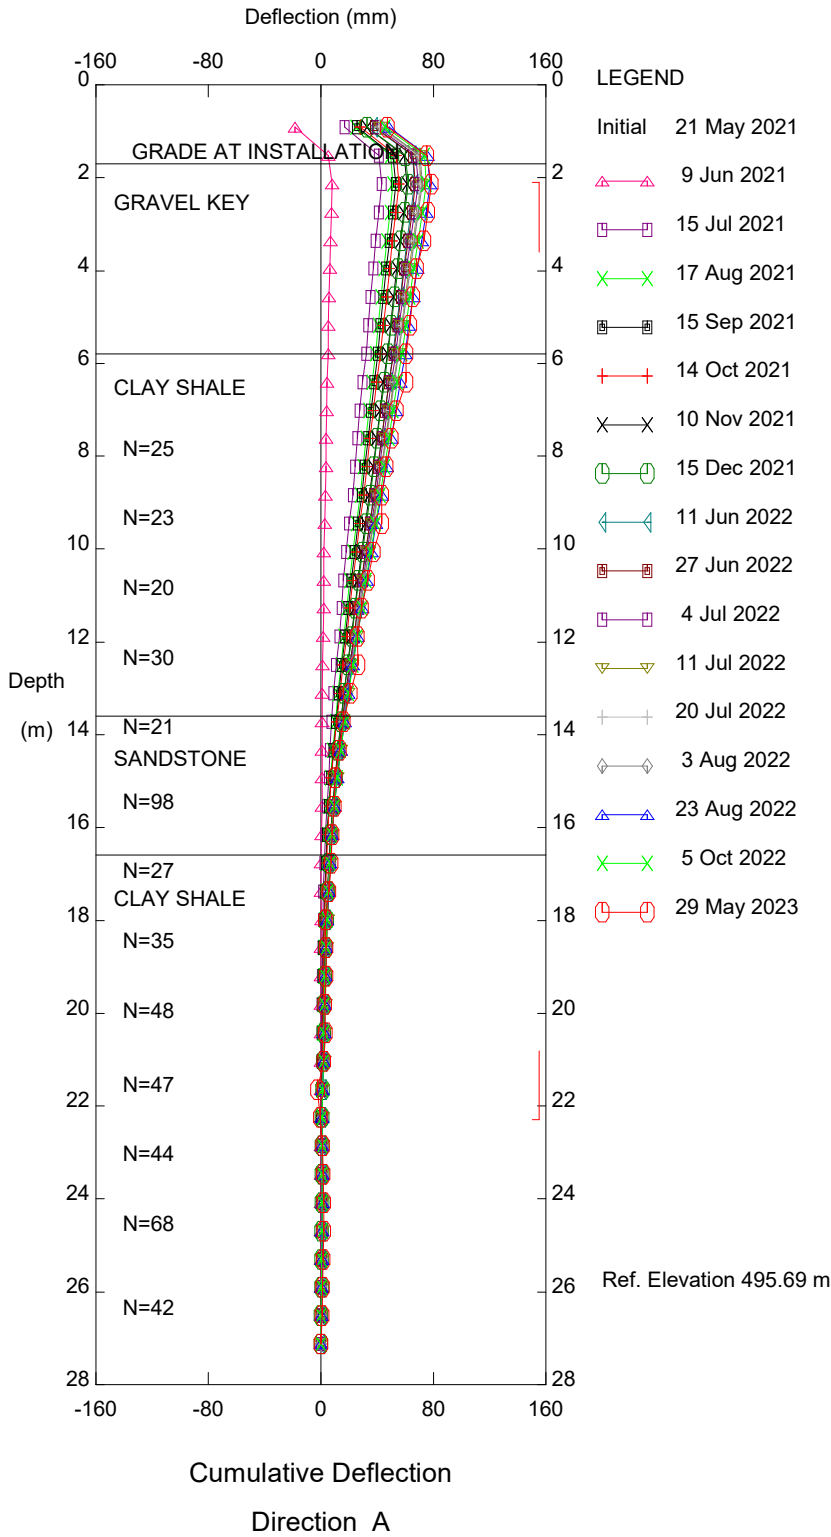
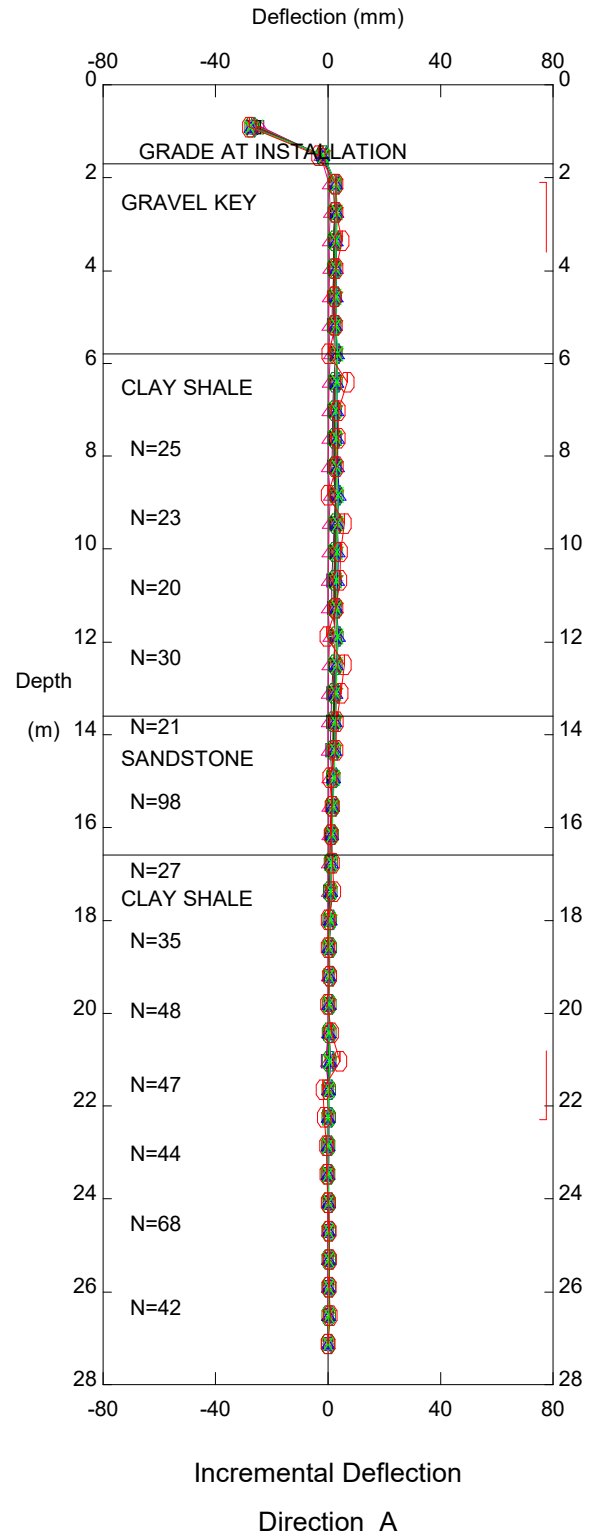
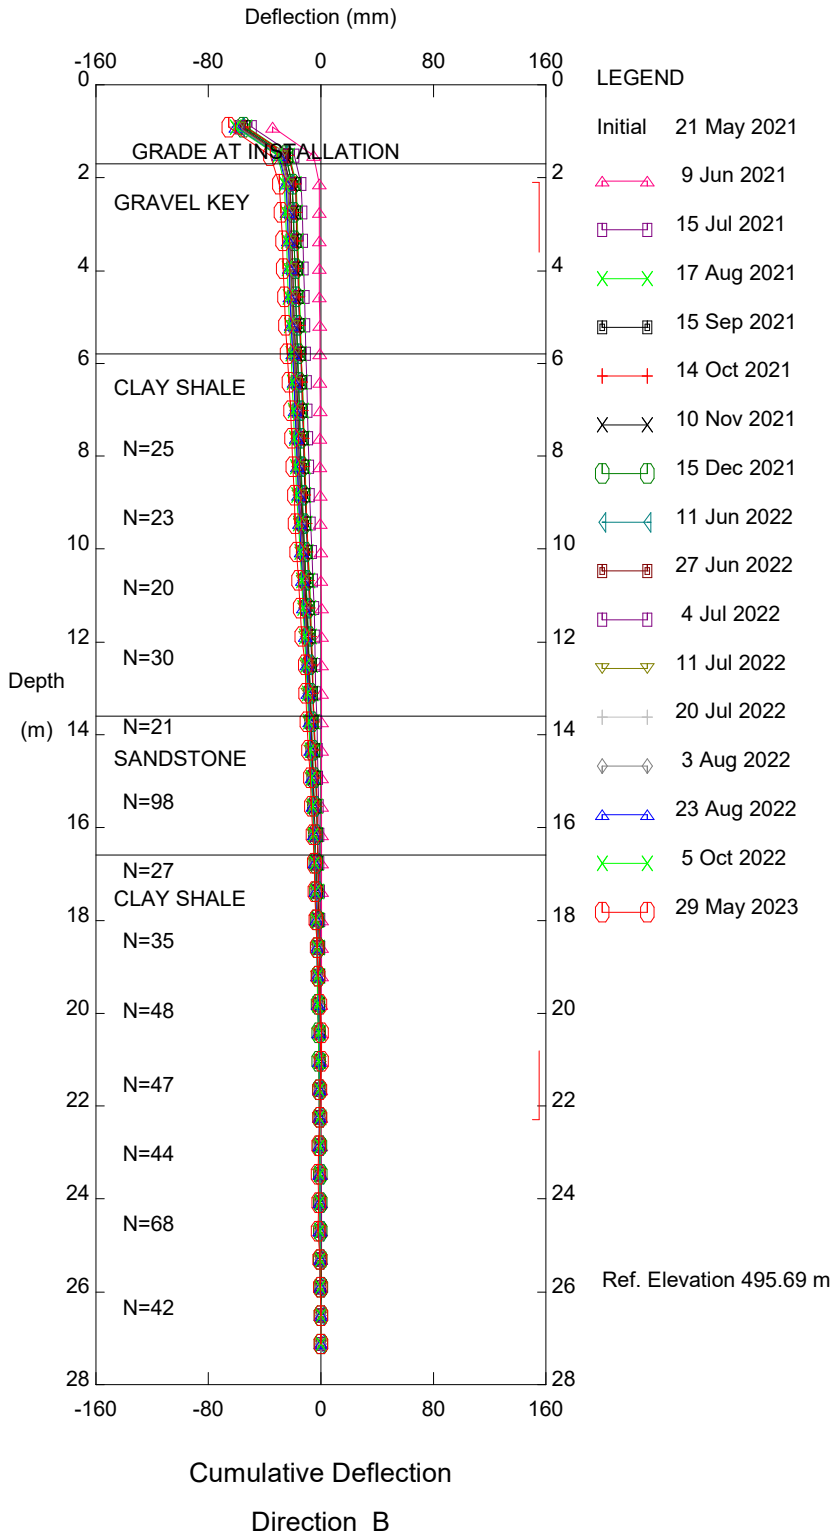
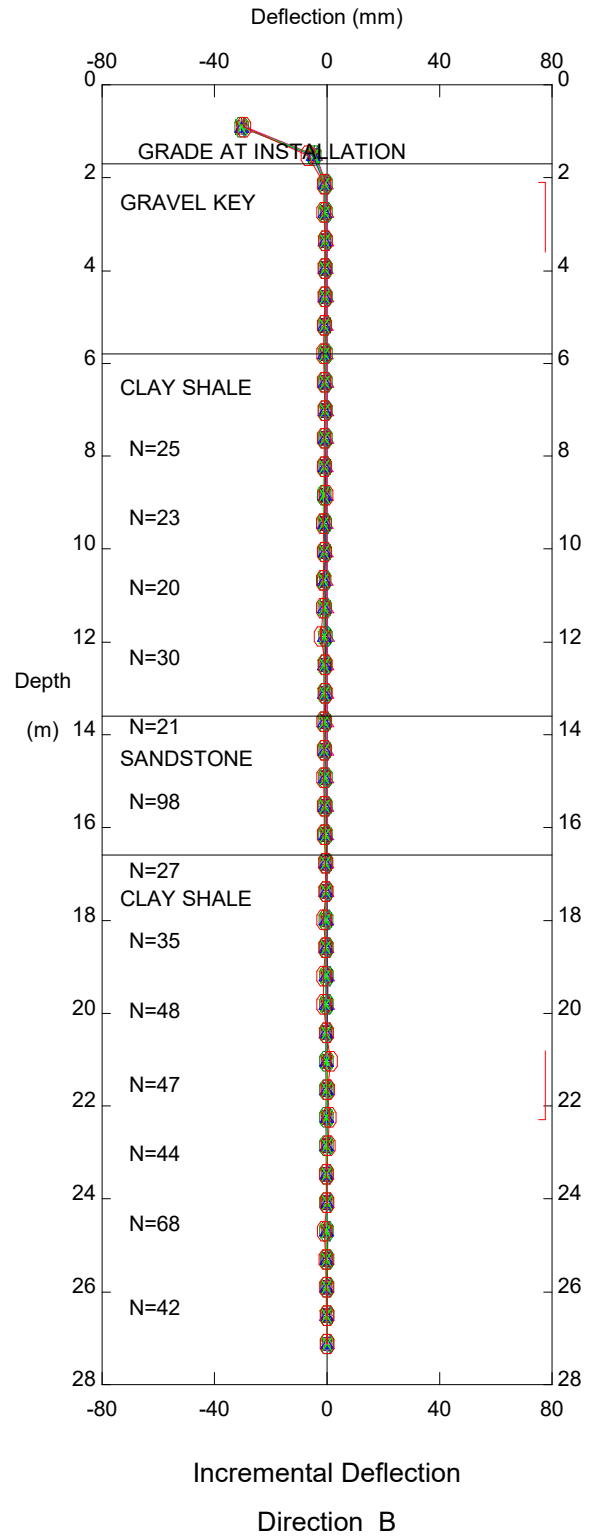
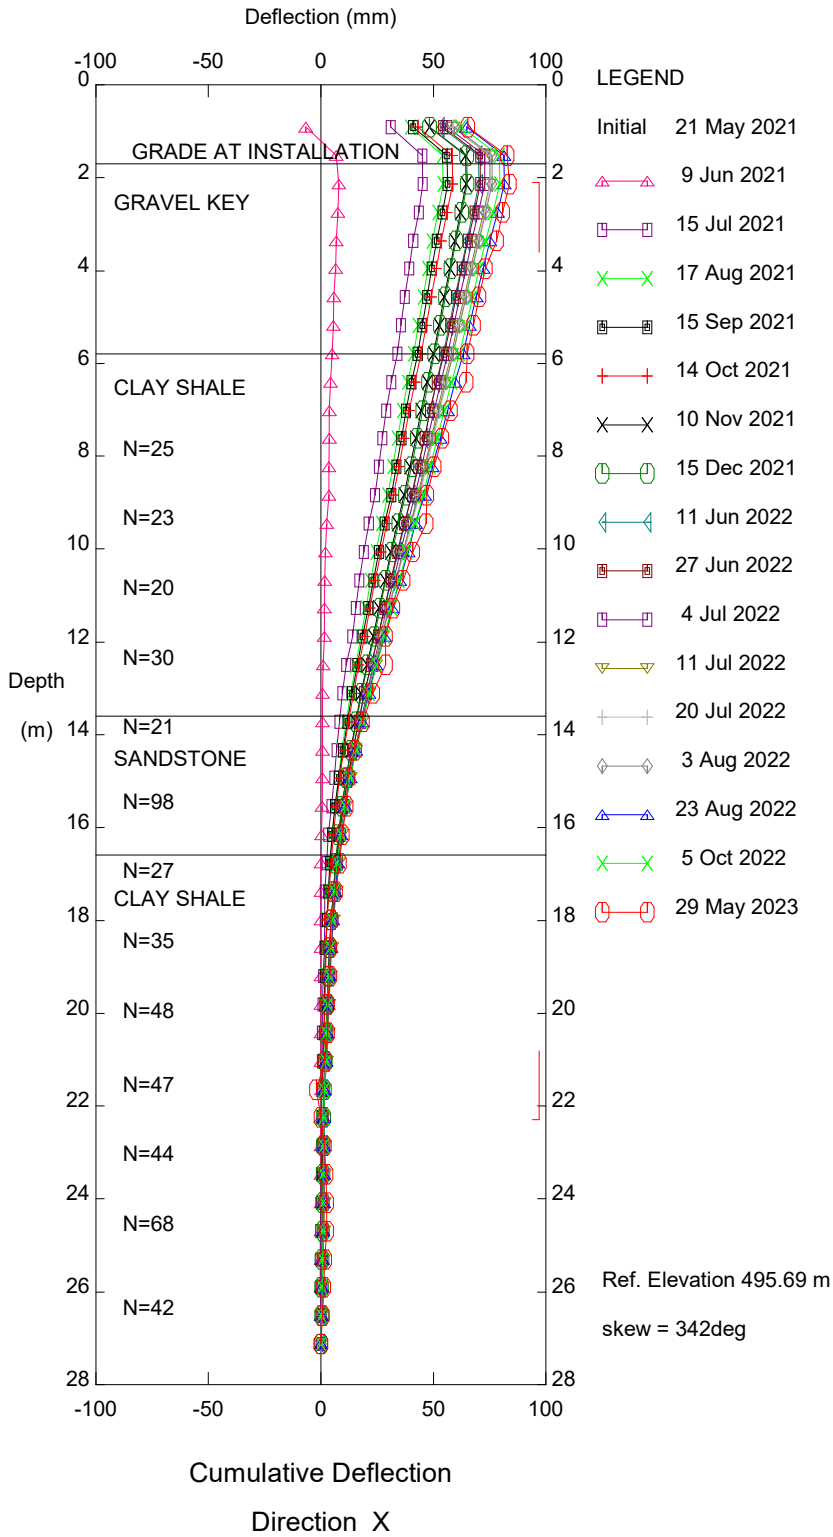
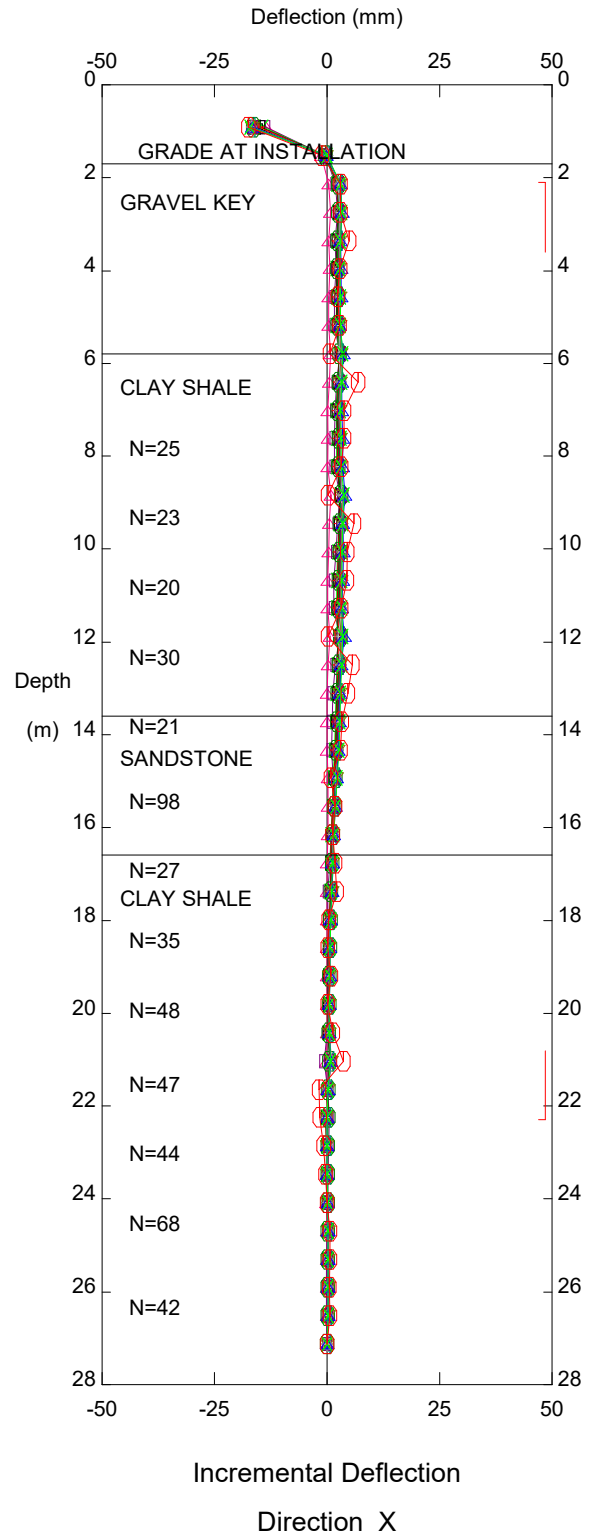
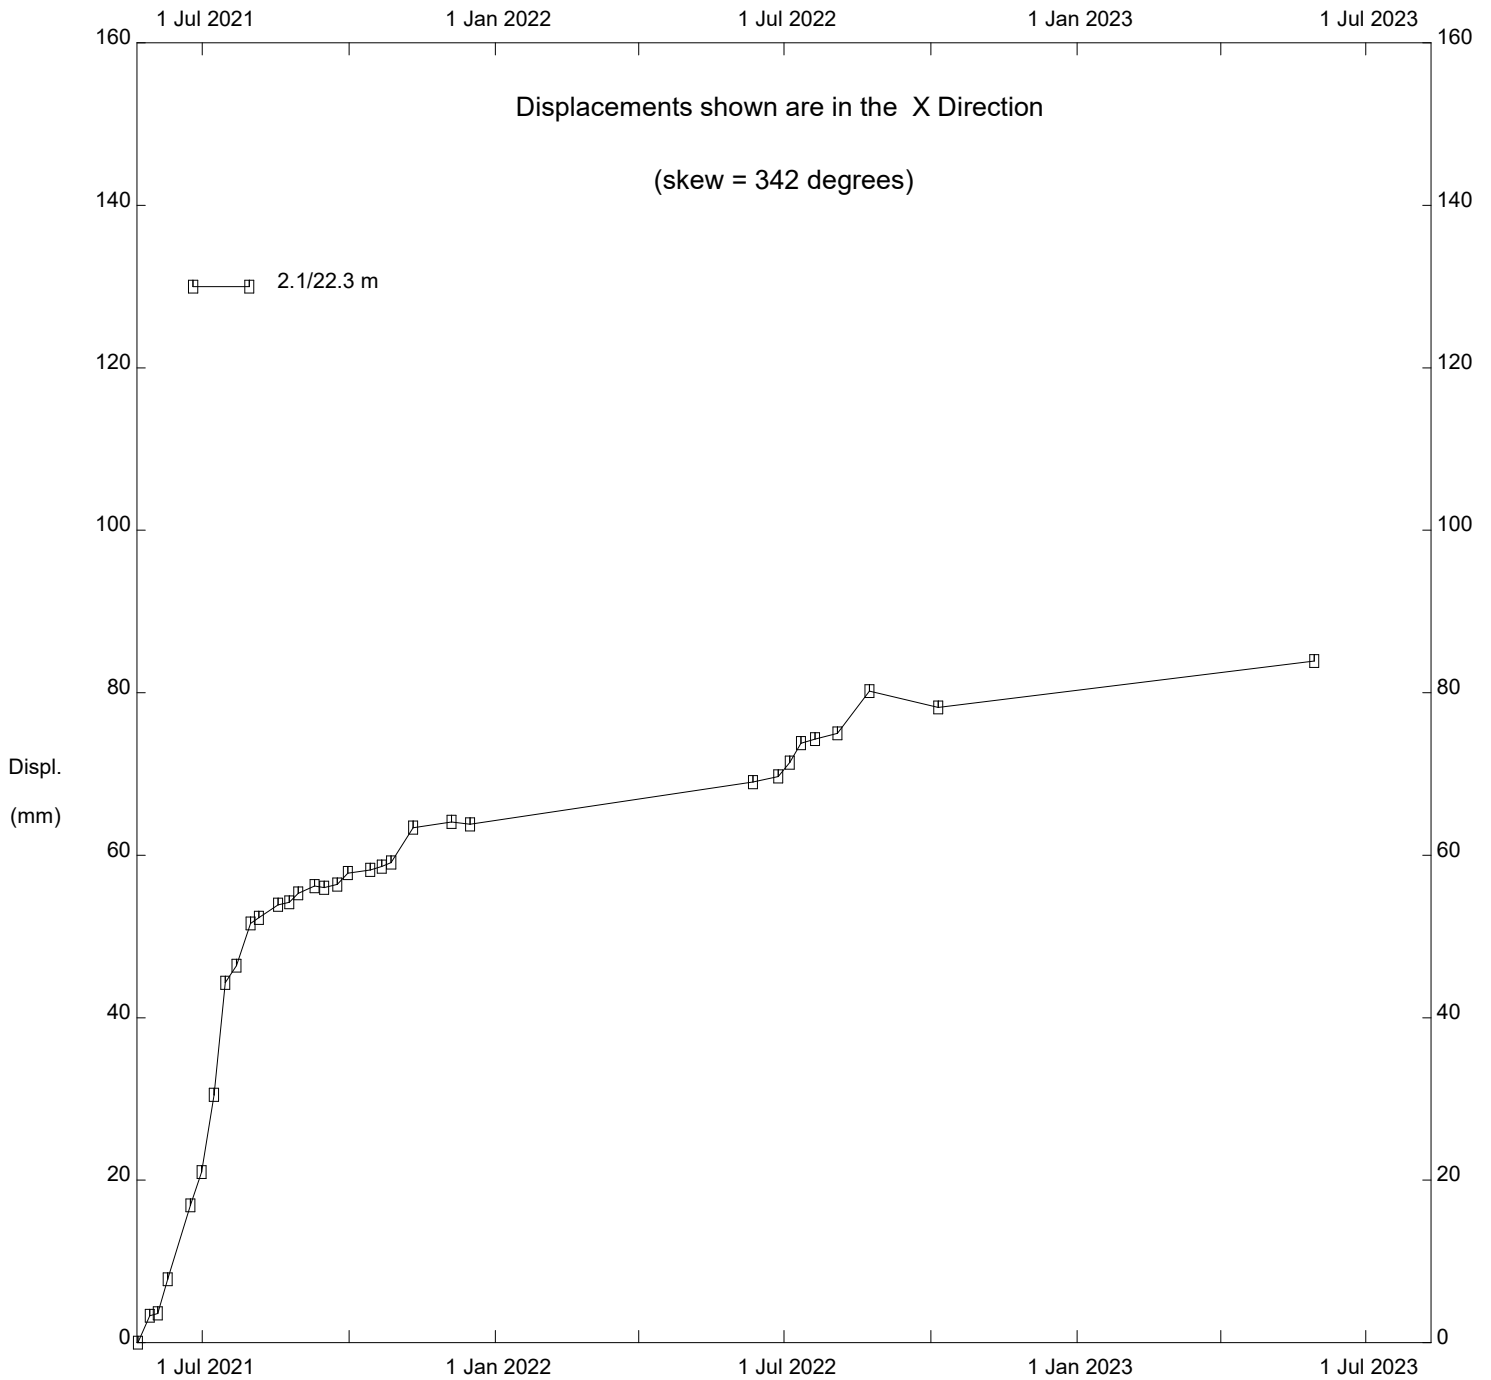
Pile Wall, Inclinator S-SI-01

| INSTRUMENT # | DATE REINITIALIZED | TOTAL CUMULATIVE RESULTANT MOVEMENT AND DEPTH OF MOVEMENT TO DATE (mm) | MAXIMUM RATE OF MOVEMENT (mm/yr) | CURRENT STATUS | DATE OF LATEST READING | DATE OF PREVIOUS READING | INCREMENTAL MOVEMENT SINCE PREVIOUS READING (mm) | CURRENT RATE OF MOVEMENT (mm/yr) | CHANGE IN RATE OF MOVEMENT SINCE PREVIOUS READING (mm/yr) |
|---|---|---|---|---|---|---|---|---|---|
| S-SI-01 | May 29, 2023 | 83.9 over 2.1 m to 22.3 m in 5° direction | 726.1 on July 15, 2021 | Operational | May 29, 2023 | October 5, 2022 | 5.8 | 8.9 | 25.8 |

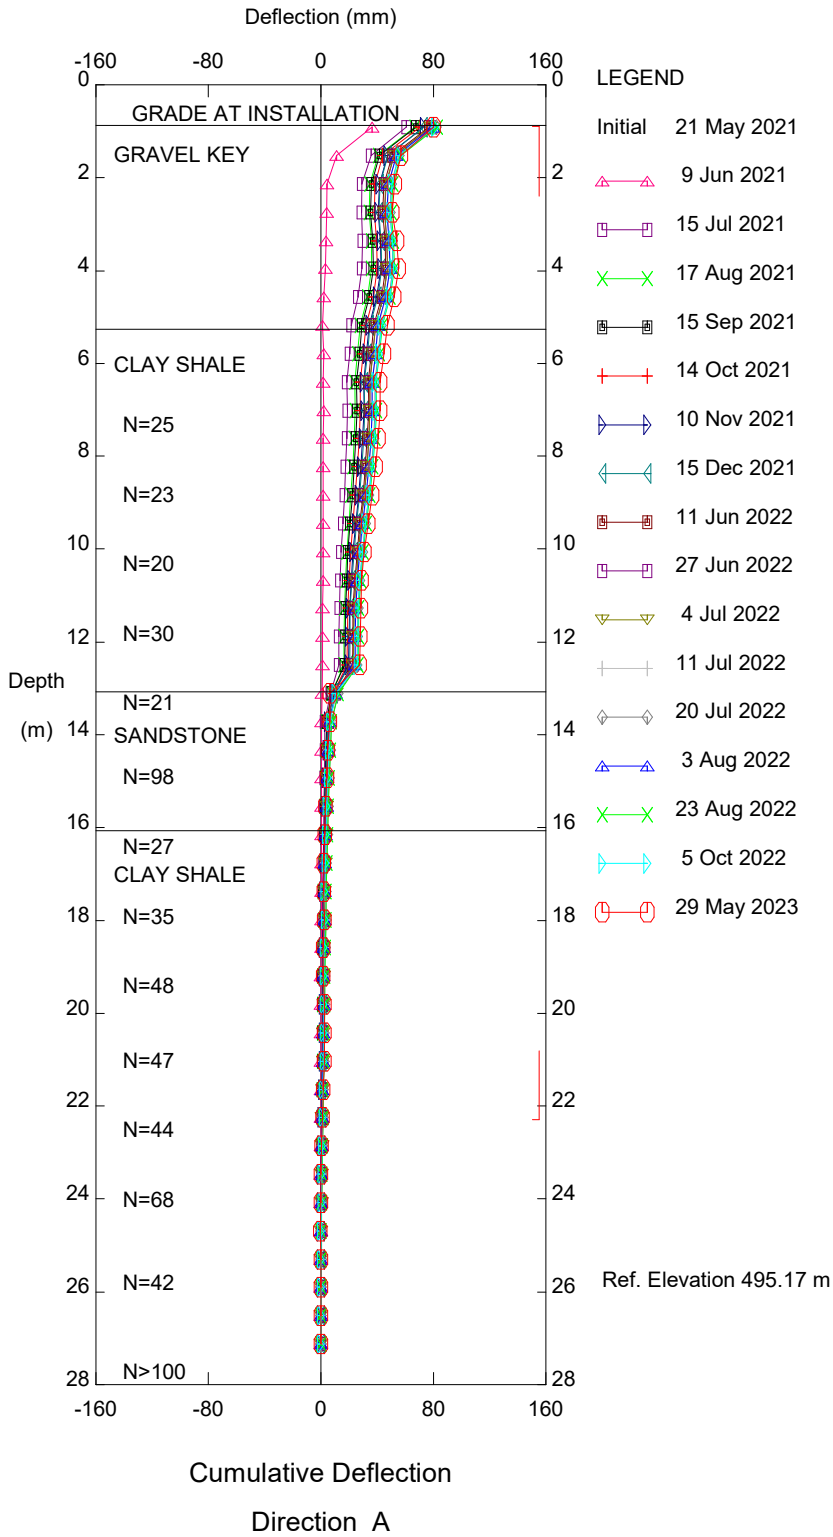
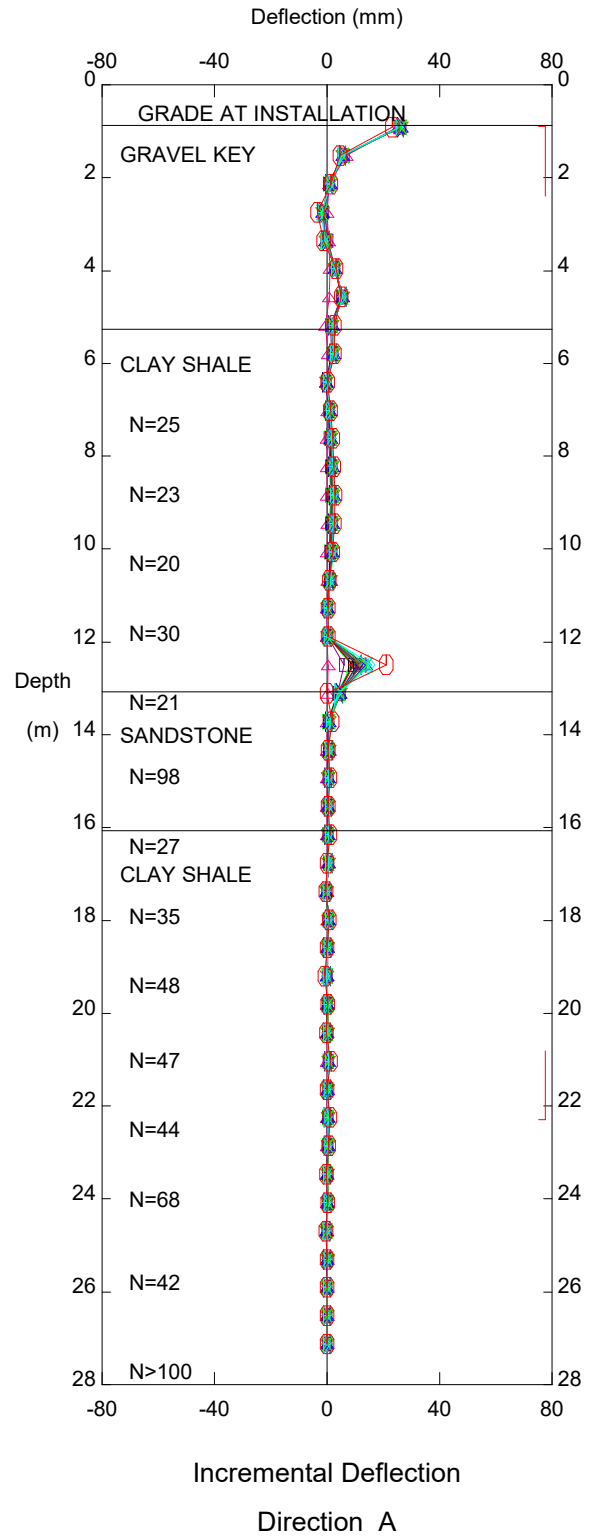
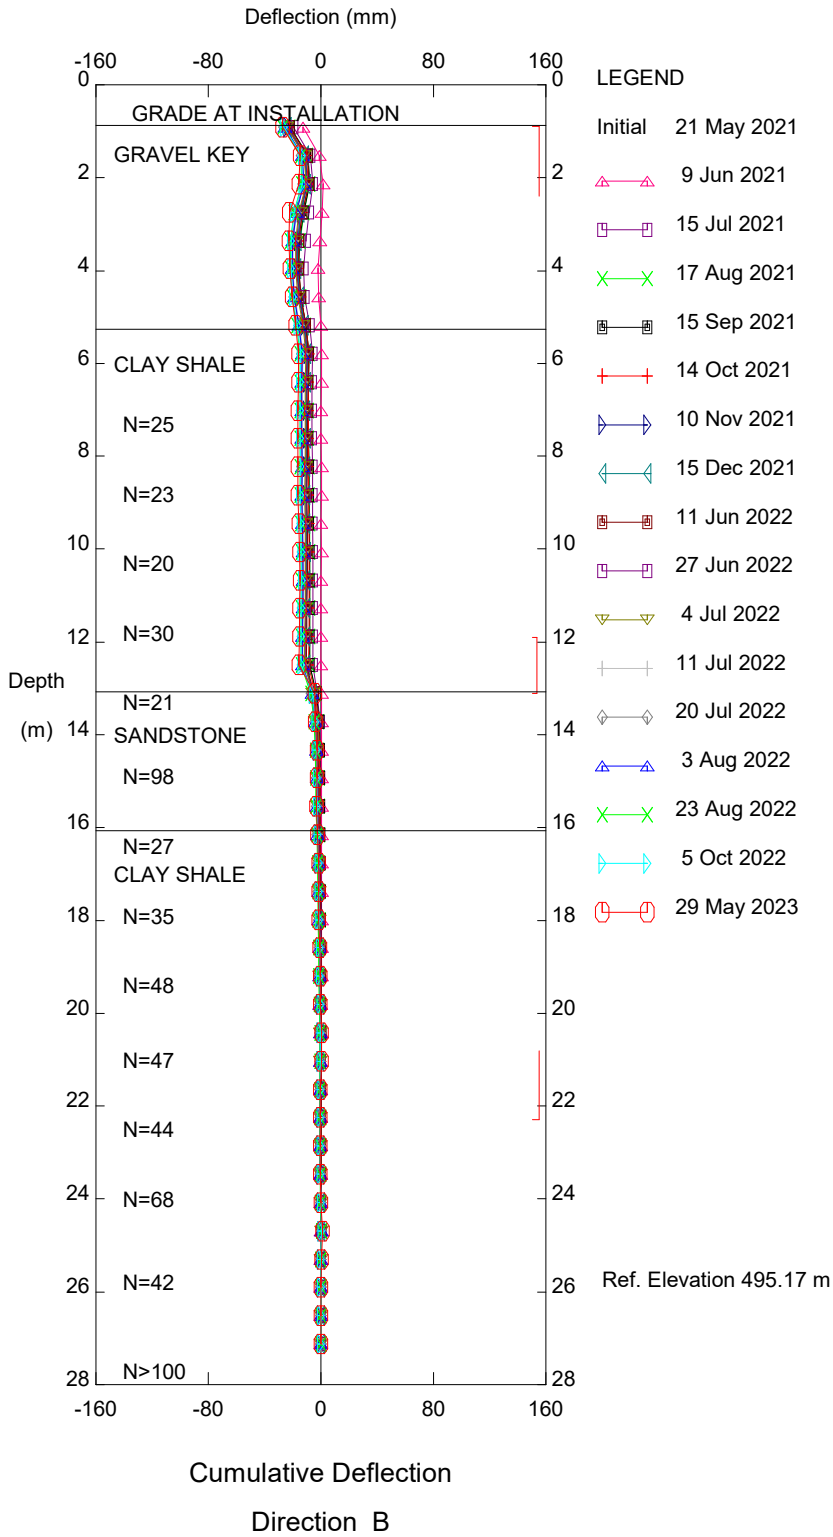
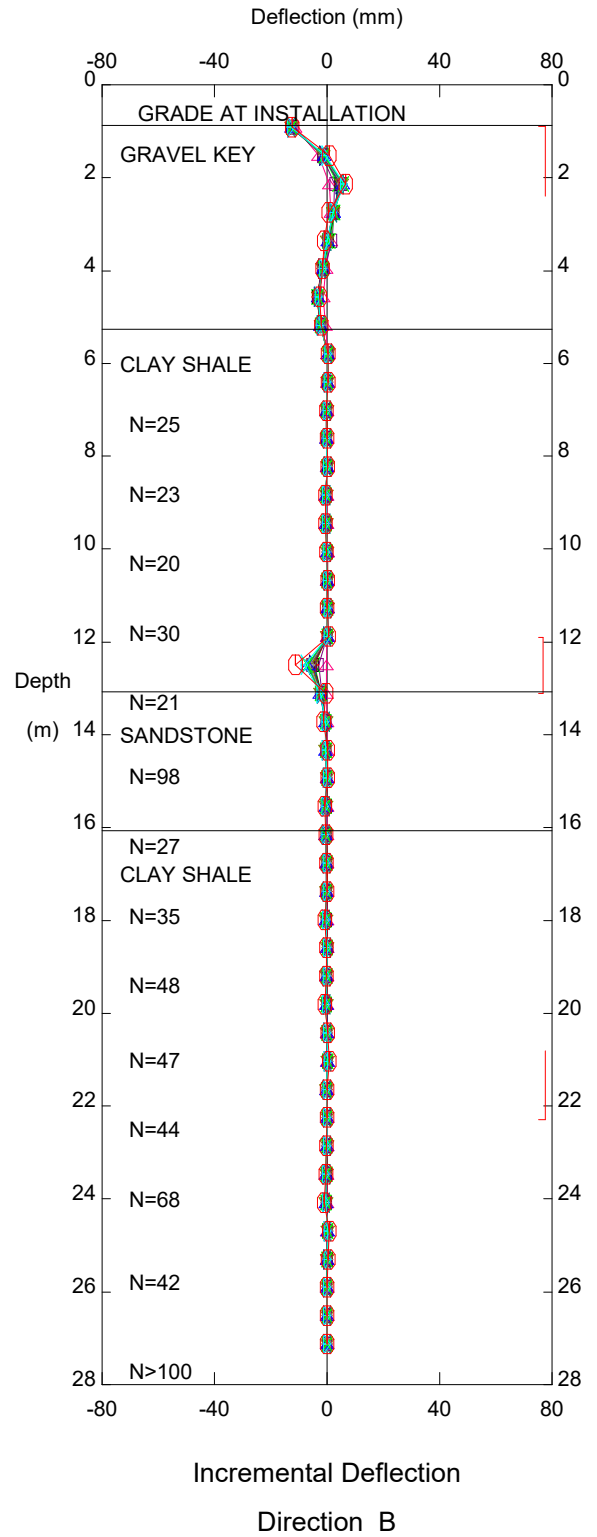
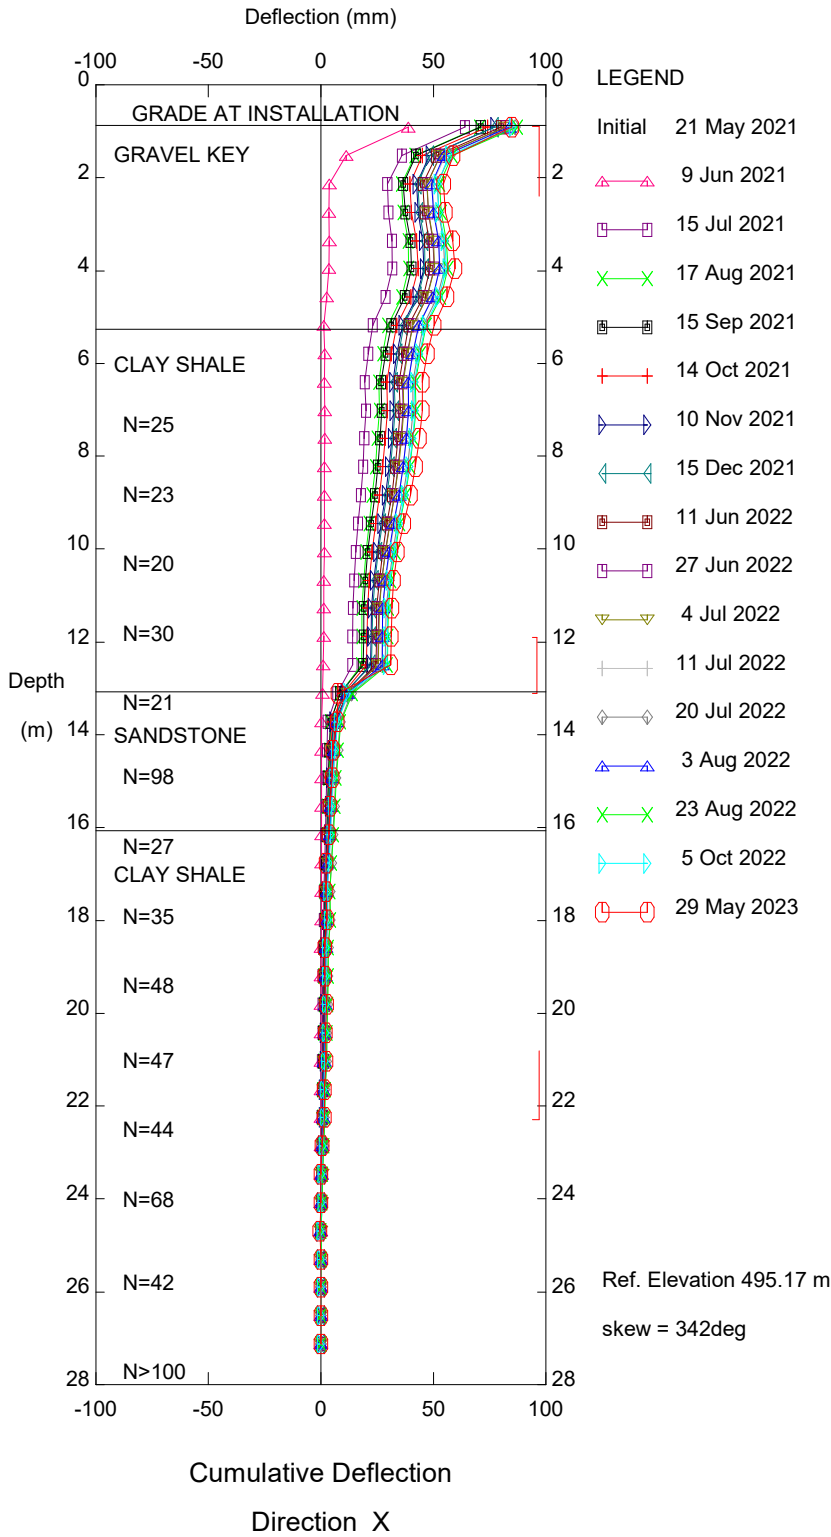
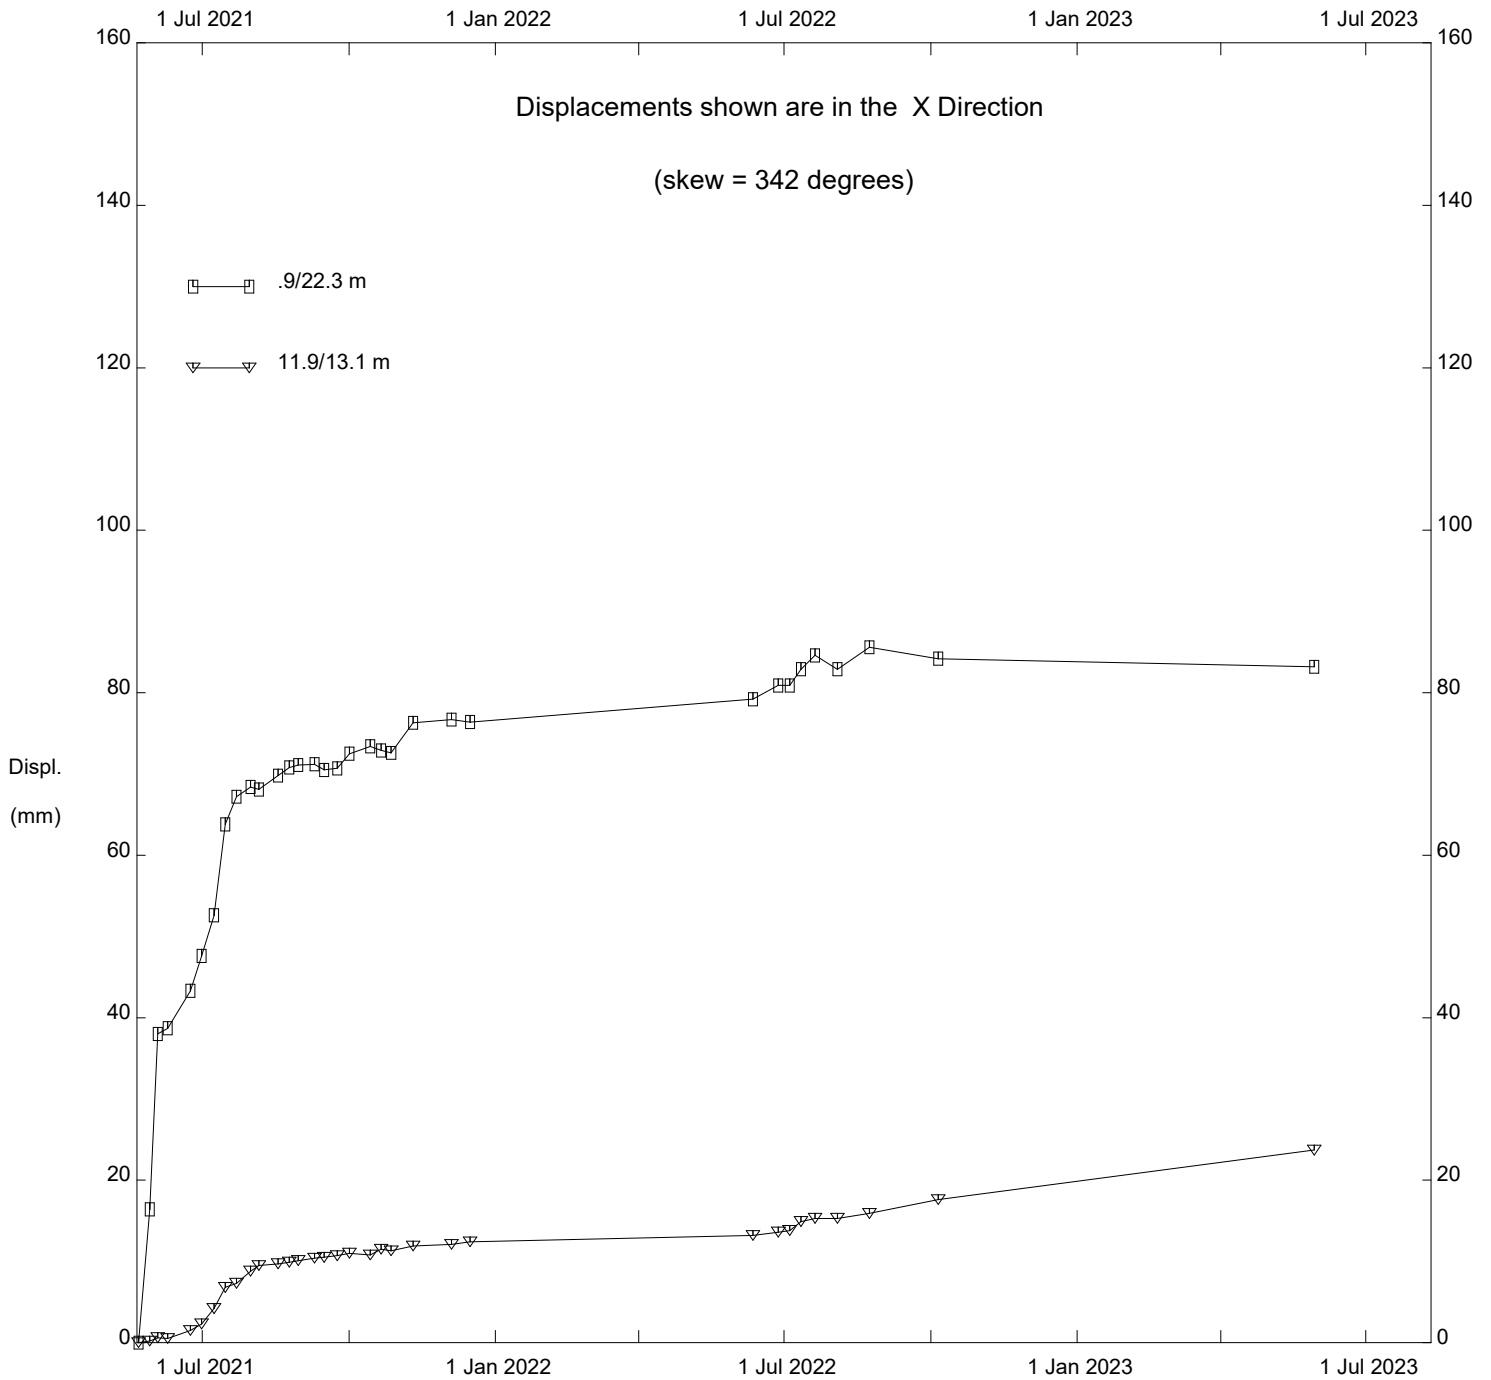
In Ground, Inclinator S-SI-02

| INSTRUMENT # | DATE REINITIALIZED | TOTAL CUMULATIVE RESULTANT MOVEMENT AND DEPTH OF MOVEMENT TO DATE (mm) | MAXIMUM RATE OF MOVEMENT (mm/yr) | CURRENT STATUS | DATE OF LATEST READING | DATE OF PREVIOUS READING | INCREMENTAL MOVEMENT SINCE PREVIOUS READING (mm) | CURRENT RATE OF MOVEMENT (mm/yr) | CHANGE IN RATE OF MOVEMENT SINCE PREVIOUS READING (mm/yr) |
|---|---|---|---|---|---|---|---|---|---|
| S-SI-02 | May 29, 2023 | 83.2 over 0.9 m to 22.3 m in 27° direction | 1596.4 on June 22, 2021 | Operational | May 29, 2023 | October 5, 2022 | No discernible movement | N/A | 10.9 |
| | | 23.7 over 11.9 m to 13.1 m in 27° direction | 138.44 on July 15, 2021 | | | | 6.0 | 9.3 | -5.5 |
