ALBERTA TRANSPORTATION AND  
ECONOMIC CORRIDORS GRMP  
NORTH CENTRAL (ATHABASCA AND FORT  
McMURRAY DISTRICTS)  
INSTRUMENTATION MONITORING- SPRING 2024

| Site Number | Location | Name | Hwy | km |
|---|---|---|---|---|
| NC025 | HWY 646:04 C1 16.082 | Lindbergh Hill | 646:04 | Km 16.1 |

| <b>Current Monitoring:</b> | 5-June-2024 | <b>Previous Monitoring</b> | 24-May-2023 |

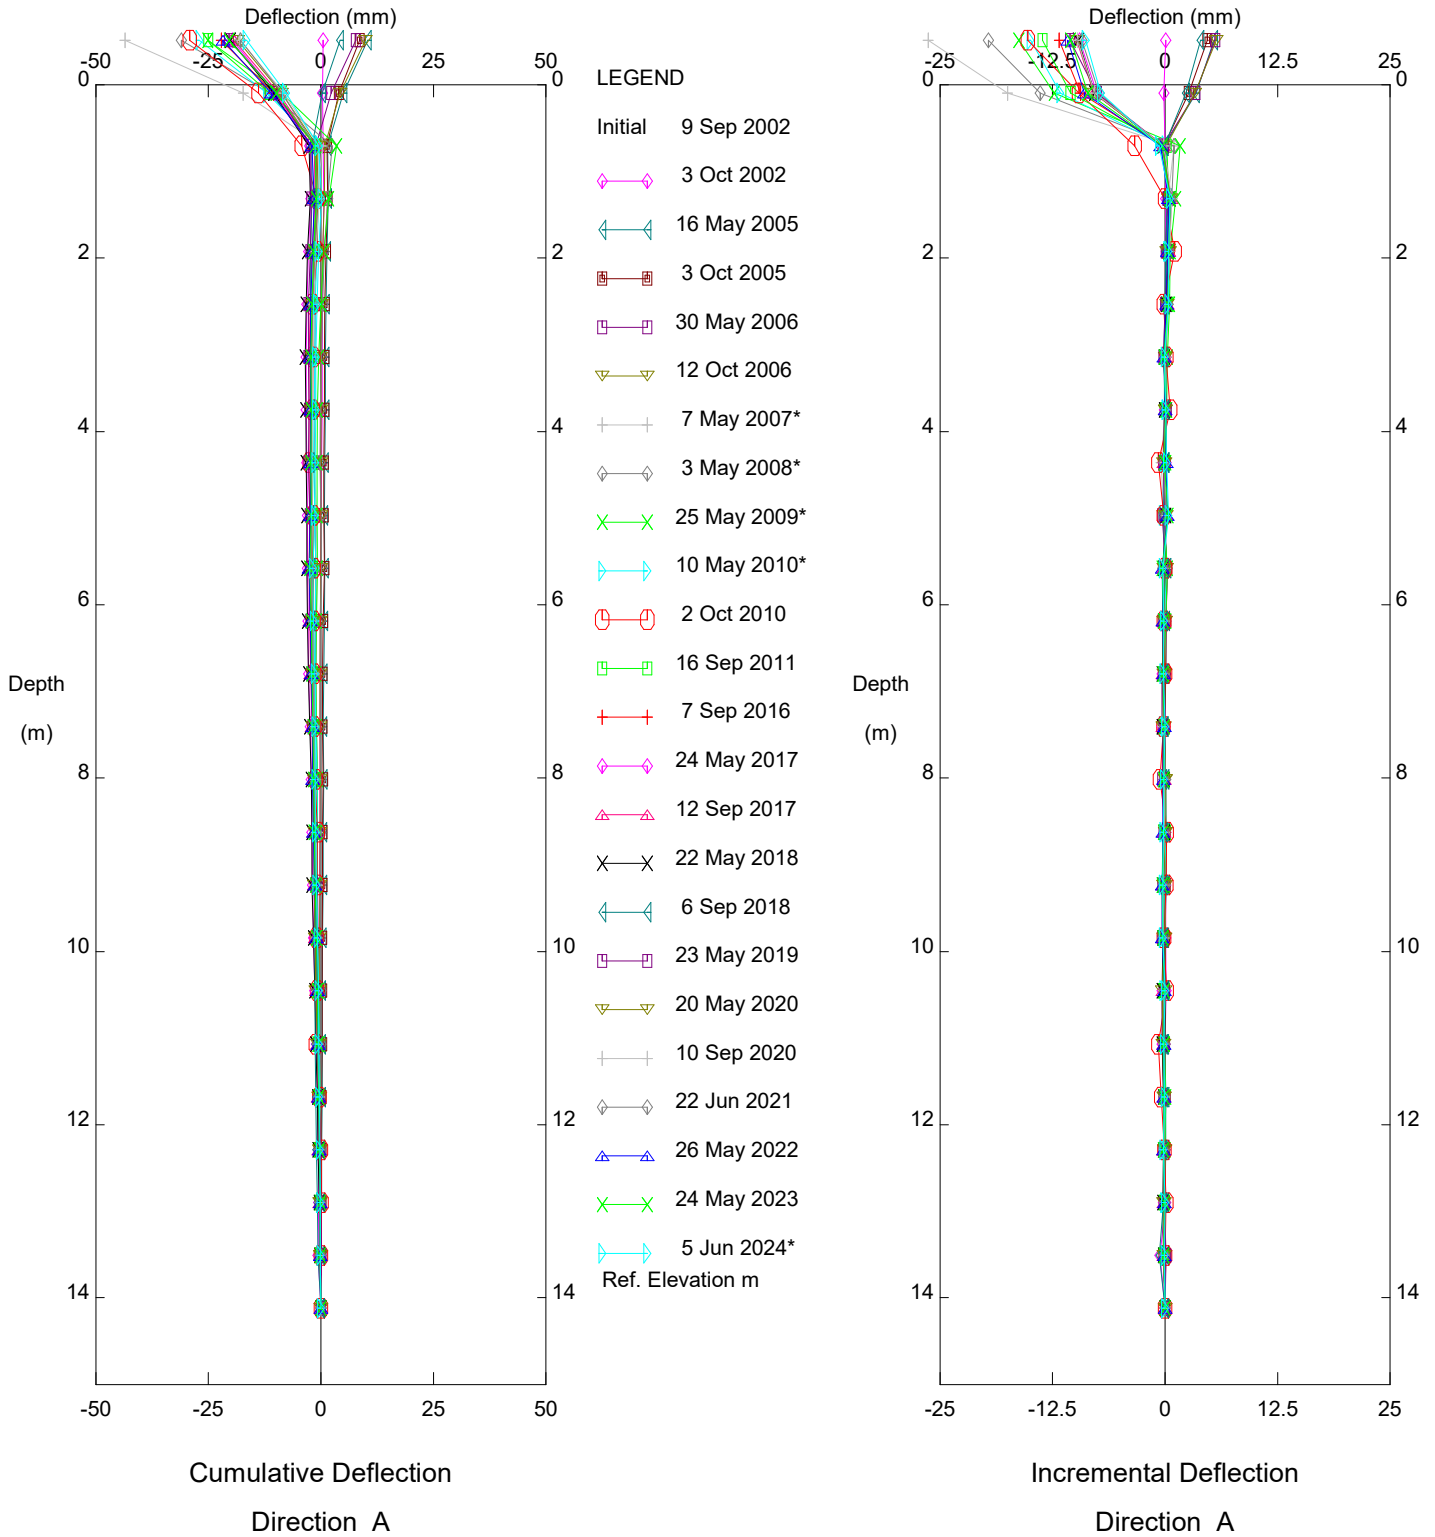
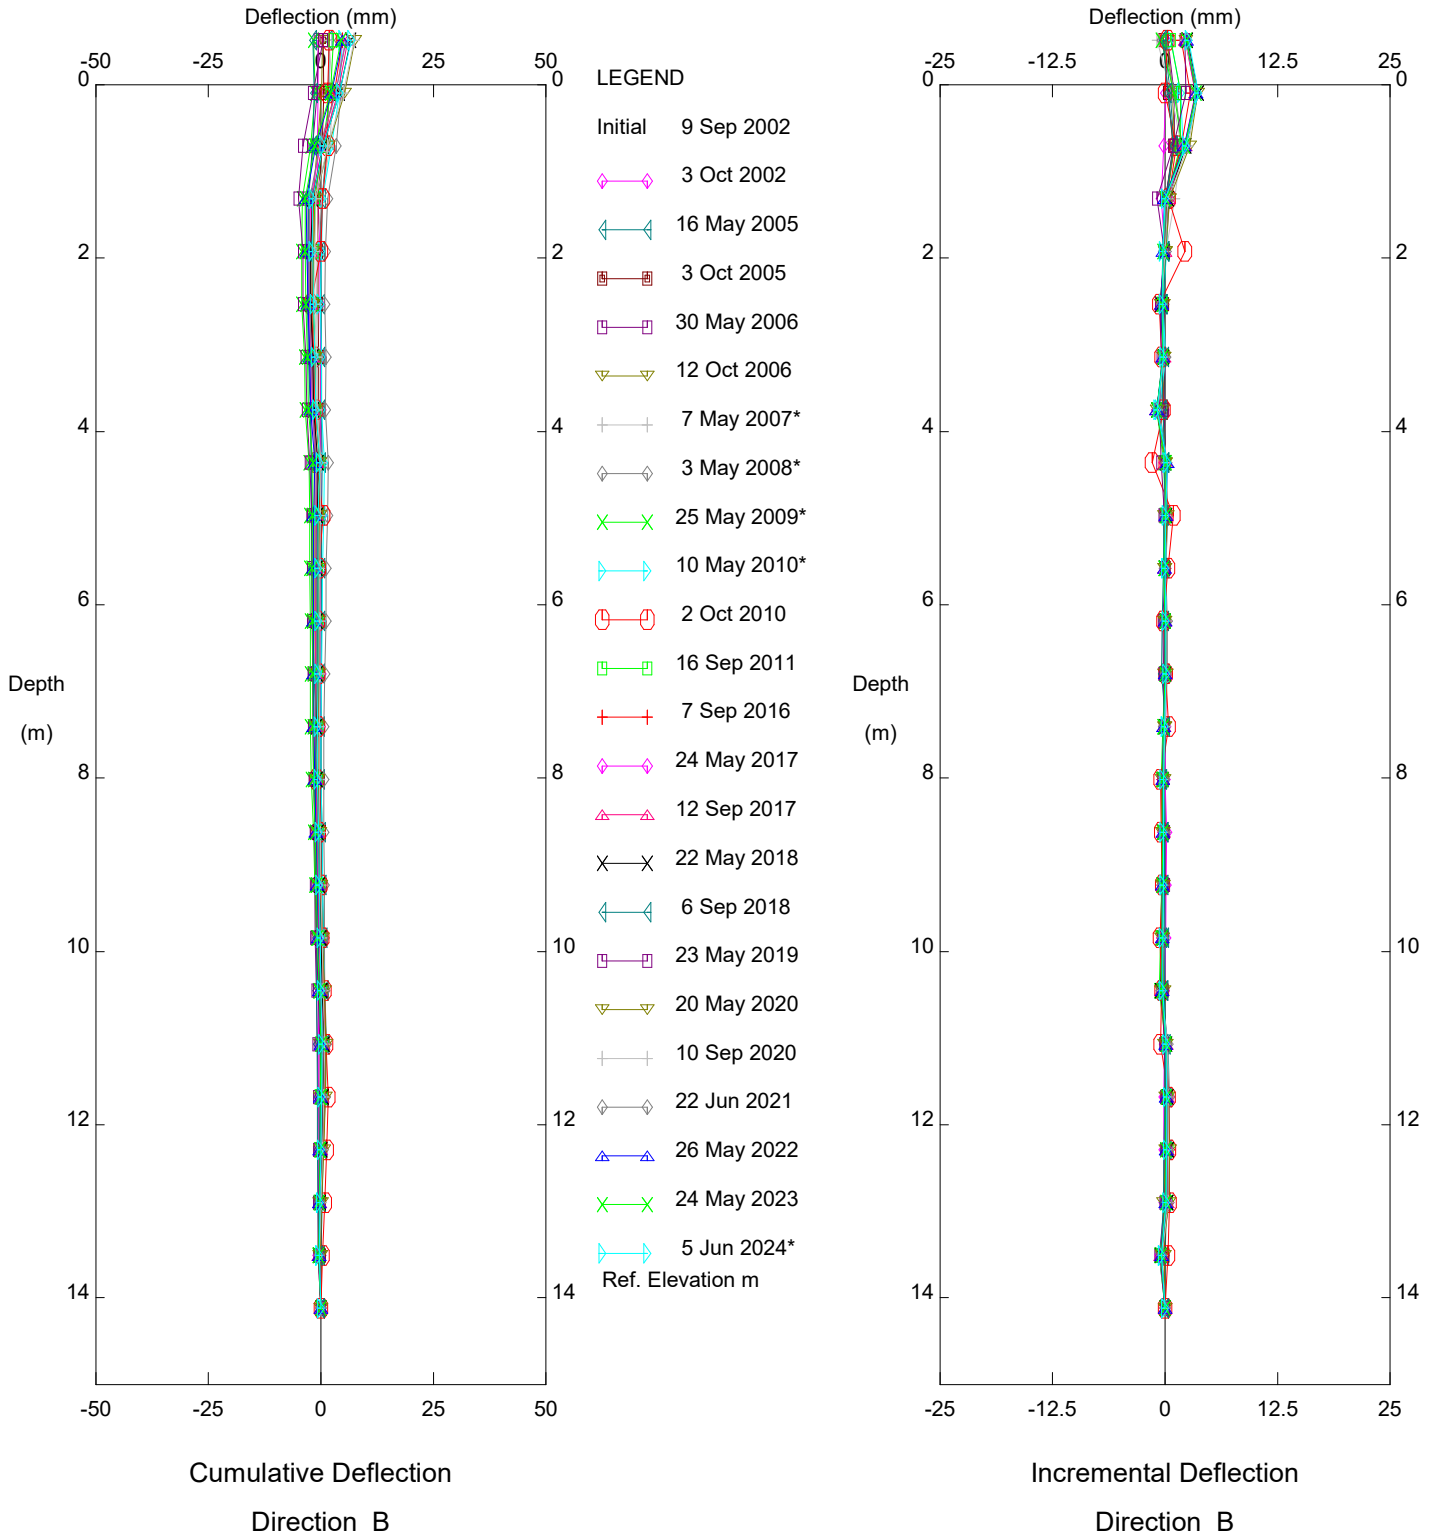
HWY 646:04 Lindbergh Hill, Inclinator SI02-1

| Discussion | |
|---|---|
| <b>Interpretation of Monitoring Results:</b> | <p>SI02-1, installed in the south ditch of the highway, continued to show no discernible movement.</p> <p>The movements in the SIs installed in the piles were as follows:</p> <ul style="list-style-type: none"> <li>• SI07-1 = - 4.1 mm pile head movement over 0.4 m to 12.0 m depth</li> <li>• SI07-2 = 20.4 mm pile head movement over 0.3 m to 16.7 m depth</li> <li>• SI07-3 = 40.8 mm pile head movement over 0.2 m to 13.6 m depth.</li> </ul> <p>SI07-1, located in the western segment of the wall, showed no discernible movement over 0.4 m to 12.0 m depth and over 0.4 m to 20.0 m depth since the spring 2023 readings.</p> |

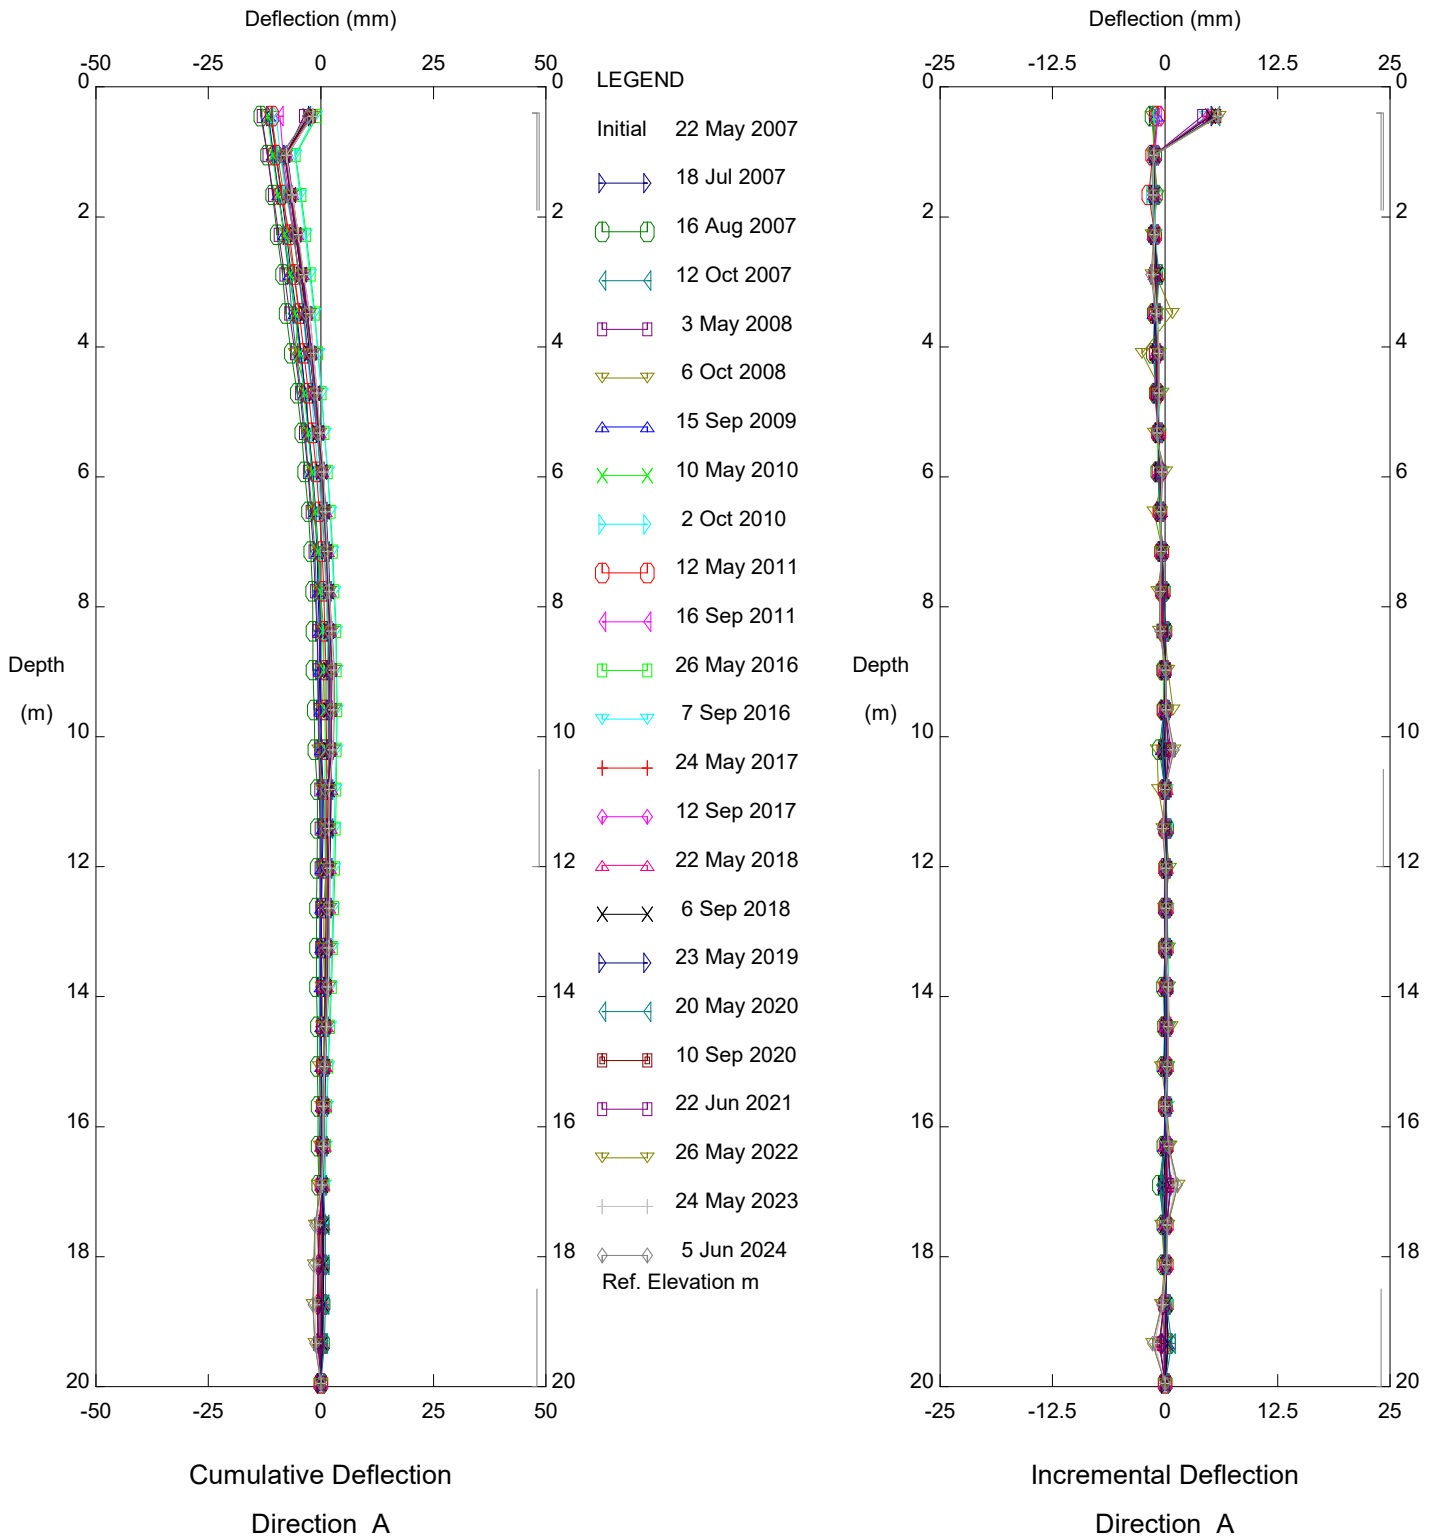
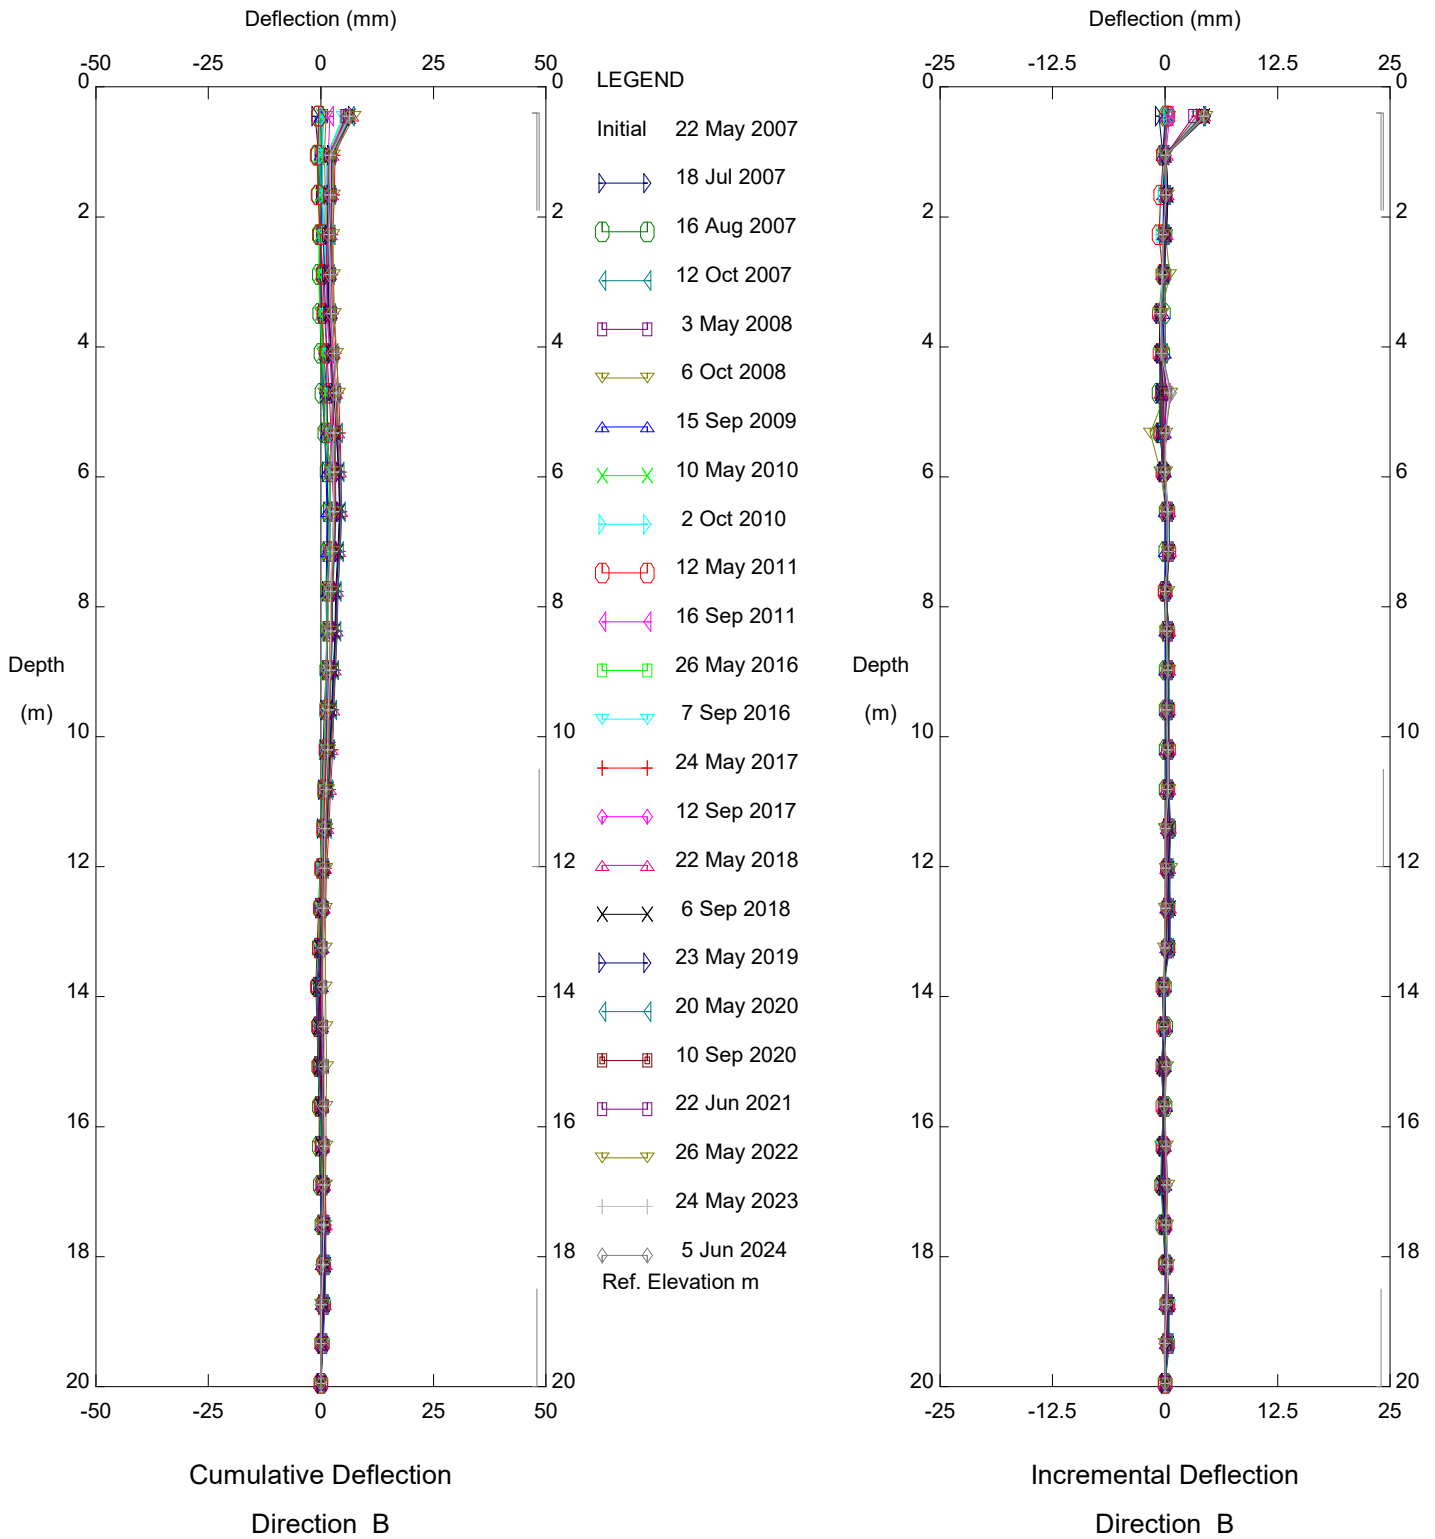
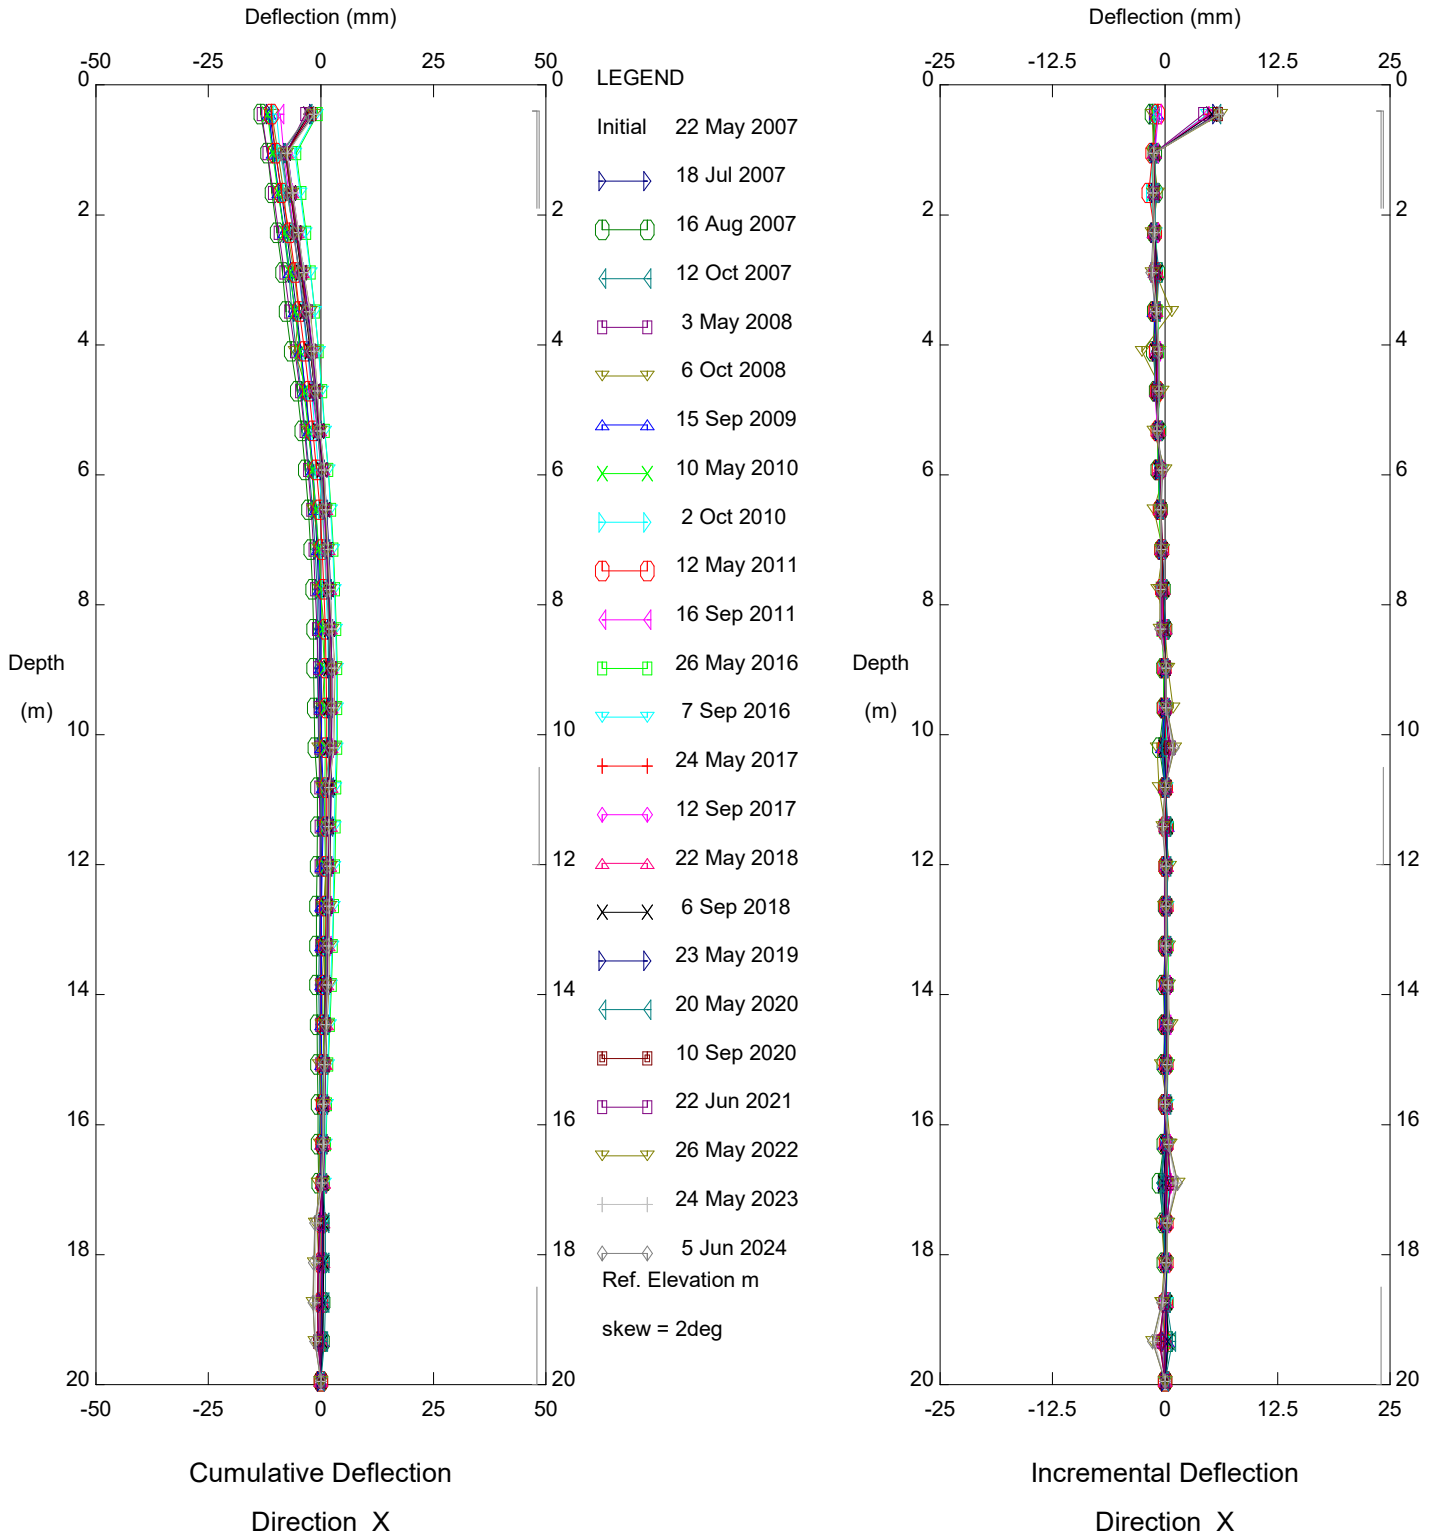
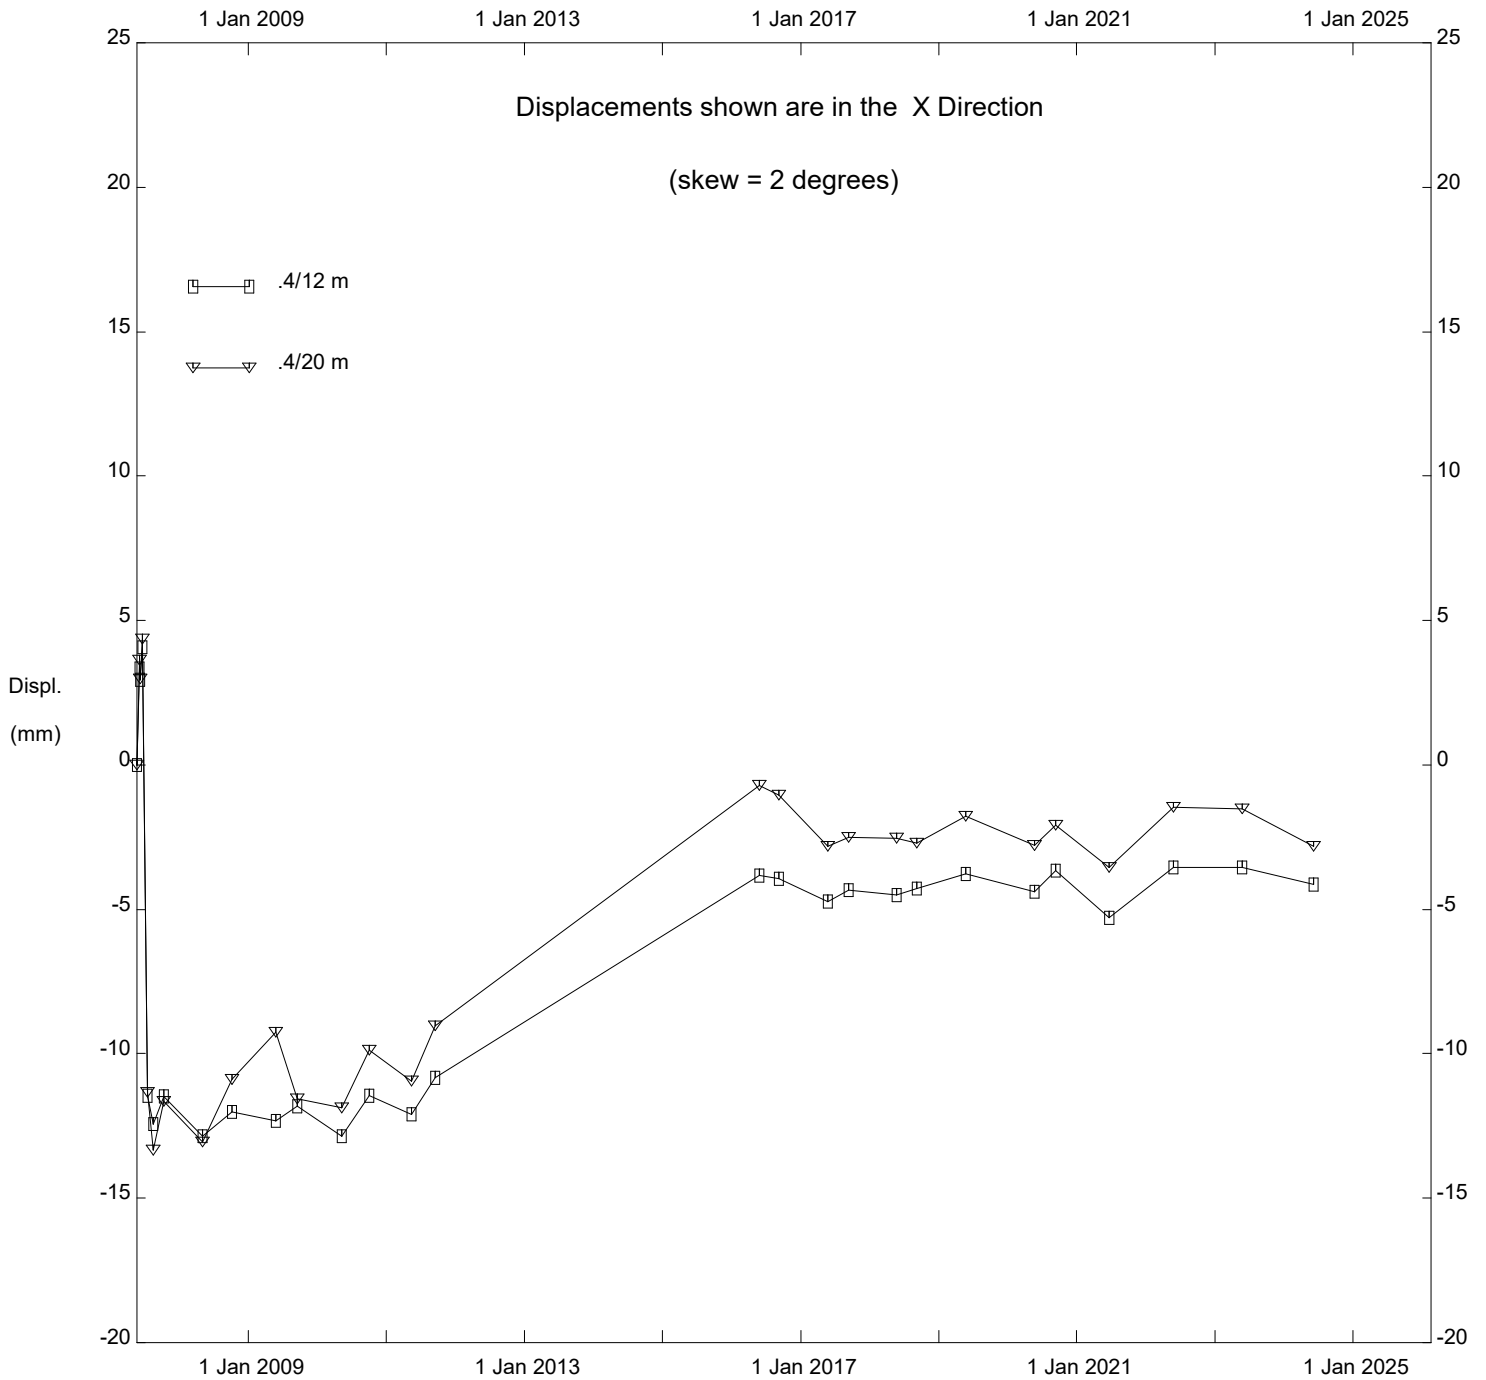
HWY646:04 Lindbergh Hill, Inclinometer SI07-1

| INSTRUMENT # | DATE INITIALIZED | TOTAL CUMULATIVE RESULTANT MOVEMENT AND DEPTH OF MOVEMENT TO DATE (mm) | MAXIMUM RATE OF MOVEMENT (mm/yr) | CURRENT STATUS OF SI | DATE OF PREVIOUS READING | INCREMENTAL MOVEMENT SINCE PREVIOUS READING (mm) | CURRENT RATE OF MOVEMENT (mm/yr) | CHANGE IN RATE OF MOVEMENT SINCE PREVIOUS READING (mm/yr) |
|---|---|---|---|---|---|---|---|---|
| SI07-1 (Pile #14) | May 22, 2007 | -4.1 over 0.4 m to 12.0 m depth in 20° direction | 84.8 mm/yr between May 2007 and June 2007 | Operational | May 24, 2023 | No discernible movement | N/A | -0.6 |
| | | -2.8 over 0.4 m to 20.0 m depth in 20° direction | 92.2 mm/yr between May 2007 and June 2007 | | | No discernible movement | N/A | -1.2 |

| ***SI07-1 hard to pull at 6 ft |

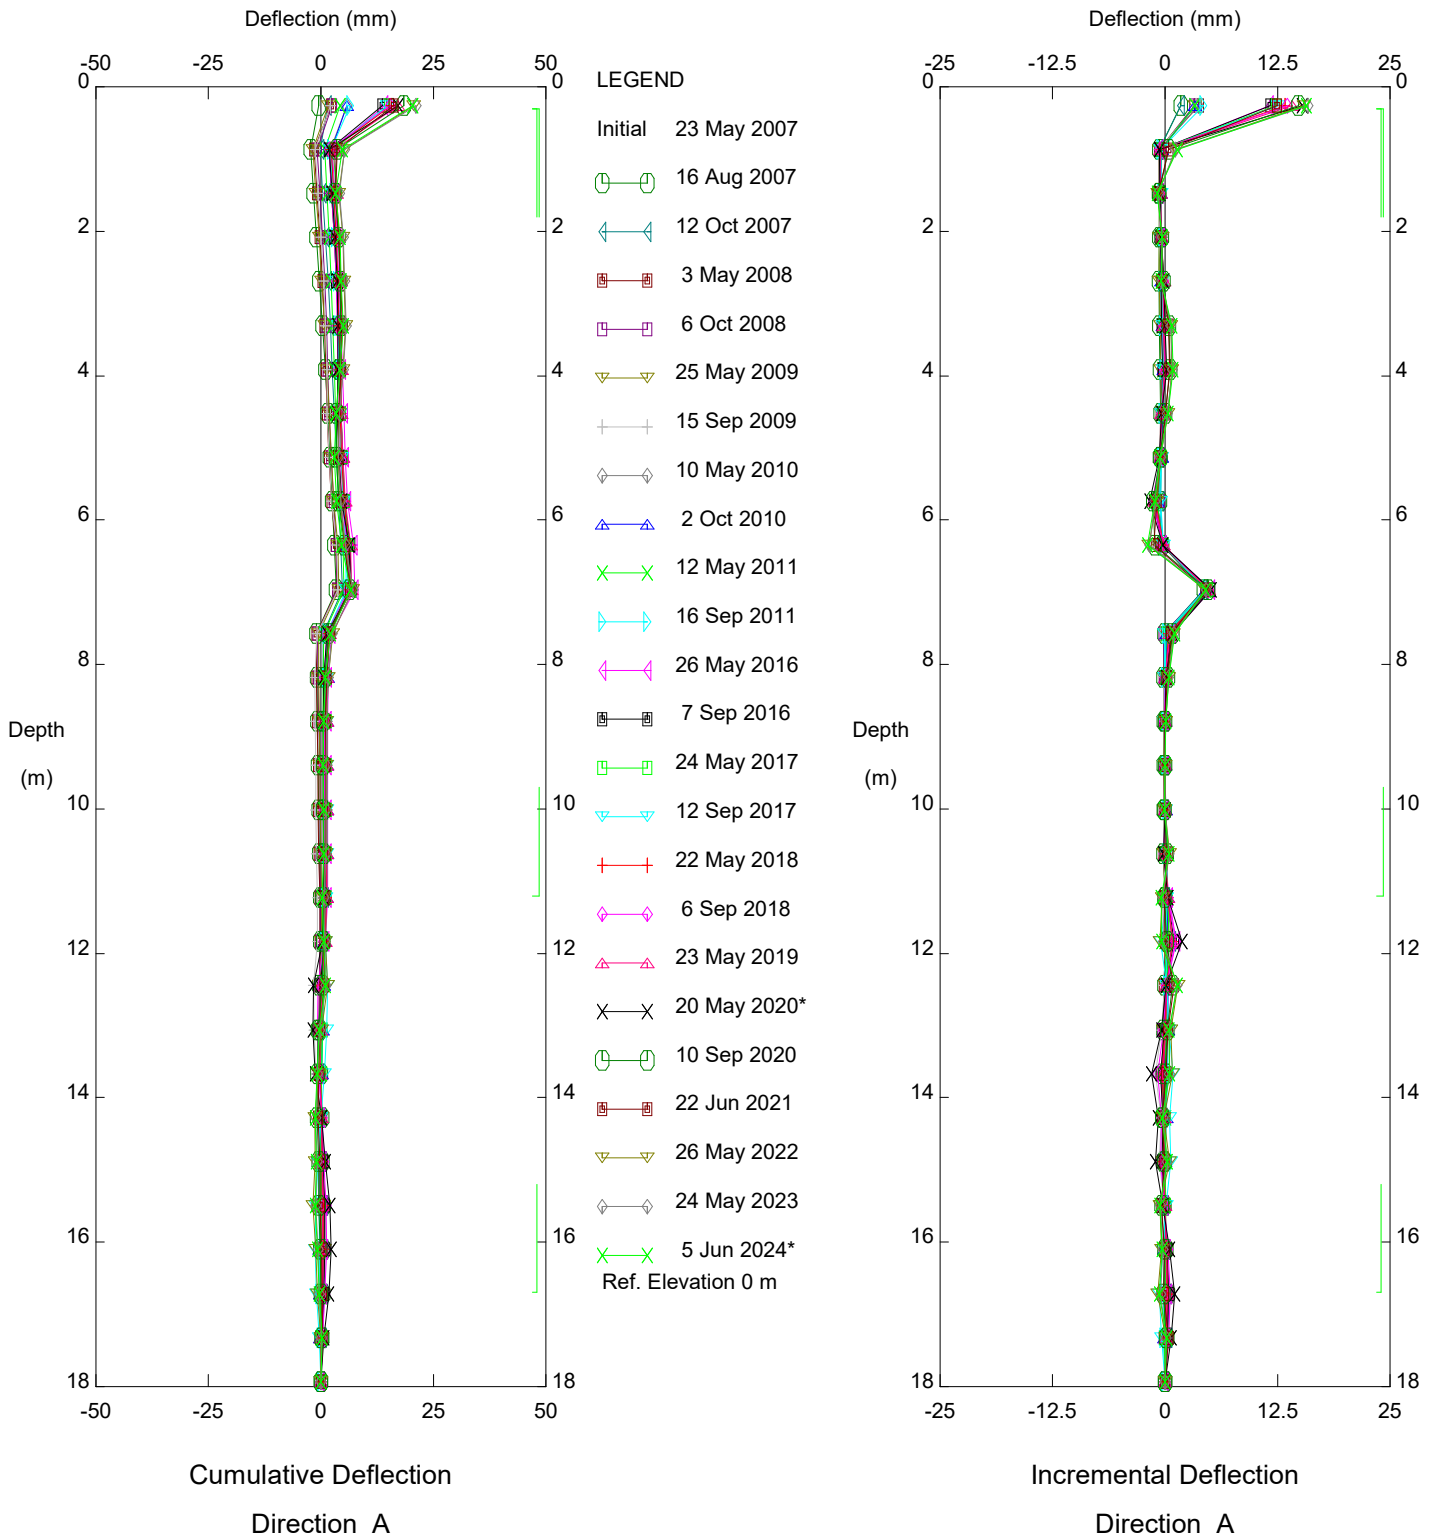
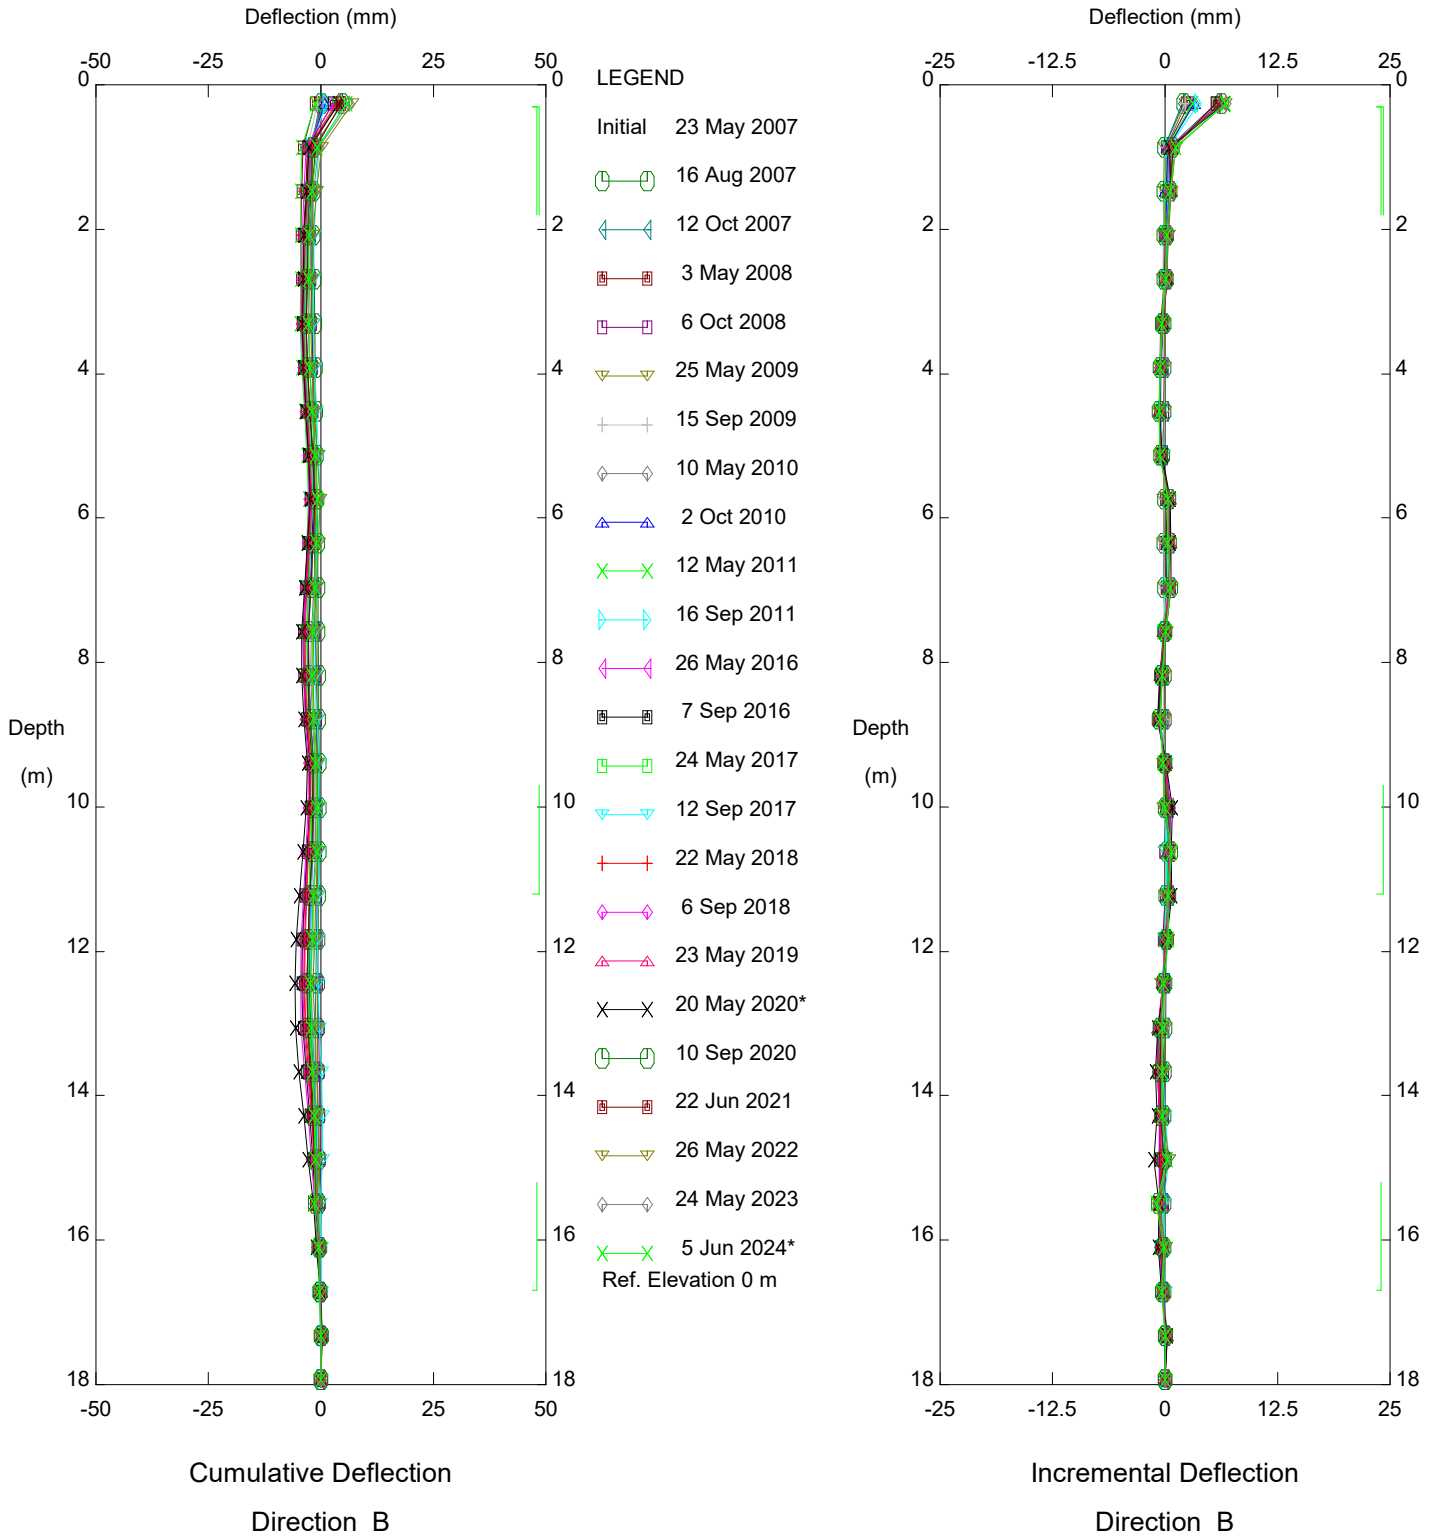
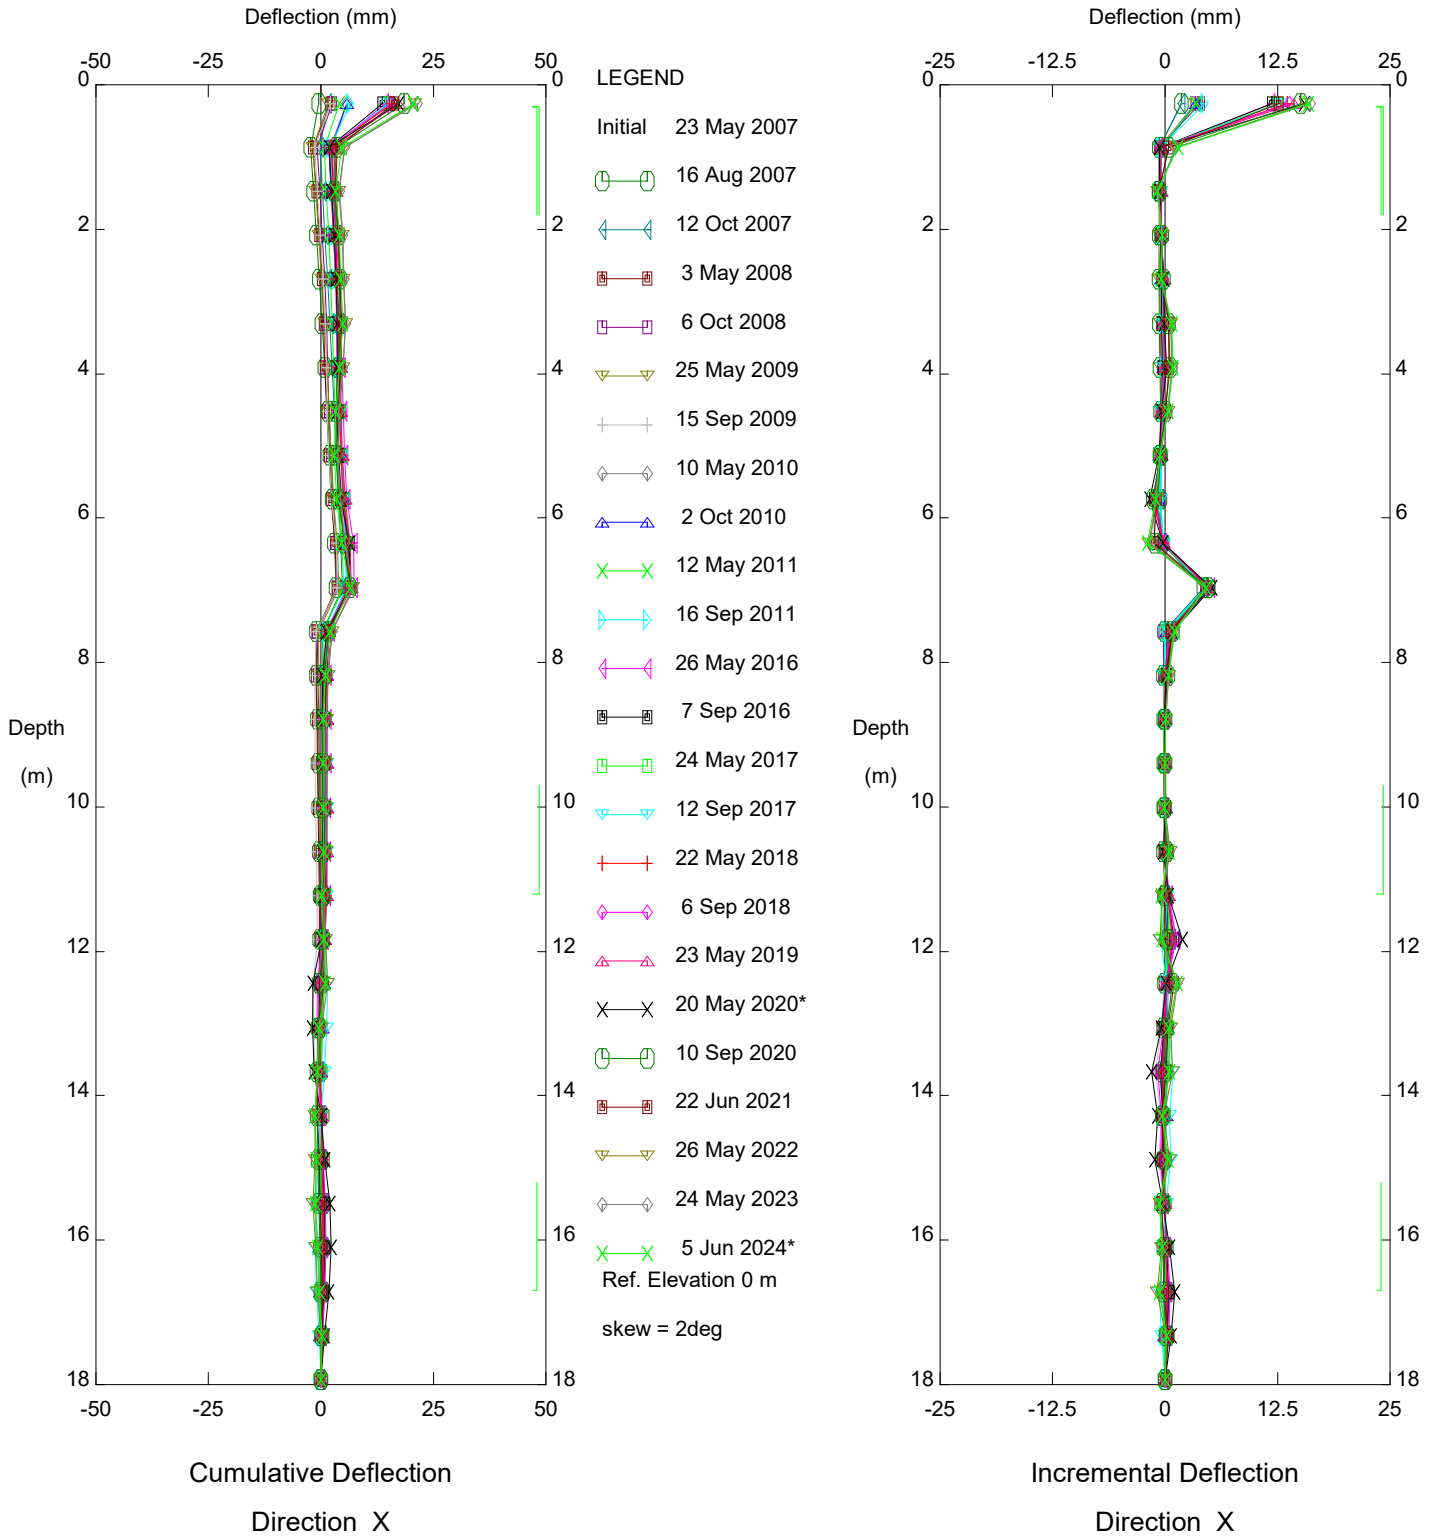
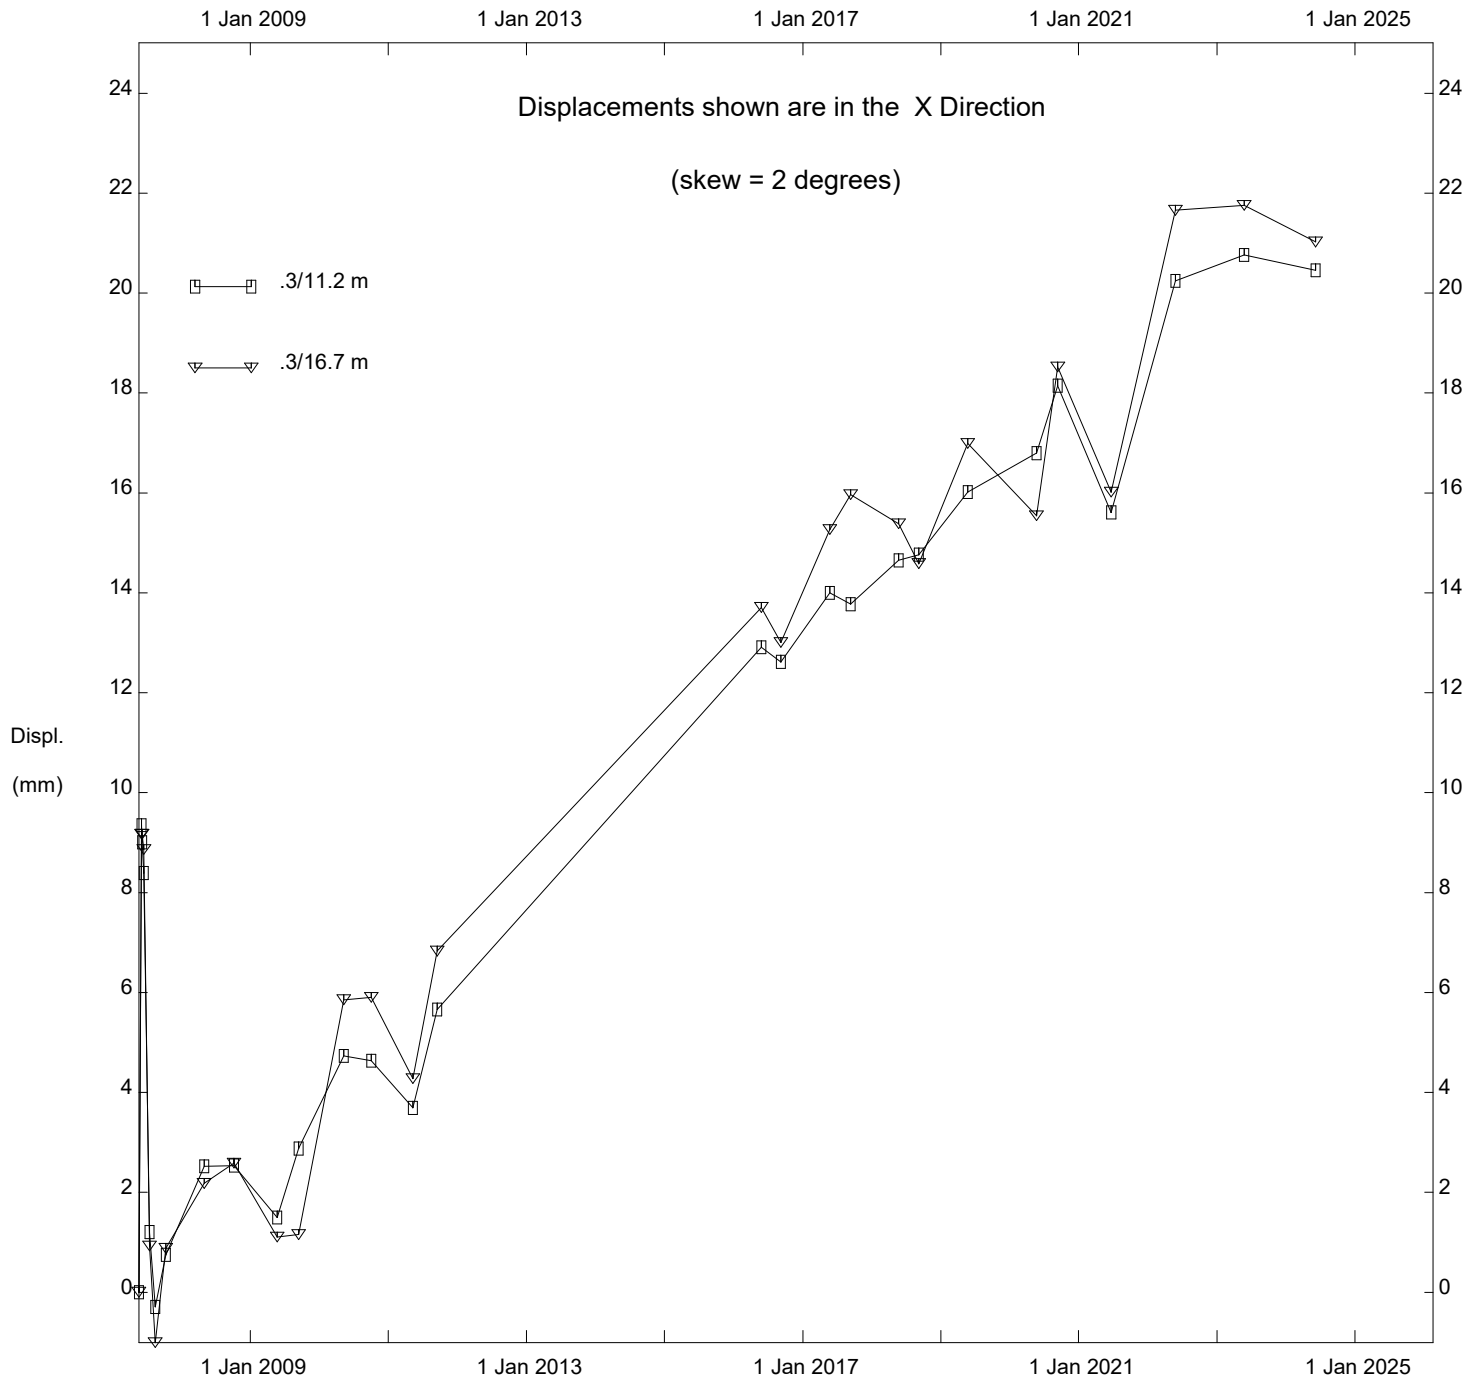
HWY646:04 Lindbergh Hill, Inclinometer SI07-2

| | <p>SI07-2, located in the middle segment of the pile wall, showed no discernible movement over 0.3 m to 11.2 m depth and over 0.3 m to 16.7 m depth since the spring 2023 readings.</p> <p>SI07-3, located in the eastern segment of the wall, showed a rate of movement of 0.1 mm/yr over 0.2 m to 5.6 m depth, and a rate of movement of 0.6 mm/yr over 0.2 m to 13.6 m depth, since the spring of 2023 readings.</p> <p>Standpipe piezometers SP02-1 showed no change in groundwater level since the spring of 2023 readings. SP02-4 showed a decrease in groundwater level of 0.80 m since the spring of 2023 readings.</p> <p>Load cell VC1463 showed a decrease in measured load of 1.47 kN since the spring of 2023 readings, and a decrease of 46.47 kN since the spring of 2022 readings. The large decrease of the load in VC1463 is likely from one of the vibrating wires functioning incorrectly.</p> <p>VC1465, VC1466, VC1467 and VC1468 showed decreases in measured load of 11.82 kN, 0.76 kN, 0.39 kN, and 1.37 kN, respectively, since the spring of 2023 readings. VC1464 showed an increase in measured load of 0.16 kN, since the spring of 2023 readings. VC1463, VC1464 and VC1467 currently have three of the four vibrating wire channels functioning so the measured load is the average of the functioning channels. VC1465 currently has only one wire functioning.</p> <p>.</p> <p>In general, the instrumentation monitoring results indicate that the pile wall has performed well since construction completion.</p> |

| INSTRUMENT # | DATE INITIALIZED | TOTAL CUMULATIVE RESULTANT MOVEMENT AND DEPTH OF MOVEMENT TO DATE (mm) | MAXIMUM RATE OF MOVEMENT (mm/yr) | CURRENT STATUS OF SI | DATE OF PREVIOUS READING | INCREMENTAL MOVEMENT SINCE PREVIOUS READING (mm) | CURRENT RATE OF MOVEMENT (mm/yr) | CHANGE IN RATE OF MOVEMENT SINCE PREVIOUS READING (mm/yr) |
|---|---|---|---|---|---|---|---|---|
| SI07-2 (Pile #28) | May 22, 2007 | 20.4 over 0.3 m to 11.2 m depth in 20° direction | 262.7 mm/yr between May 2007 and June 2007 | Operational | May 24, 2023 | No discernible movement | N/A | -0.8 |
| | | 21.0 over 0.3 m to 16.7 m depth in 20° direction | 258.0 mm/yr between May 2007 and June 2007 | | | No discernible movement | N/A | -0.8 |
