ALBERTA TRANSPORTATION AND  
ECONOMIC CORRIDORS GRMP  
NORTH CENTRAL (ATHABASCA AND FORT  
McMURRAY DISTRICTS)  
INSTRUMENTATION MONITORING- SPRING 2024

| Site Number | Location | Name | Hwy | km |
|---|---|---|---|---|
| NC025 | HWY 646:04 C1 16.082 | Lindbergh Hill | 646:04 | Km 16.1 |

| <b>Current Monitoring:</b> | 5-June-2024 | <b>Previous Monitoring</b> | 24-May-2023 |

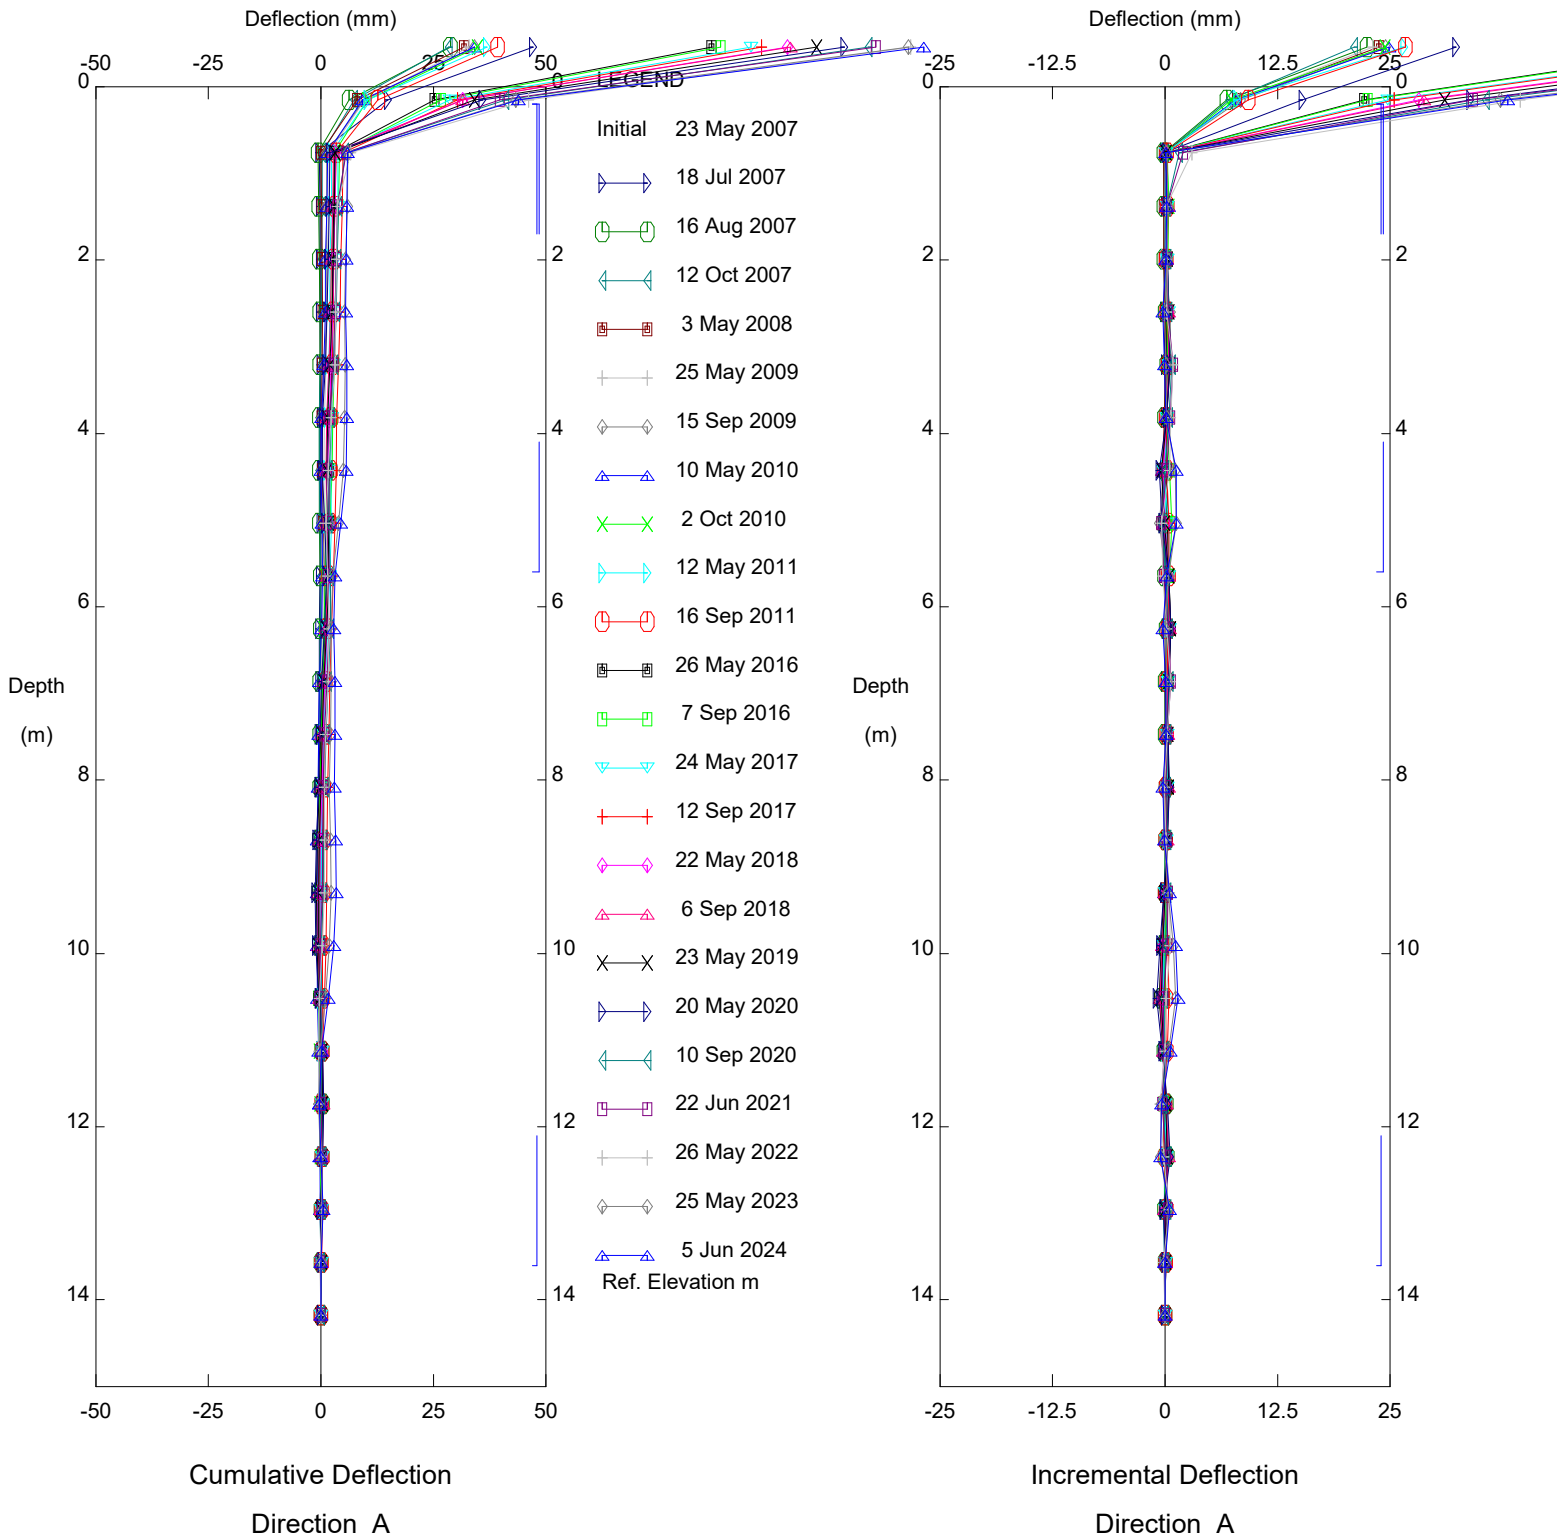
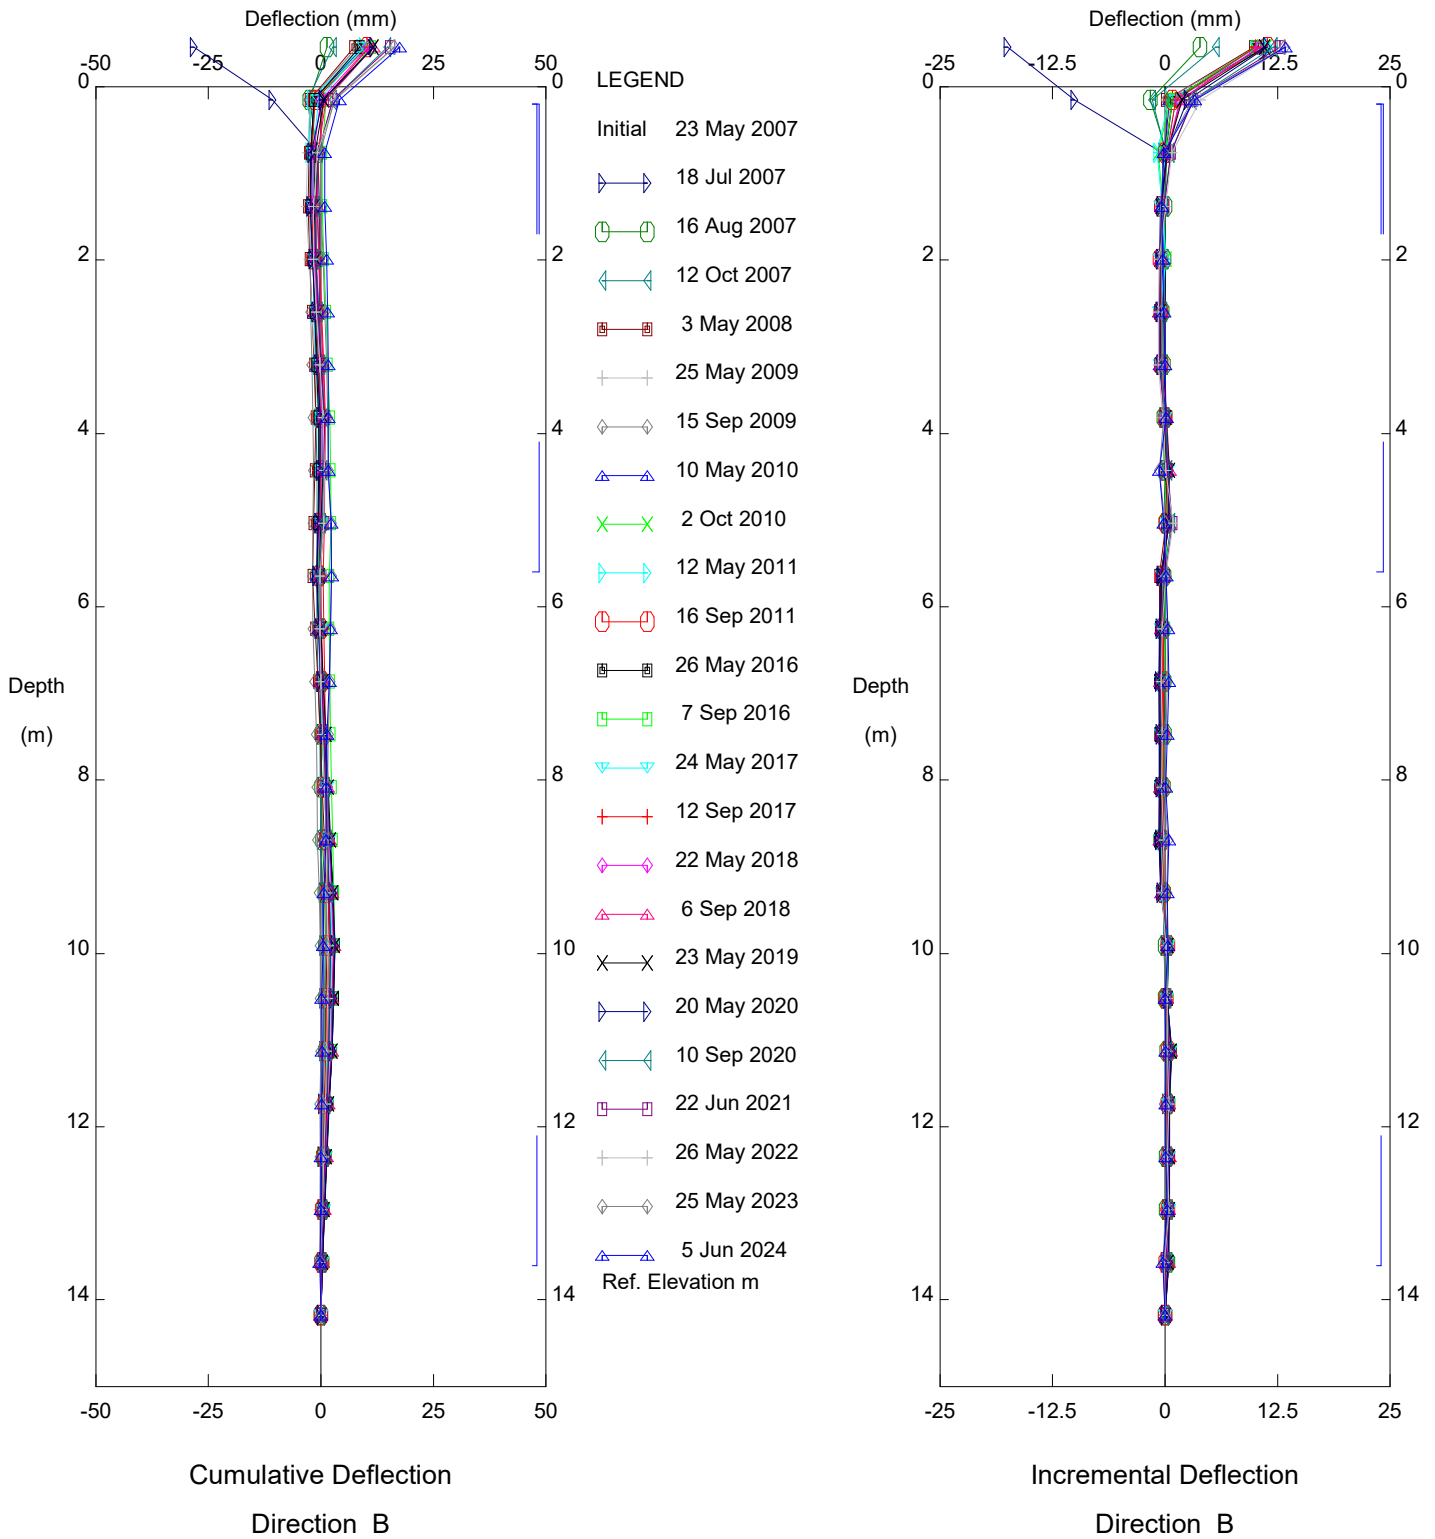
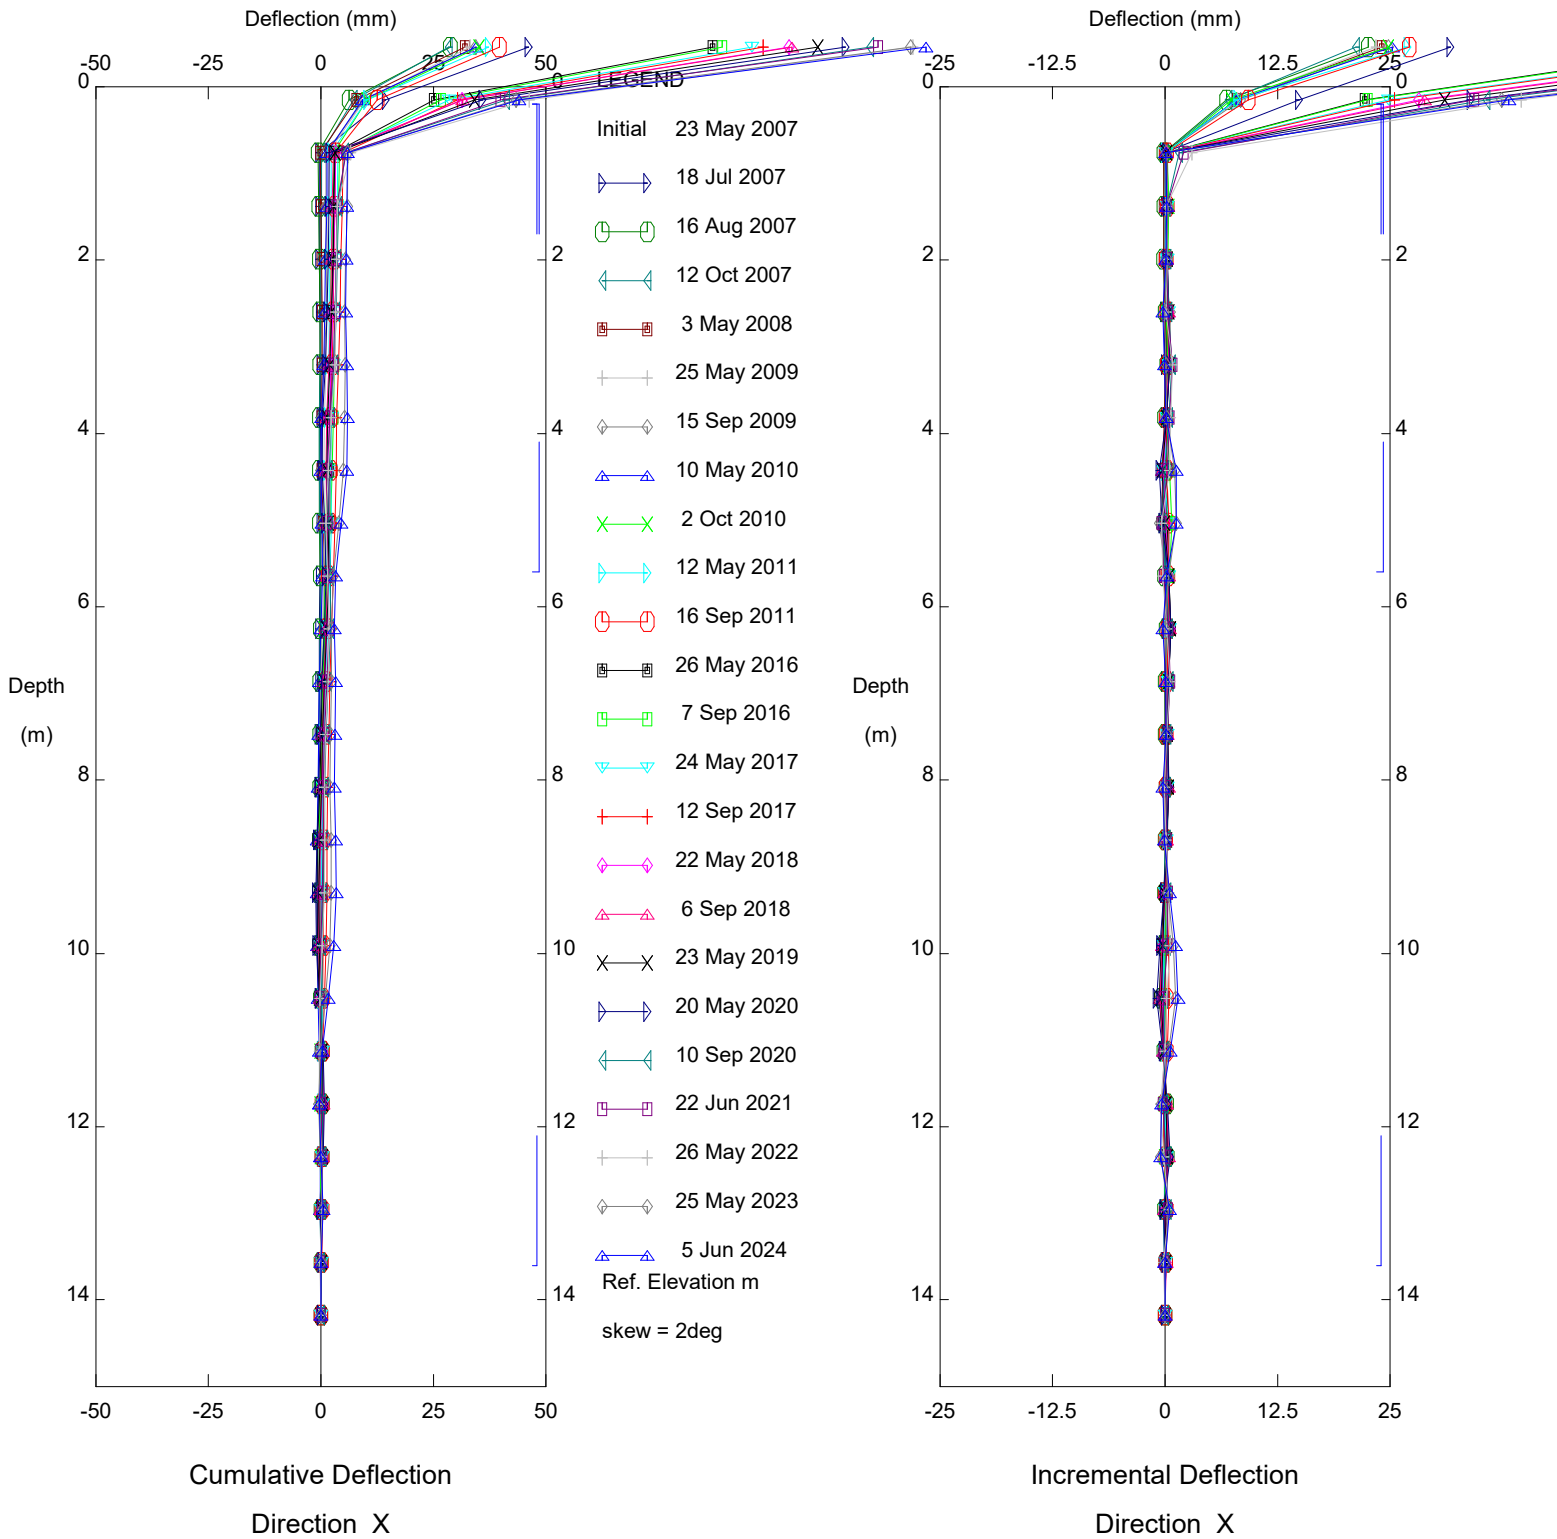
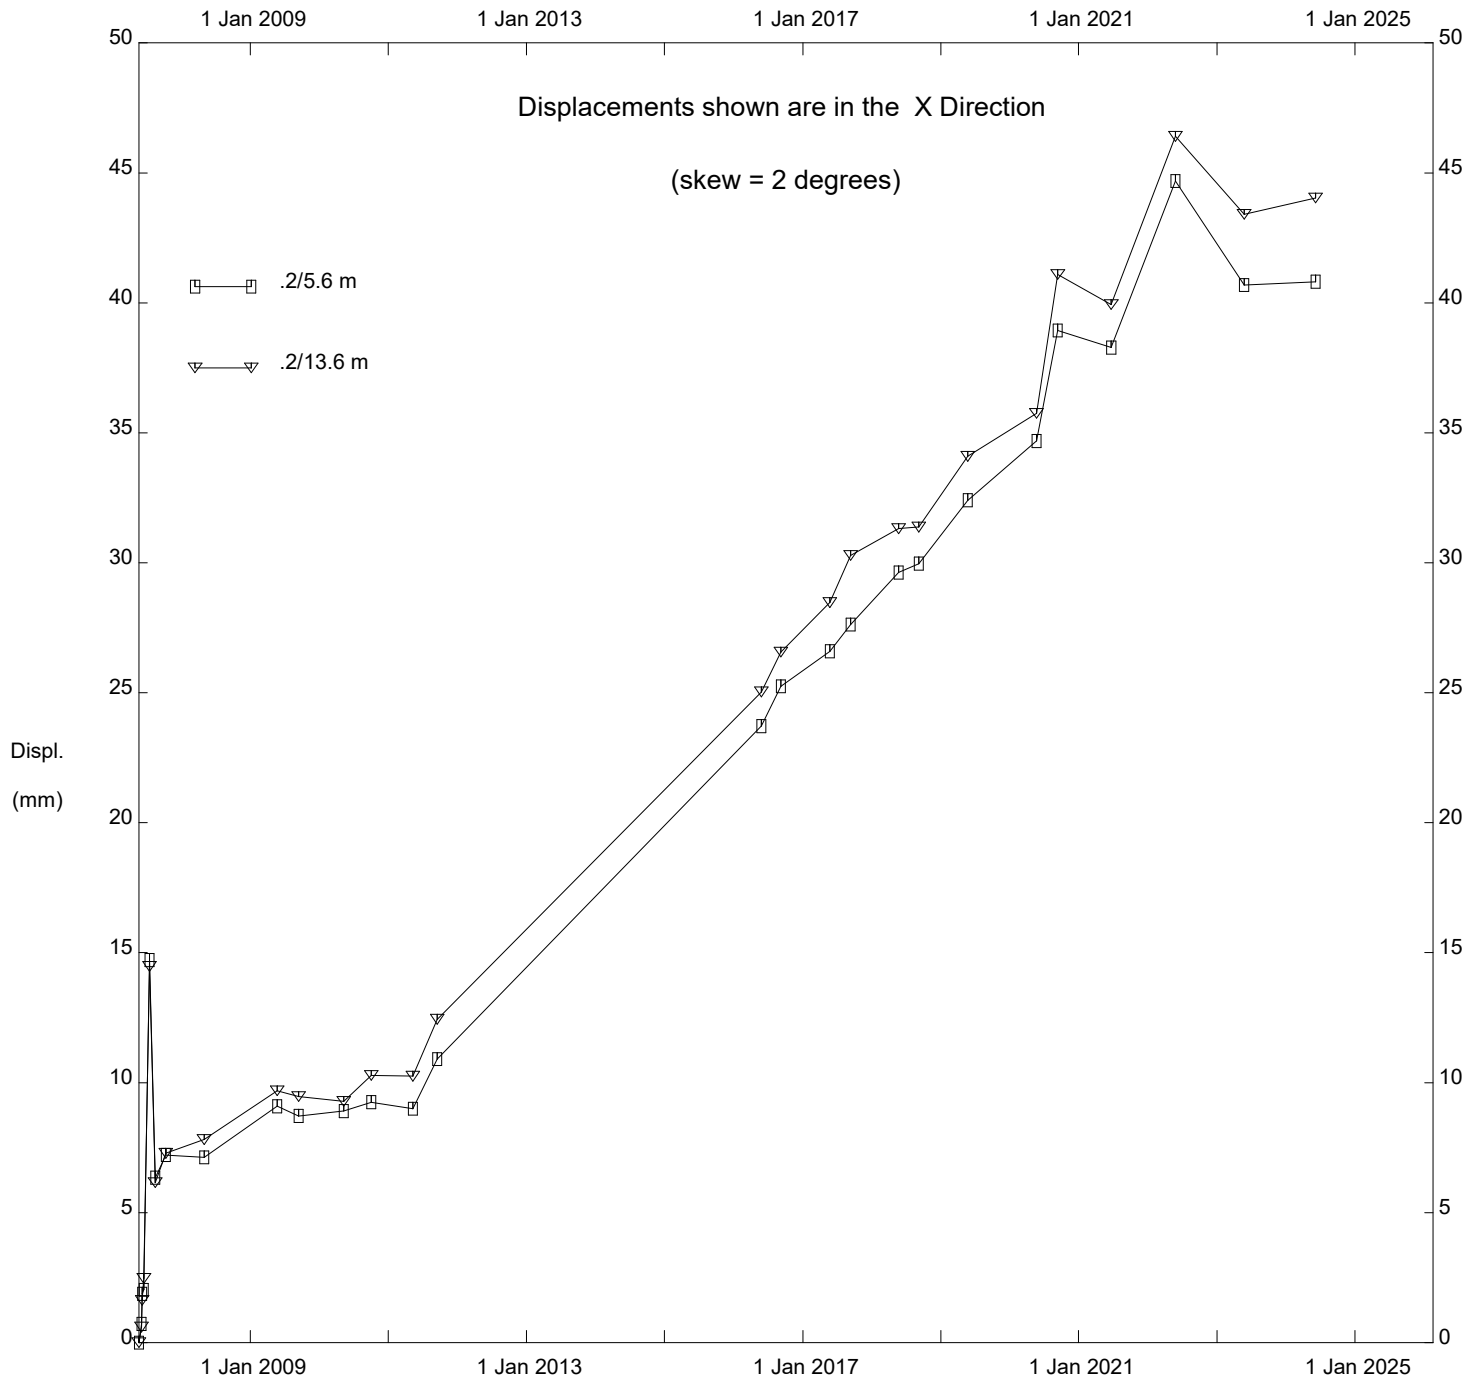
HWY646:04 Lindbergh Hill, Inclinometer SI07-3

| | <p>SI07-2, located in the middle segment of the pile wall, showed no discernible movement over 0.3 m to 11.2 m depth and over 0.3 m to 16.7 m depth since the spring 2023 readings.</p> <p>SI07-3, located in the eastern segment of the wall, showed a rate of movement of 0.1 mm/yr over 0.2 m to 5.6 m depth, and a rate of movement of 0.6 mm/yr over 0.2 m to 13.6 m depth, since the spring of 2023 readings.</p> <p>Standpipe piezometers SP02-1 showed no change in groundwater level since the spring of 2023 readings. SP02-4 showed a decrease in groundwater level of 0.80 m since the spring of 2023 readings.</p> <p>Load cell VC1463 showed a decrease in measured load of 1.47 kN since the spring of 2023 readings, and a decrease of 46.47 kN since the spring of 2022 readings. The large decrease of the load in VC1463 is likely from one of the vibrating wires functioning incorrectly.</p> <p>VC1465, VC1466, VC1467 and VC1468 showed decreases in measured load of 11.82 kN, 0.76 kN, 0.39 kN, and 1.37 kN, respectively, since the spring of 2023 readings. VC1464 showed an increase in measured load of 0.16 kN, since the spring of 2023 readings. VC1463, VC1464 and VC1467 currently have three of the four vibrating wire channels functioning so the measured load is the average of the functioning channels. VC1465 currently has only one wire functioning.</p> <p>.</p> <p>In general, the instrumentation monitoring results indicate that the pile wall has performed well since construction completion.</p> |

| INSTRUMENT # | DATE INITIALIZED | TOTAL CUMULATIVE RESULTANT MOVEMENT AND DEPTH OF MOVEMENT TO DATE (mm) | MAXIMUM RATE OF MOVEMENT (mm/yr) | CURRENT STATUS OF SI | DATE OF PREVIOUS READING | INCREMENTAL MOVEMENT SINCE PREVIOUS READING (mm) | CURRENT RATE OF MOVEMENT (mm/yr) | CHANGE IN RATE OF MOVEMENT SINCE PREVIOUS READING (mm/yr) |
|---|---|---|---|---|---|---|---|---|
| SI07-3<br>(Pile #38) | May 22,<br>2007 | 40.8 over 0.2 m to 5.6 m depth in 10° direction | 158.5 mm/yr between Jun. 2007 and July 2007 | Operational | May 24,<br>2023 | 0.1 | 0.1 | 4.1 |
| | | 44.0 over 0.2 m to 13.6 m depth in 10° direction | 149.8 mm/yr between June 2007 and July 2007 | | | 0.6 | 0.6 | 3.7 |

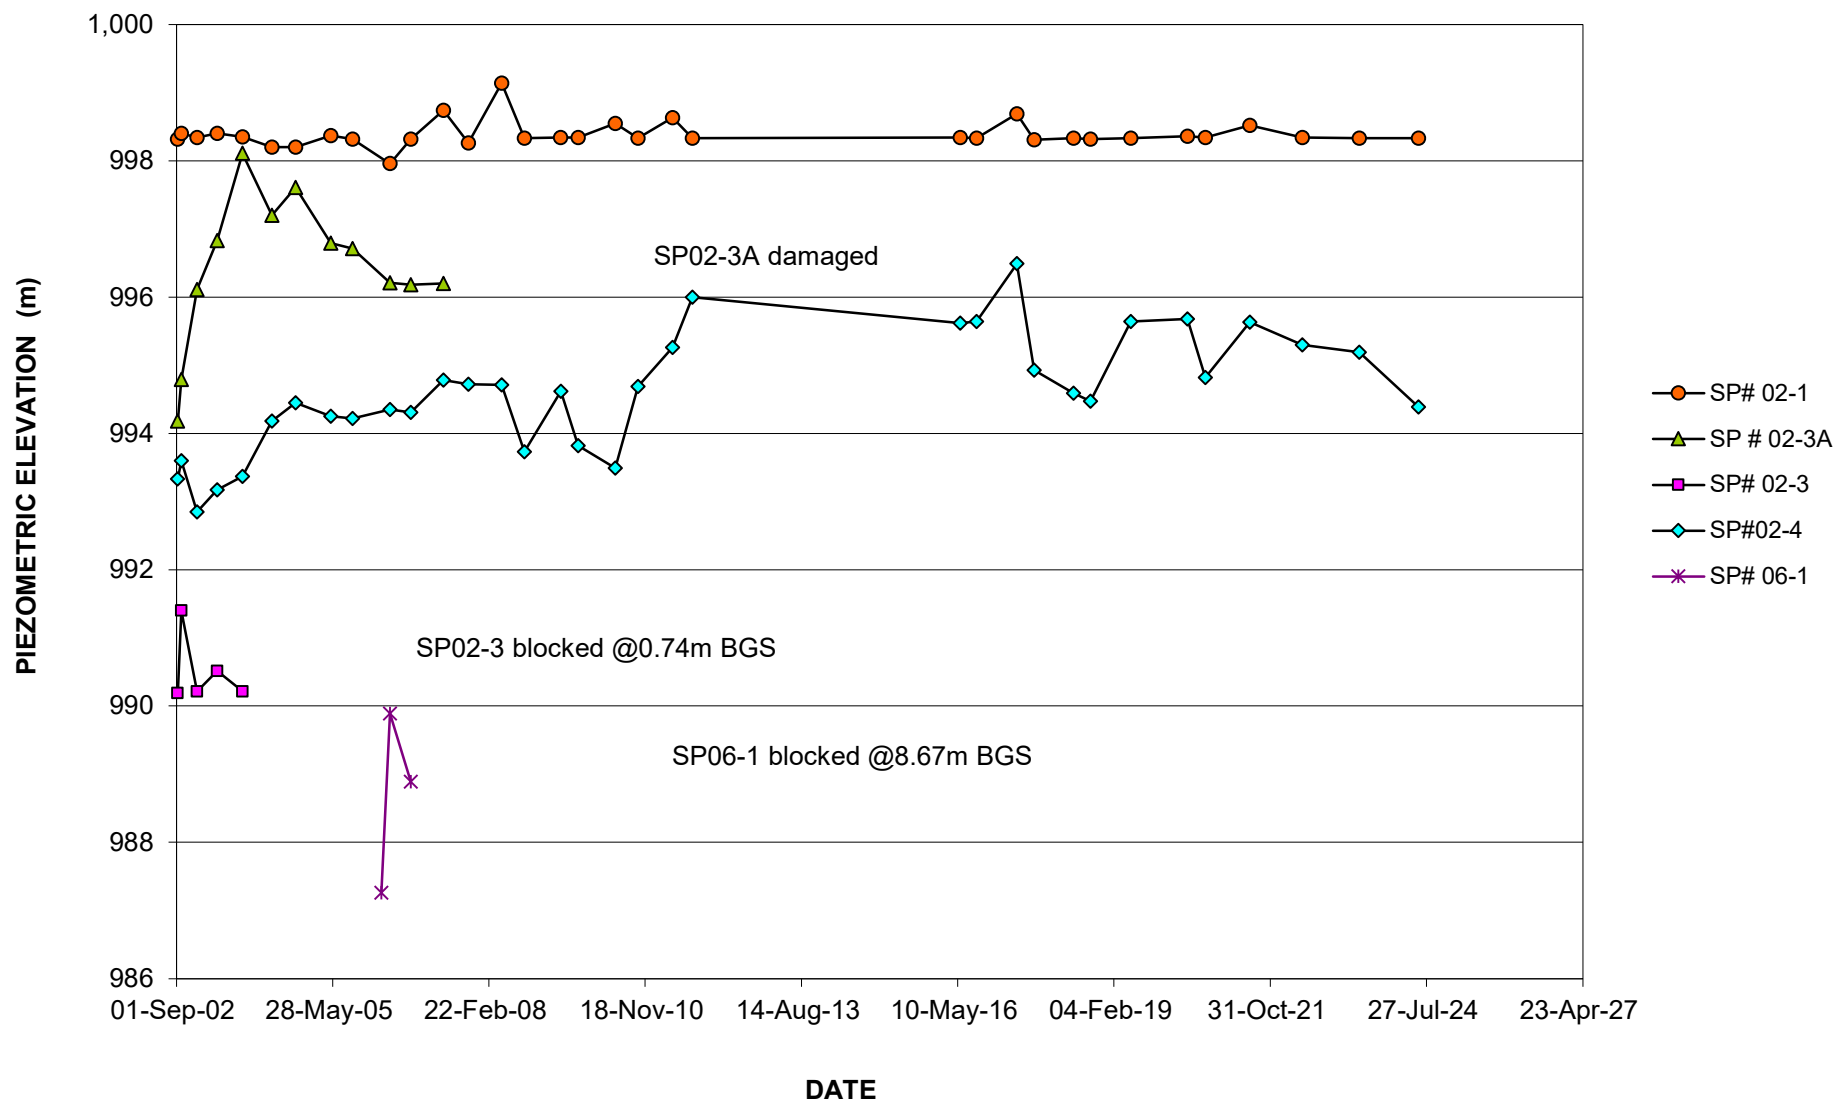
**FIGURE NC025-1**  
**STANDPIPE PIEZOMETER DATA FOR HWY 646:04, LINDBERG HILL**

| INSTRUMENT # | DATE INITIALIZED | TIP ELEV. (m) | GROUND ELEV. (m) | CURRENT STATUS | HIGHEST MEASURED GROUNDWATER LEVEL BGS (m) | CURRENT GROUNDWATER DEPTH BGS (m) | PREVIOUS GROUNDWATER DEPTH BGS (m) | CHANGE IN WATER LEVEL SINCE PREVIOUS READING (m) |
|---|---|---|---|---|---|---|---|---|
| SP02-4 | N/A | 989.01 | 997.45 | Operational | 996.44 on May 24, 2017 (1.01 mBGS) | 994.39 (3.06 mBGS) | 995.19 (2.26 mBGS) | -0.80 |

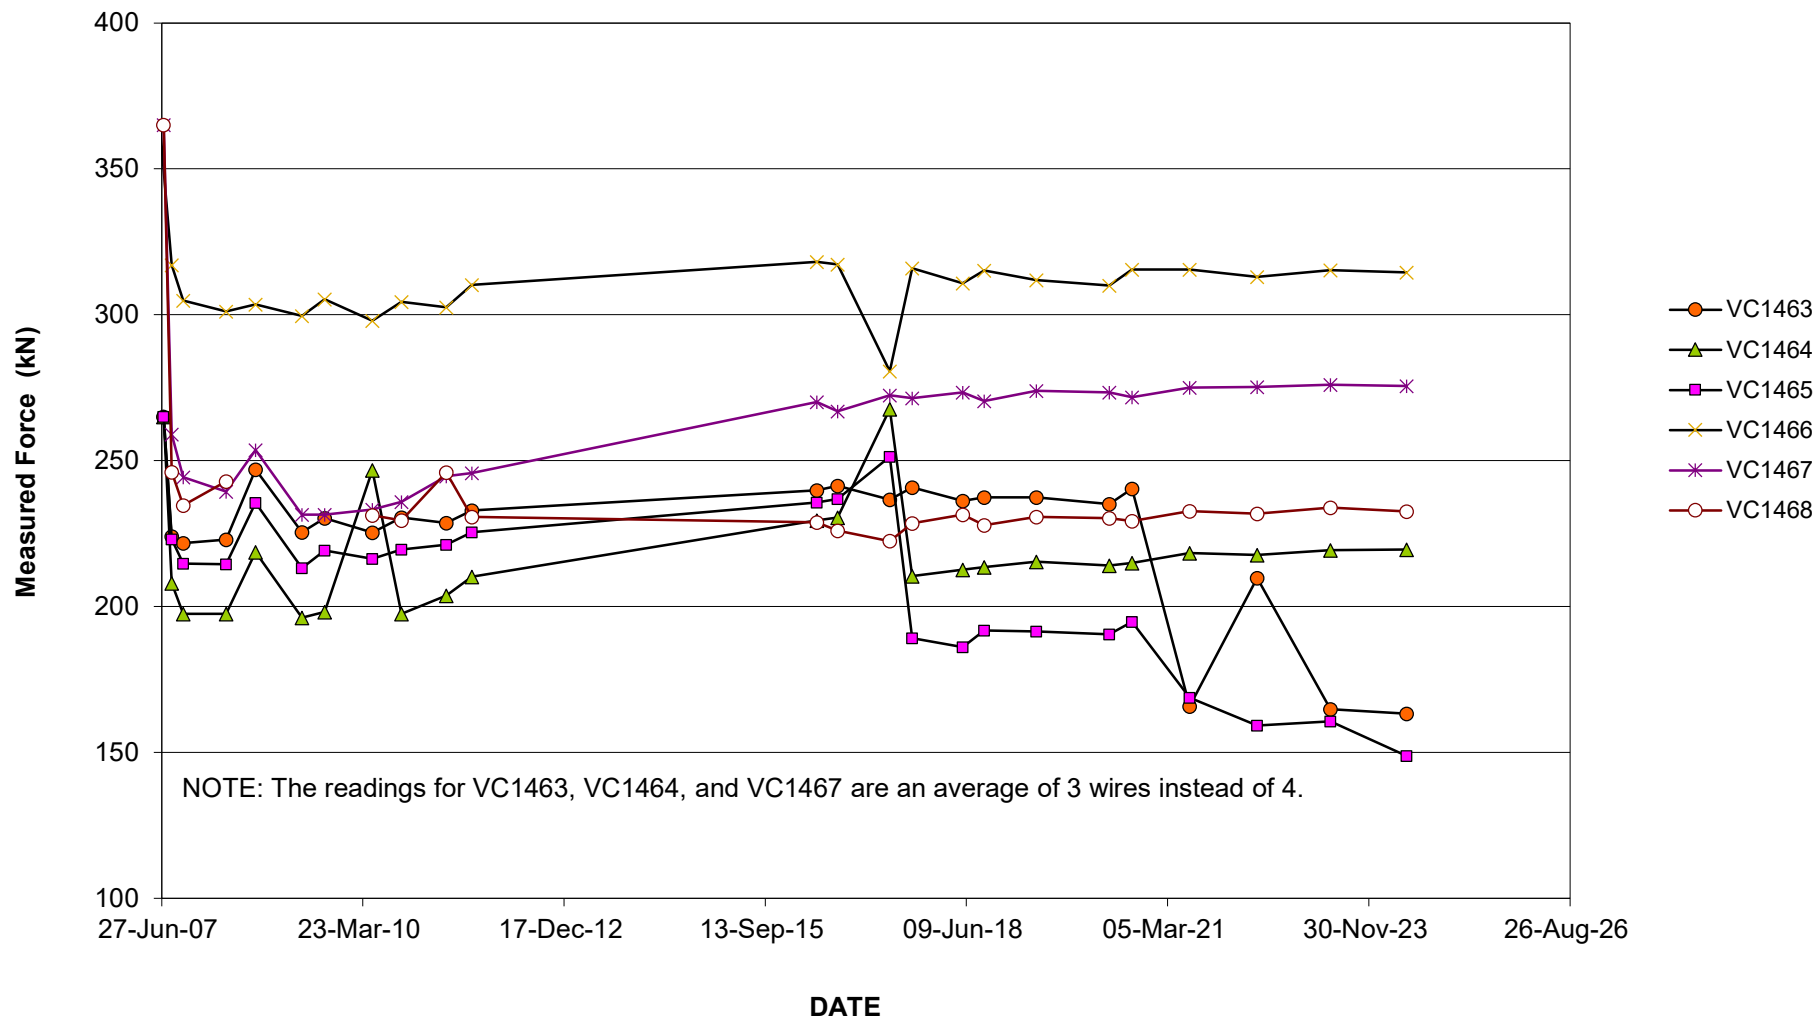
**FIGURE NC025-2**  
**LOAD CELL DATA FOR HWY 646:04, LINDBERG HILL**

| SERIAL # | ANCHOR NUMBER | DESIGN LOAD (kN) | DATE INSTALLED | MEASURED FORCE (kN) | PREVIOUS READING (kN) | CHANGE IN FORCE SINCE PREVIOUS READING (kN) |
|---|---|---|---|---|---|---|
| VC 1465 | G28L | 240 | Jul. 6, 2007 | 148.81** | 160.63 | -11.82 |

\*\* The estimated load for VC1465 is only based on one operating vibrating wire.

| ** Temp. sensor not working, only one Vibrating wire functioning |
