June 25, 2001

Central Region Landslide Assessment Site C16
H11:08 Frost Heave @ Ch 17.6
2001 Annual Inspection Report

This report was prepared by Klohn Crippen Consultants Ltd. for Alberta Transportation Central Region under Contract No. CE053/2000.

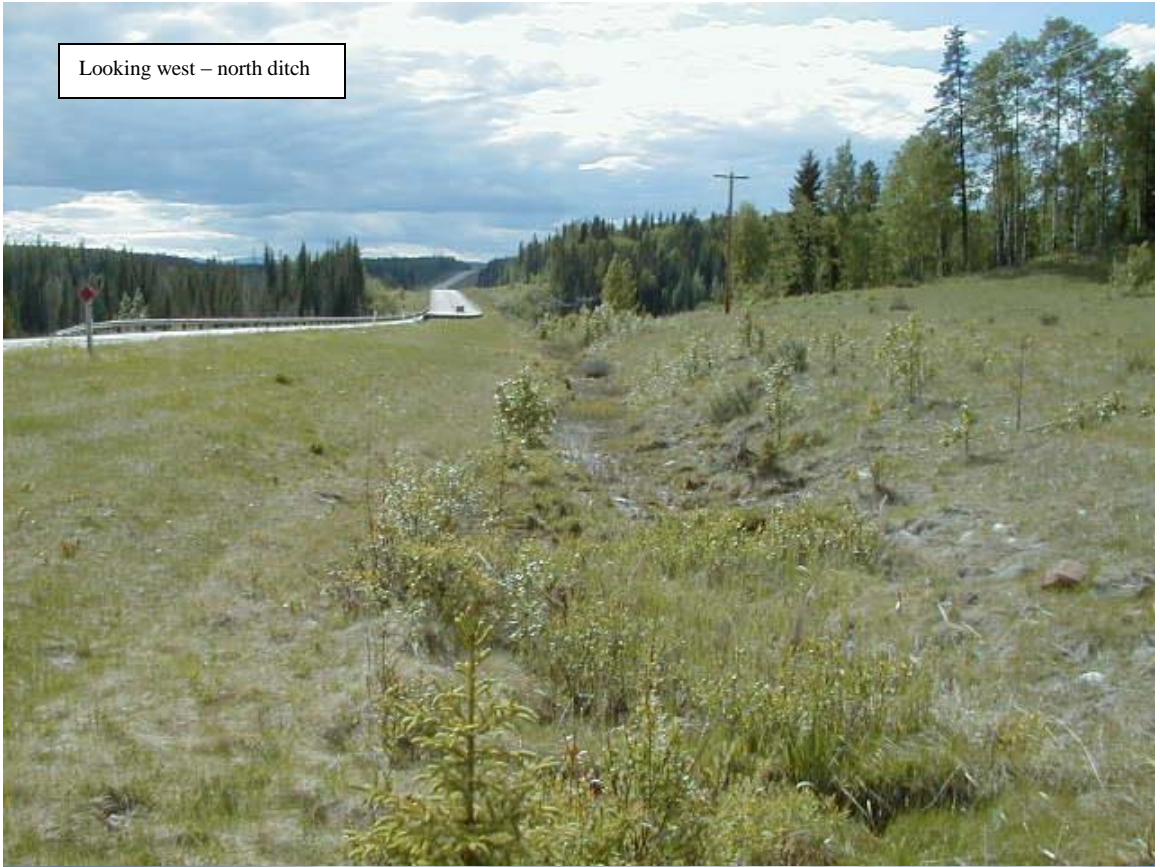
Looking west – north ditch

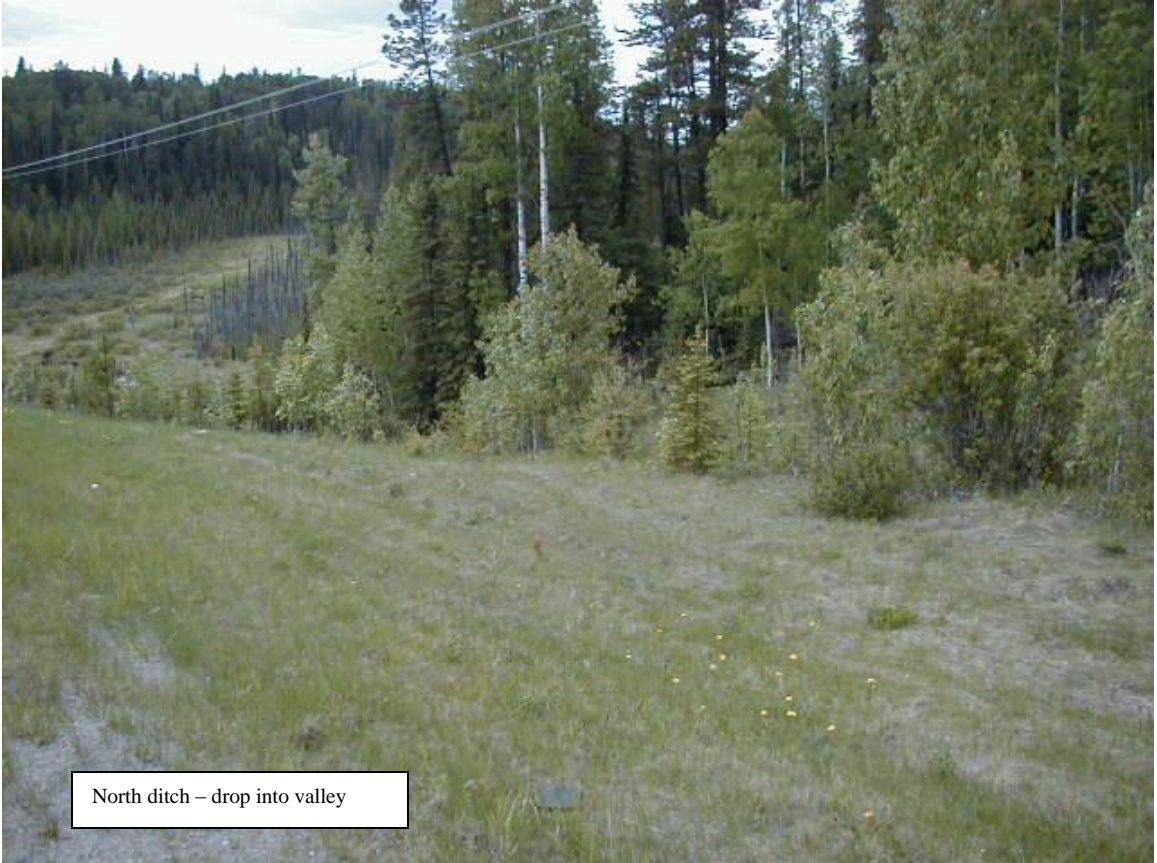
North ditch – drop into valley

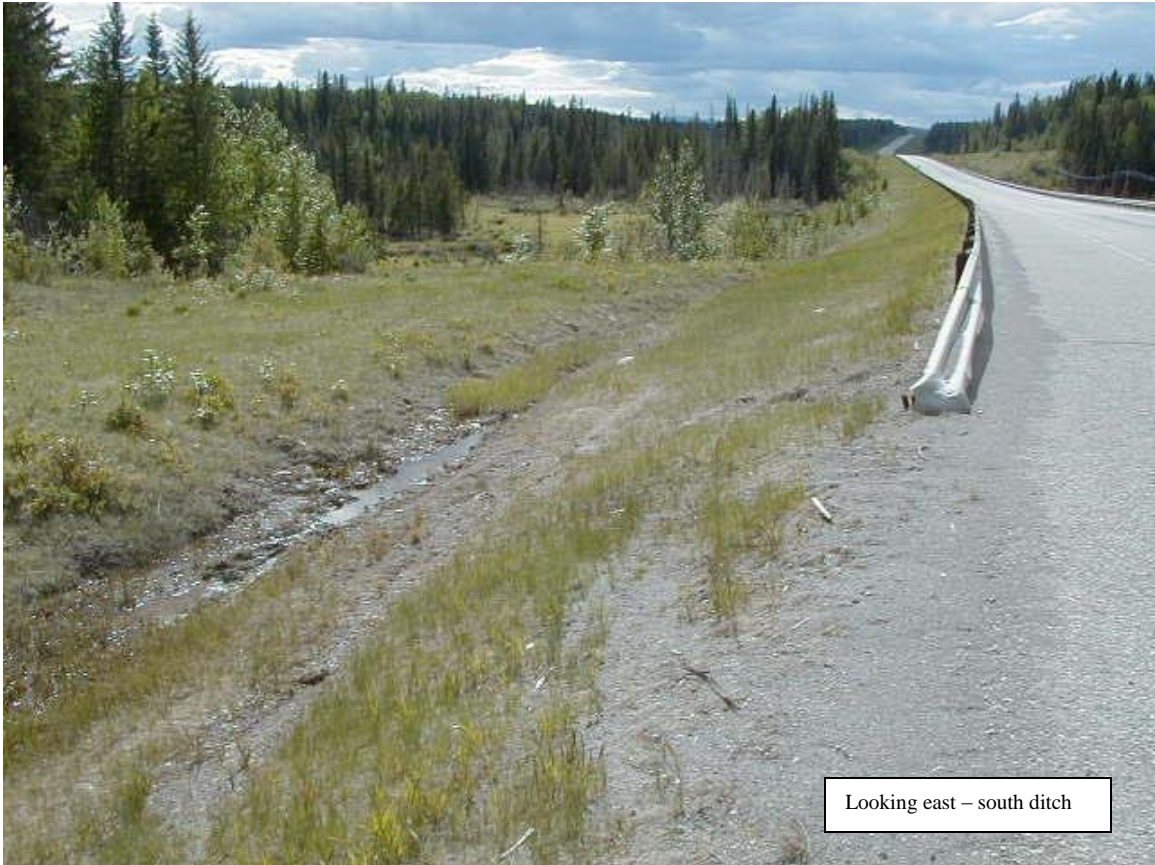
Looking east – south ditch

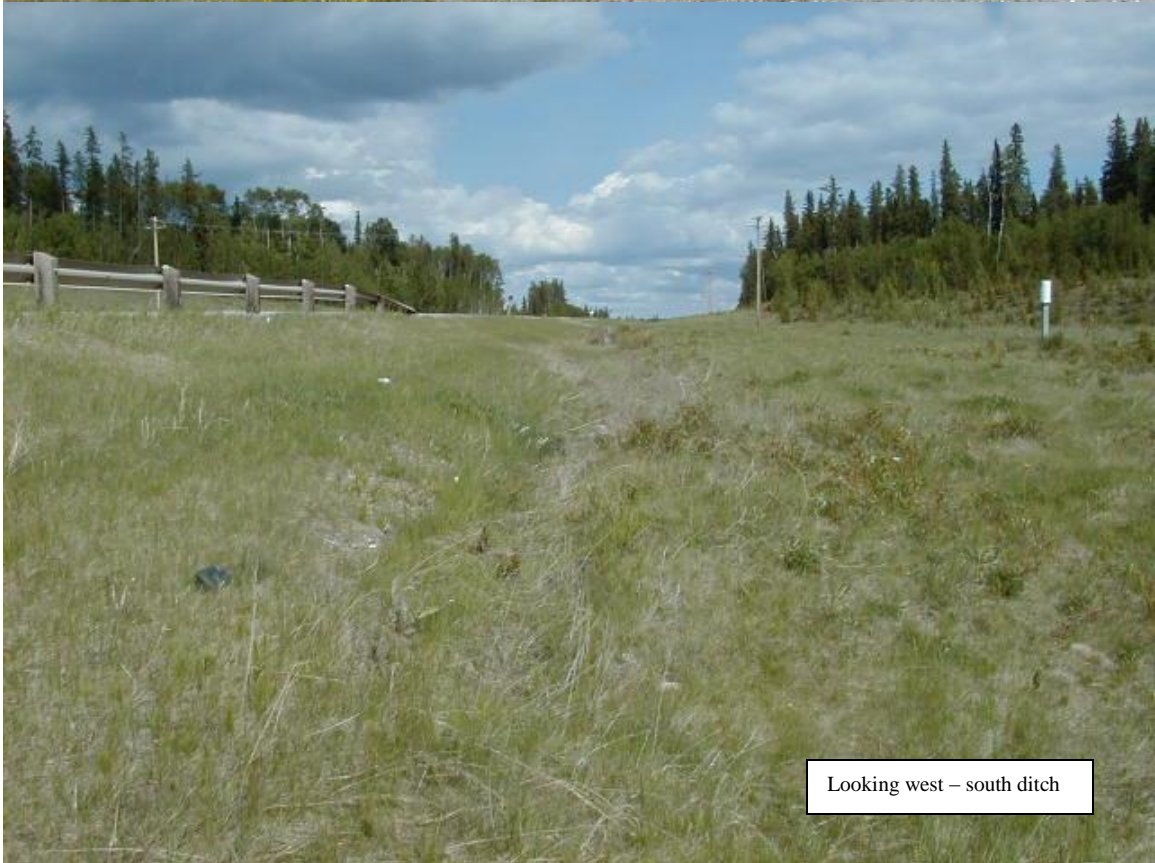
Looking west – south ditch

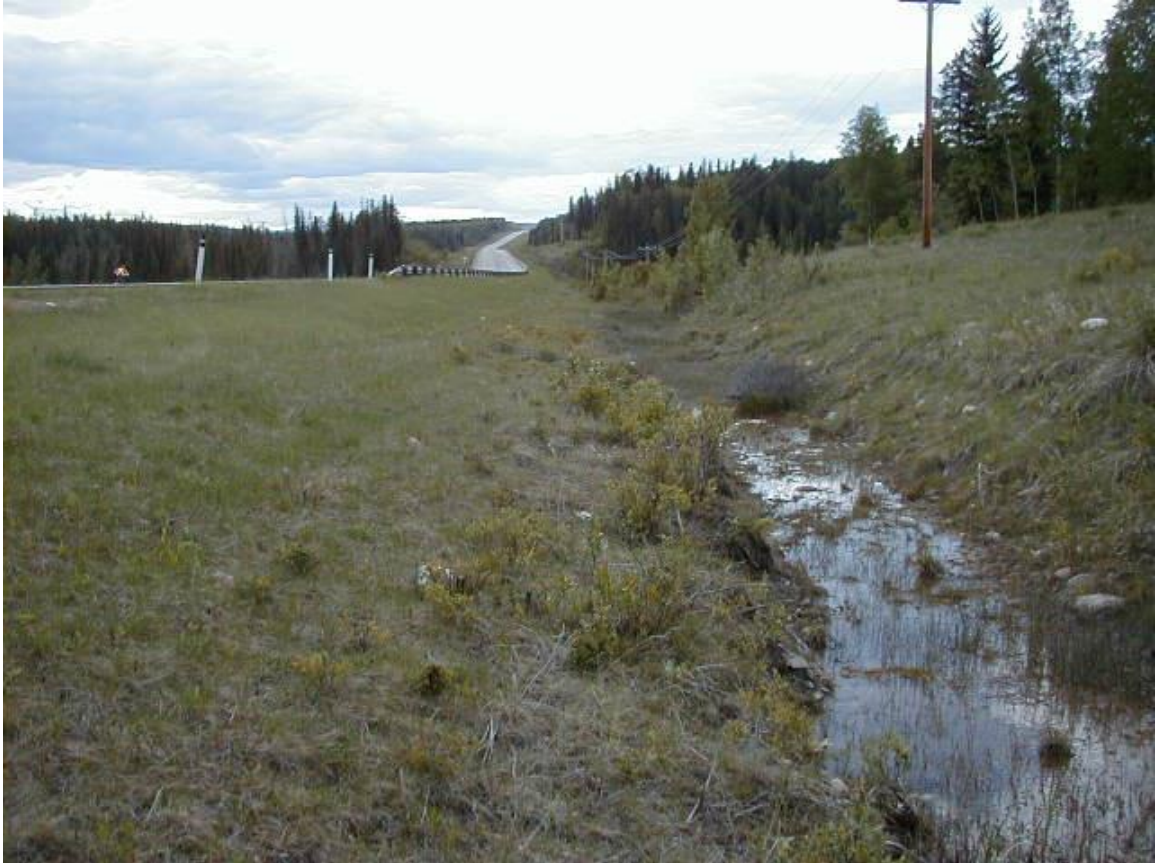
There is standing water in both ditches, but this is more noticeable in the north ditch. The ditches are also well vegetated that is also indicative of a high groundwater level. At least two damaged culvert ends were located in the north ditch, but no corresponding culvert ends in the south ditch could be located.

Standing water in north ditch

It is recommended that the drainage in the area be improved. The most practical way to achieve this is by the use of free-draining gravel filled french drains running in both ditches beside the highway. At the base of the drains, it is recommended that a filter fabric wrapped perforated PVC pipe (say, 150 mm diameter) be provided to reduce the risk of the drain clogging with fines. The gravel drain should be a minimum of 1 m wide by about 3 m deep below the ditch invert and should also be wrapped in geotextile filter

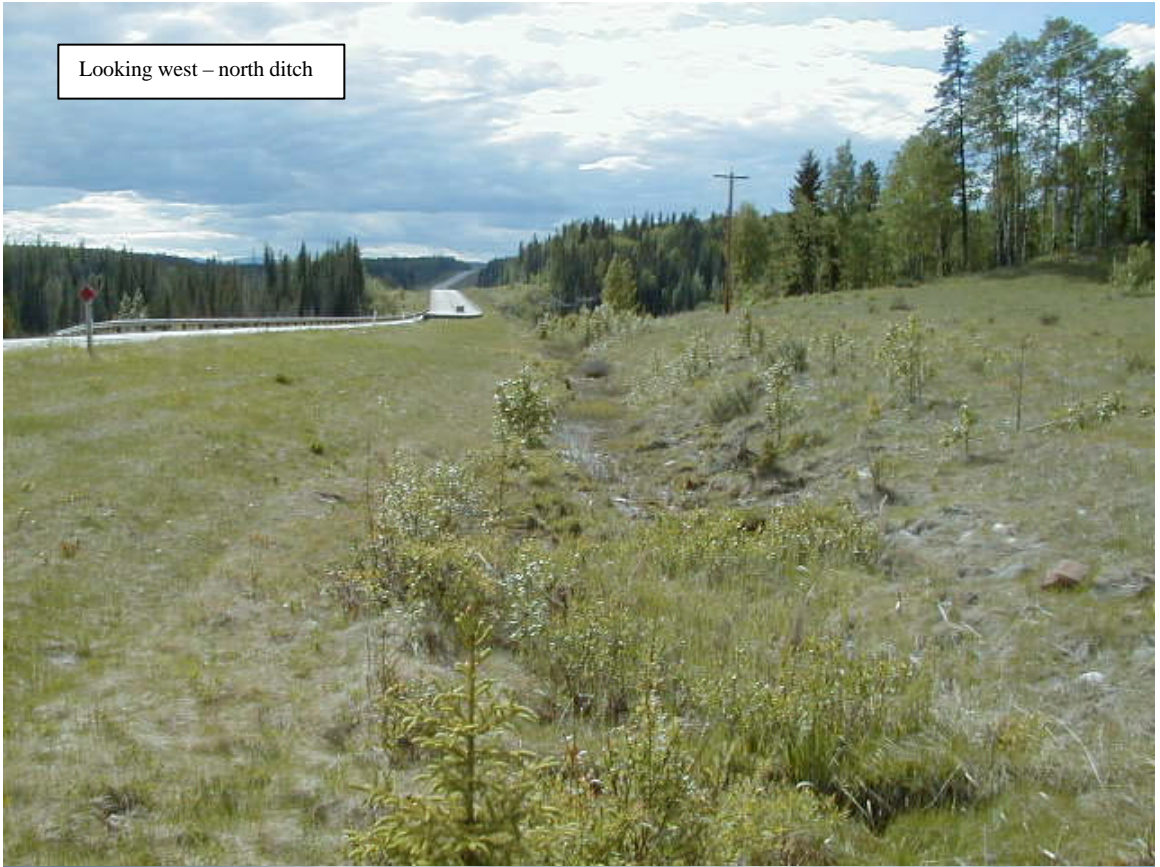
Looking west – north ditch

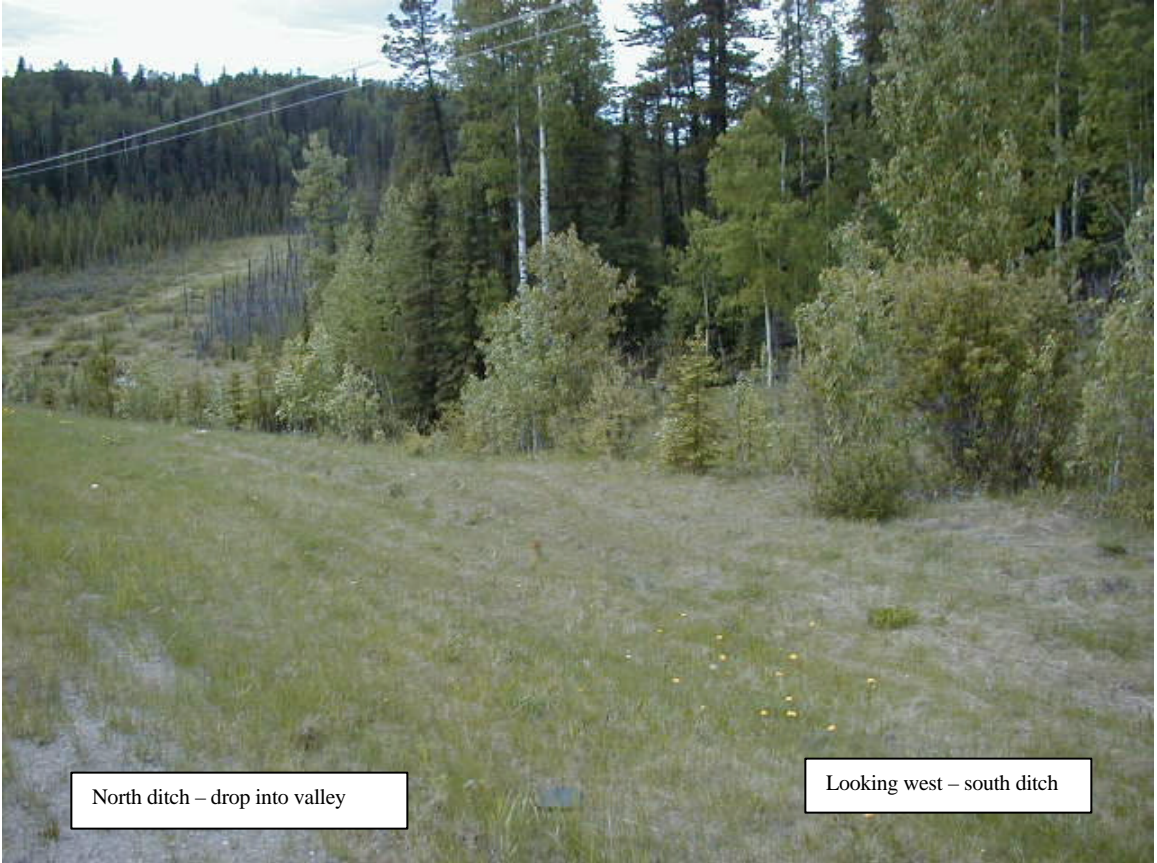
North ditch – drop into valley

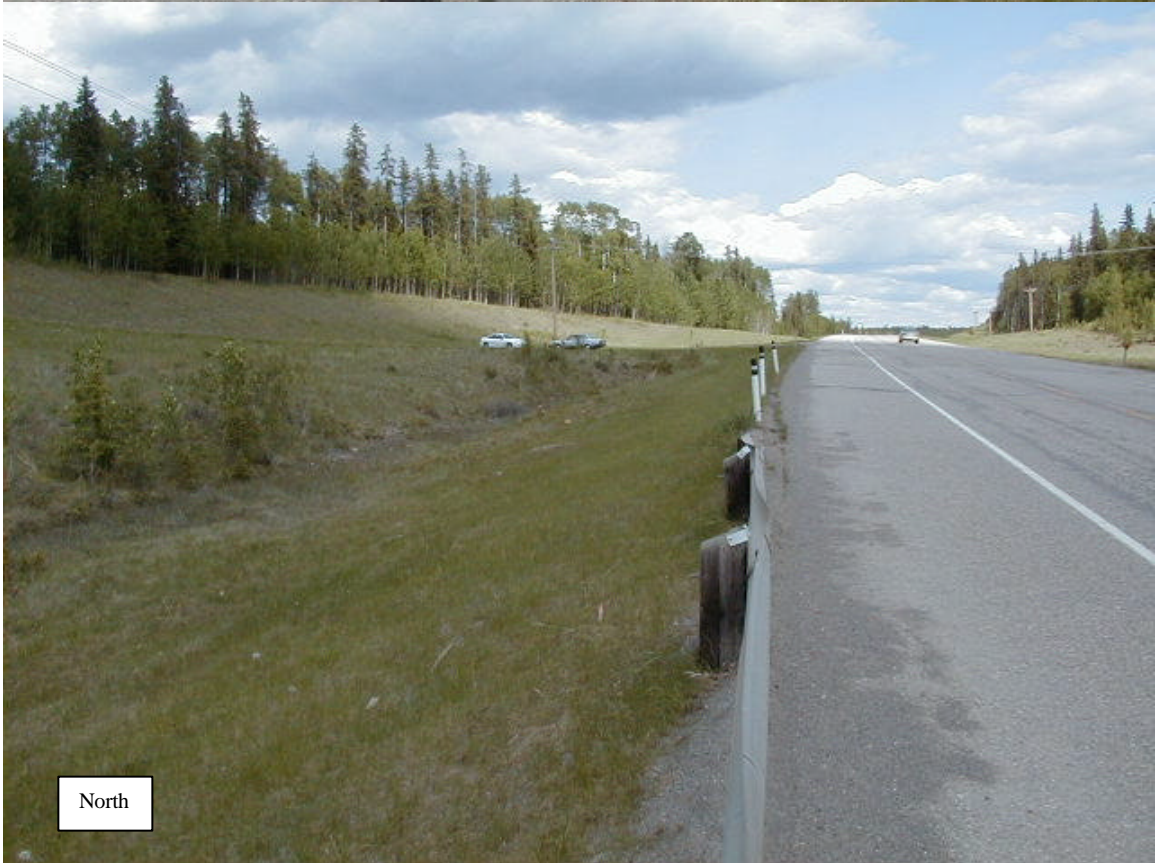
Standing water in north ditch
