**Central Region Landslide Assessment Site C16**  
**H11:08 Frost Heave @ Ch 17.6**  
**2002 Annual Inspection Report**

This report was prepared by Klohn Crippen Consultants Ltd. for Alberta Transportation Central Region under Contract No. CE053/2000.

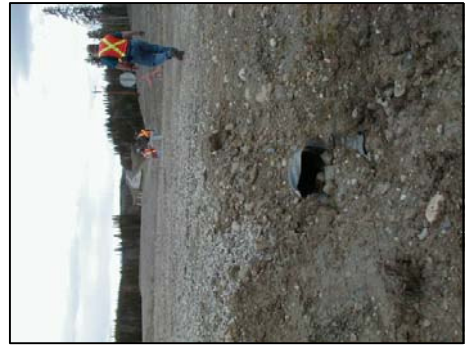
150 $\phi$  CULVERT

END PARTIALLY BLOCKED

The partially blocked culvert under the local road should be cleaned out.

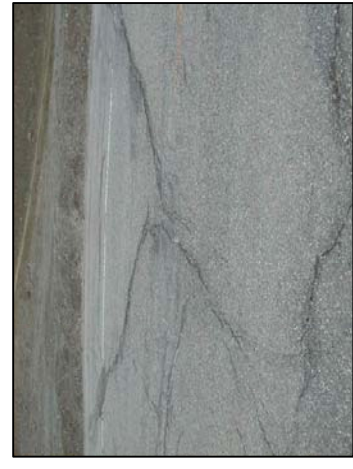
At Ch 17.6, the site is immediately east of a deep valley fill. Significant longitudinal and transverse cracks in the pavement extend over a length of highway of about 95 m and have necessitated a speed restriction with bump warning signs. There was one noticeable depression in the westbound lane of about 150 mm deep with radial cracks leading from it that has now been patched.

TYPICAL CRACKS IN PAVEMENT (SEE PHOTOS)

HOLE PATCHED

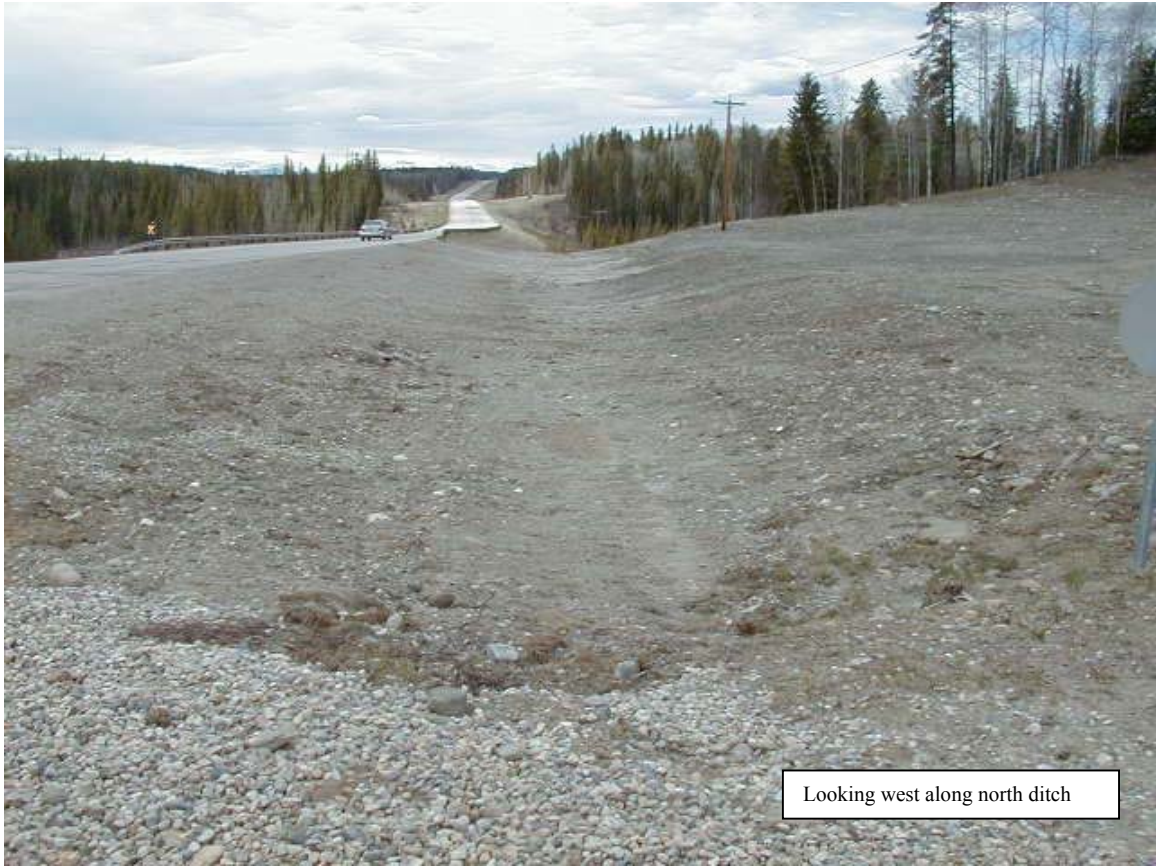
Looking west along north ditch

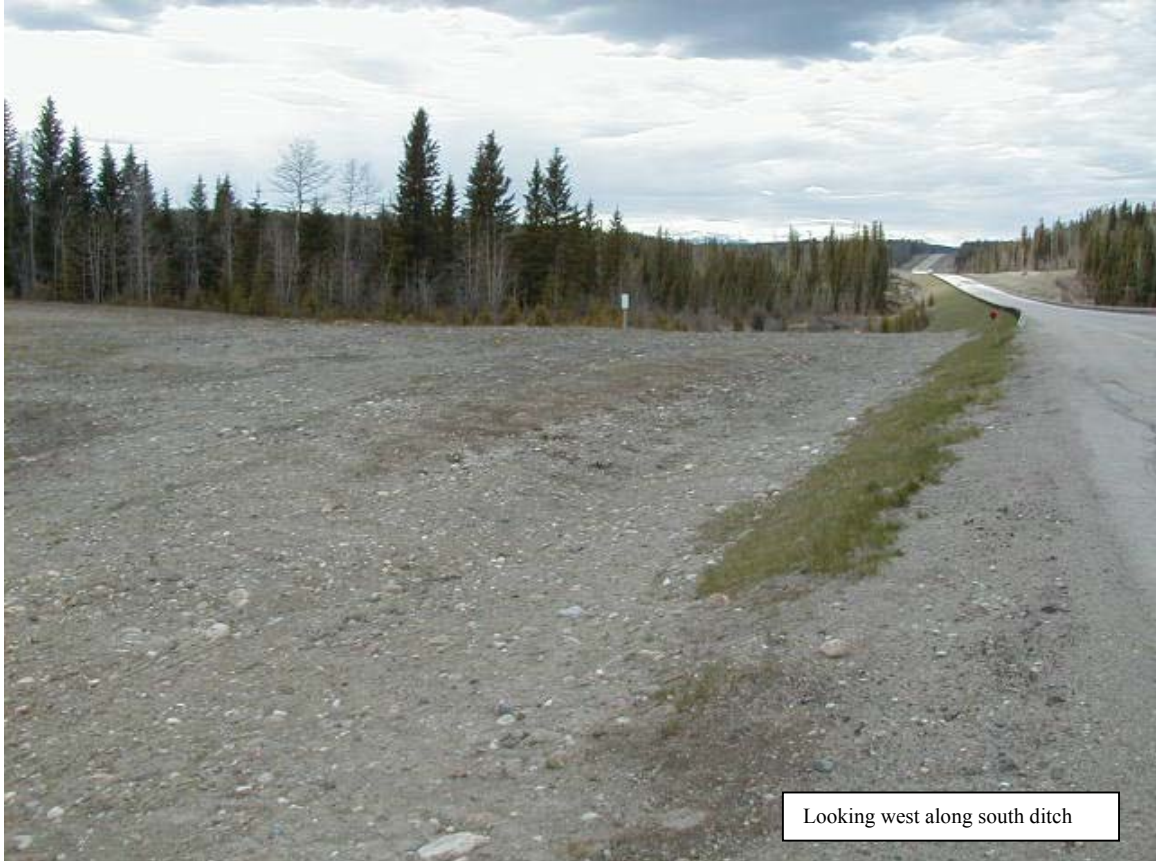
Looking west along south ditch

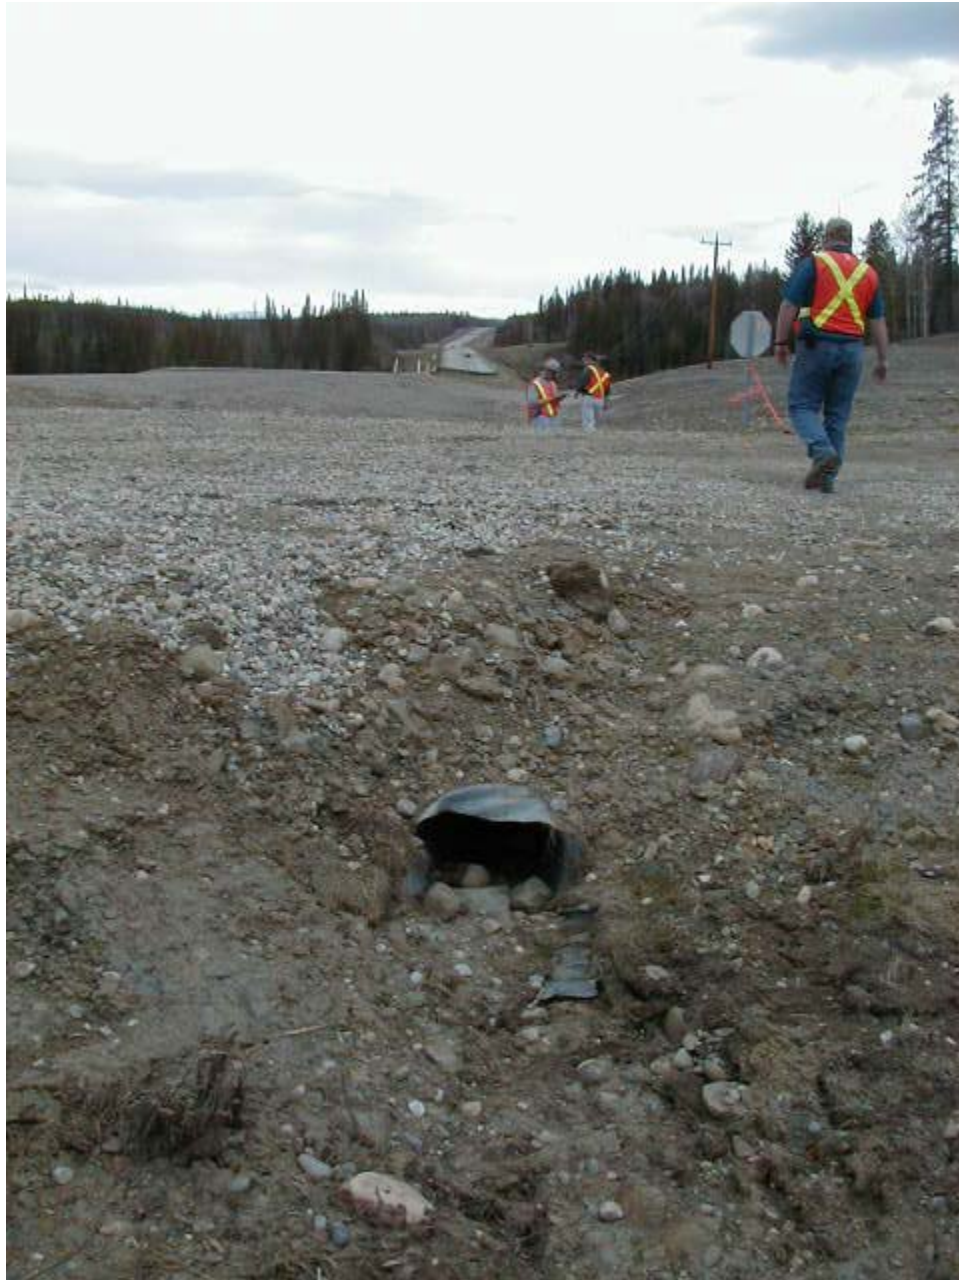
Looking west along north ditch from east of access road.  
Note partial blockage of culvert.

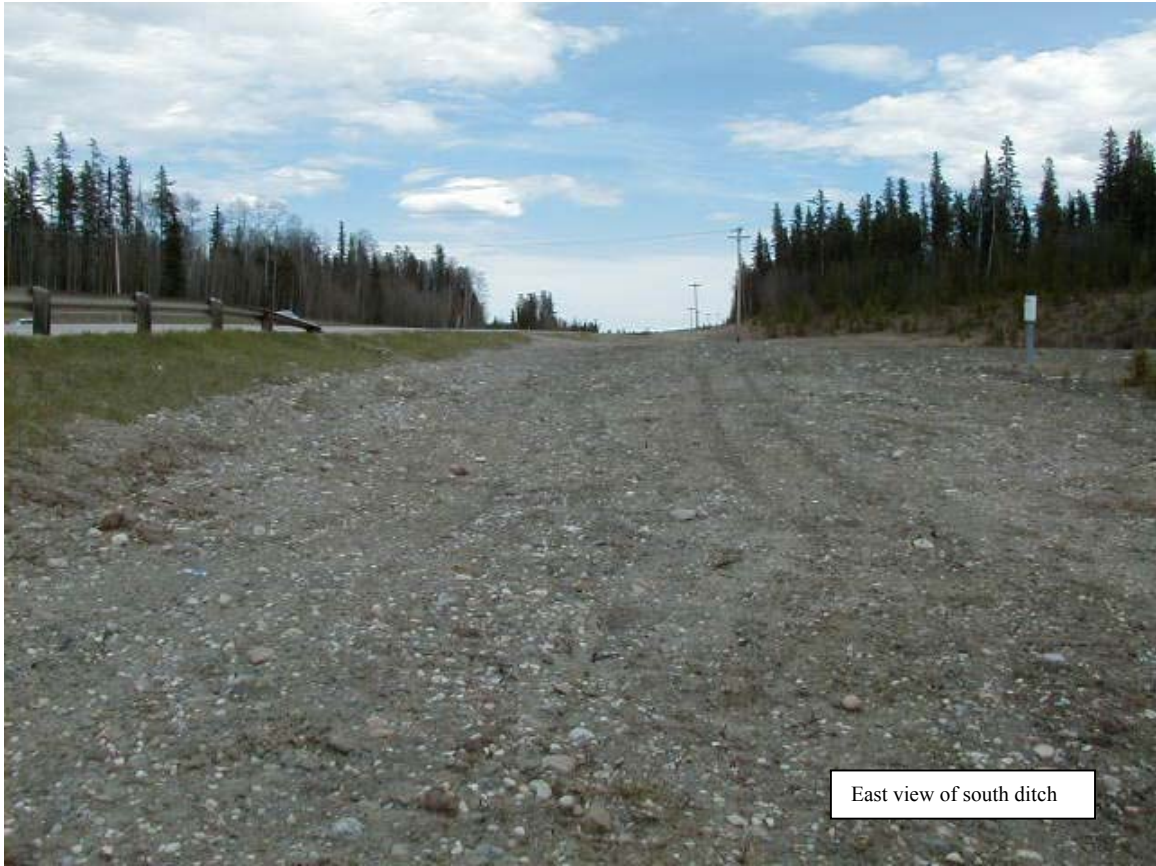
East view of south ditch

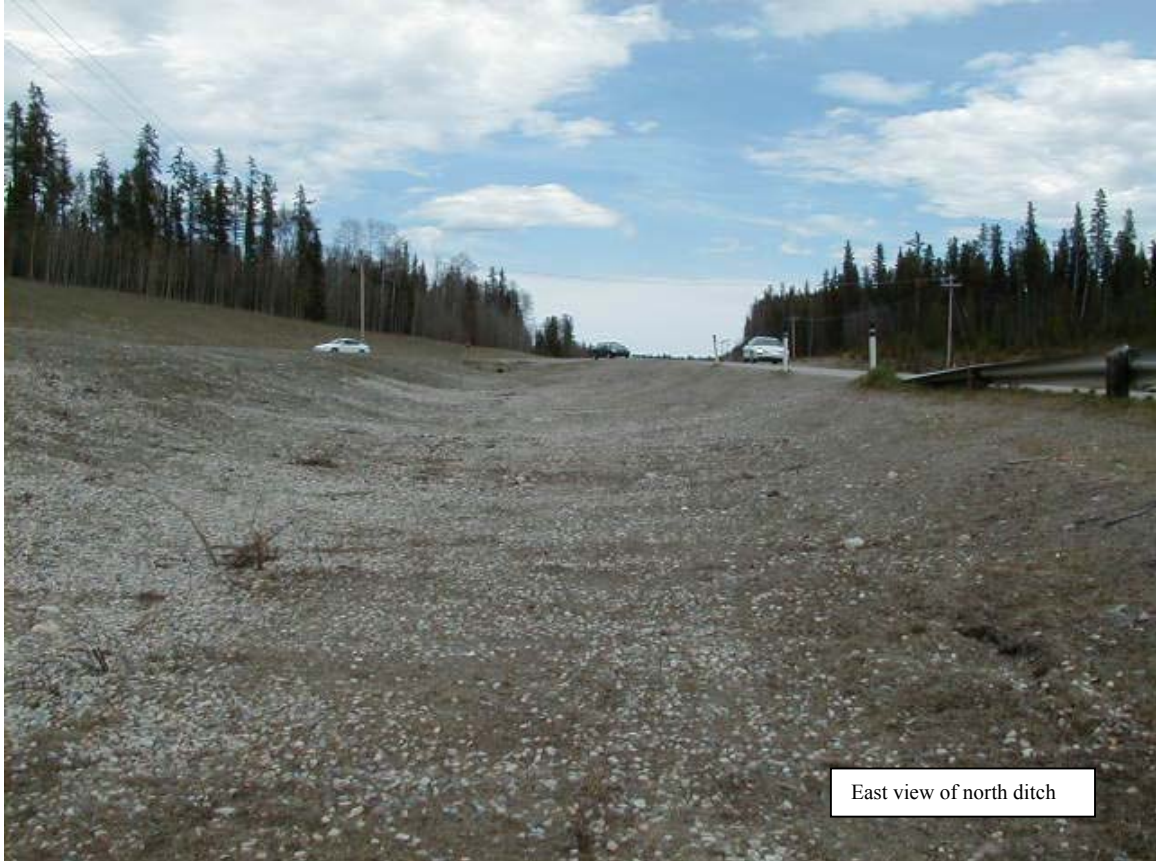
East view of north ditch
