SITE NUMBER AND NAME C27A H11:08 Embankment Slide		HIGHWAY & KM	PREVIOUS INSPECTION DATE June 18, 2012	INSPECTION DATE May 14, 2013
LEGAL DESCRIPTION NW 32-40-11-W5	NAD 83 COORDINATES N 5816691 E 598230		RISK ASSESMENT PF: 6 CF: 2 TOTAL: 12

Water Level (mbgl)																											
	2005	2006	2007	2010	2012																							
TH03-01	5.75	7.83	5.46	4.25	2.6																							
TH03-02	3.94	7.52	3.76	-	1.7																							
LAST READING DATE:																												
PRIMARY SITE ISSUE: <p align="center">Slide on highway embankment</p>																												
APPROXIMATE DIMENSIONS:																												
DATE OF ANY REMEDIAL ACTION:

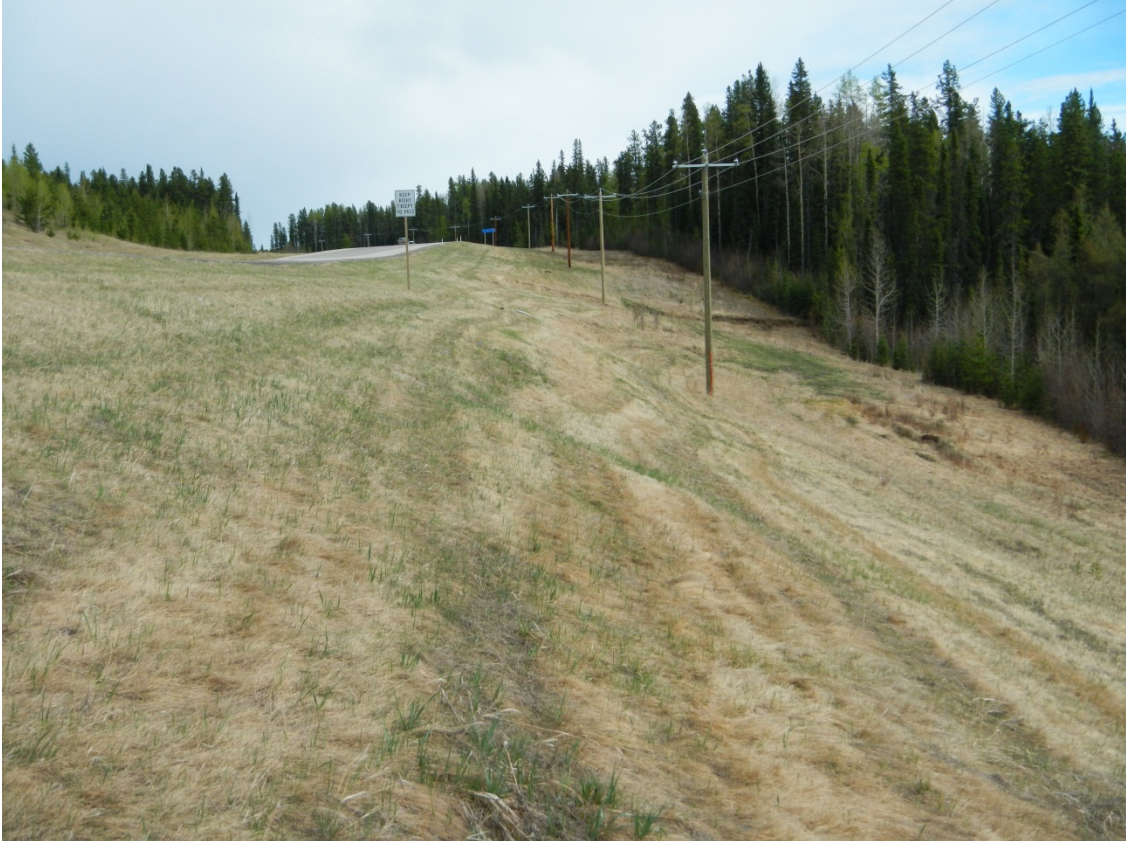
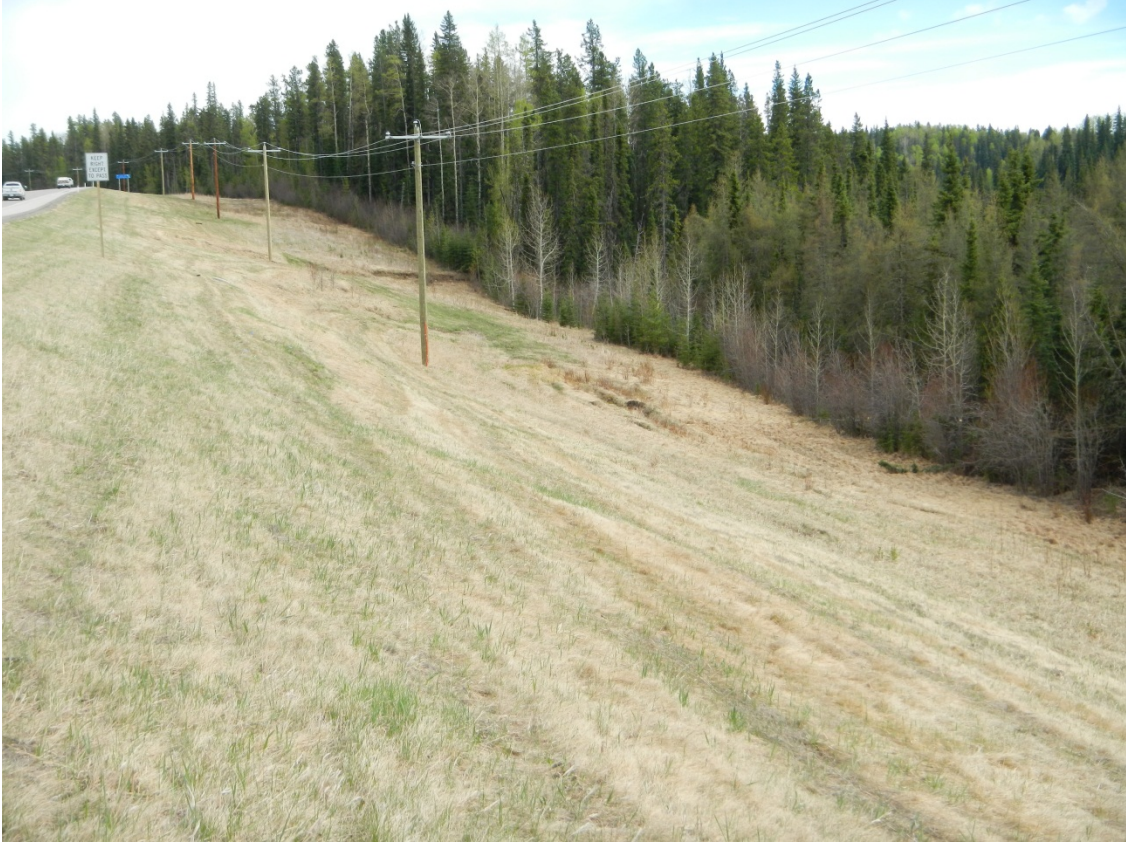
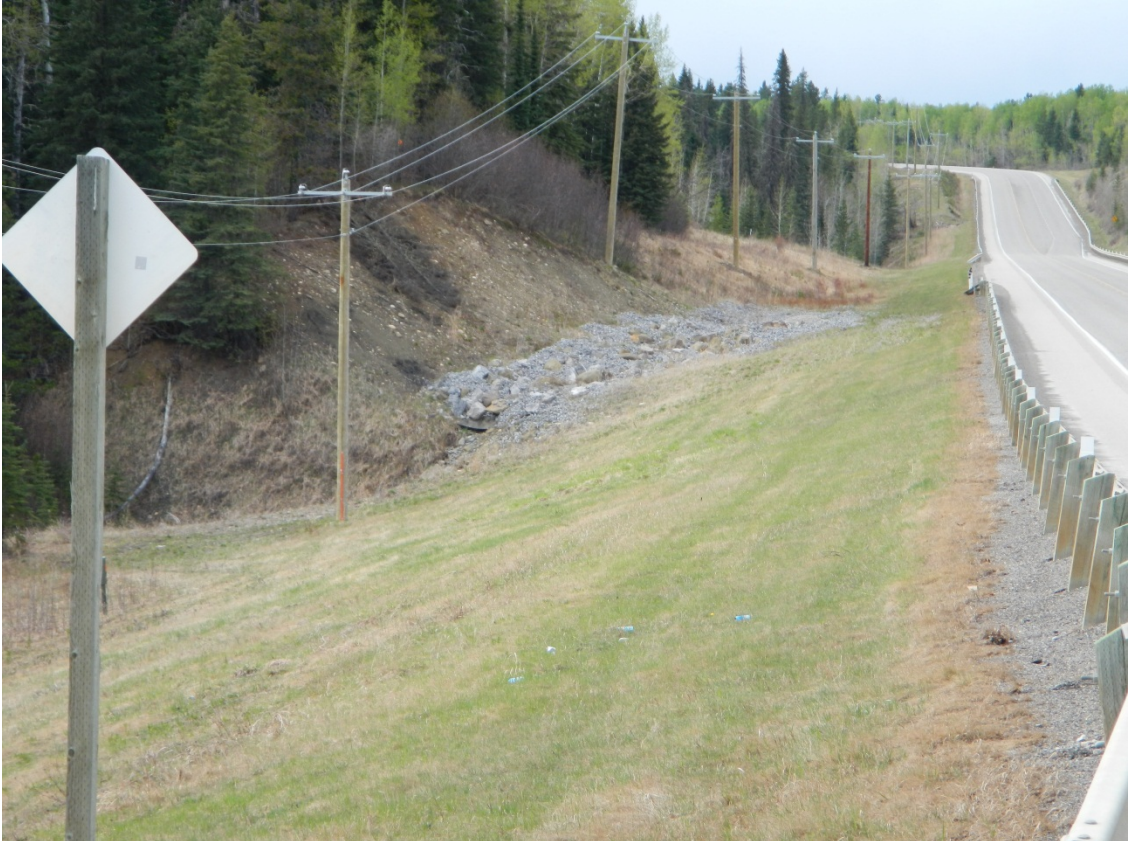
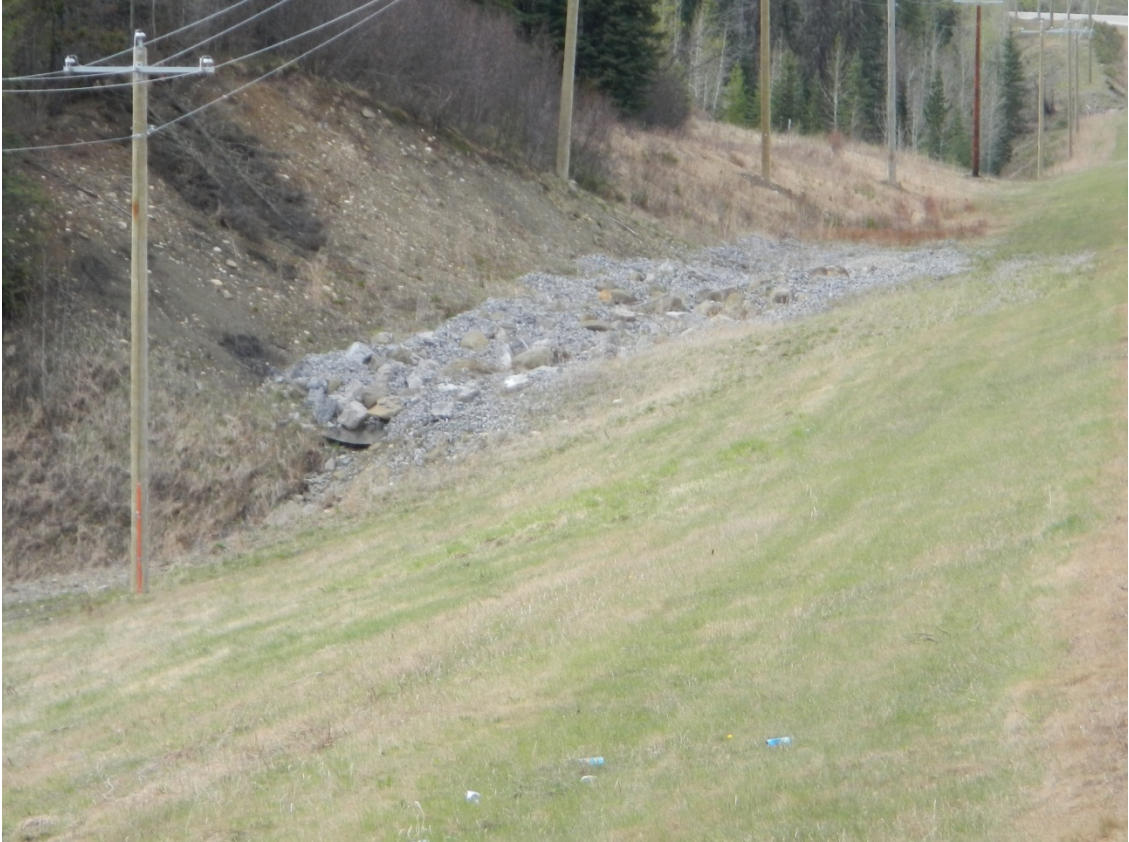
ITEM	CONDITION EXISTS		DESCRIPTION AND LOCATION	NOTICABLE CHANGE FROM LAST INSPECTION	
	YES	NO		YES	NO
Pavement Distress		X	Pavement overlay in 2003 – no cracks on highway		X
Slope Movement	X		Cracks and scarp on slope – no significant changes since 2011.		X
Erosion		X			X
Seepage		X			X
Culvert Distress		X			X

Slide is likely related to the relatively high water levels within the fill, likely associated with seepage from the high ground to the northeast. Seepage zones (indicated by vegetation growth) are apparent on the slope and coincide with the movement zones.

MCI to monitor – remove from Geohazard program.
