SITE NUMBER AND NAME C27B H11:08 Erosion		HIGHWAY & KM	PREVIOUS INSPECTION DATE June 18, 2012	INSPECTION DATE
LEGAL DESCRIPTION NW 32-40-11-W5	NAD 83 COORDINATES N 5816691 E 598230		RISK ASSESMENT PF: 1 CF: 1 TOTAL: 1

LAST READING DATE:	
PRIMARY SITE ISSUE: A storm event in June 2007 blocked a culvert upstream. Significant flows were passed along the ditch, causing erosion and wash out of the slope above the culvert.	
APPROXIMATE DIMENSIONS:	
DATE OF ANY REMEDIAL ACTION: Summer 2008

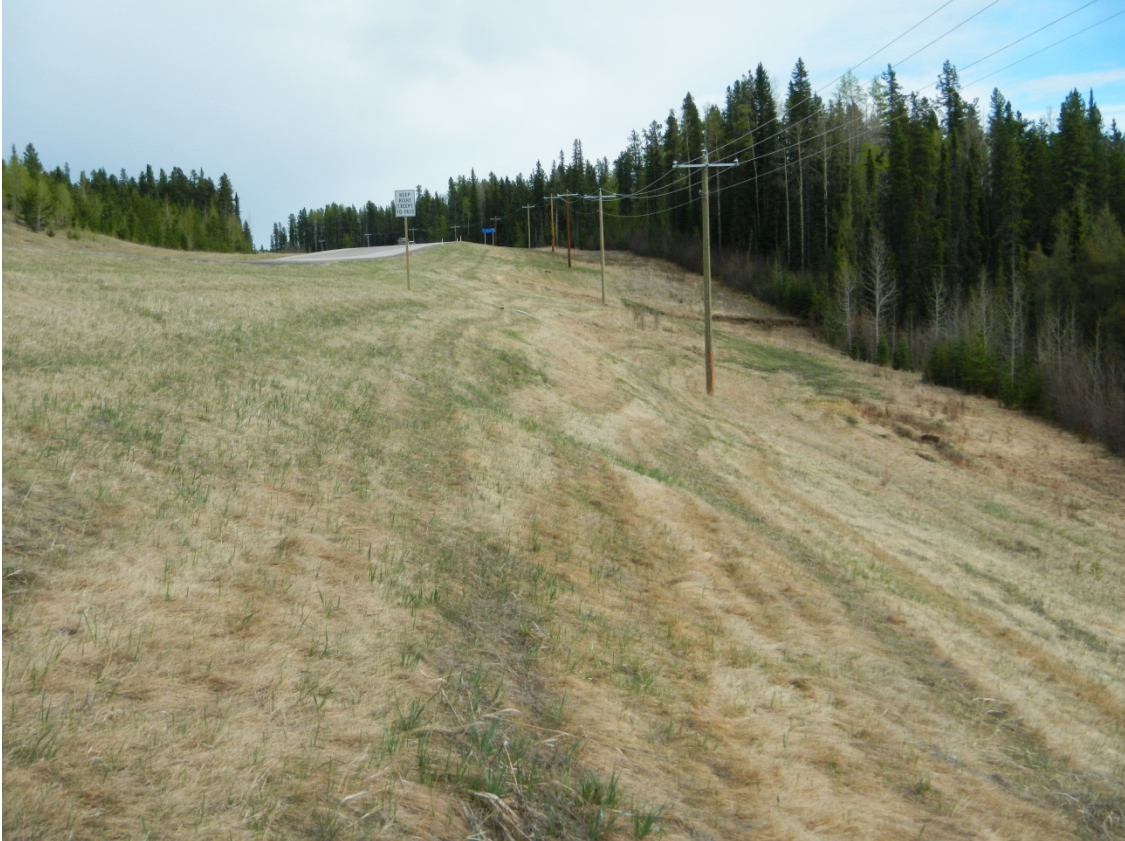
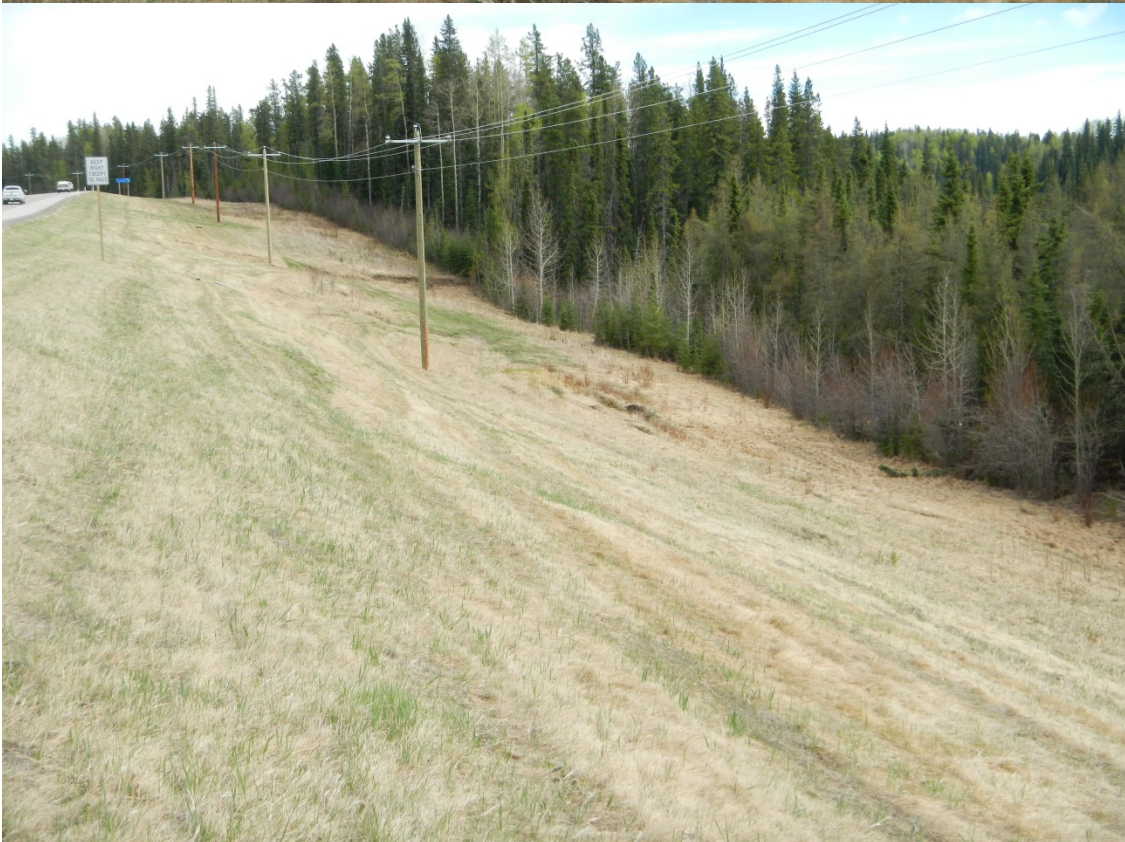
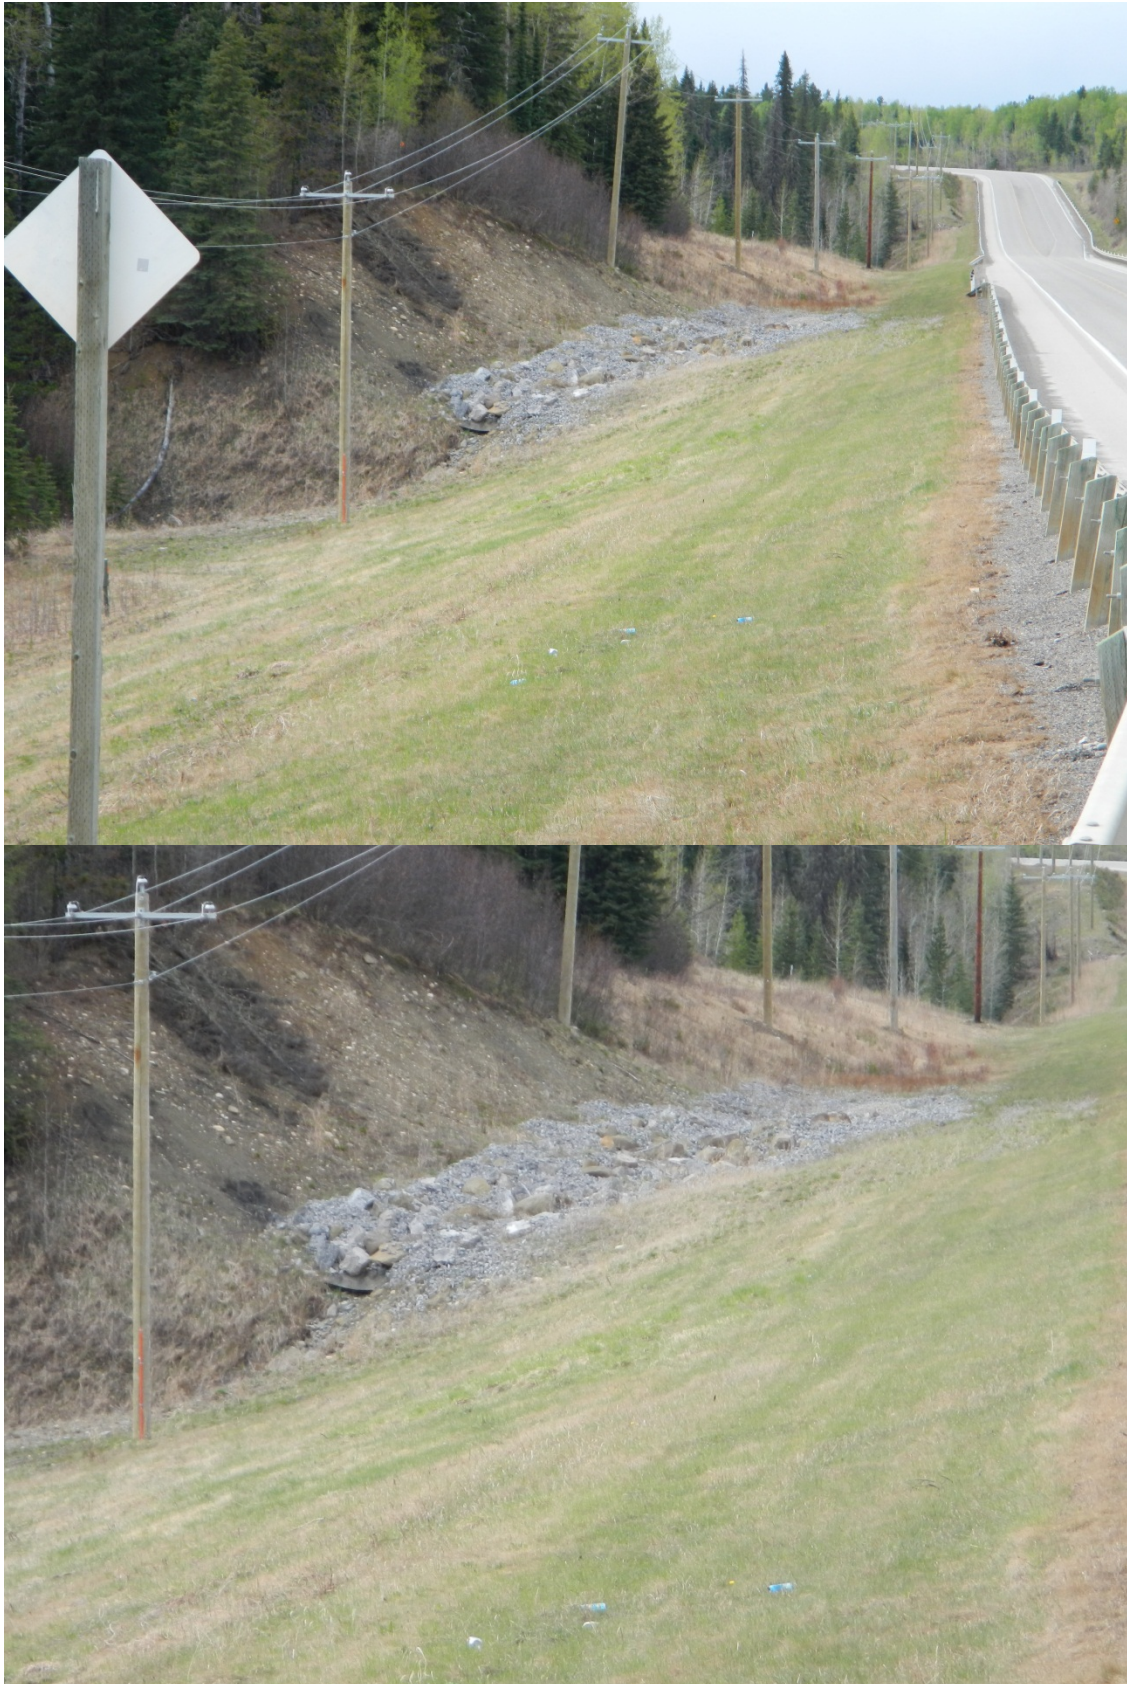
ITEM	CONDITION EXISTS		DESCRIPTION AND LOCATION	NOTICABLE CHANGE FROM LAST INSPECTION	
	YES	NO		YES	NO
Pavement Distress		X		X	
Slope Movement		X		X	
Erosion		X	Ditch and slope eroded. No further erosion since storm event and subsequent repairs.	X	
Seepage		X		X	
Culvert Distress		X		X

The ditch slope was protected with riprap and the slope above the culvert was re-graded and vegetation is now growing. The site appears to be performing well.

Remove from program.
