CENTRAL REGION GEOHAZARD RISK ASSESSMENT SITE INSPECTION FORM

C27A H11:08 Embankment Slide			INSPECTION DATE May 14, 2013 May 20, 2014				_		
LEGAL DESCRIPTION	NAD 83 COORD	INATES	RISK	ASSE	SMENT	Γ			
NW 32-40-11-W5	N 5816691 E	598230	PF:	6	CF:	2	TOTAL:	12

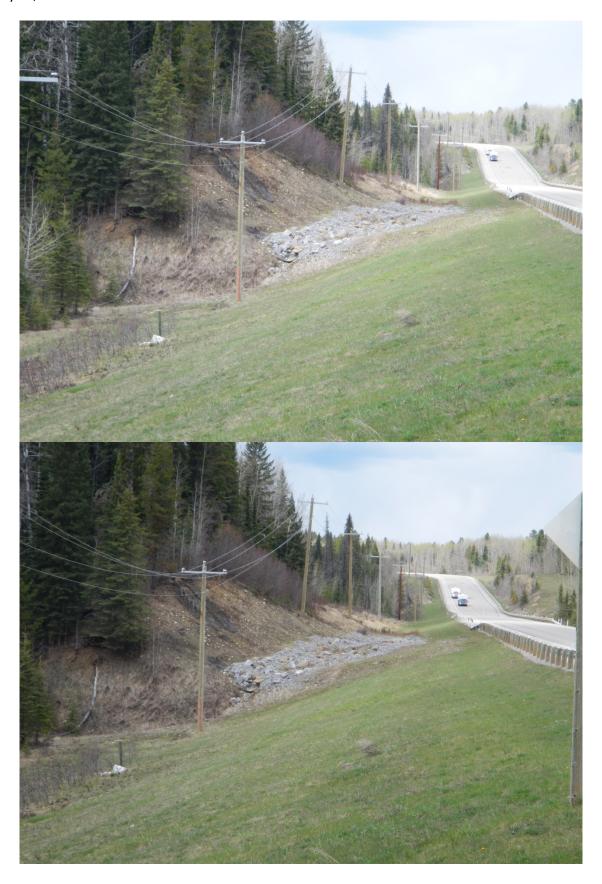
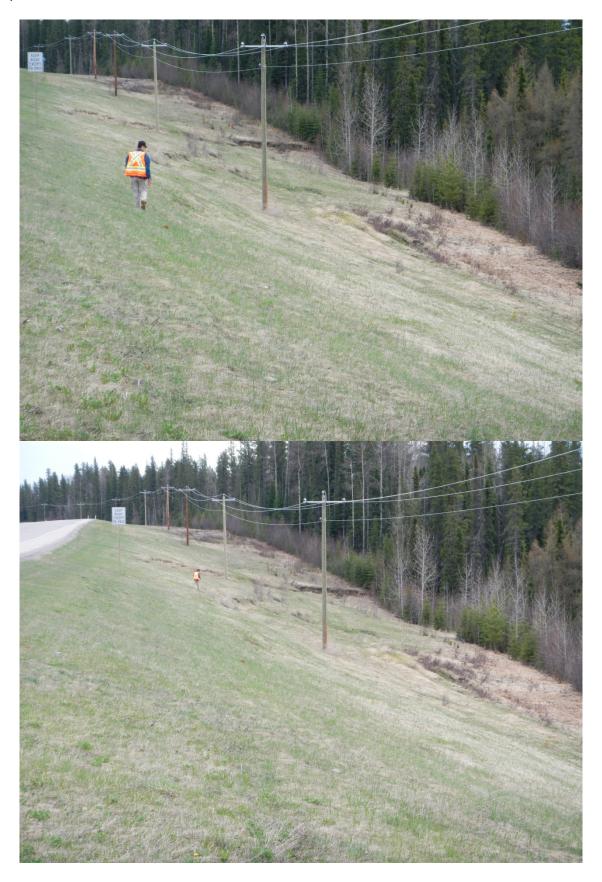
ITEM	CONDITION EXISTS		DESCRIPTION AND LOCATION		NOTICABLE CHANGE FROM LAST INSPECTION	
	YES	NO		YES	NO	
Pavement Distress		Х	Pavement overlay in 2003 – no cracks on highway		Χ	
Slope Movement	Х		Cracks and scarp on slope – no significant changes since 2011.		Χ	
Erosion		Х			Χ	
Seepage		Х			Х	
Culvert Distress		Х			Χ

Slide is likely related to the relatively high water levels within the fill, associated with seepage from the high ground to the northeast. Seepage zones (indicated by vegetation growth) are apparent on the slope and coincide with the movement zones.

MCI to monitor – remove from Geohazard program.
