SITE NUMBER AND NAME C09 H11:10 Gabion Wall		HIGHWAY & KM 5.1	PREVIOUS INSPECTION DATE May 14, 2013	INSPECTION DATE May 20, 2014
LEGAL DESCRIPTION SE 4-40-7-W5	NAD 83 COORDINATES N 5808420 E 640245		RISK ASSESMENT PF: 9 CF: 1 TOTAL: 9

LAST READING DATE:	
PRIMARY SITE ISSUE: Ditch Instability	
APPROXIMATE DIMENSIONS:	
DATE OF ANY REMEDIAL ACTION: Failed gabion wall rebuilt and ditch slopes flattened Oct 2002	
Live stakes and wattles installed in Fall 2003.

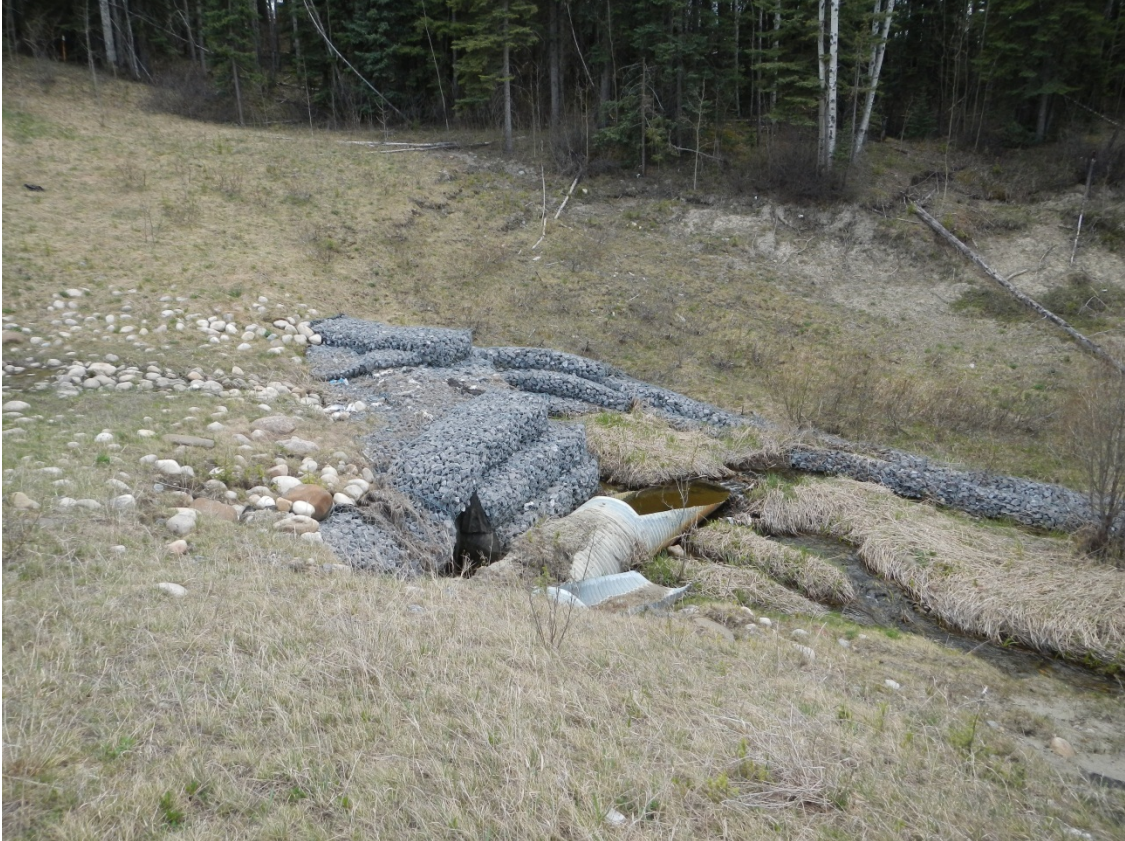
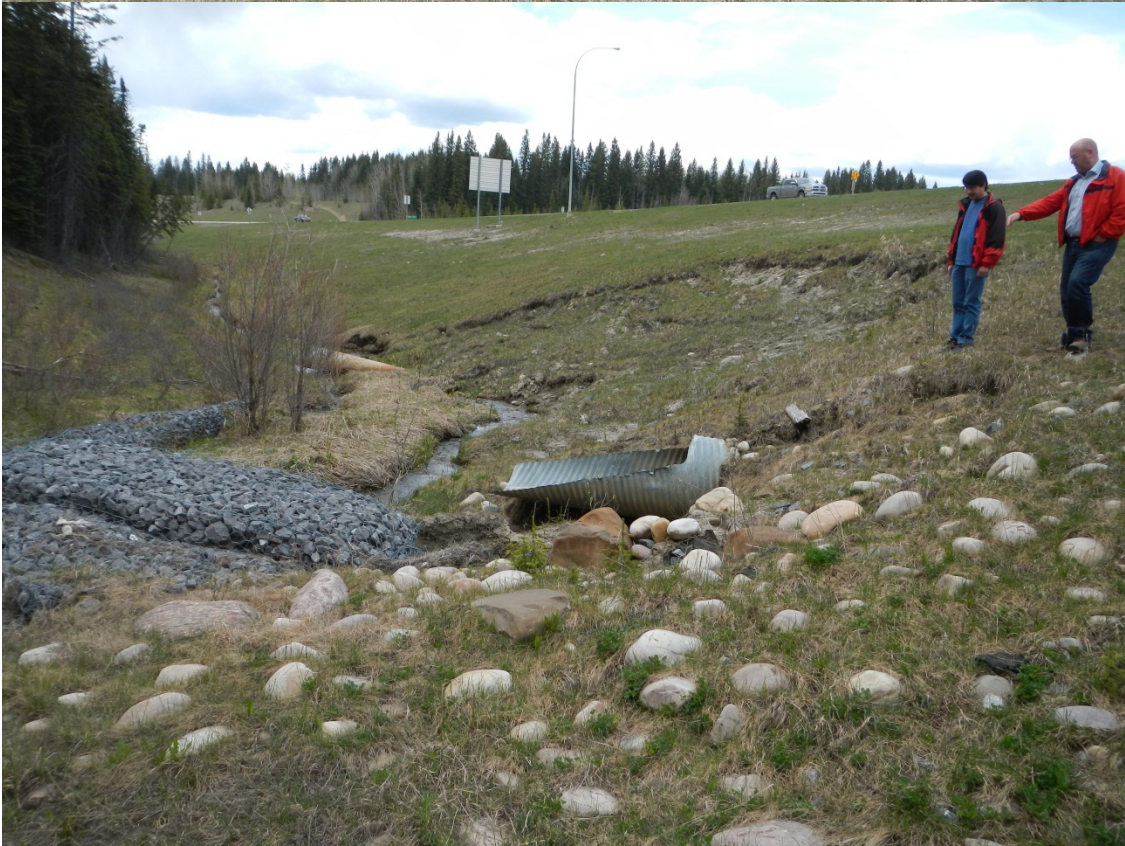
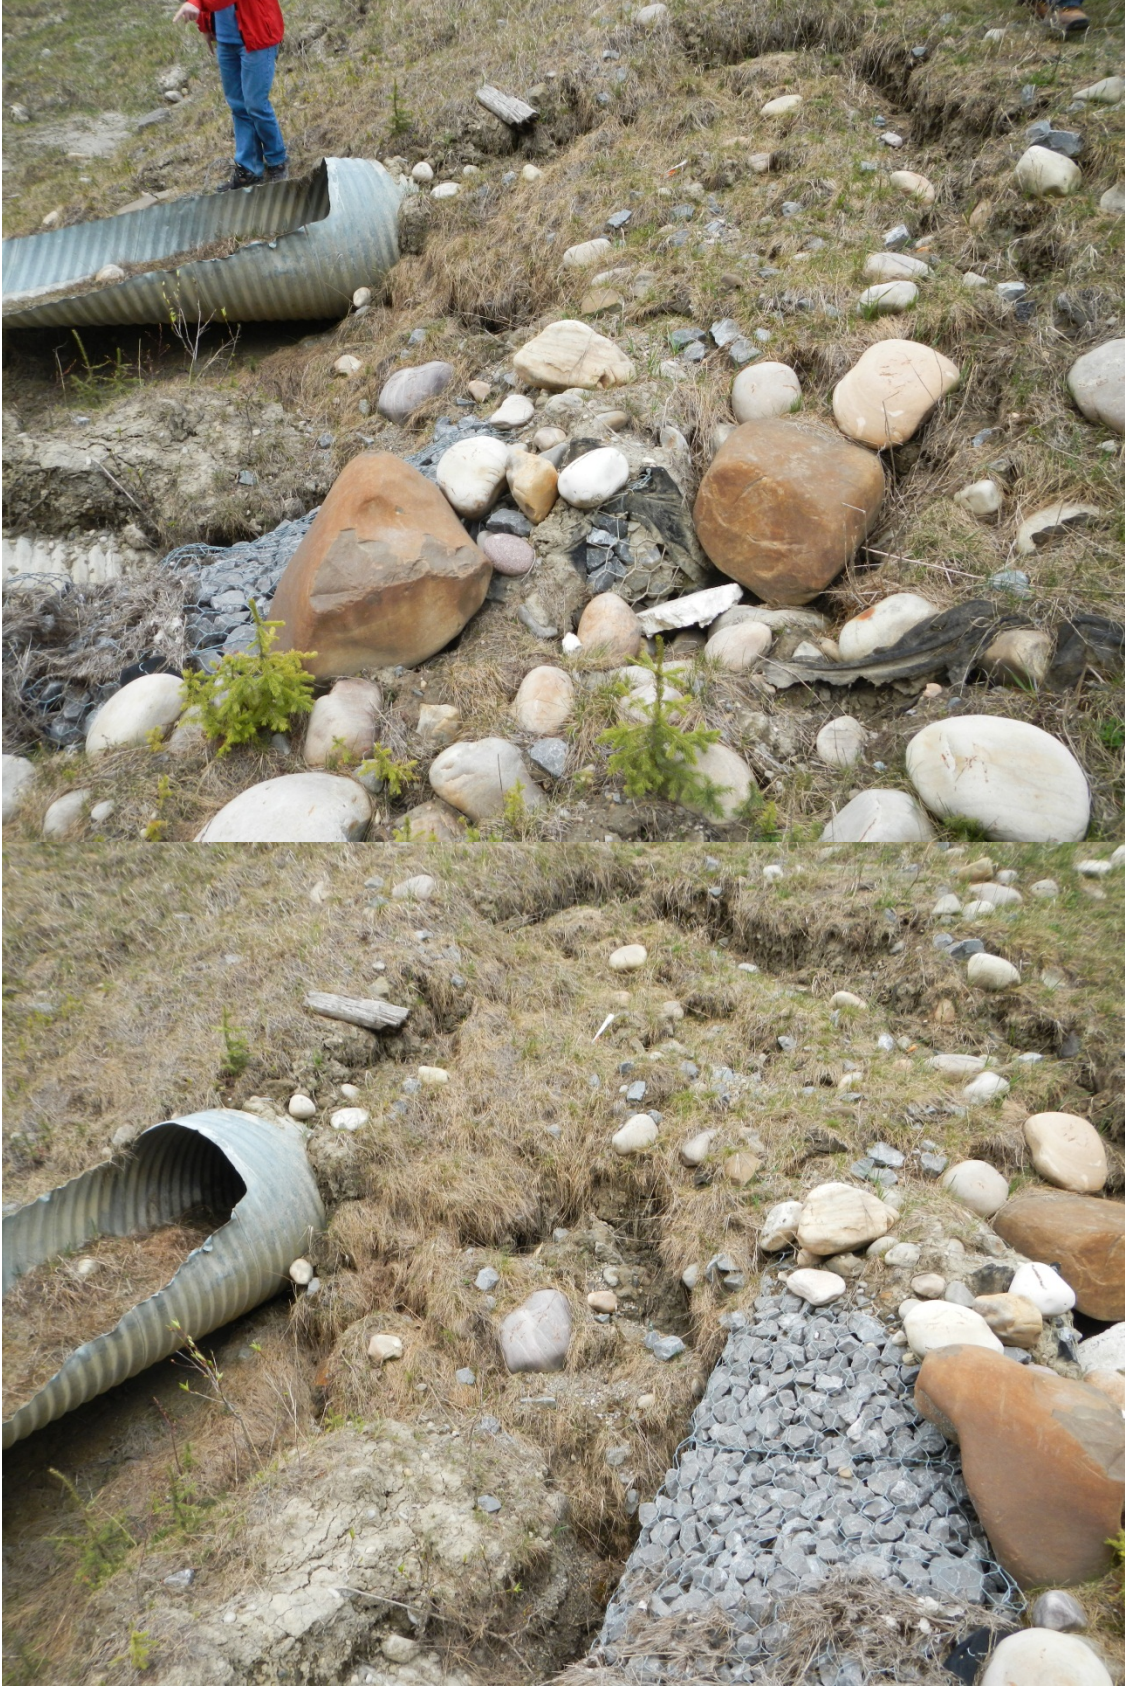
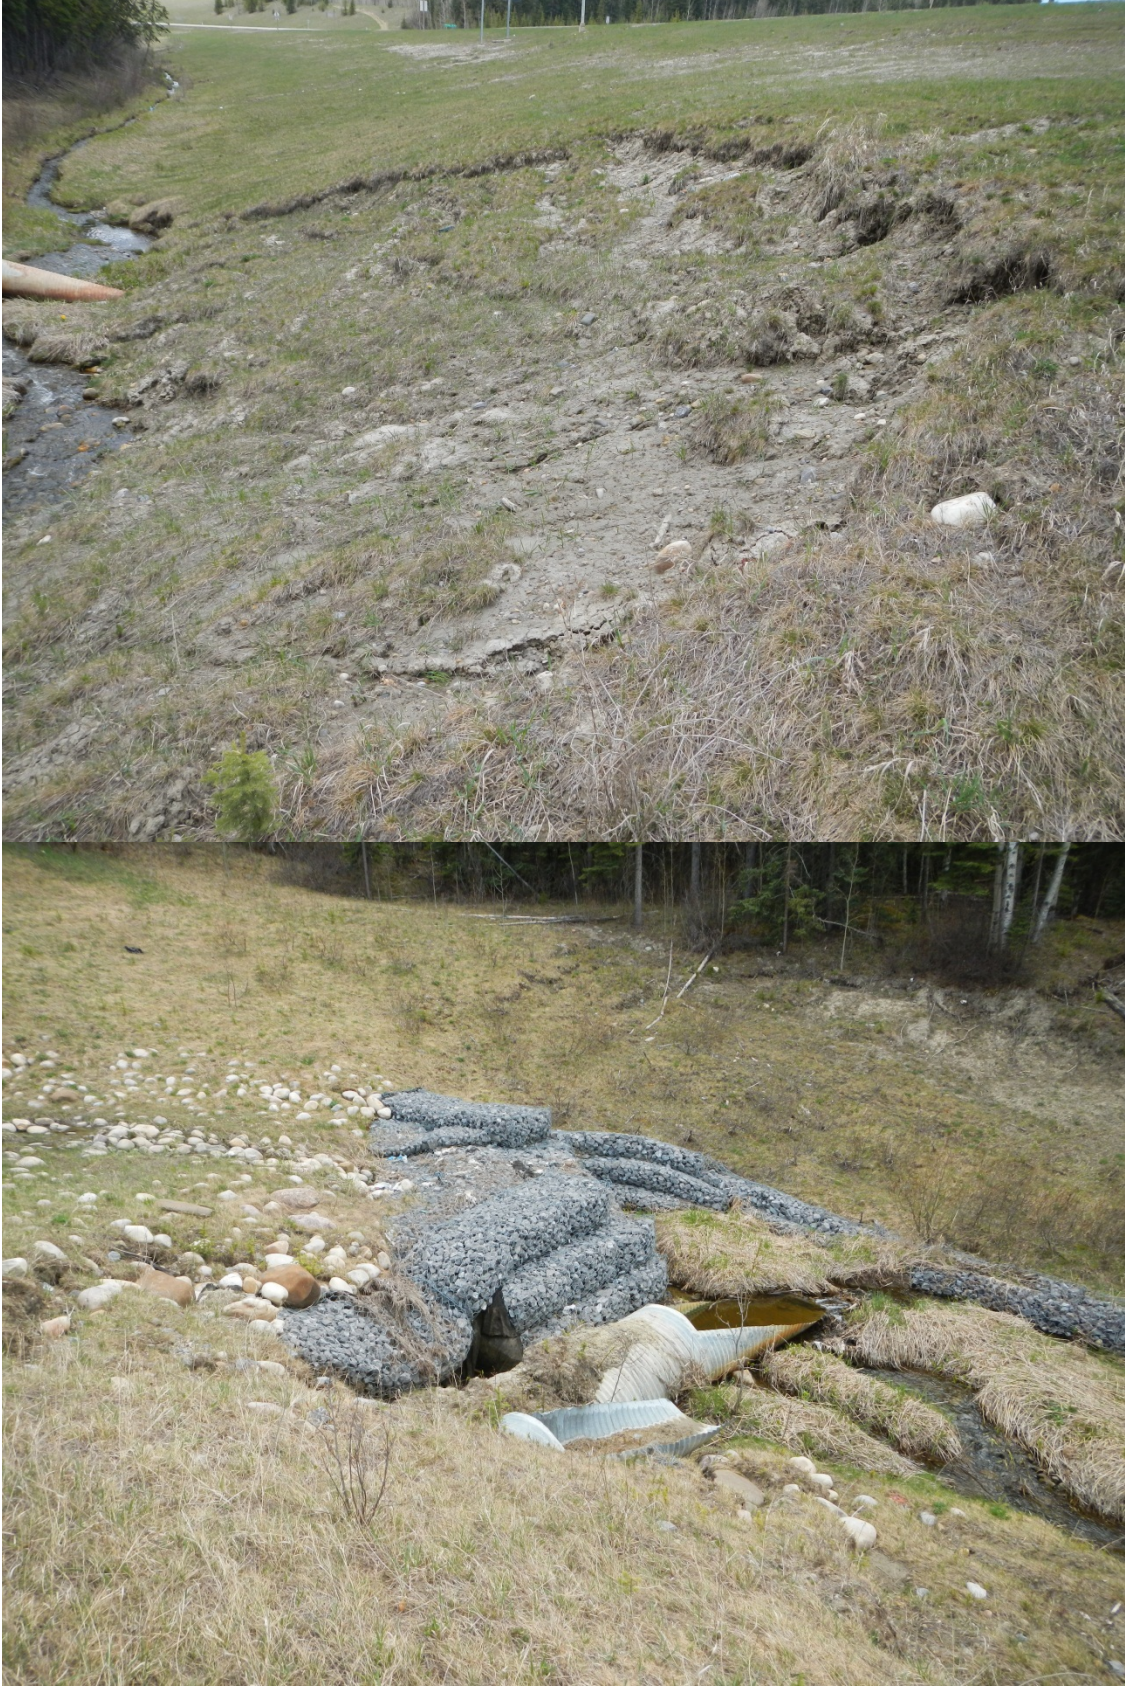
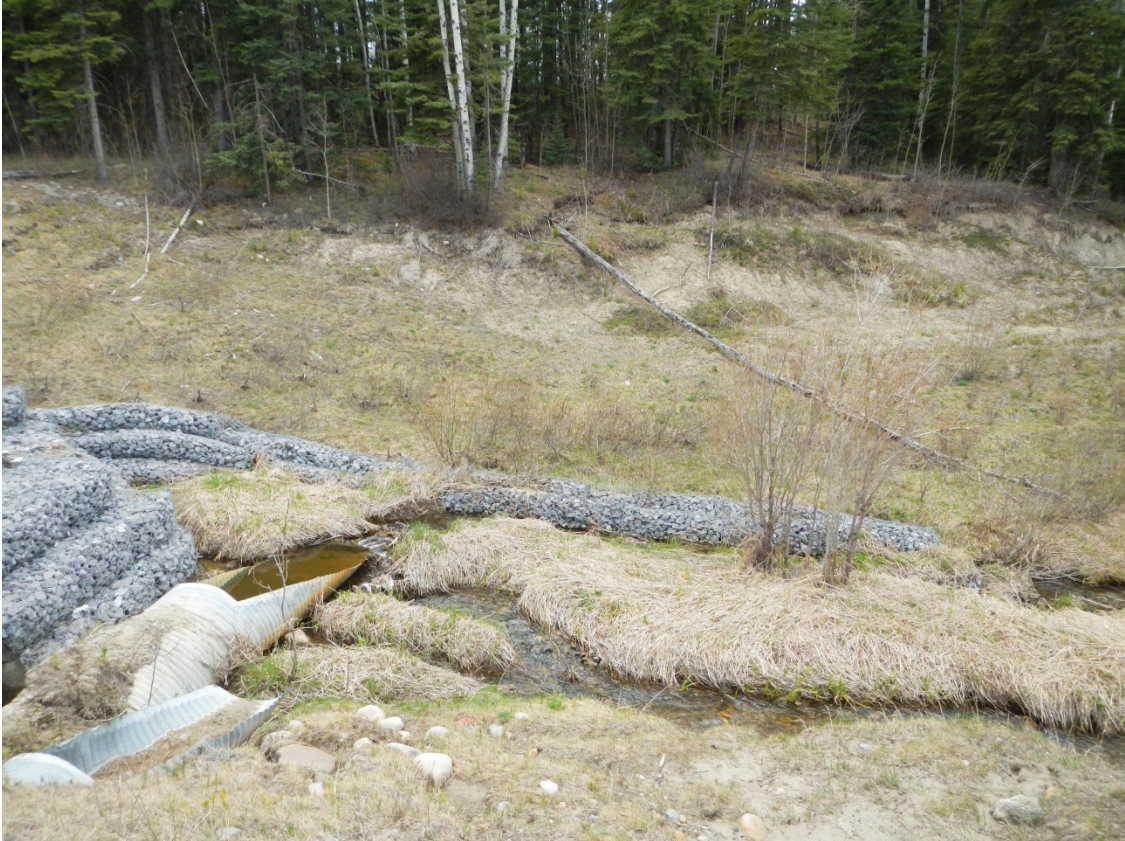
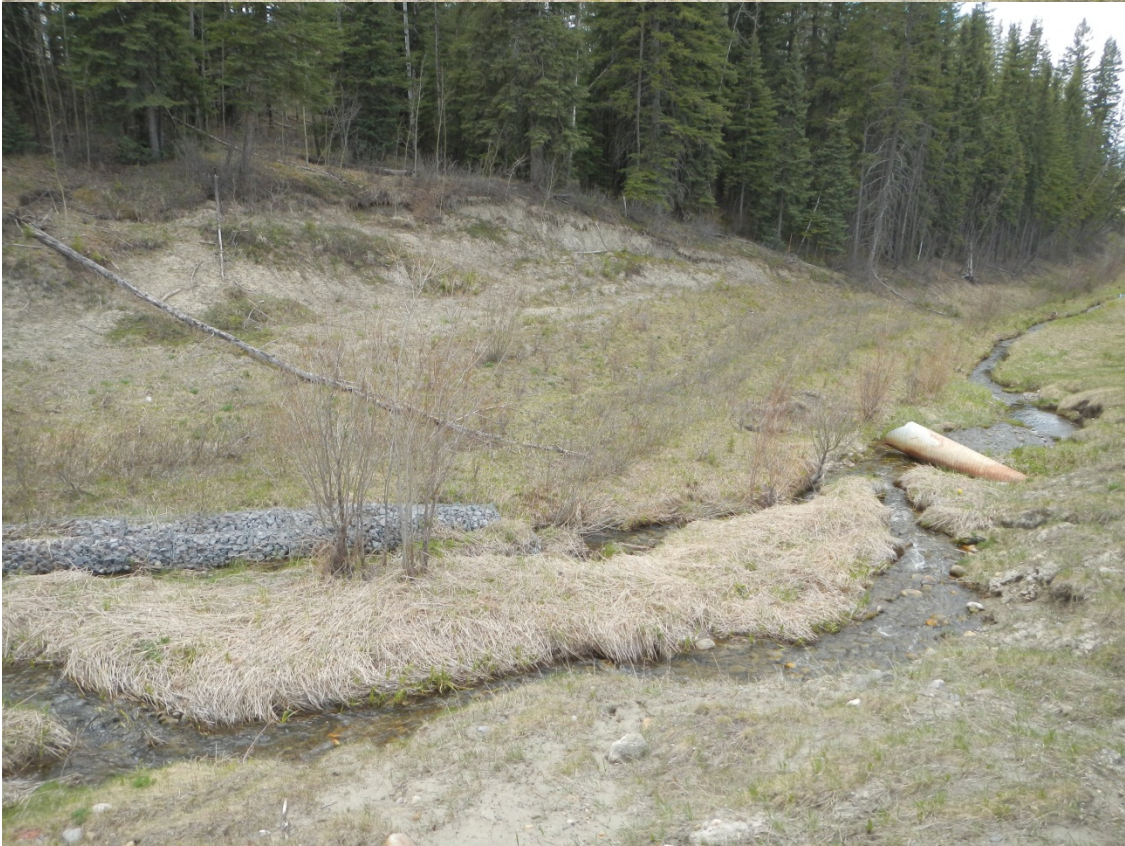
ITEM	CONDITION EXISTS		DESCRIPTION AND LOCATION	NOTICABLE CHANGE FROM LAST INSPECTION	
	YES	NO		YES	NO
Pavement Distress		X	The slumping of the ditch slope has no effect on the highway.		
Slope Movement	X		Gabion wall is performing well, except for minor undermining of right wing wall due to erosion from leakage of the large diameter adjacent culvert. Vegetation is slowly growing and several of the live stakes are doing well. Slumping on left bank slowly continues. The movement has moved the gabion toe wall out into the stream flow. This has resulted in greater protection for the left bank but at the expense of greater toe erosion on the right bank. Slumping is now apparent on the right bank, but it has no impact on the highway.	X	
Erosion	X		Toe erosion is occurring on the right bank. Also erosion caused by leaking culvert.	X	
Seepage		X			
Culvert Distress	X		The right bank has slumped and lifted the end of the culvert adjacent to the wall upwards. The culvert has separated leading to erosion of the surrounding fill.	X

COMMENTS
Refer to previous reports and attached photos
Repair to the culvert may be required if the erosion continues and undermines the wall.
