SITE NUMBER AND NAME: C009 Gabion Wall north of Rocky Mountain House		HIGHWAY & KM: 11:10, 5.125	PREVIOUS INSPECTION DATE: June 22, 2016	INSPECTION DATE: June 12, 2017
LEGAL DESCRIPTION: 01-04-040-07 W5M	NAD 83 COORDINATES: UTM Northing Easting 11 5808438 640268		RISK ASSESSMENT: PF: 8 CF: 3 TOTAL: 24	
AVERAGE ANNUAL DAILY TRAFFIC (AADT): 3,880 (west) (Ref No. 54350)			CONTRACT MAINTENANCE AREA (CMA): 18

PROJECT CENTRAL REGION GEOHAZARD RISK MANAGEMENT PROGRAM		
TITLE Site Plan C009 - Gabion Wall north of Rocky Mountain House Hwy 11:10, km 5.125		
SCALE 1:1,000	PROJECT No. A05115A02	FIG No. 1

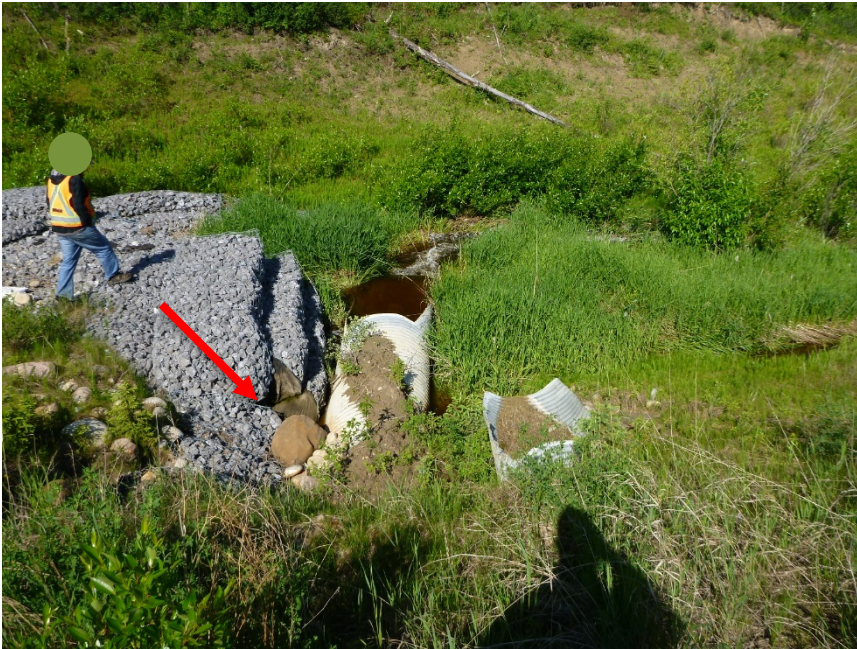
Photo 1 The east wing wall of the gabion wall drop structure has failed (marked with red arrow). The ditch and backslope are well vegetated. Photo taken June 12, 2017 looking west.

ITEM	CONDITION EXISTS		DESCRIPTION AND LOCATION	NOTICABLE CHANGE FROM LAST INSPECTION	
	YES	NO		YES	NO
			The backslope and ditch are well vegetated.		
Discussed remedial actions: repair the 1500-mm and 700-mm culverts; rebuild the gabion-wall drop structure by placing riprap where the east wing wall has failed; excavate and reconstruct the embankment slope with geosynthetic reinforced fill, with subsurface drainage.

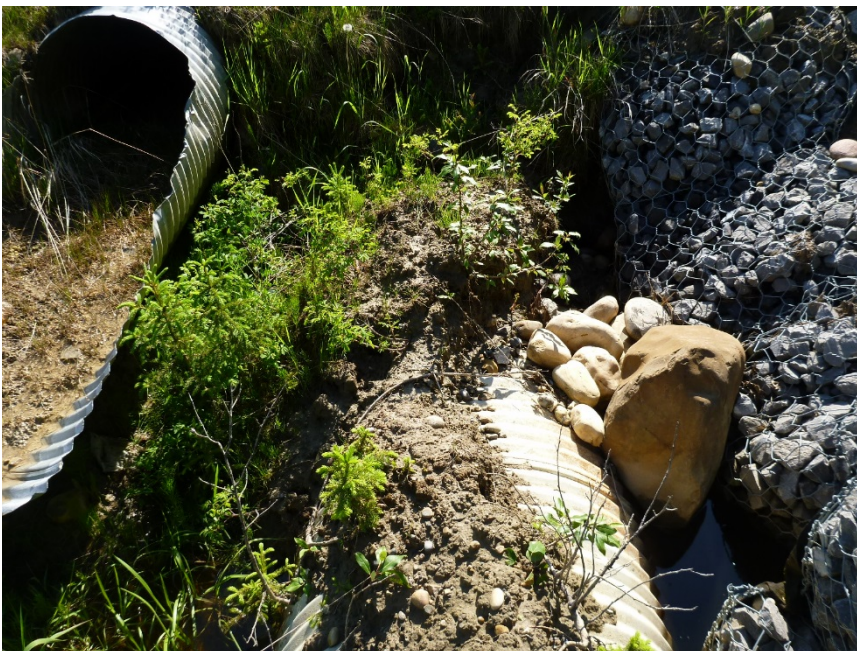
Photo 2 The 1500-mm and 900-mm culverts are being undermined by erosion around the east abutment and wing wall of the gabion wall drop structure (waypoint 482). Photo taken June 12, 2017 looking east.

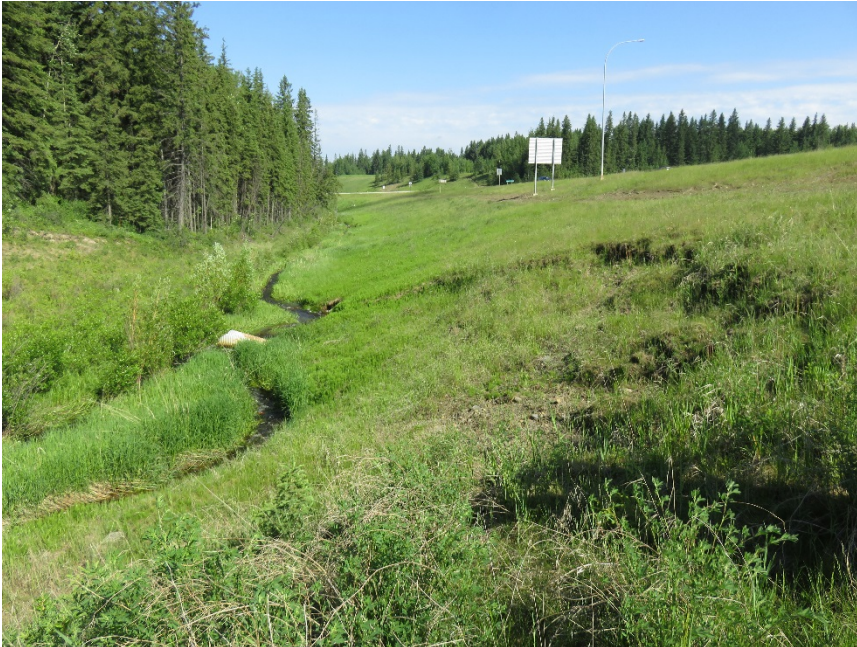
COMMENTS
The highway embankment appears to be stable under normal conditions, but susceptible to erosion initiated movements. A slope failure is located on the east slope of the ditch, downstream of the gabion wall drop structure. The backscarp of the slope failure shows evidence of recent movement.
The east wing wall of the gabion wall drop structure has failed. The 1500-mm and 900-mm culverts are being undermined by water flowing around the east abutment and wing wall of the gabion wall drop structure.
The 1500-mm culvert is flowing, but the outlet is undermined and disconnected. A sinkhole is located above the 1500-mm culvert outlet. The 900-mm culvert inlet (at waypoint 483) is dry, and the outlet is trickling (observed to be dry during previous site inspection). The 700-mm culvert inlet is steeply angled (approximately 45°), and the outlet is disconnected and deflected upwards due to slope movements. The disconnected culverts may be causing or exacerbating slope movements.

Photo 3 The backscarp of the embankment slope failure shows evidence of recent movement. The 700-mm culvert is deflected upwards and raised above the creek. Photo taken June 22, 2016 looking northwest from waypoint 482.

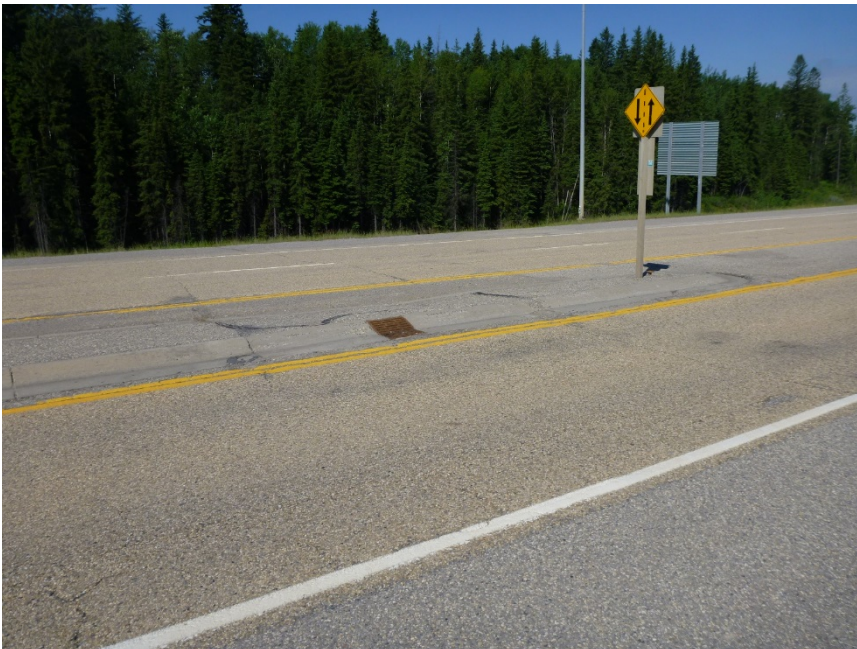
Photo 4 The center curb near the catch basin (waypoint 485). Photo taken June 12, 2017 looking northwest.
