SITE NUMBER AND NAME C38 H14:16 Culvert Erosion		HIGHWAY & KM 51.5	PREVIOUS INSPECTION DATE July 27, 2007	INSPECTION DATE June 25, 2008
LEGAL DESCRIPTION NE 5-45-01-W4	NAD 83 COORDINATES N 5855725 E 560300		RISK ASSESMENT PF: 1 CF: 1 TOTAL: 1

LAST READING DATE:	
PRIMARY SITE ISSUE: Culvert Erosion	
APPROXIMATE DIMENSIONS:	
DATE OF ANY REMEDIAL ACTION: Culvert was extended and erosion protection was placed in the summer of 2007.

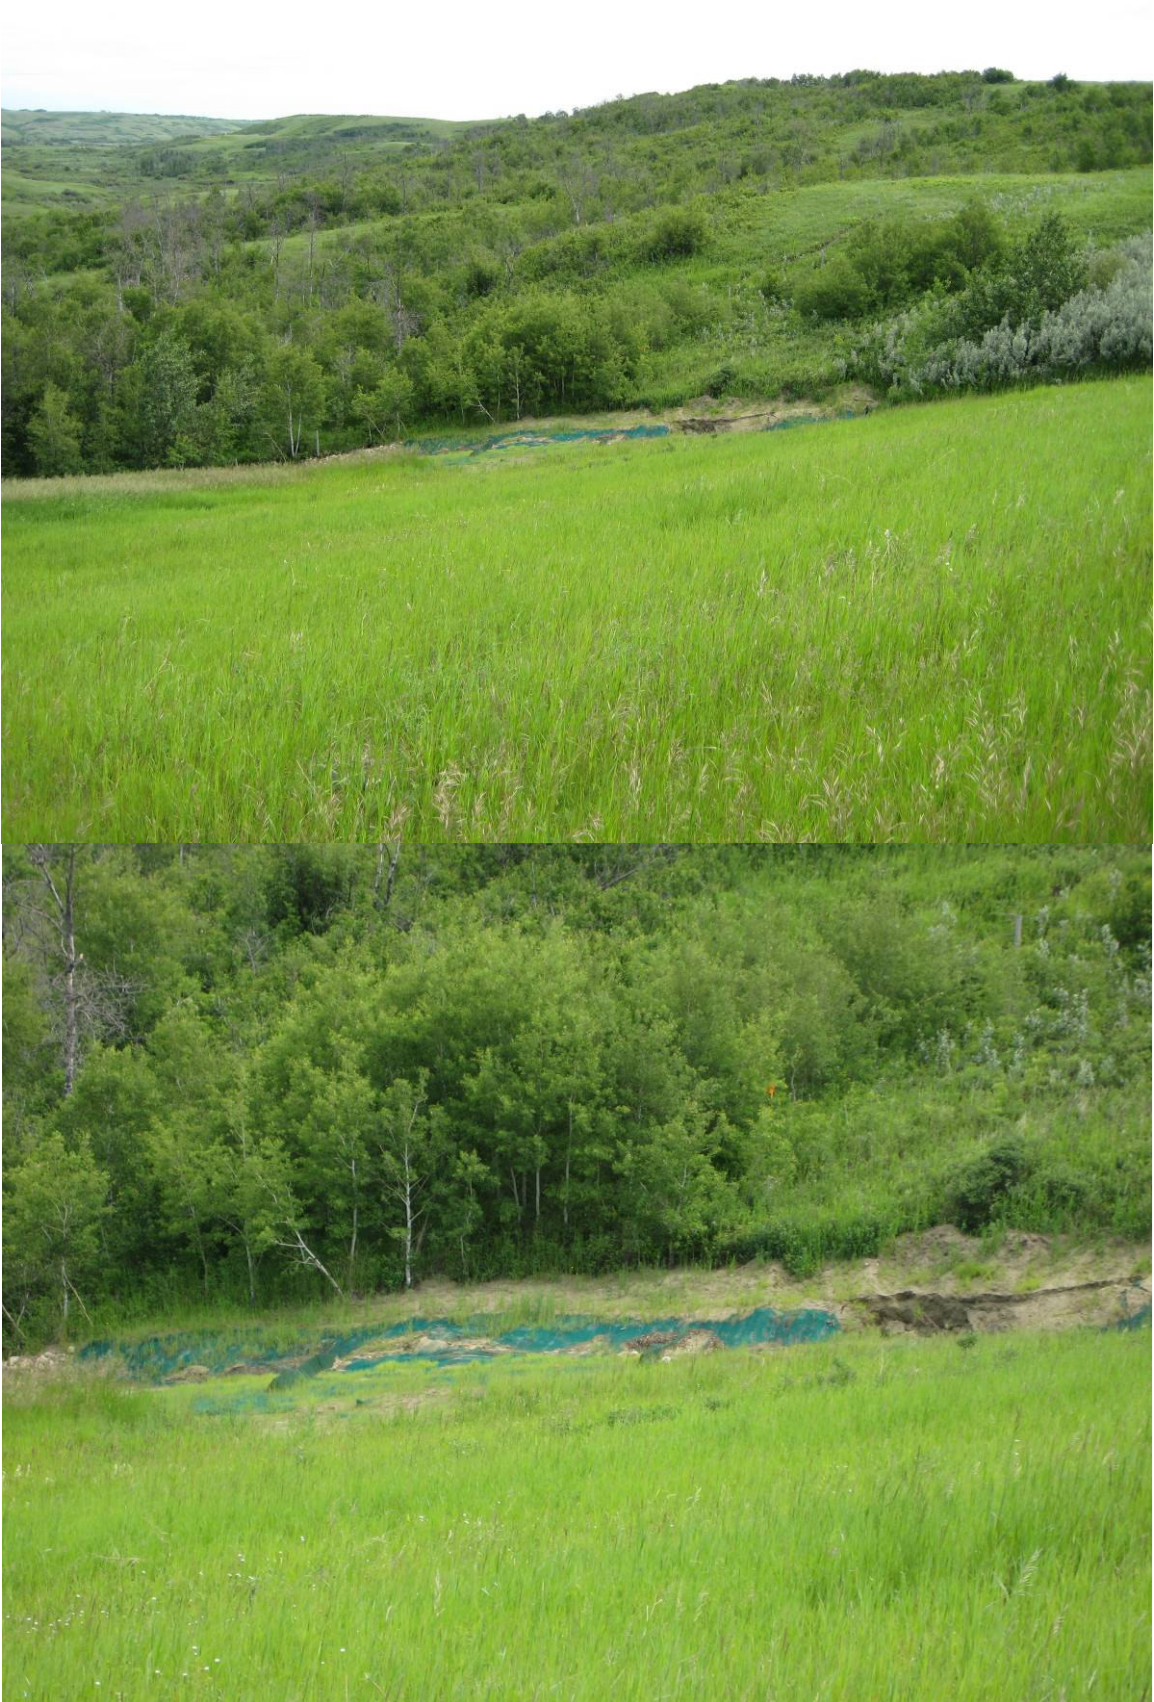
Site C38 H14:16 Culvert Erosion
June 25, 2008

ITEM	CONDITION EXISTS		DESCRIPTION AND LOCATION	NOTICABLE CHANGE FROM LAST INSPECTION	
	YES	NO		YES	NO
Pavement Distress		X			X
Slope Movement		X			X
Erosion	X		Slope is eroding under matting in some locations. However, site is well away from roadway.	X	
Seepage		X			X
Culvert Distress	X		Culvert extended and riprap placed.		X
