SITE NUMBER AND NAME C64 H16:24 Frost Heave		HIGHWAY & KM 29.3	PREVIOUS INSPECTION DATE	INSPECTION DATE May 16, 2013
LEGAL DESCRIPTION 2-52-14-W4	NAD 83 COORDINATES N53°28'59" E111°57'35"		RISK ASSESMENT PF: 9 CF: 6 TOTAL: 54

LAST READING DATE:	
PRIMARY SITE ISSUE: <p align="center">Frost Heave creating a dip at a culvert location</p>	
APPROXIMATE DIMENSIONS: Westbound lanes only – length of about 5 m centred over a culvert location that does not heave.	
DATE OF ANY REMEDIAL ACTION:

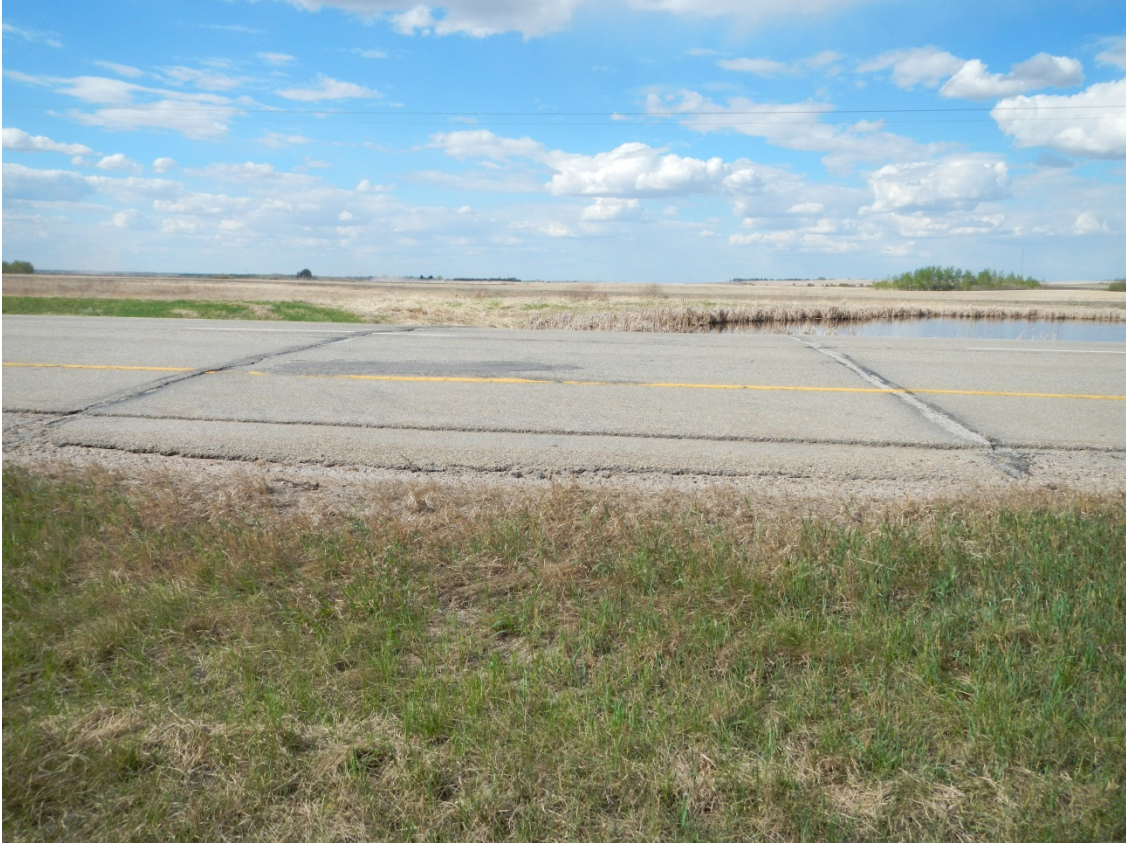
ITEM	CONDITION EXISTS		DESCRIPTION AND LOCATION	NOTICABLE CHANGE FROM LAST INSPECTION	
	YES	NO		YES	NO
Pavement Distress	X		Frost heave section with about 5 m long section centred over a culvert that does not heave.	X	
Slope Movement		X			
Erosion		X			
Seepage	X		Area is saturated due to cutoff drainage channels.		
Culvert Distress		X		X

Looking west

COMMENTS
See attached photos and report
Remediation options include removal of the culvert and backfill with clay fill or insulation of the adjacent highway sections.

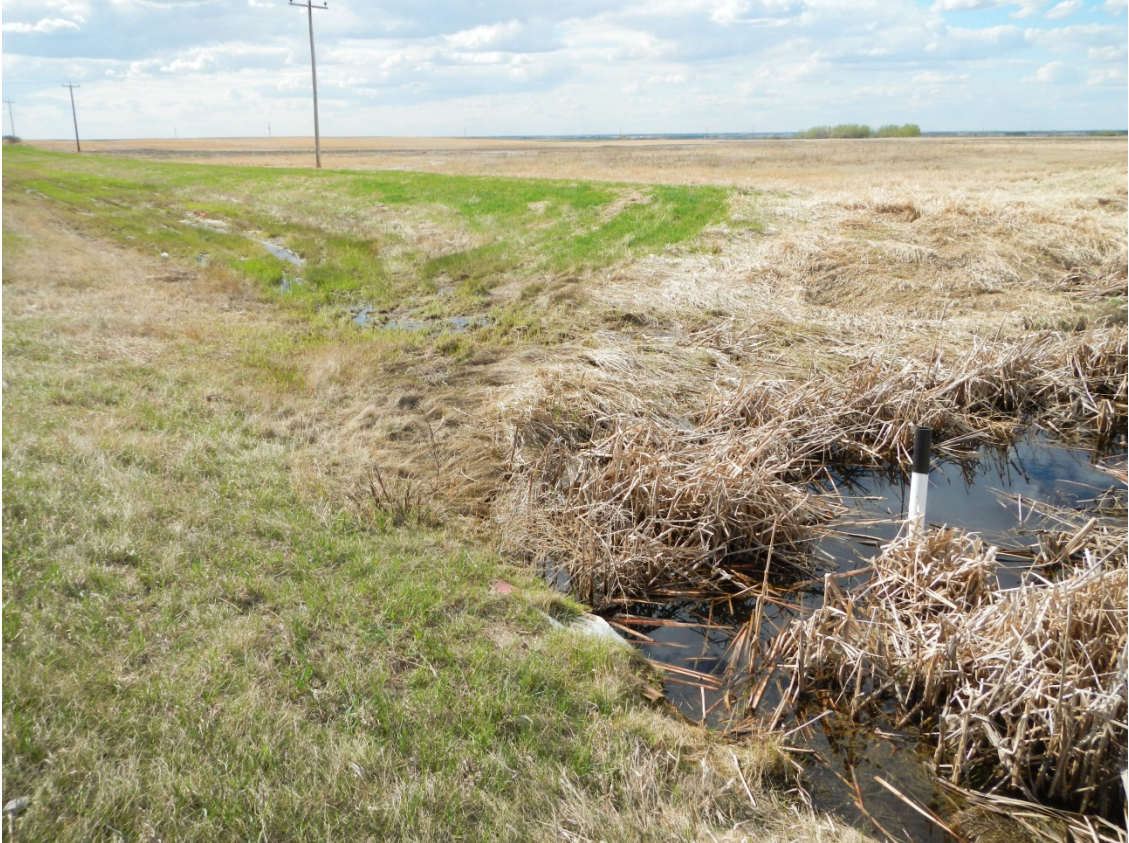
Ponded water north of highway
