SITE NUMBER AND NAME C064 Vegreville Frost Heave		HIGHWAY & KM H16:24 km 29.17	PREVIOUS INSPECTION DATE March 2, 2017	INSPECTION DATE Feb 28, 2018
LEGAL DESCRIPTION SW 14-52-14-W4	NAD 83 COORDINATES Northing Easting 53°29.000' 111°57.548'		RISK ASSESSMENT PF: 1 CF: 1 TOTAL: 1	
2017 Average Annual Daily Traffic (Ref. No.: 120507) (AADT): 7520 (westbound) 7480 (eastbound)			Contract Maintenance Area (CMA): 14

NOTES: 1. HORIZONTAL DATUM: NAD83 2. GRID ZONE: UTM Zone 12N 3. IMAGE SOURCE: Bing Maps 2018, Microsoft Corporation. Image dated August 2013 4. Site visit photo dated February 28, 2018	CLIENT 	PROJECT CENTRAL REGION GEOHAZARD RISK MANAGEMENT PROGRAM
		TITLE C064 Site Inspection Hwy 16:24, km 29.177
	SCALE 1:1,000	PROJECT No. A05115A02
		FIG No. 1

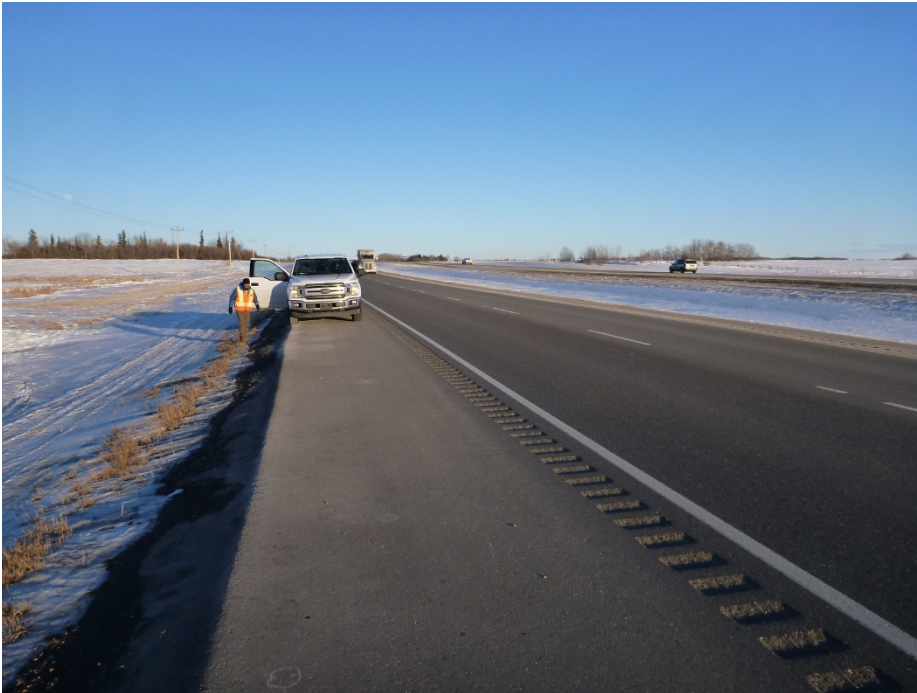
COMMENTS
The MCI reported that the heaving conditions at the site are much better since the repair in 2016.
Pavement heaving and lateral cracking were not observed during the last inspection in March 2, 2017.
Since heaving was not observed during this inspection, KCB recommends that the C064 site be removed from the GRMP.

Photo 1 **Location of repaired lateral cracking along the highway above the culvert backfill.
Photo taken on February 28, 2018 looking east.**
