**CENTRAL REGION
GEOHAZARDS RISK ASSESMENT
SITE INSPECTION FORM**

SITE NUMBER AND NAME C29 Meridian Pit		HIGHWAY & KM	PREVIOUS INSPECTION DATE July 18, 2003	INSPECTION DATE May 19, 2004
LEGAL DESCRIPTION NE/SE26-53-01-W4	NAD 83 COORDINATES N 5939566 E 565036		RISK ASSESMENT PF: 9 CF: 2 TOTAL: 18

1. SITE C29 H17:08 GABION STRUCTURE REPAIR

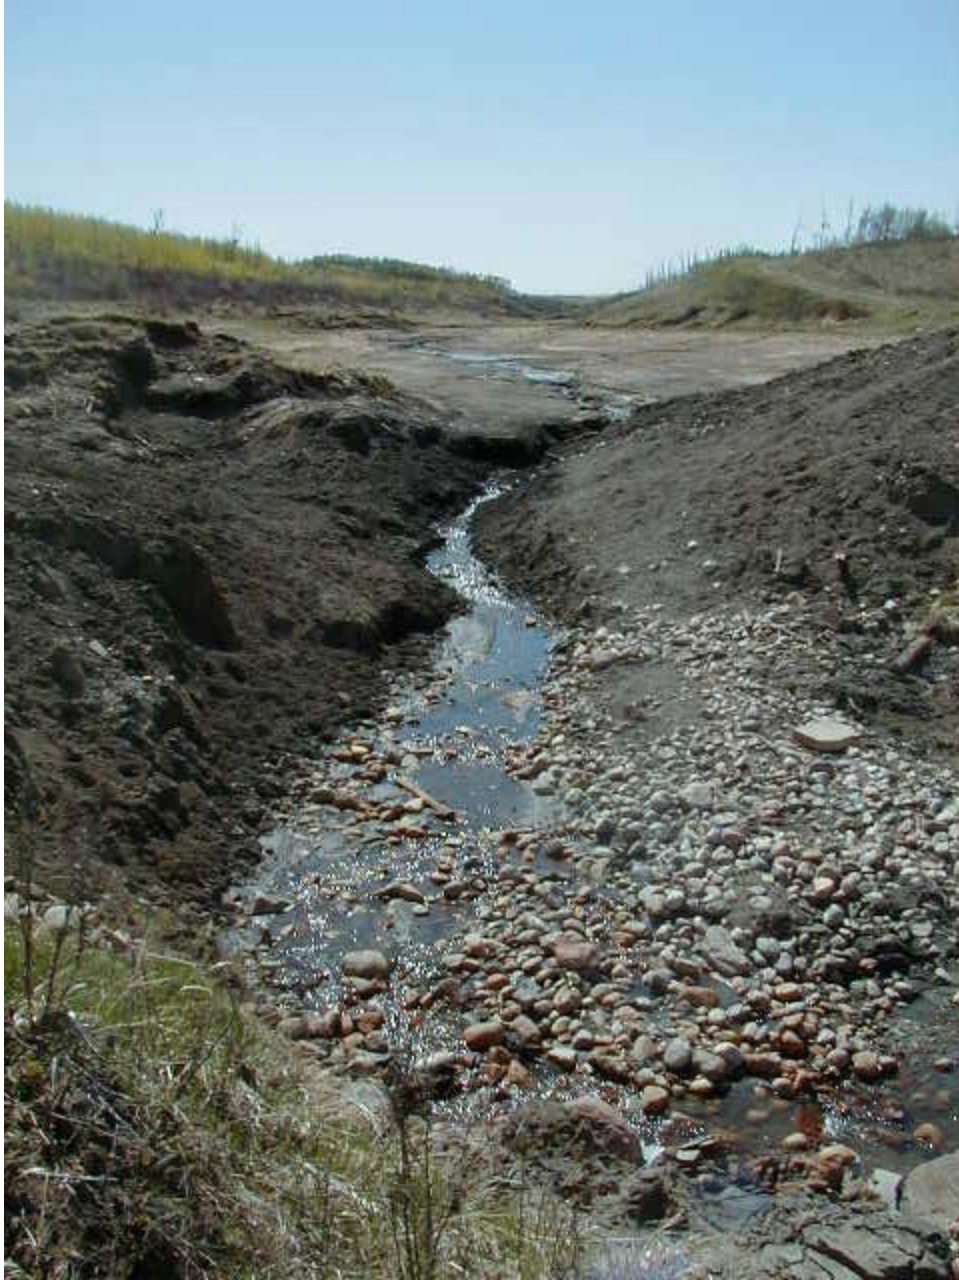
Looking upstream

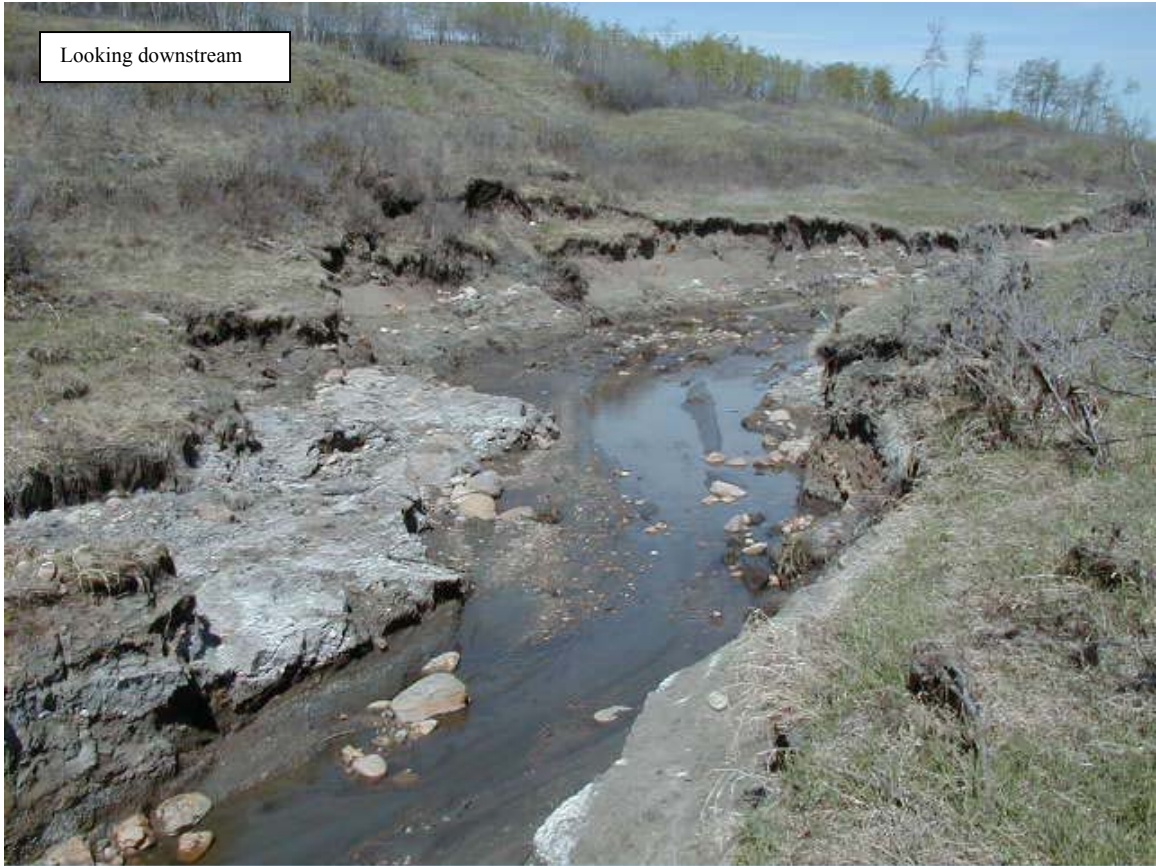
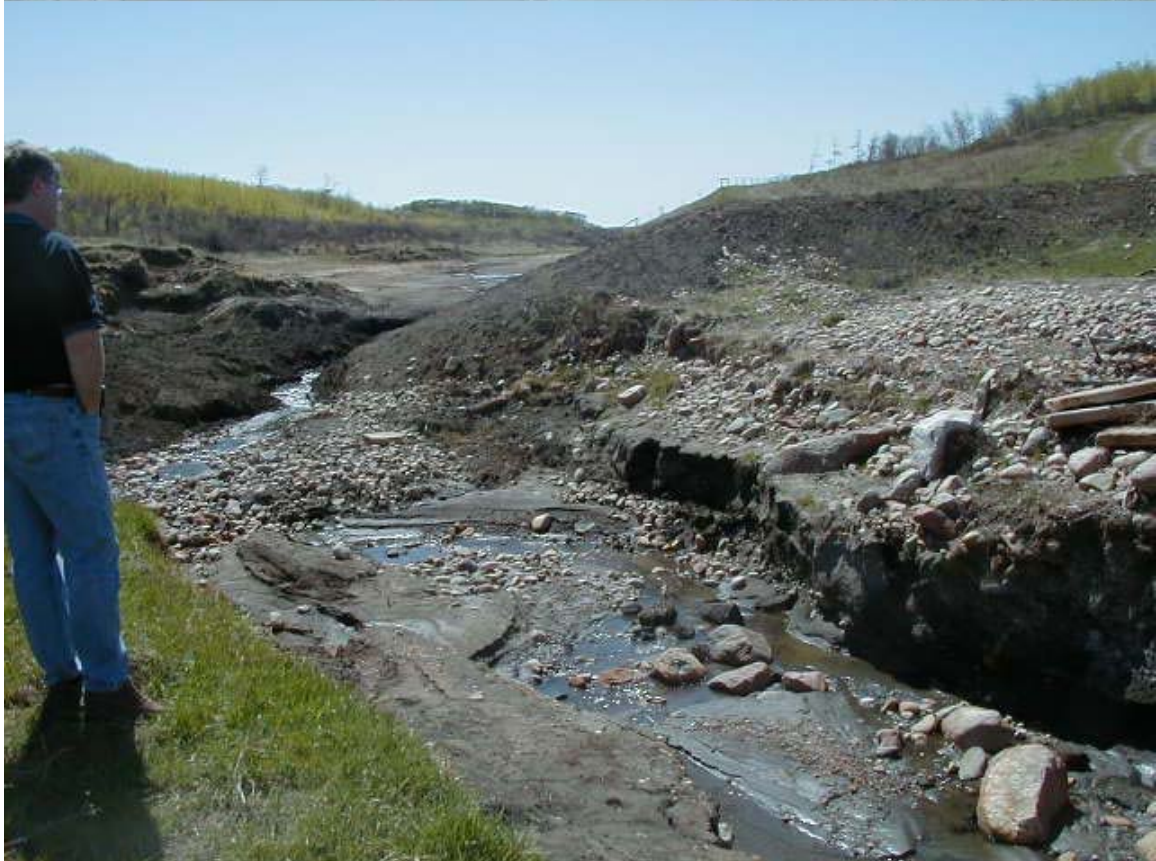
Gabion drop structure

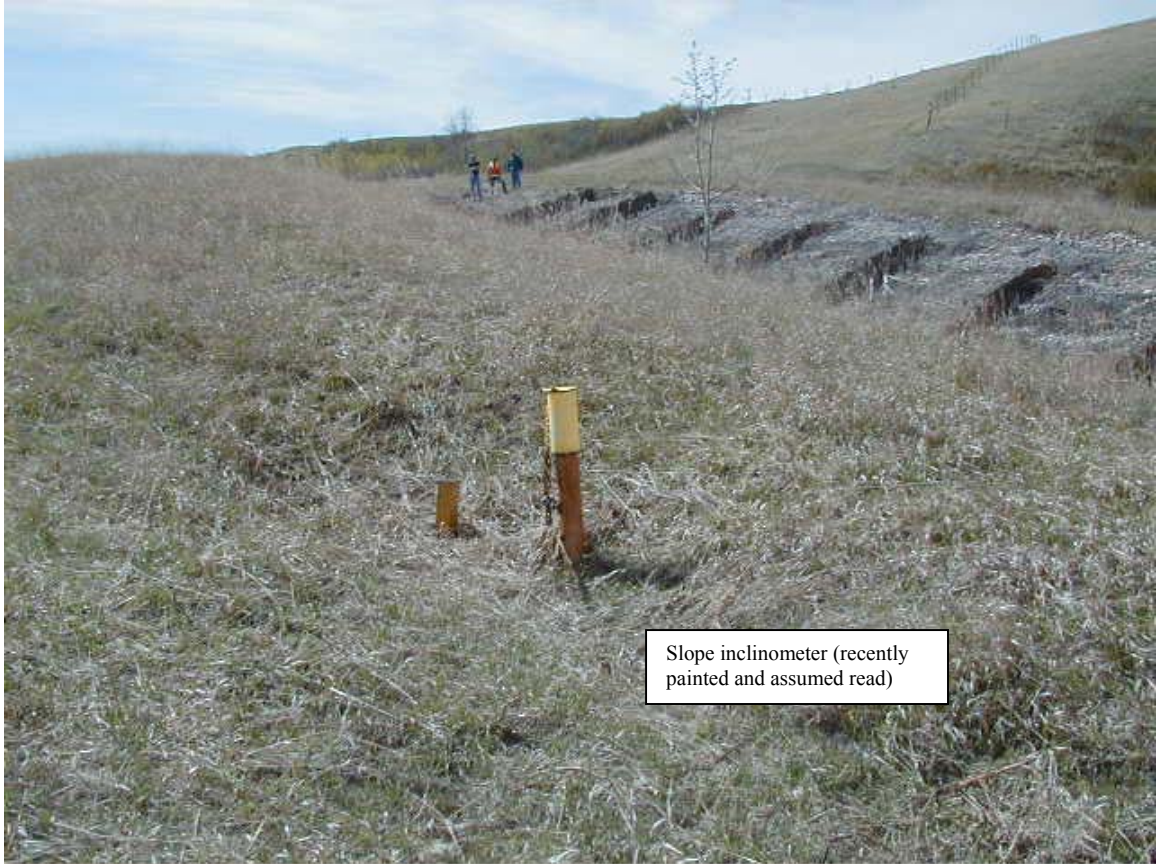
Slope inclinometer (recently painted and assumed read)

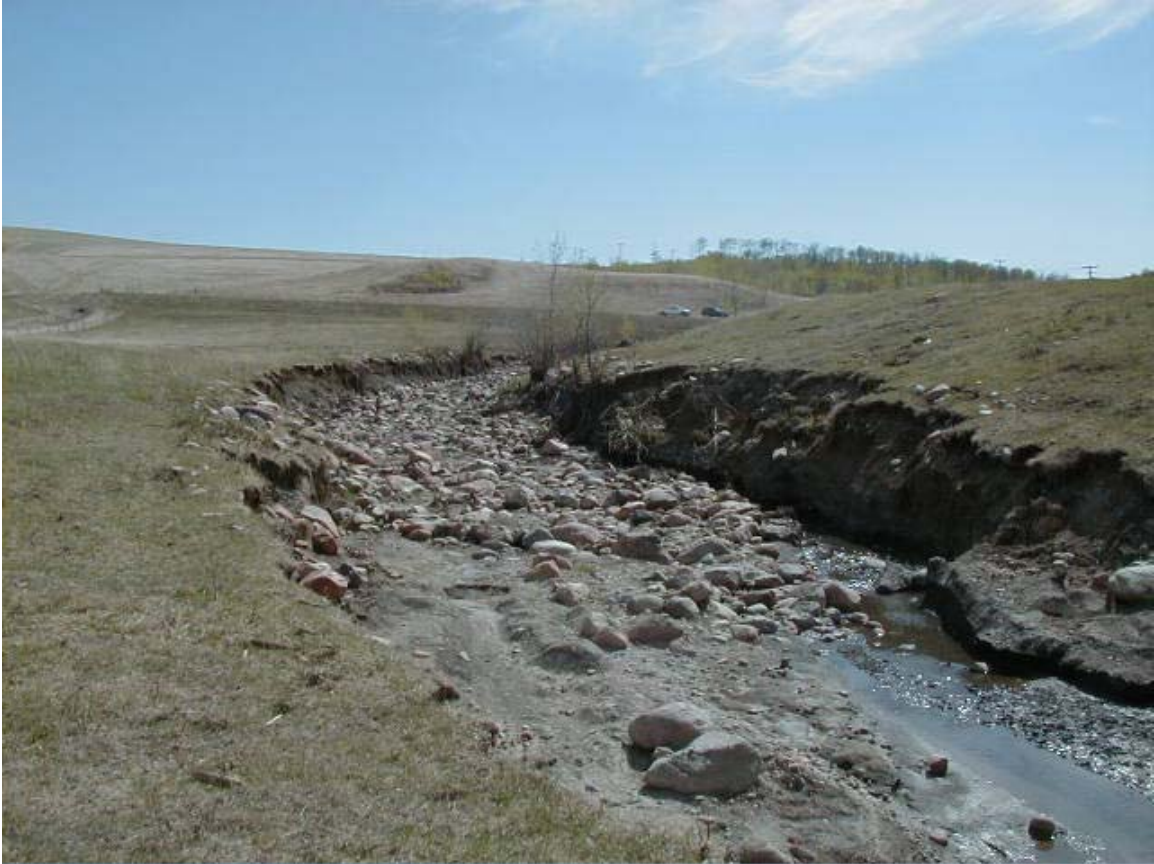
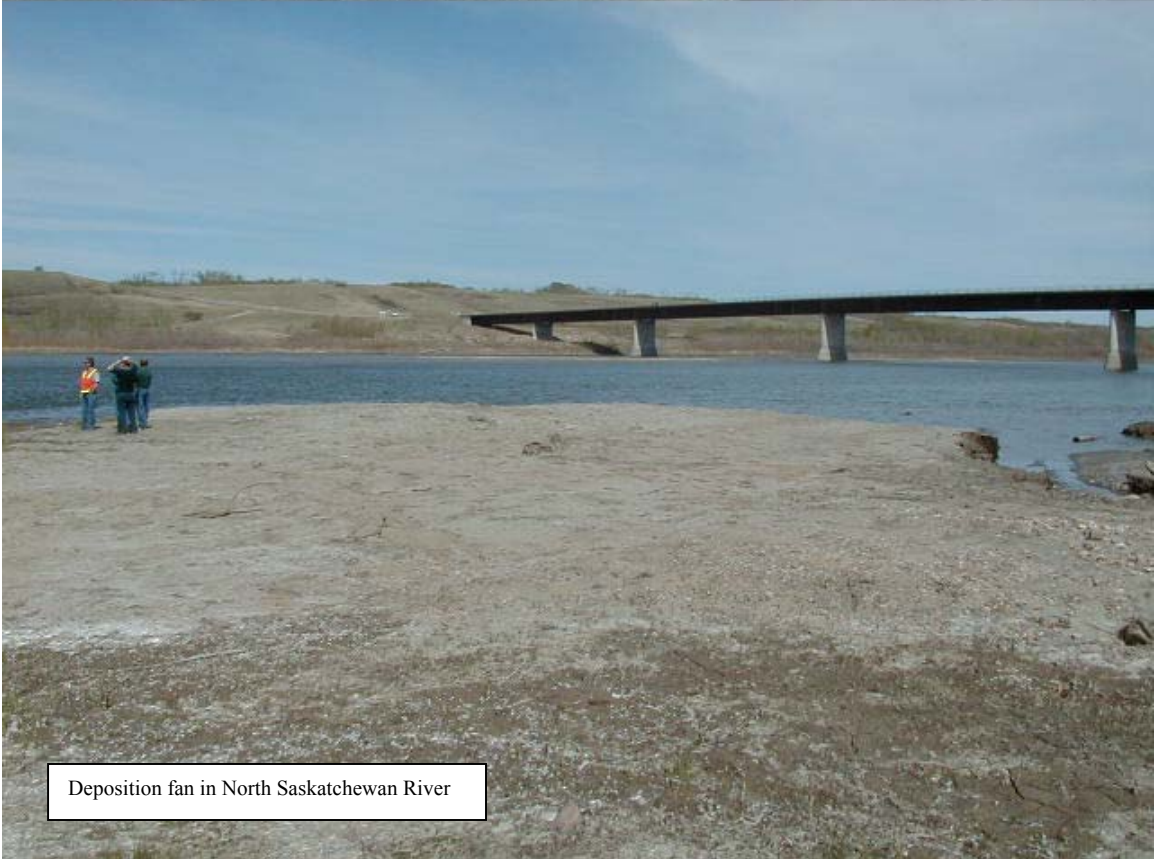
Deposition fan in North Saskatchewan River
