SITE NUMBER AND NAME C061 Frost Heave		HIGHWAY & KM H20:02; km 12.212	PREVIOUS INSPECTION DATE March 2, 2017	INSPECTION DATE Feb 28, 2018
LEGAL DESCRIPTION SE 33-39-1-W5	NAD 83 COORDINATES Northing Easting 52°23.564' 114°4.592'		RISK ASSESSMENT PF: 8 CF: 3 TOTAL: 24	
2017 Average Annual Daily Traffic (Ref. 997219) (AADT): 5930 (northbound) 6260 (southbound)		Contract Maintenance Area (CMA): 19

NOTES: 1. HORIZONTAL DATUM: NAD83 2. GRID ZONE: UTM Zone 11N 3. IMAGE SOURCE: Bing Maps 2018, Microsoft Corporation. Image dated September 2013 4. Site visit photos dated February 28, 2018	CLIENT 	PROJECT CENTRAL REGION GEOHAZARD RISK MANAGEMENT PROGRAM
		TITLE C061 Site Inspection Hwy 20:02 km 12.212
SCALE 1:1,000	PROJECT No. A05115A02	FIG No. 1

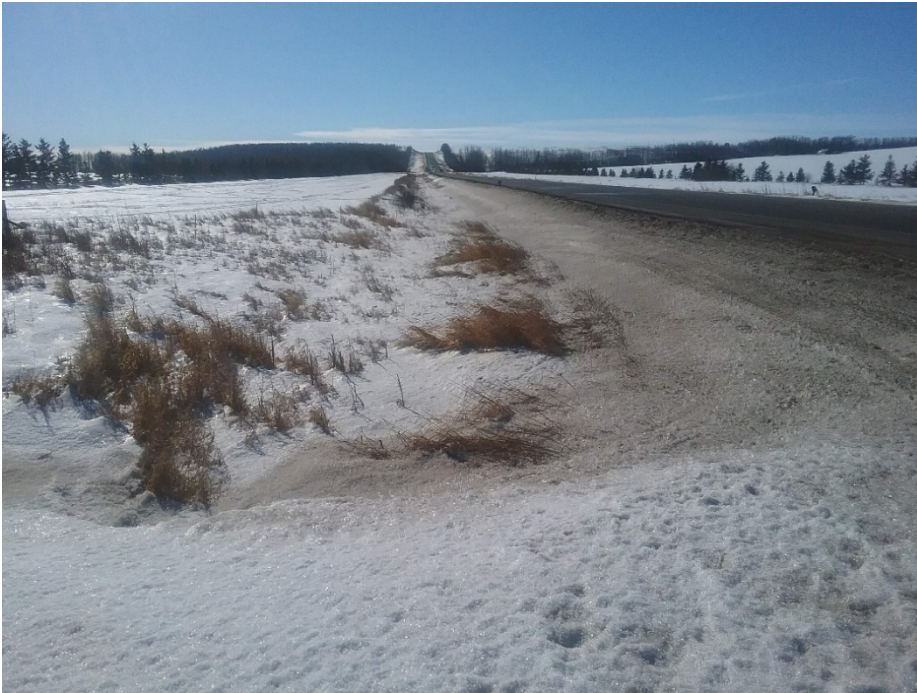
Photo 1 **Drainage ditch off the northbound lane of the highway. Photo taken February 28, 2018 looking south.**

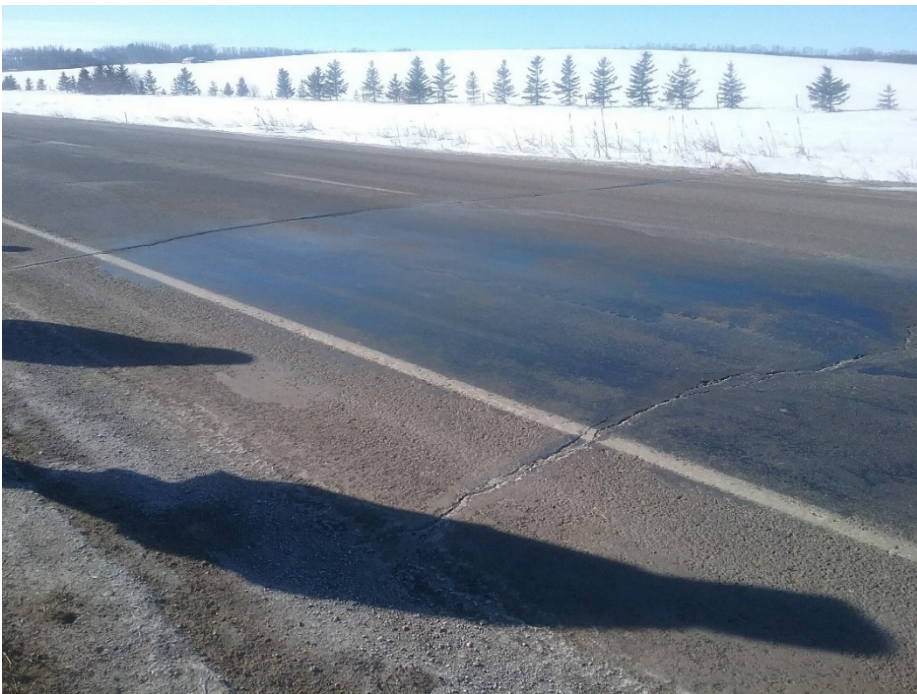
Photo 2 **Patched area (1 of 3) at heaved location on northbound lane bounded by transverse cracks (about 7 m apart). Photo taken February 28, 2018 looking south-west.**

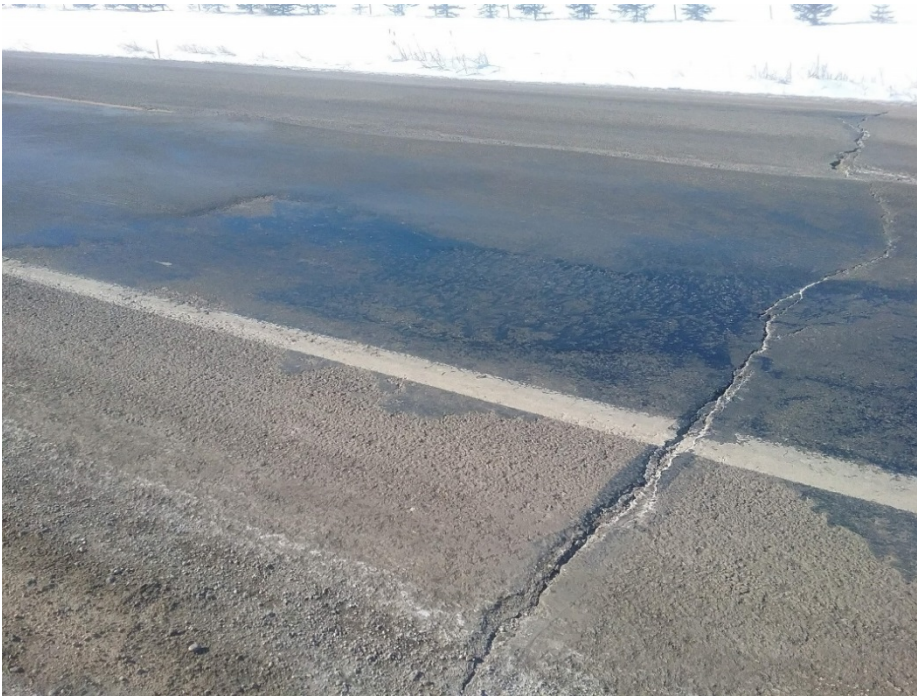
Photo 3 Patched area (2 of 3) at heaved location on northbound lane. Photo taken on February 28, 2018 looking south.

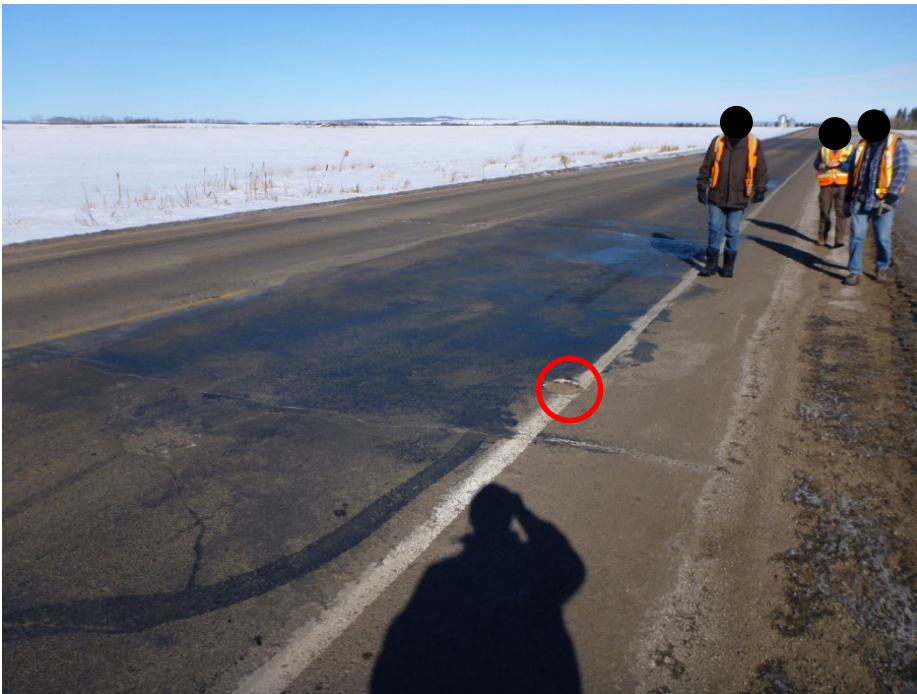
Photo 4 Location of KCB 2016 borehole and instrumentation (shown in red circle) at patch area (1 of 3). Photo taken on February 28, 2018 looking north-west.

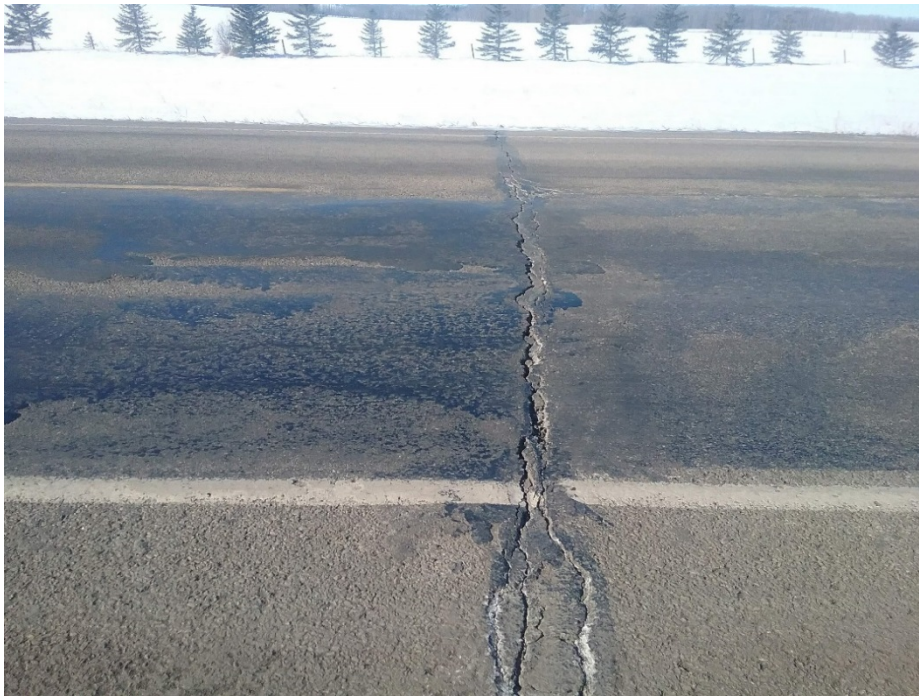
Photo 5 Transverse crack at patched area (3 of 3). Photo taken on February 28, 2018 looking west.

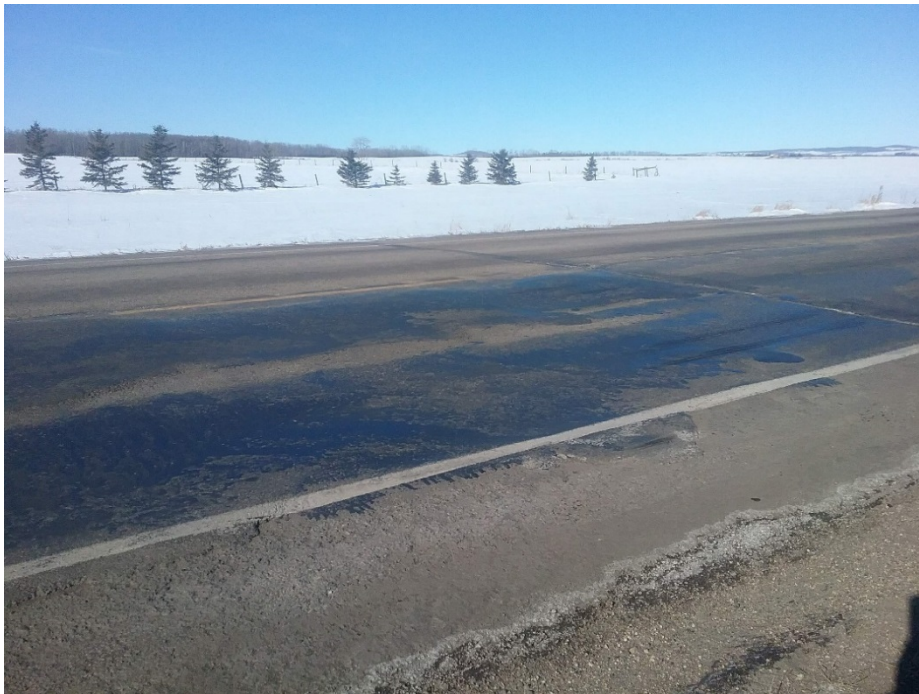
Photo 6 Patched area (3 of 3) at heaved location. Photo taken February 28, 2018 looking north-west.
