SITE NUMBER AND NAME H21:22 Pavement Distress		HIGHWAY & KM from km 16.4 to km 17.7	PREVIOUS INSPECTION DATE	INSPECTION DATE May 15, 2007
LEGAL DESCRIPTION	NAD 83 COORDINATES	RISK ASSESMENT PF: 9 CF: 4 TOTAL: 36

LAST READING DATE:	
PRIMARY SITE ISSUE: Pavement distress	
APPROXIMATE DIMENSIONS:	
DATE OF ANY REMEDIAL ACTION:

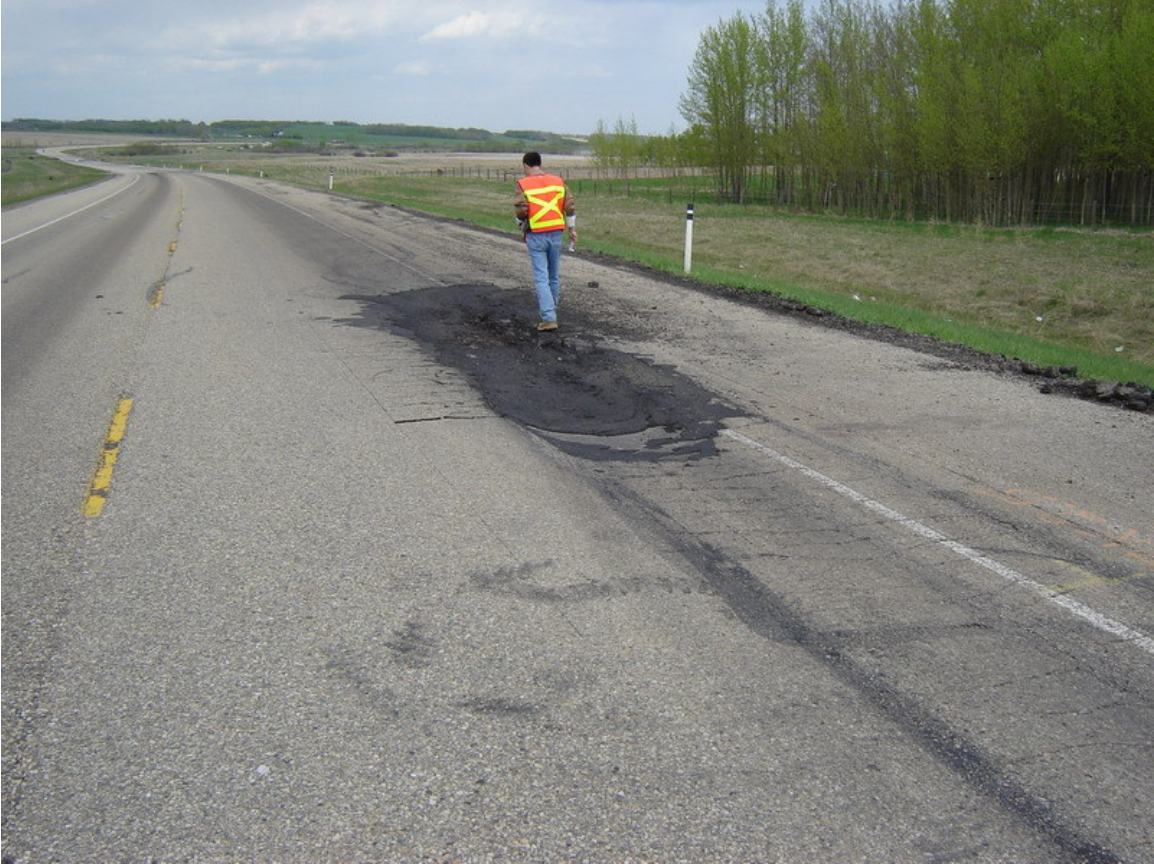
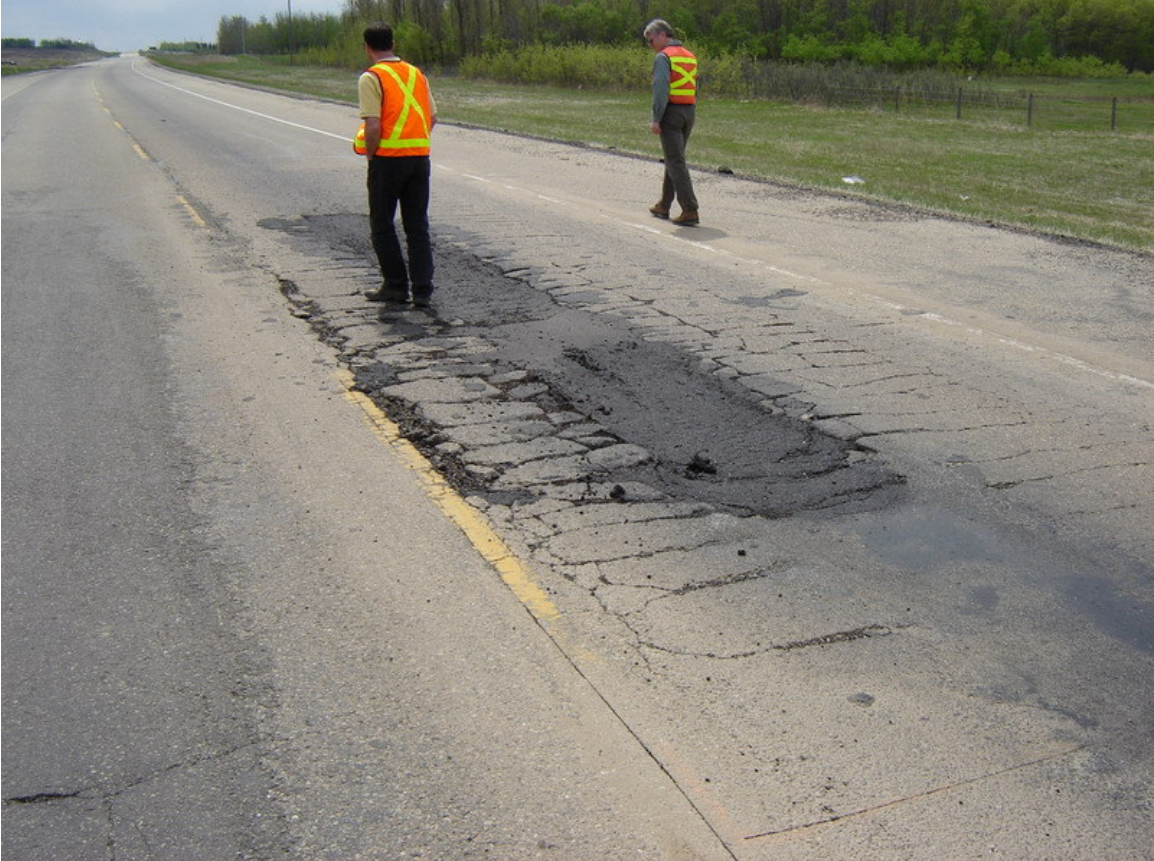
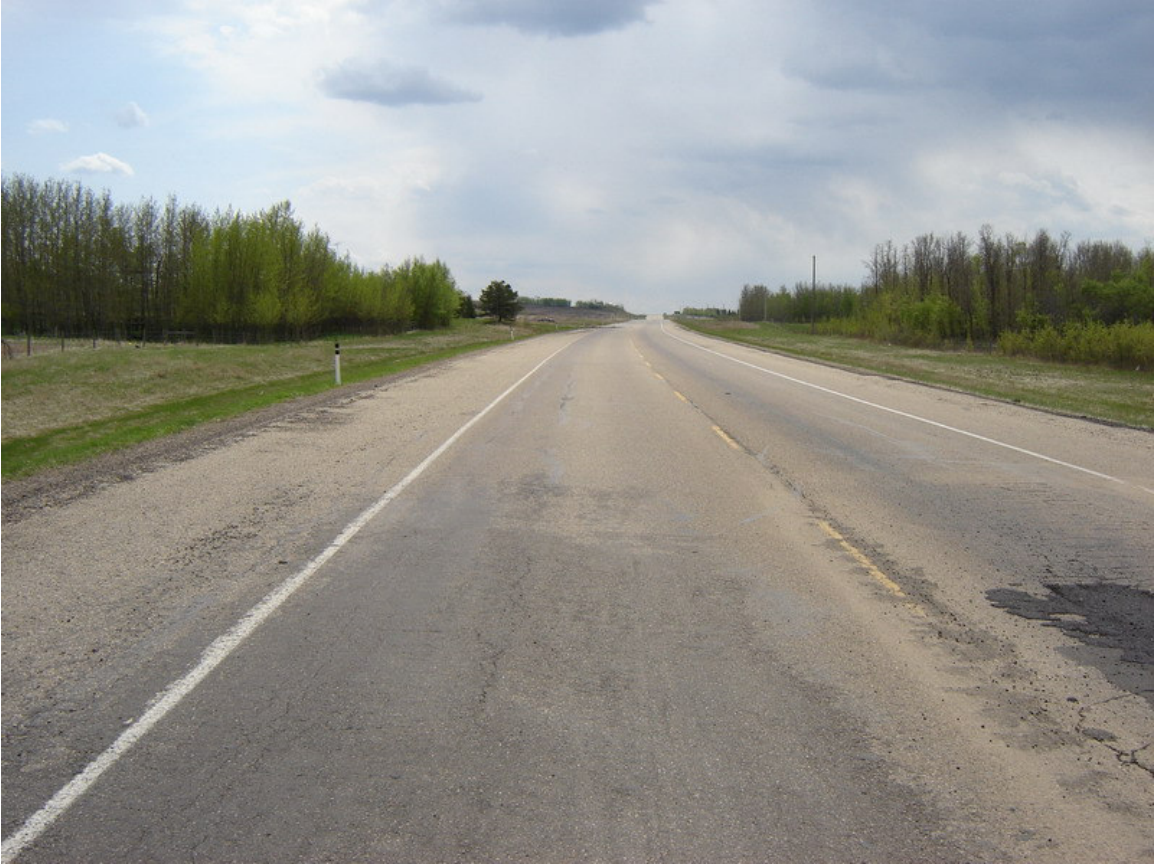
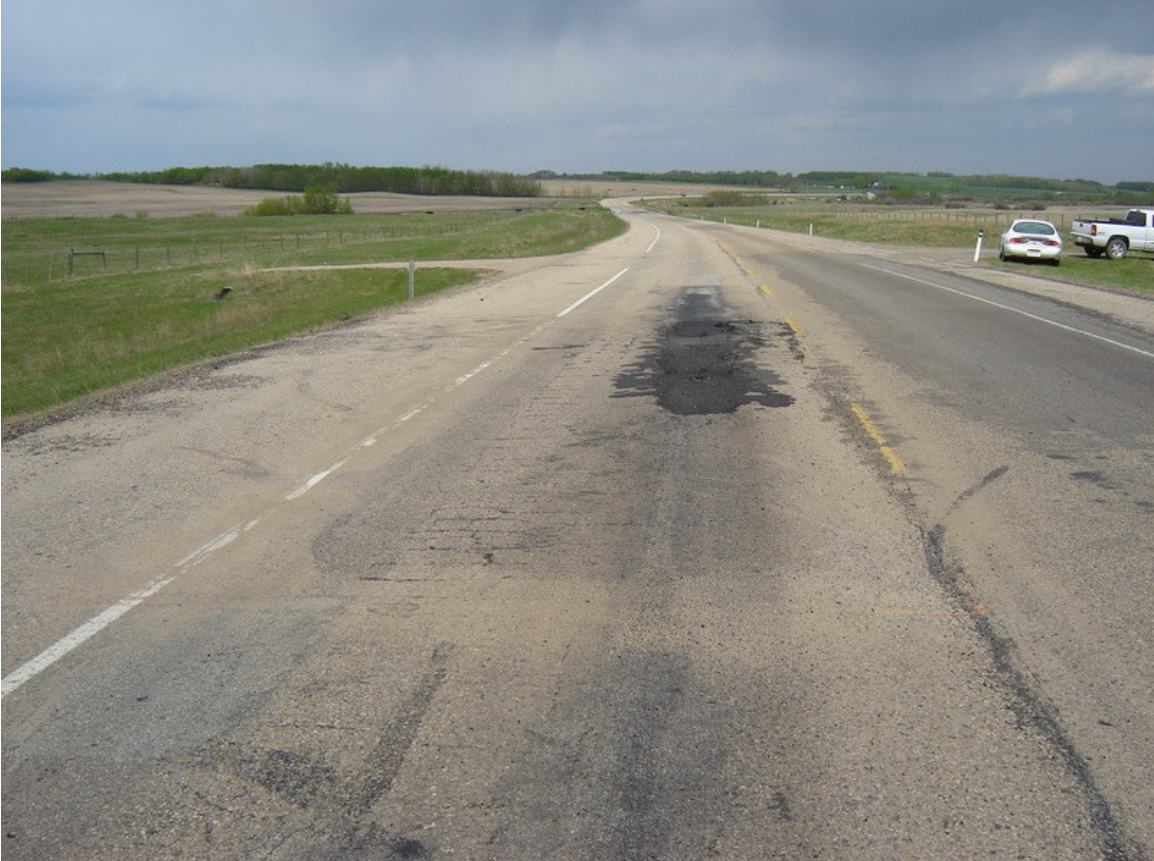
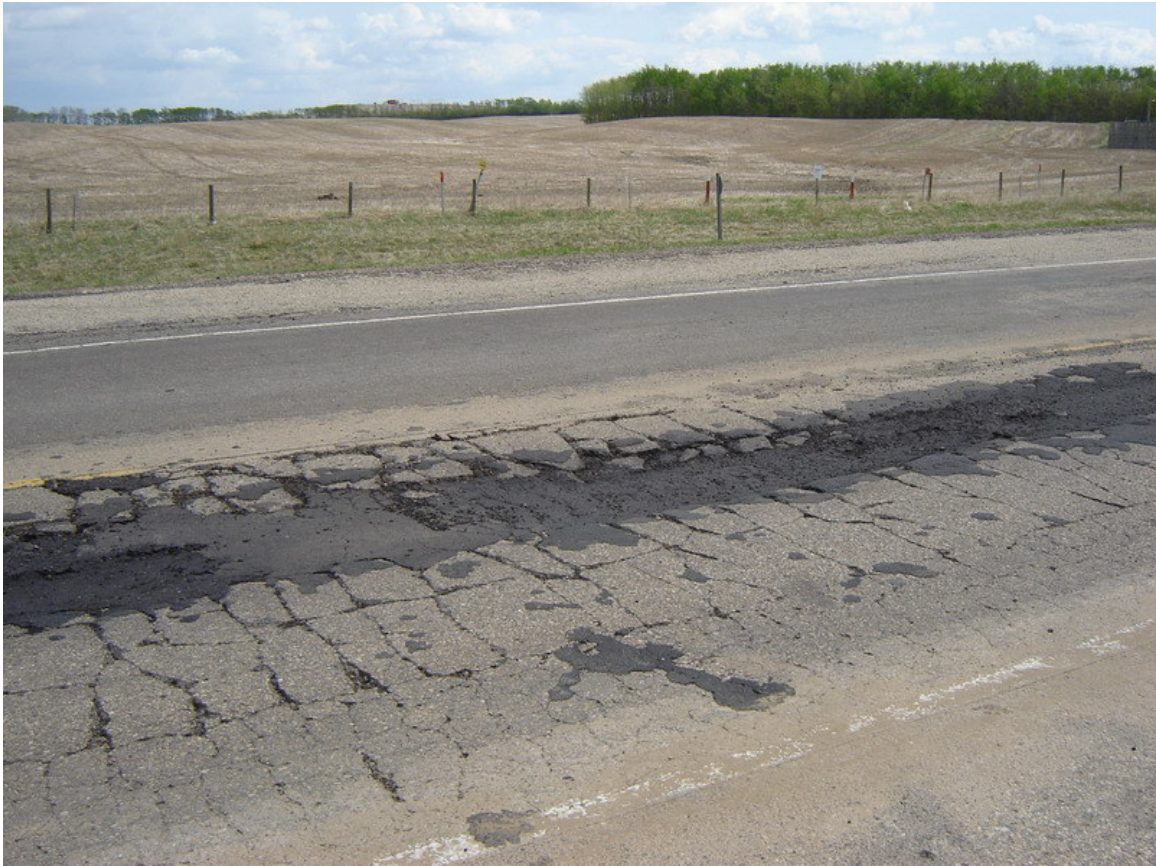
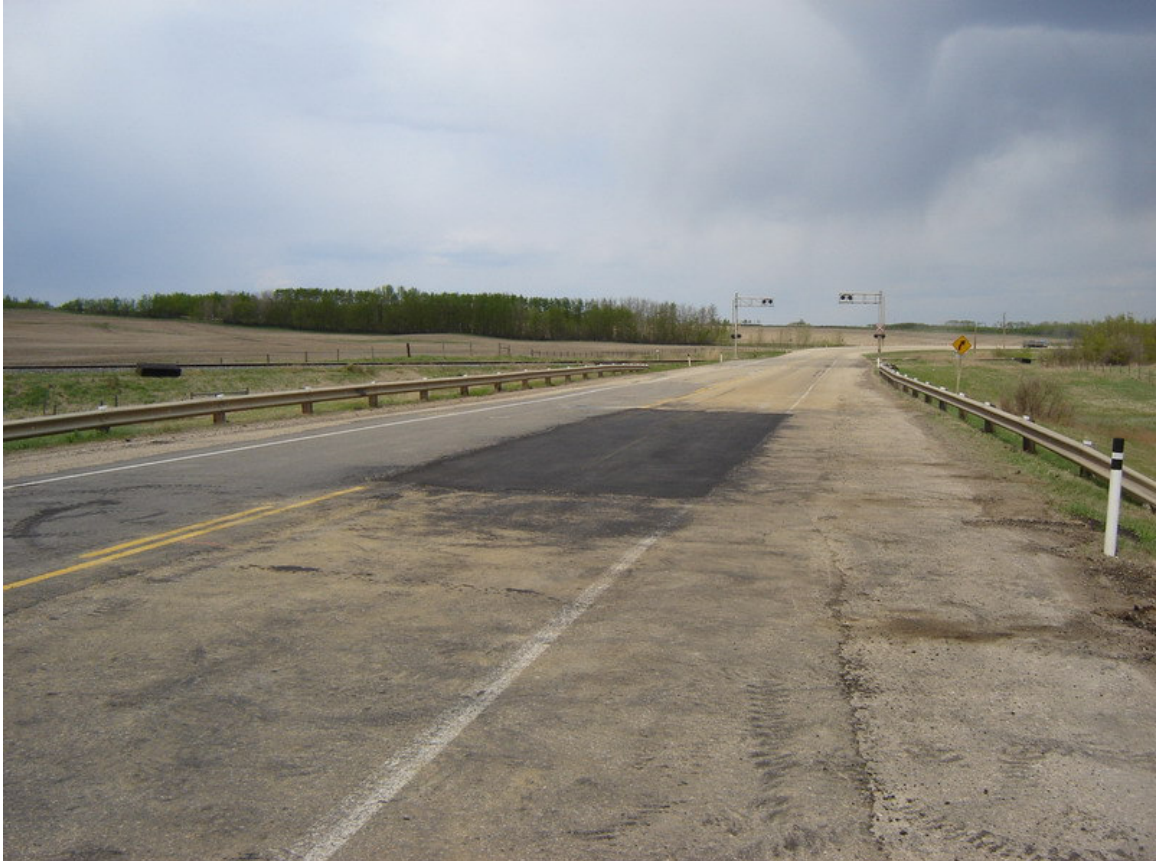
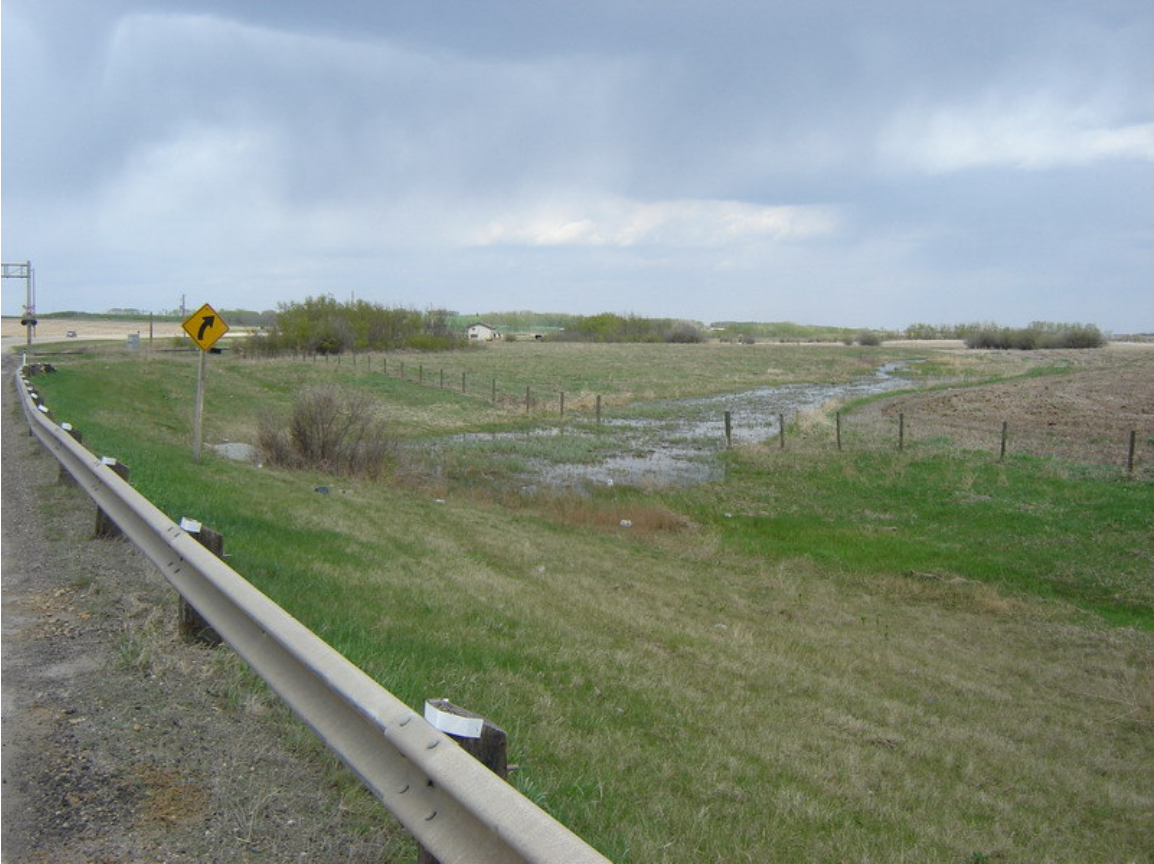
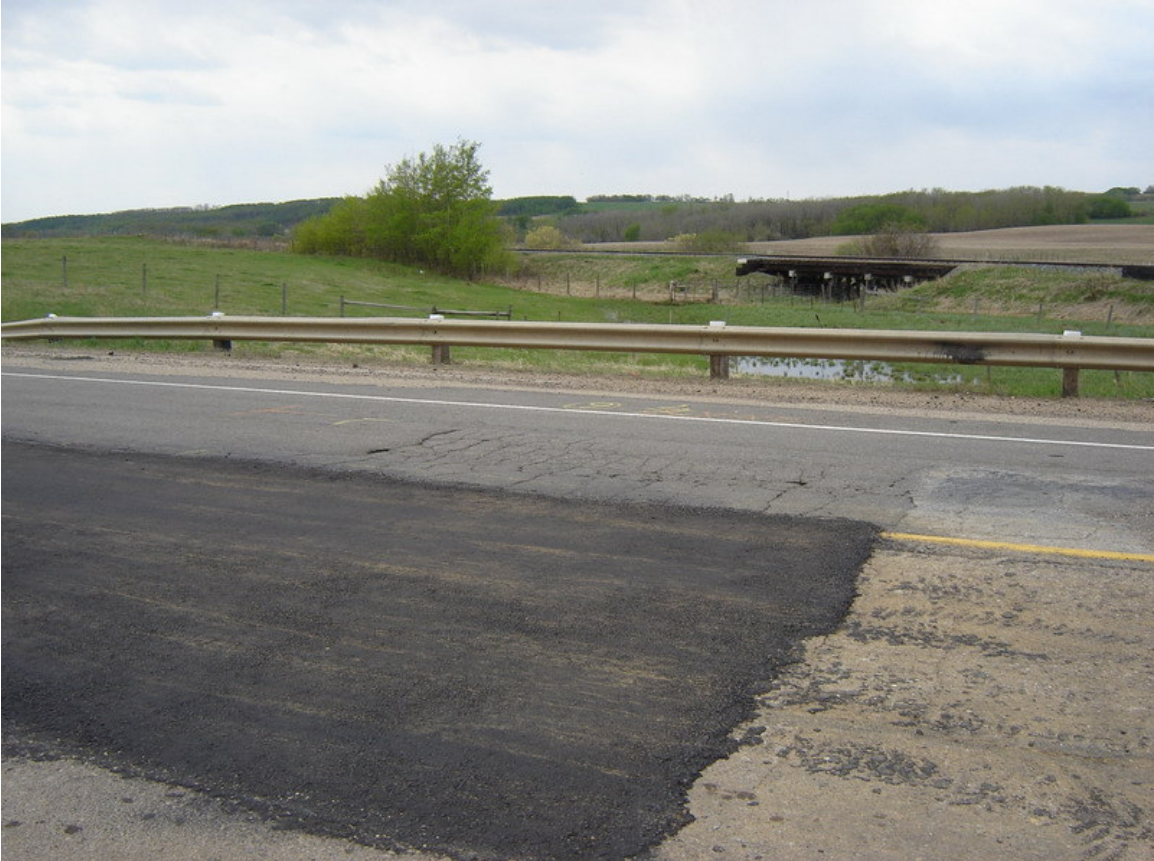
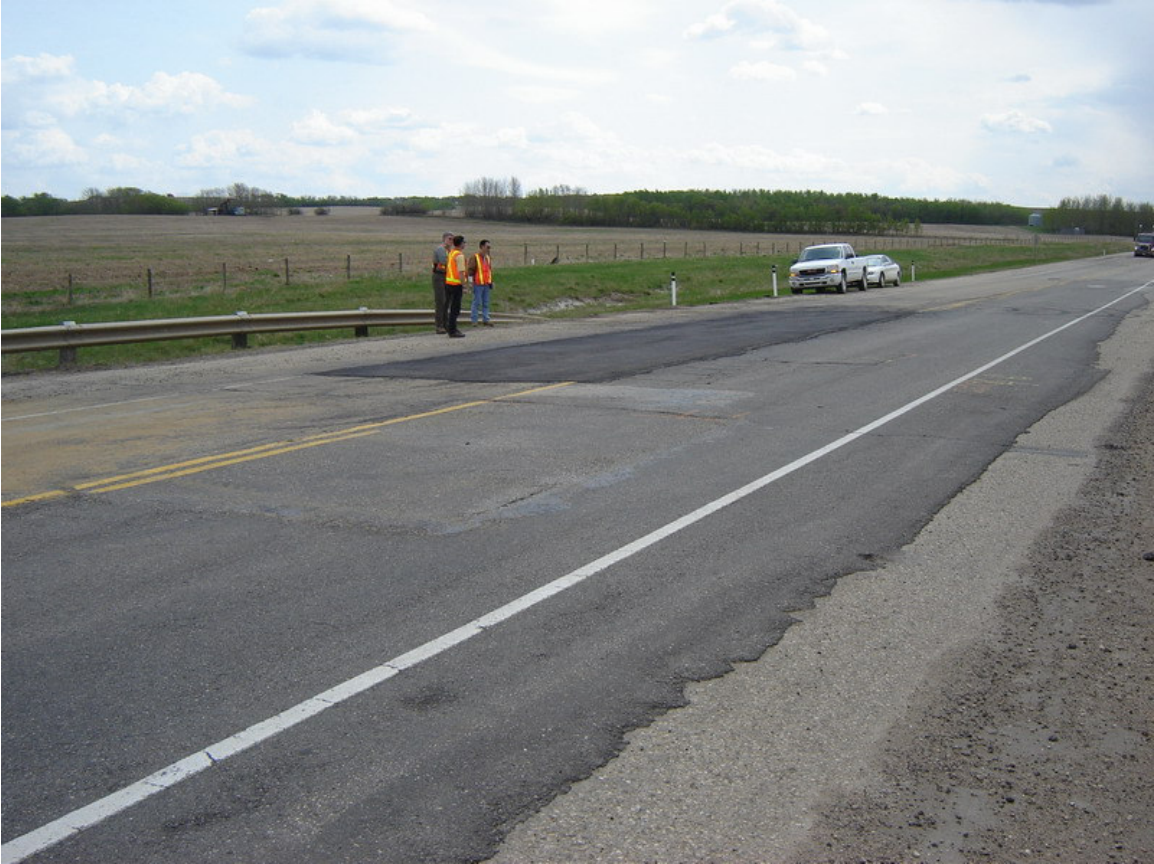
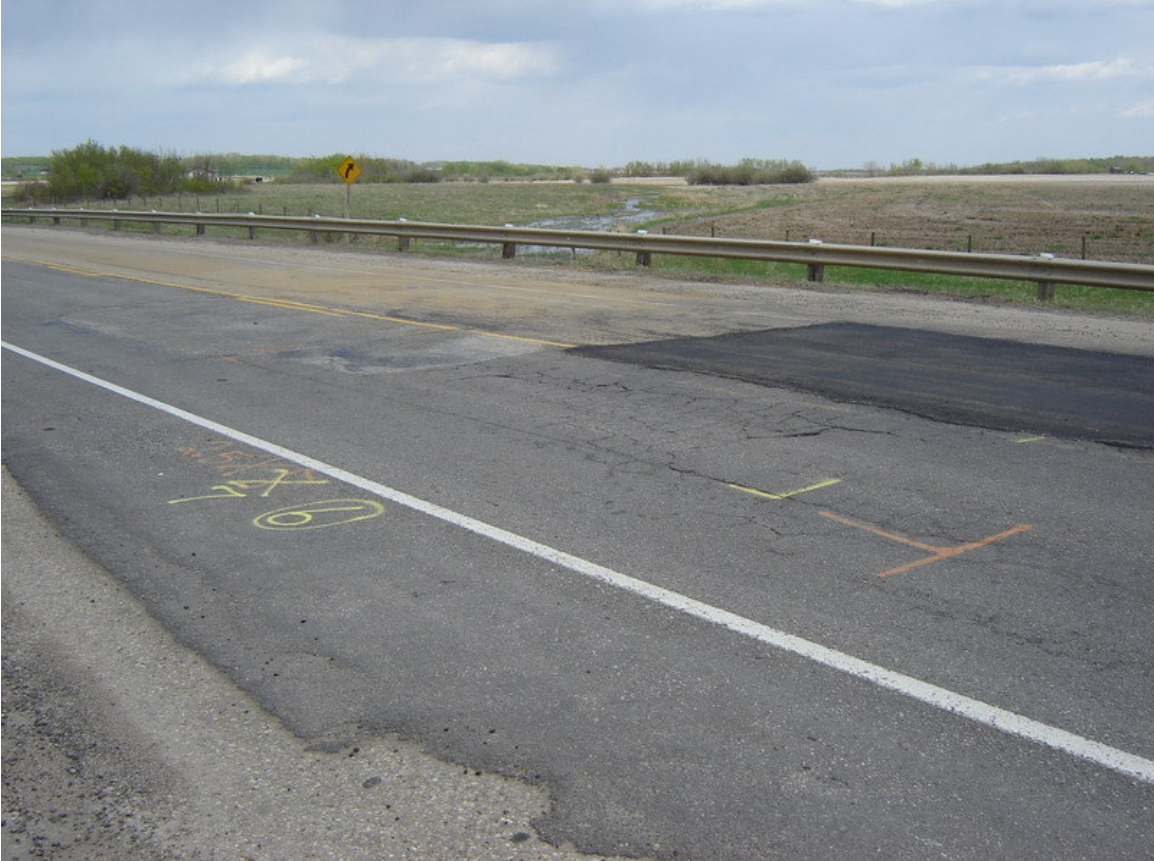
ITEM	CONDITION EXISTS		DESCRIPTION AND LOCATION	NOTICABLE CHANGE FROM LAST INSPECTION	
	YES	NO		YES	NO
Pavement Distress	X		Three areas of severe fatigue cracking in pavement, indicative of a soft subgrade.		X
Slope Movement		X			X
Erosion		X			X
Seepage		X			X
Culvert Distress		X			X

COMMENTS
Refer to attached photographs and description overpage.
Distress is observed in 3 areas: the 2 southernmost areas comprise one lane only and measure about 10 m long by 5 m wide. The area immediately south of the railway crossing is more extensive and measures about 50 m long by 10 m wide.

Areas of pavement distress are located about 1 km north of Highway 609 and south of the railway crossing in a low area. The road is used for a daily haul route to the Edmonton area. It is understood that the highway is to be overlain in the next 2 to 3 years.

This type of pavement failure generally occurs when the pavement has been stressed to the limit of its fatigue life by repetitive axle load applications. Fatigue cracking is often associated with loads which are too heavy for the pavement structure or more repetitions of a given load than provided for in design. The problem is often made worse by inadequate pavement drainage which contributes to this distress by allowing the pavement layers to become saturated and lose strength. Fatigue cracking is also often caused by repetitive passes with overweight trucks and/or inadequate pavement thickness due to poor quality control during construction. Fatigue cracking can lead to the development of potholes when the individual pieces of asphalt physically separate from the adjacent material and are dislodged from the pavement surface by the action of traffic. Potholes generally occur when fatigue cracking is in the advanced stages and when relatively thin layers of asphalt comprise the bound portion of the pavement (such as a patch).

Repair strategies for fatigue cracking typically involve sub-base removal and replacement. The fatigue cracking is often caused by high moisture content and a poor subgrade. The poor material should be removed and replaced with good material (possibly with the inclusion of geotextile reinforcement) and improving the drainage. Alternatively, a substantial overlay could be placed over the entire surface. Fatigue cracking is a load-associated failure and hence the thickness of the overlay must be structurally designed to carry the number of loads anticipated during the design life of the pavement. If thin overlays or patches are used, the overlays fail prematurely because the underlying layers are too weak and the thin surface does not provide enough thickness to withstand the high stresses produced by truck loadings.

We would recommend that a sub-base removal and replacement approach be adopted for this site. It is understood that the highway structure comprises the following:

For the distressed pavement areas, it is recommended that the soft subgrade soils be excavated to a depth of about 1 m (or to a depth where a competent subgrade is encountered). A layer of woven geotextile with a minimum grab tensile strength of 1400N (e.g. Nilex Woven 2006 or equivalent) should be placed on the subgrade and the excavation backfilled with compacted pitrun gravel (Des. 80). A further layer of woven geotextile should be placed on the surface of the pitrun gravel followed by 250 mm of GBC and 250 mm of ACP. It is recommended that the excavation be inspected by a geotechnical engineer to evaluate the subgrade soils and modify the recommendations accordingly.
