SITE NUMBER AND NAME C46 H21:22 Pavement Distress		HIGHWAY & KM from km 16.4 to km 17.7	PREVIOUS INSPECTION DATE May 15, 2007	INSPECTION DATE June 25, 2008
LEGAL DESCRIPTION 15-44-21-W4	NAD 83 COORDINATES N 5851490 E 367320		RISK ASSESMENT PF: 9 CF: 4 TOTAL: 36

Site C46 H21:22 Pavement Distress
June 25, 2008

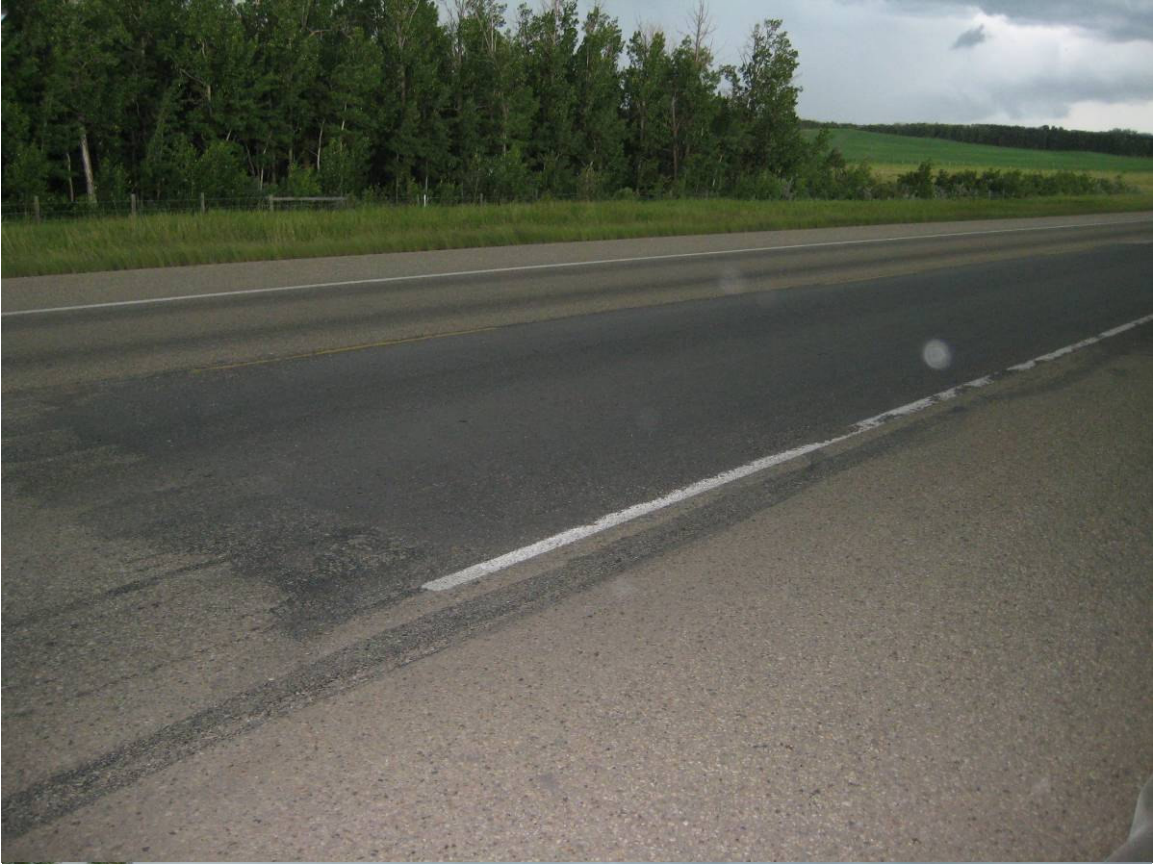
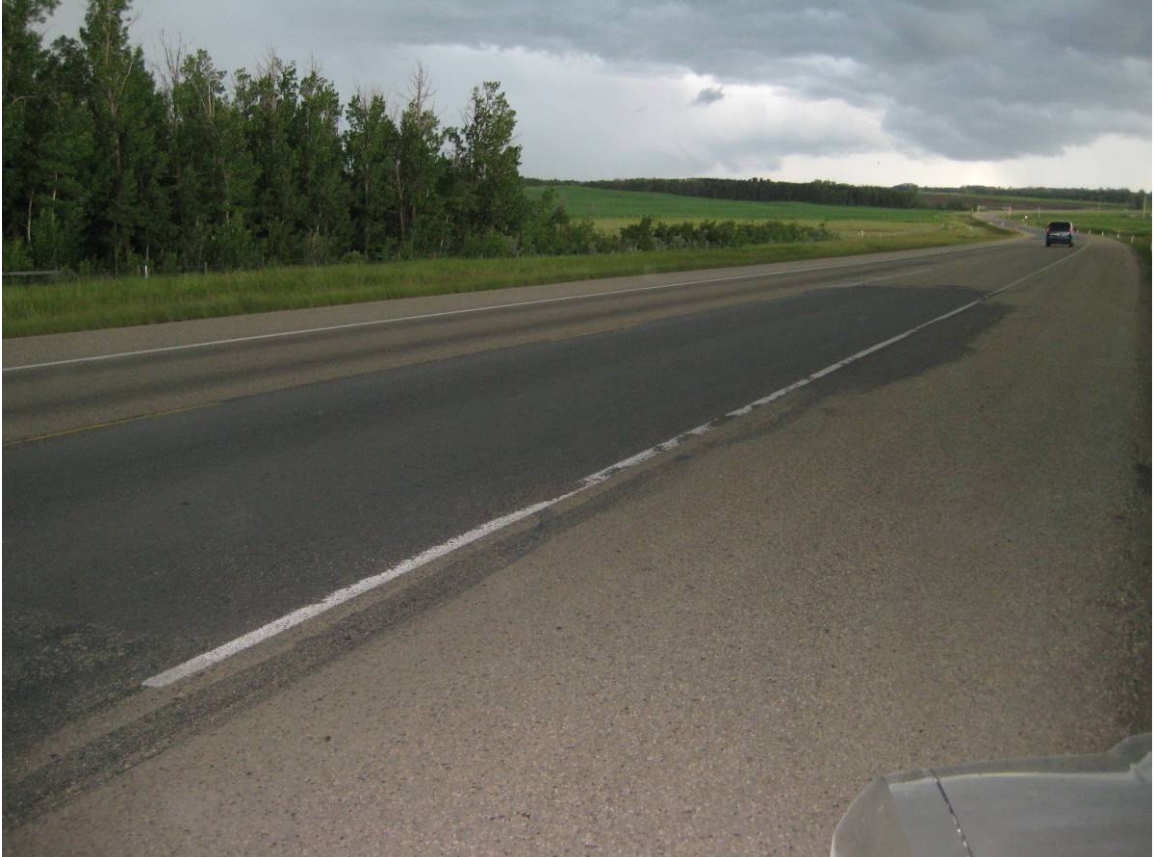
ITEM	CONDITION EXISTS		DESCRIPTION AND LOCATION	NOTICABLE CHANGE FROM LAST INSPECTION	
	YES	NO		YES	NO
Pavement Distress	X		Three areas of severe fatigue cracking in pavement, indicative of a soft subgrade. Asphalt has been patched since previous inspection.	X	
Slope Movement		X			X
Erosion		X			X
Seepage		X			X
Culvert Distress		X			X

COMMENTS
Refer to attached photographs and description overpage.
Distress is observed in 3 areas: the 2 southernmost areas comprise one lane only and measure about 10 m long by 5 m wide. The area immediately south of the railway crossing is more extensive and measures about 50 m long by 10 m wide.
It is recommended that a drilling program be undertaken in 2008 to determine the extent of the weak subgrade.

This type of pavement failure generally occurs when the pavement has been stressed to the limit of its fatigue life by repetitive axle load applications. Fatigue cracking is often associated with loads which are too heavy for the pavement structure or more repetitions of a given load than provided for in design. The problem is often made worse by inadequate pavement drainage which contributes to this distress by allowing the pavement layers to become saturated and lose strength. Fatigue cracking is also often caused by repetitive passes with overweight trucks and/or inadequate pavement thickness due to poor quality control during construction. Fatigue cracking can lead to the development of potholes when the individual pieces of asphalt physically separate from the adjacent material and are dislodged from the pavement surface by the action of traffic. Potholes generally occur when fatigue cracking is in the advanced stages and when relatively thin layers of asphalt comprise the bound portion of the pavement (such as a patch).

The GBC appears relatively thin compared to other lengths of the Control Section where the GBC is typically about 250 mm thick.

Repair strategies for fatigue cracking typically involve sub-base removal and replacement. The fatigue cracking is often caused by high moisture content and a poor subgrade. The poor material should be removed and replaced with good material (possibly with the inclusion of geotextile reinforcement) and improving the drainage. Alternatively, a substantial overlay could be placed over the entire surface. Fatigue cracking is a load-associated failure and hence the thickness of the overlay must be structurally designed to carry the number of loads anticipated during the design life of the pavement. If thin overlays or patches are used, the overlays fail prematurely because the underlying layers are too weak and the thin surface does not provide enough thickness to withstand the high stresses produced by truck loadings.

We would recommend that a sub-base removal and replacement approach be adopted for this site. It is understood that the highway structure comprises the following:
