SITE NUMBER AND NAME C22 H22:20 Road Dips		HIGHWAY & KM	PREVIOUS INSPECTION DATE June 18, 2011	INSPECTION DATE June 18, 2012
LEGAL DESCRIPTION SW 9-35-5-W5	NAD 83 COORDINATES N 5761985 E 660135		RISK ASSESMENT PF: 9 CF: 3 TOTAL: 27

PRIMARY SITE ISSUE: Settlement due to consolidation of underlying muskeg materials.	
APPROXIMATE DIMENSIONS:	
DATE OF ANY REMEDIAL ACTION:

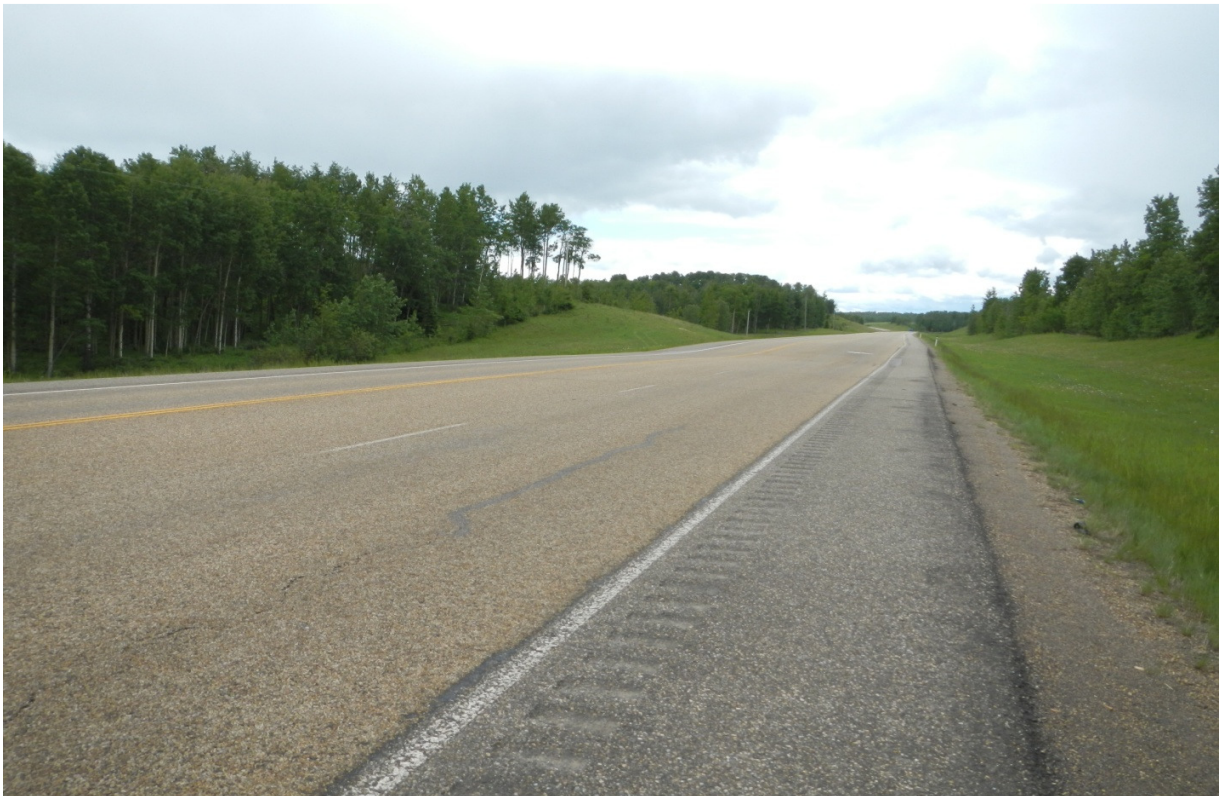
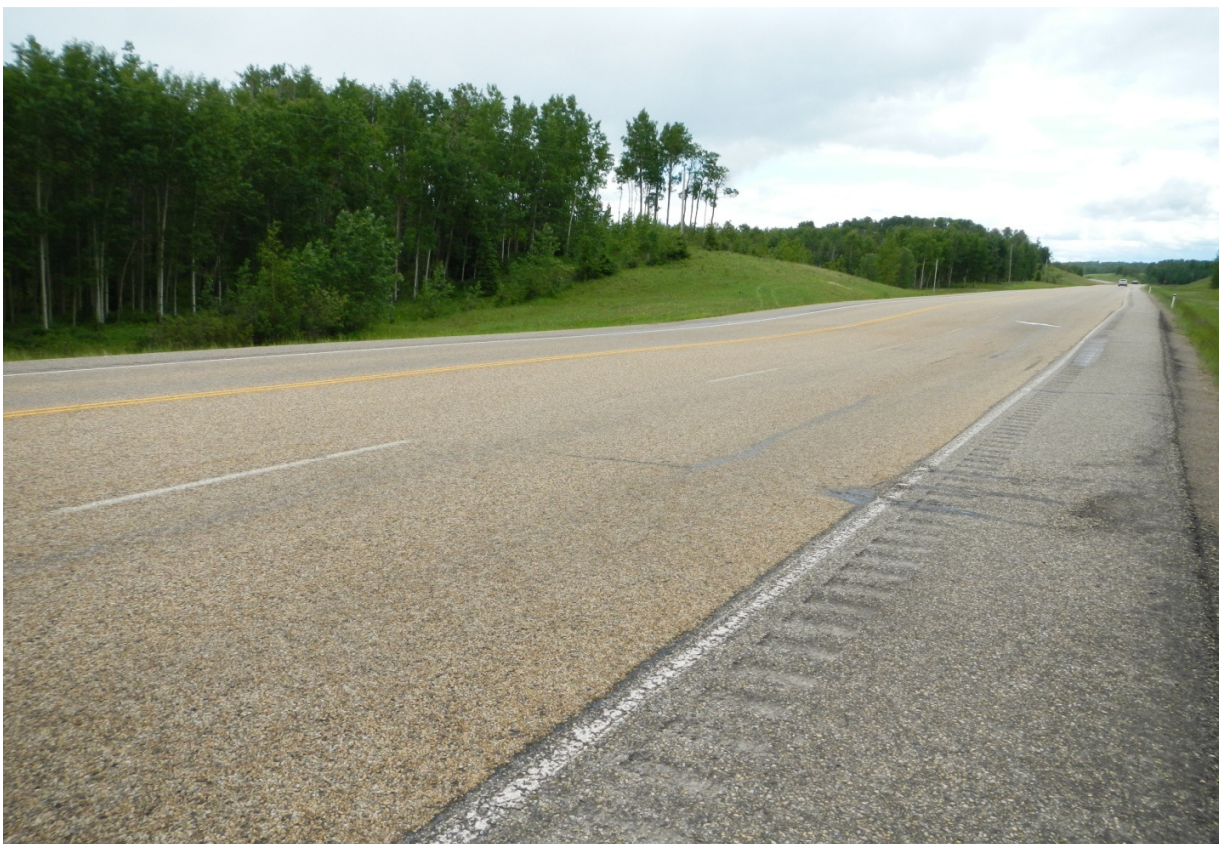
Site C22 H22 Dips
June 18, 2012

ITEM	CONDITION EXISTS		DESCRIPTION AND LOCATION	NOTICABLE CHANGE FROM LAST INSPECTION	
	YES	NO		YES	NO
Pavement Distress	X		Pavement settlement at two locations about 100 m apart. Settlement is on-going but slow. The settlement zones are sufficiently long to reduce the hazard to traffic, but creates an uncomfortable ride due to the dip. No significant changes were observed.		X
Slope Movement					
Erosion					
Seepage					
Culvert Distress

COMMENTS
Refer to the previous reports and attached photos.
The dips should be repaired during the next overlay project on this highway section.
Expanding foam injection could be considered to consolidate the muskeg and potentially raise the road at this location.
The cover for the flush-mount road-box protecting the slope inclinometer was missing at the time of the June 2012 inspection. The cover was located, but debris may have entered the inclinometer casing while the cover was off.
