SITE NUMBER AND NAME <b>C22 H22:20 Road Dips</b>		HIGHWAY & KM	PREVIOUS INSPECTION DATE June 18, 2012	INSPECTION DATE <b>May 20, 2014</b>
LEGAL DESCRIPTION SW 9-35-5-W5	NAD 83 COORDINATES N 5761985 E 660135	RISK ASSESMENT PF: 9 CF: 3 TOTAL: <b>27</b>

PRIMARY SITE ISSUE: Settlement due to consolidation of underlying muskeg materials.	
APPROXIMATE DIMENSIONS:	
DATE OF ANY REMEDIAL ACTION:

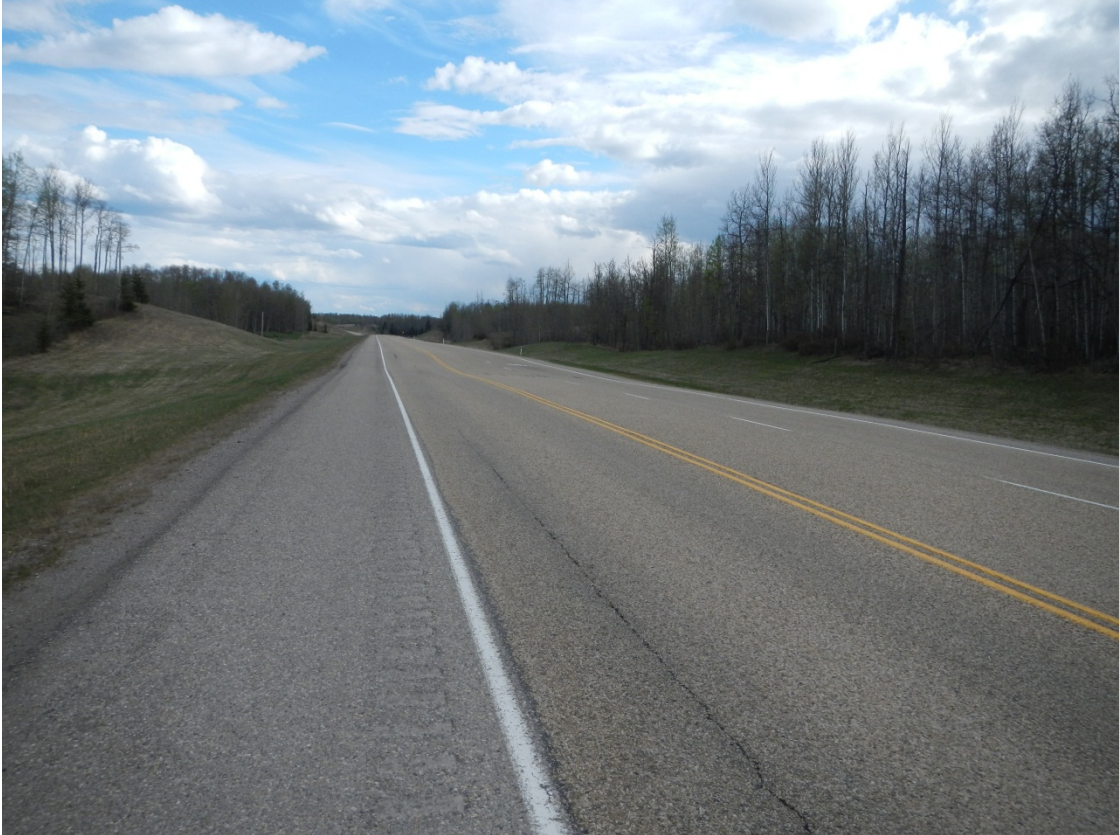
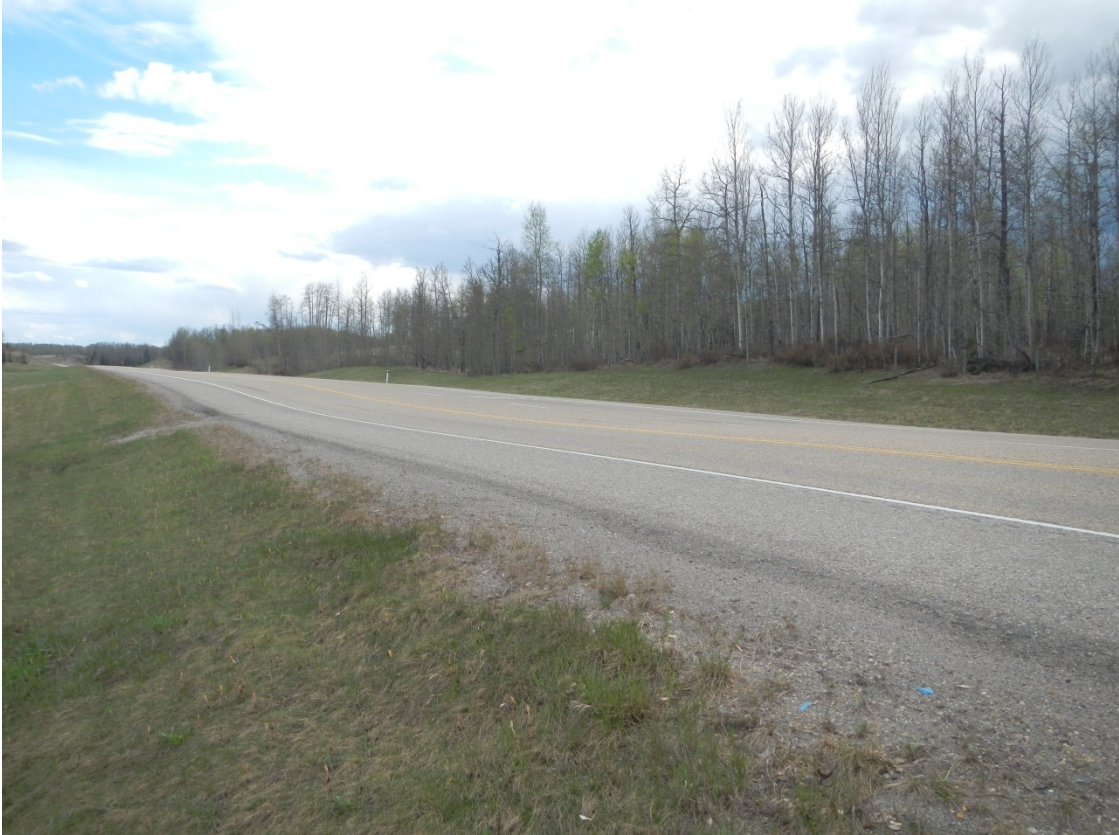
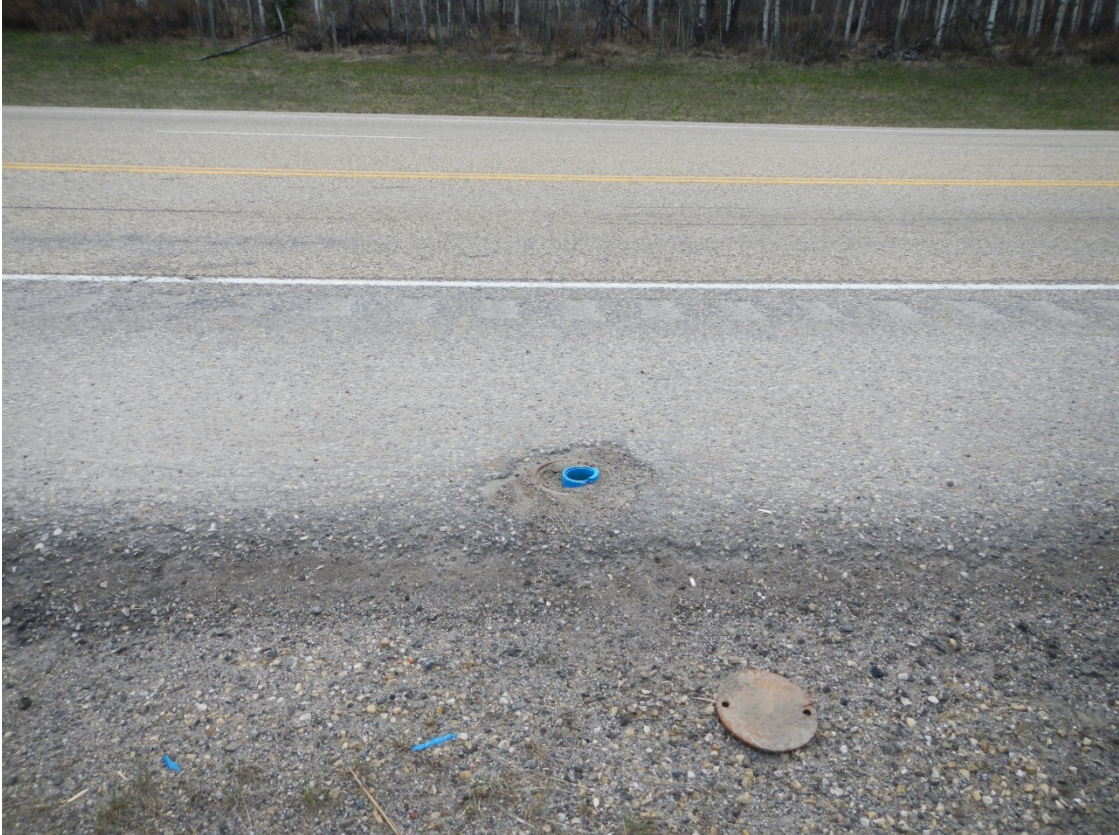
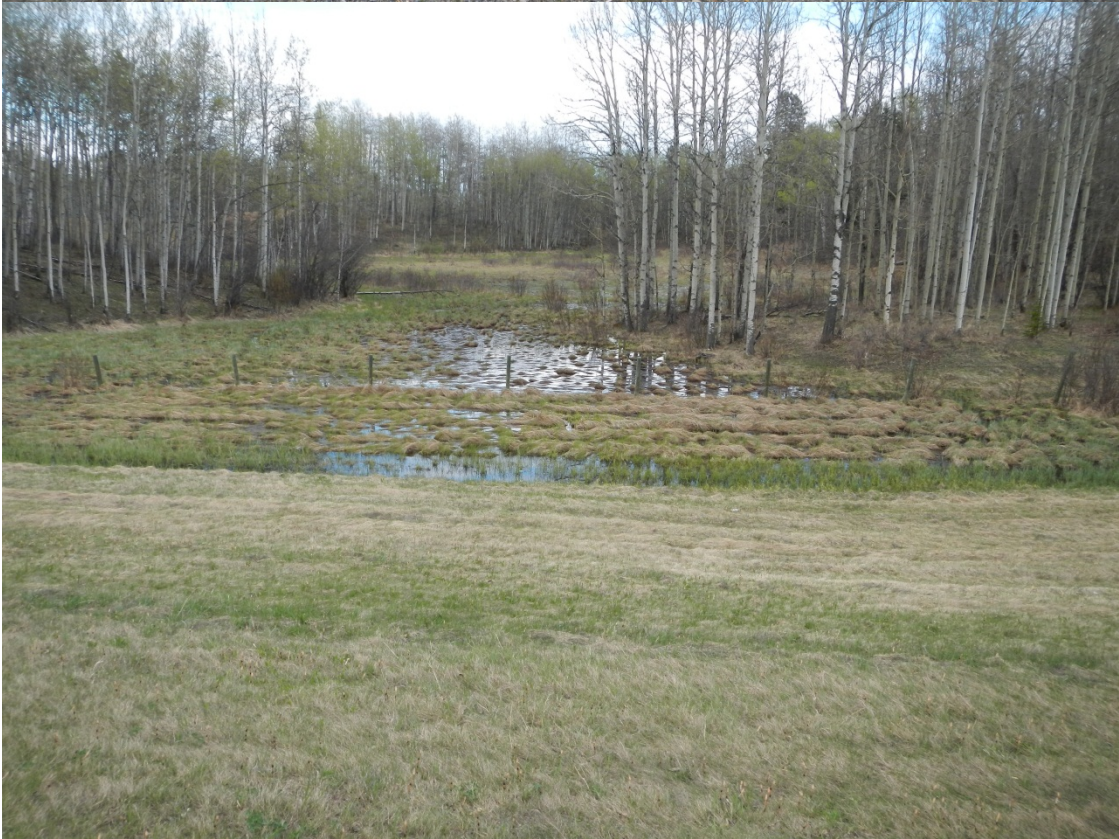
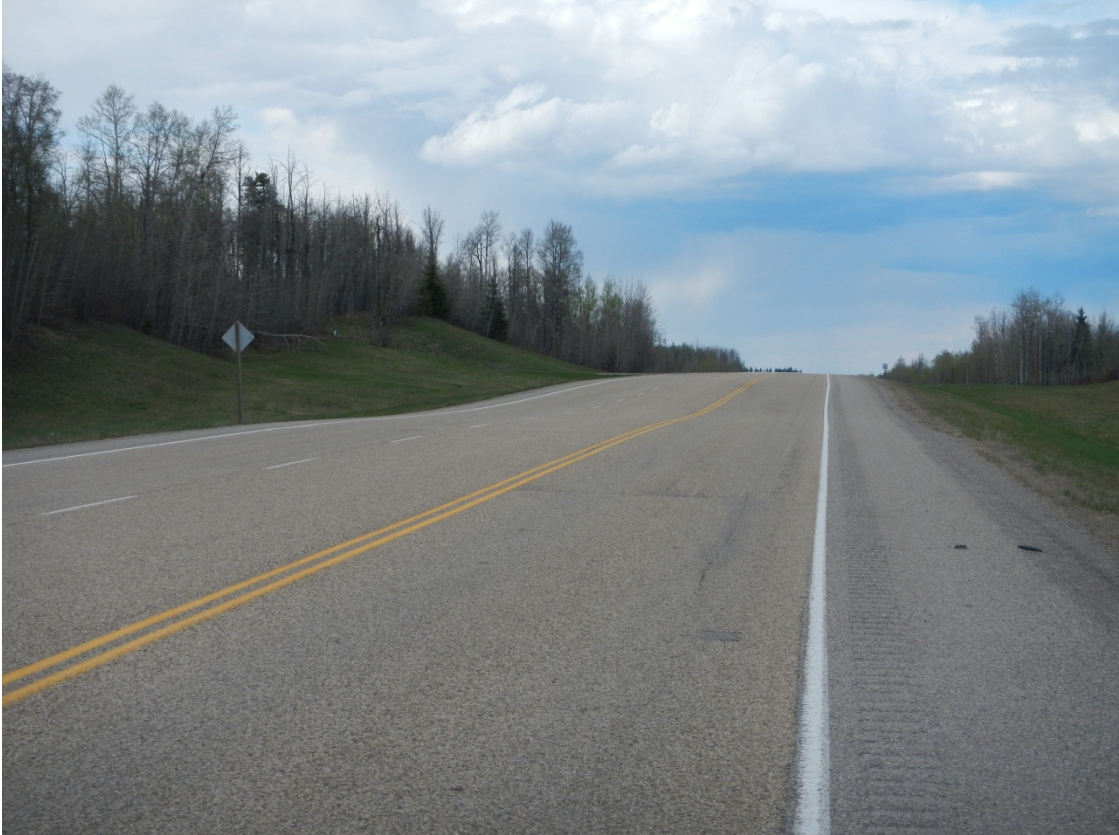
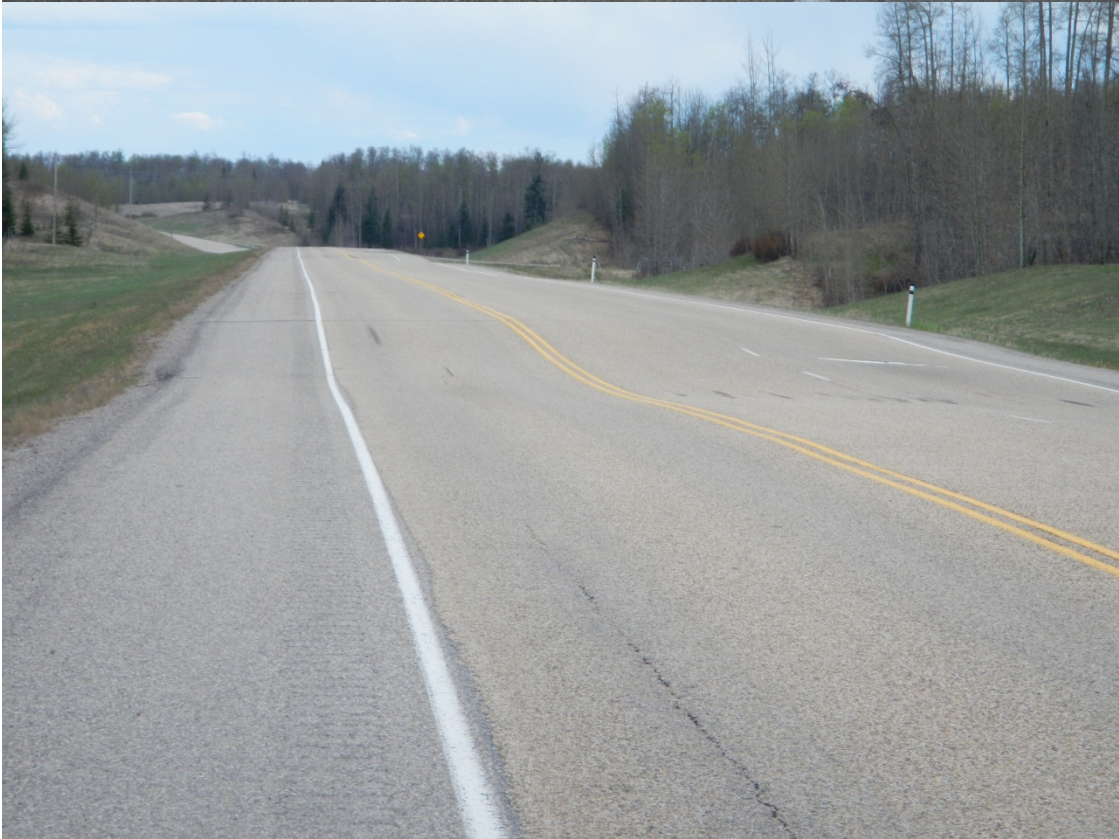
ITEM	CONDITION EXISTS		DESCRIPTION AND LOCATION	NOTICABLE CHANGE FROM LAST INSPECTION	
	YES	NO		YES	NO
Pavement Distress	X		Pavement settlement at two locations about 100 m apart. Settlement is on-going but slow. The settlement zones are sufficiently long to reduce the hazard to traffic, but creates an uncomfortable ride due to the dip. No significant changes were observed.		X
Slope Movement					
Erosion					
Seepage					
Culvert Distress

COMMENTS
Refer to the previous reports and attached photos.
The dips should be repaired during the next overlay project on this highway section.
Expanding foam injection could be considered to consolidate the muskeg and potentially raise the road at this location.
The cover for the flush-mount road-box protecting the slope inclinometer was missing at the time of the inspection. The cover was located, but debris may have entered the inclinometer casing while the cover was off. Due to the settlement of the road, the top of the SI pipe is now at road level (originally about 50 mm below road surface).
