SITE NUMBER AND NAME C41 H22:22 Erosion		HIGHWAY & KM 17.8	PREVIOUS INSPECTION DATE May 18, 2011	INSPECTION DATE May 20, 2014
LEGAL DESCRIPTION 7-38-6-W5	NAD 83 COORDINATES N5791465 E646190		RISK ASSESMENT PF: 1 CF: 1 TOTAL: 1

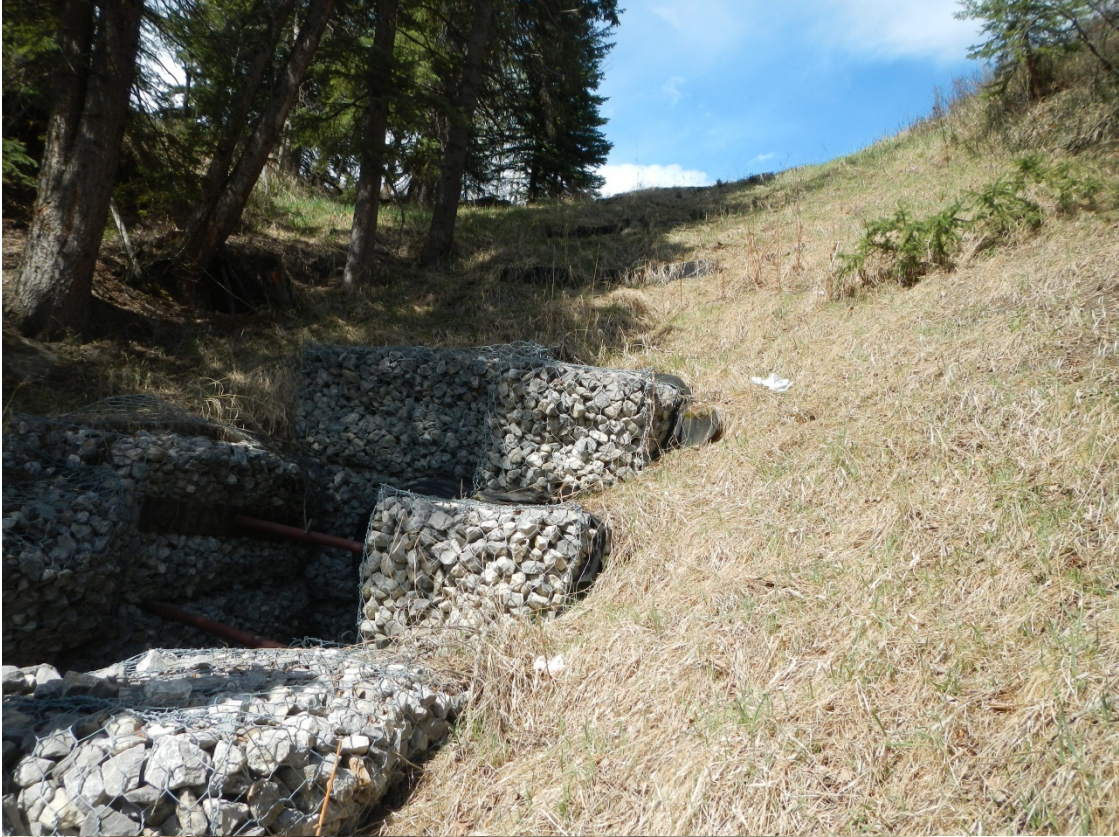
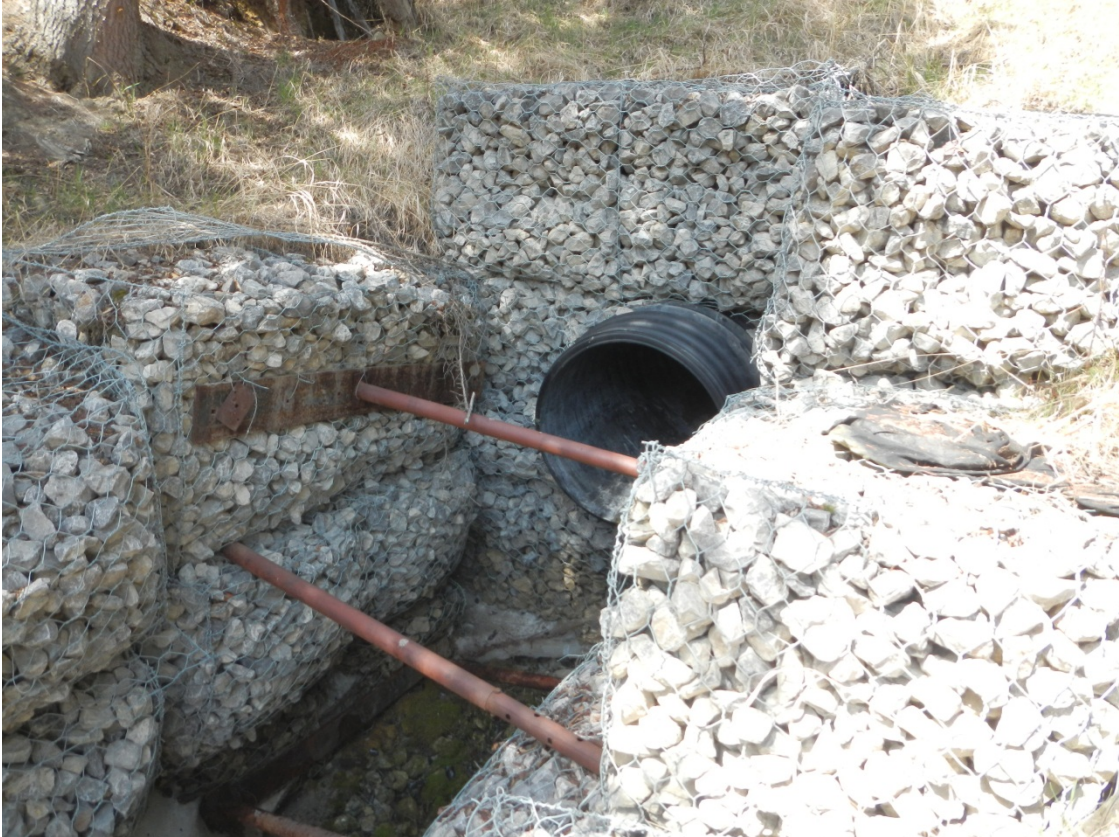
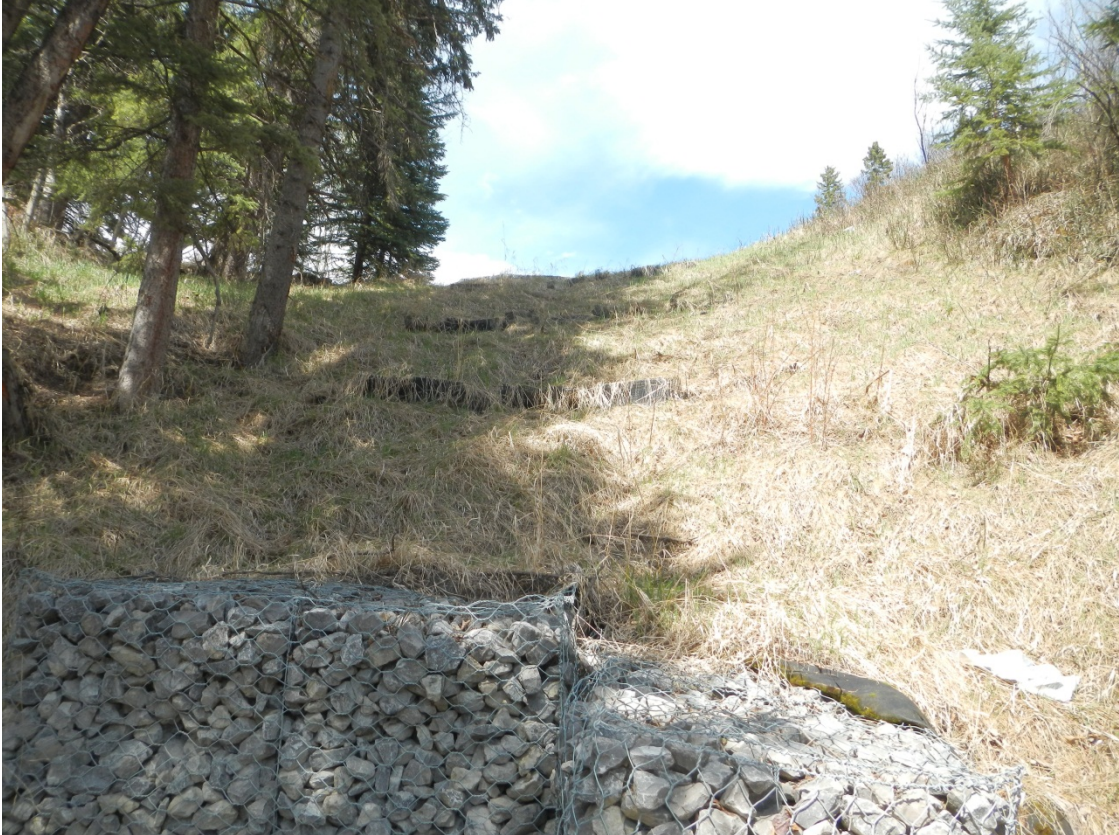
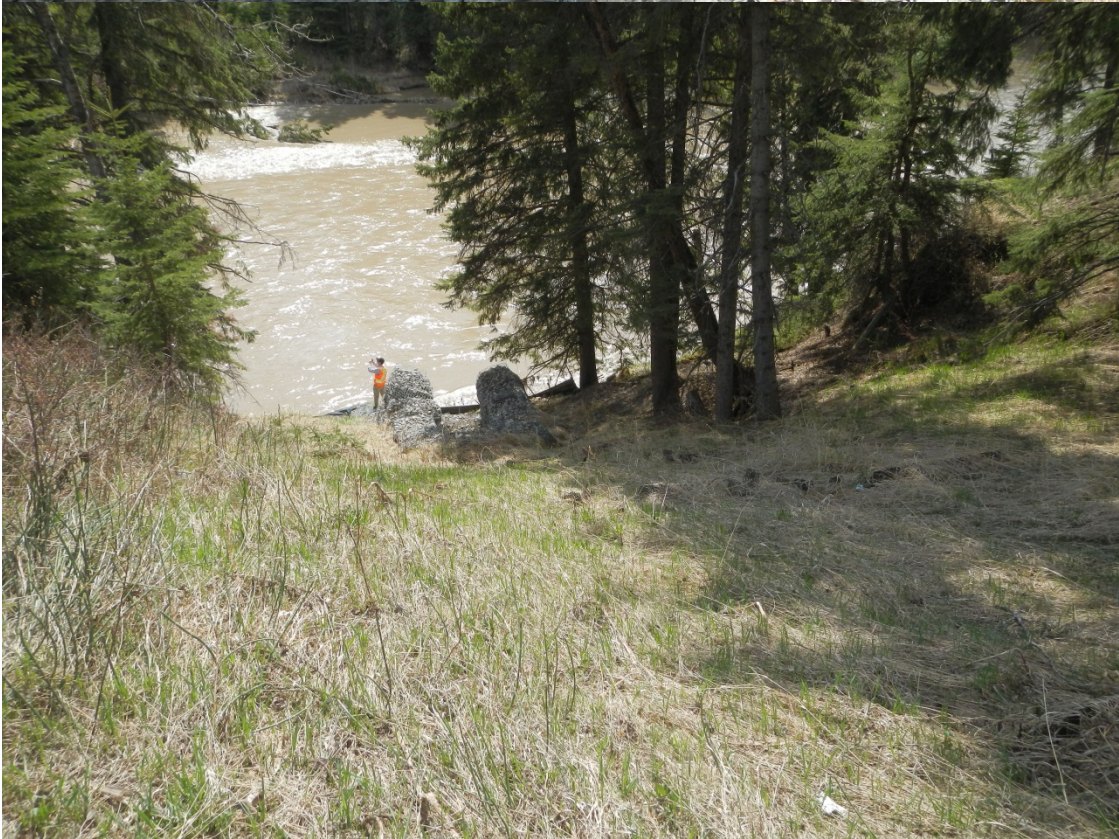
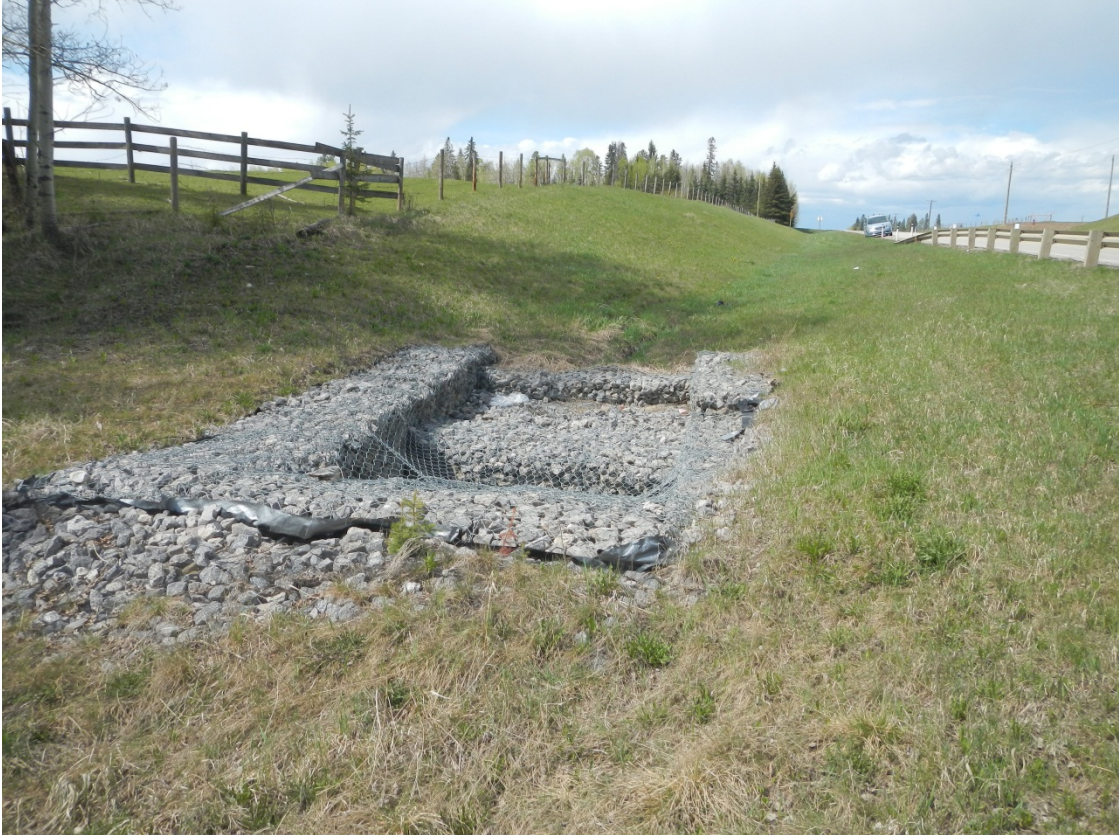
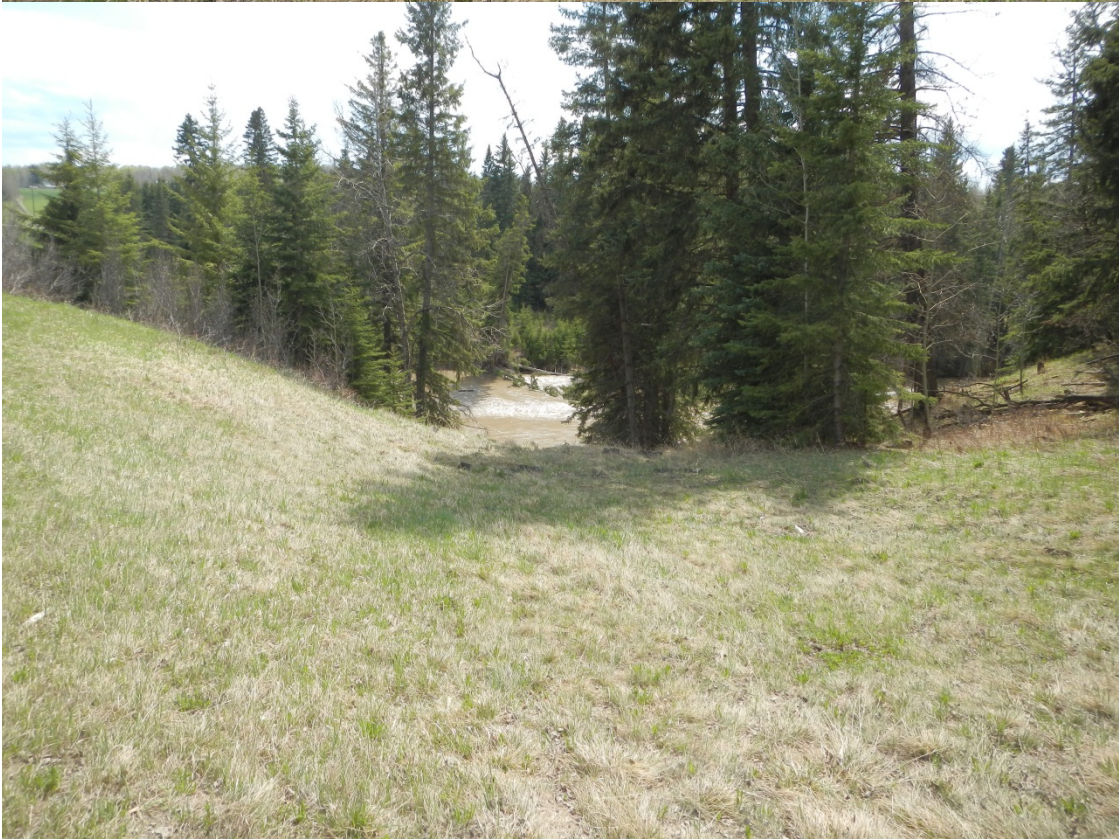
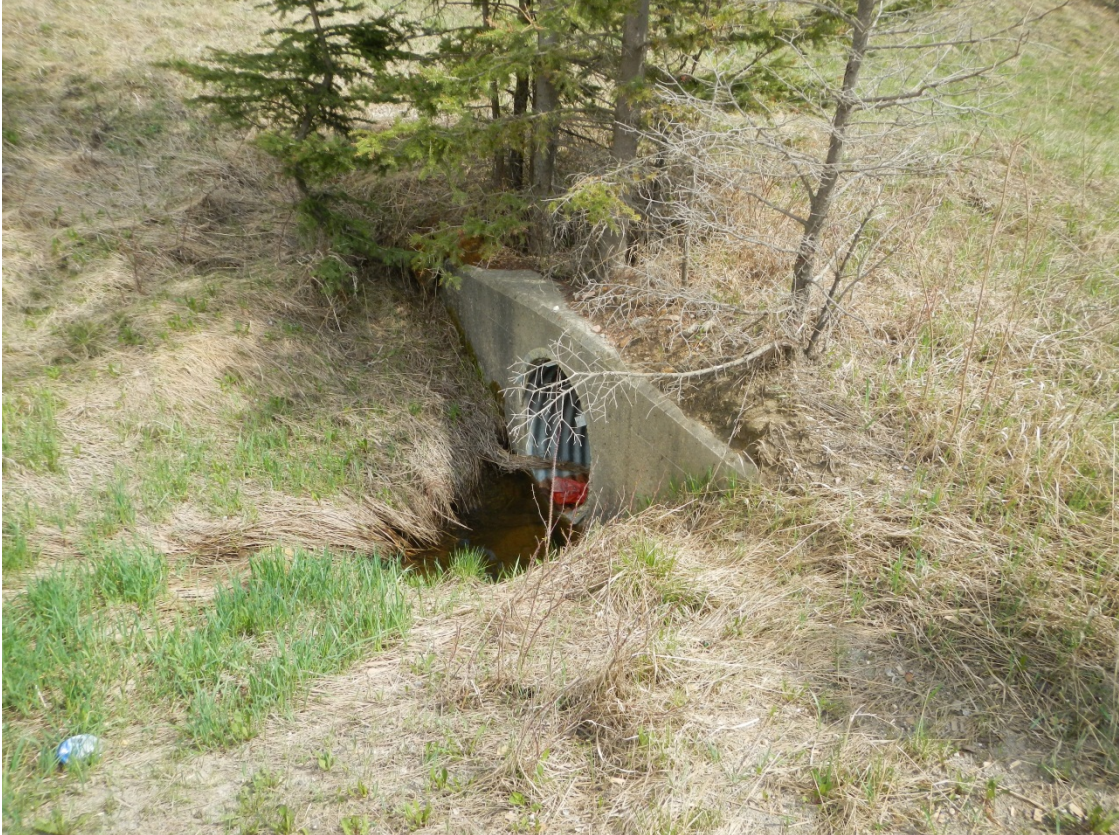
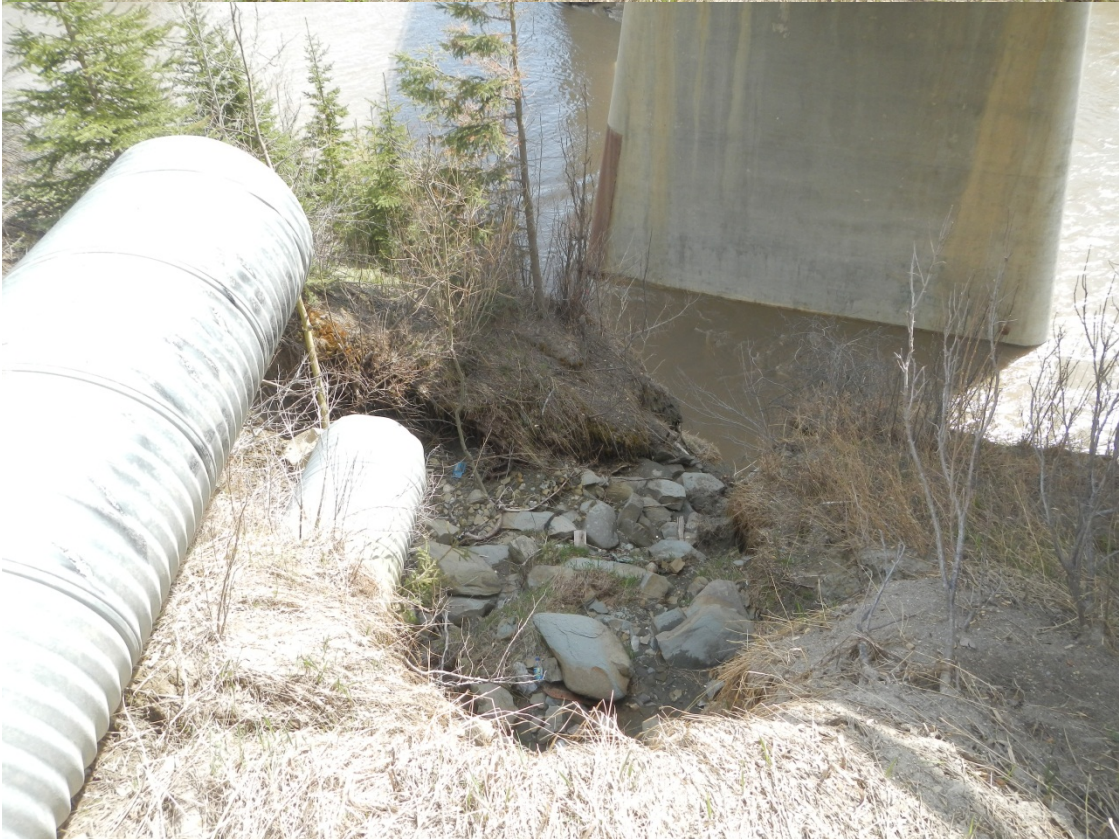
ITEM	CONDITION EXISTS		DESCRIPTION AND LOCATION	NOTICABLE CHANGE FROM LAST INSPECTION	
	YES	NO		YES	NO
Pavement Distress					
Slope Movement					
Erosion	X	X	No erosion is apparent since construction on west side. Slope is eroding below culvert on east side of bridge.	X	X
Seepage					
Culvert Distress		X			X

COMMENTS
Refer to previous reports and attached photos.
Repairs to be conducted as part of High Water Mitigation Program
