| SITE NUMBER AND NAME C41 H22:22 Erosion | | HIGHWAY & KM 17.8 | PREVIOUS INSPECTION DATE May 20, 2014 | INSPECTION DATE June 23, 2015 |

PRIMARY SITE ISSUE: The site is located on the north abutment of the Highway 22 crossing of the Clearwater River. Heavy rain in Southern Alberta in June 2005 and 2013 caused significant flood events and subsequent damage to infrastructure. Erosion has historically occurred on the east and west sides of the north abutment which is at the crest of a steep (estimated 0.5H:1V slope) slope on the outside bend of the river. Repairs were conducted to the erosion site to the west of the abutment, but erosion continues on the east abutment.

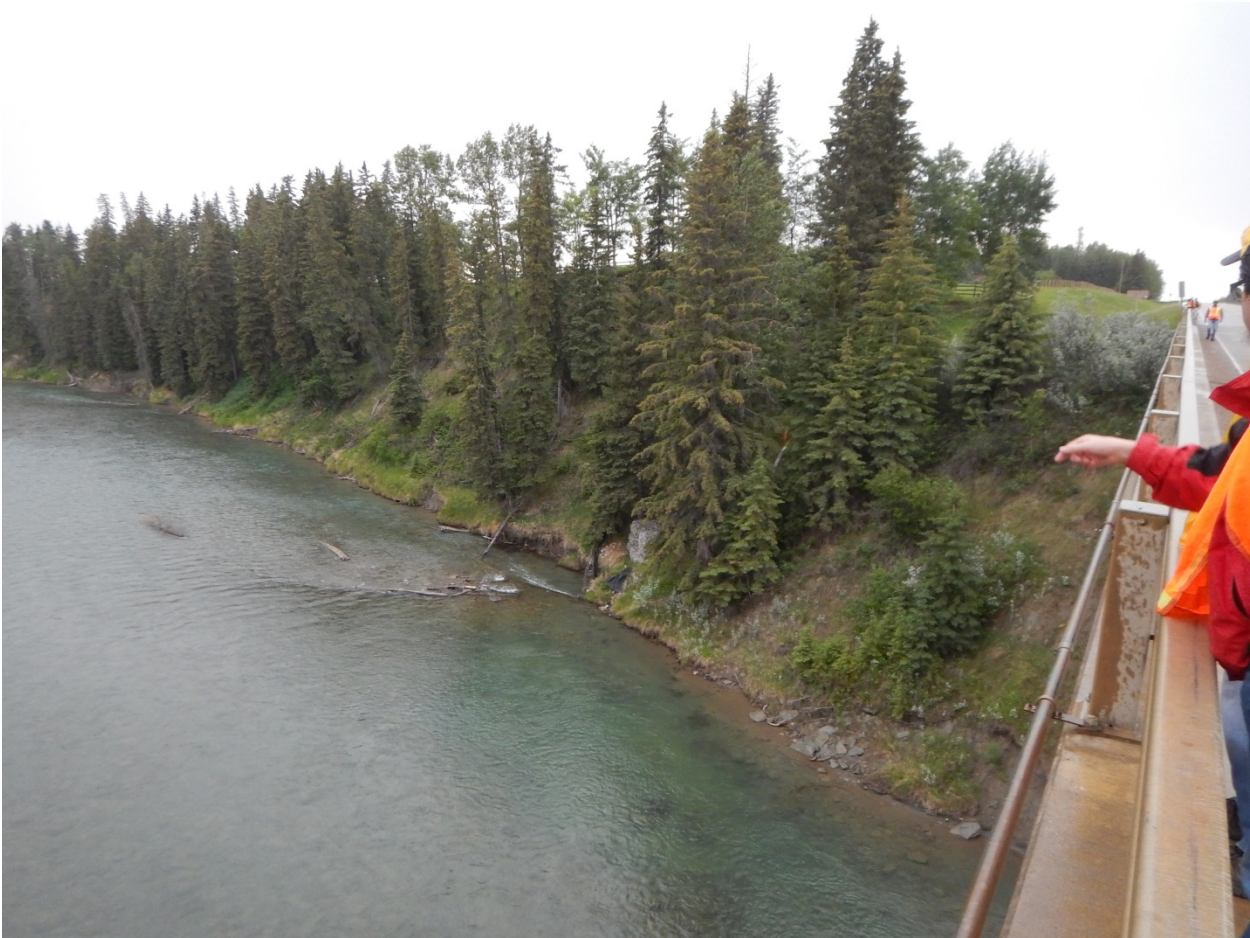
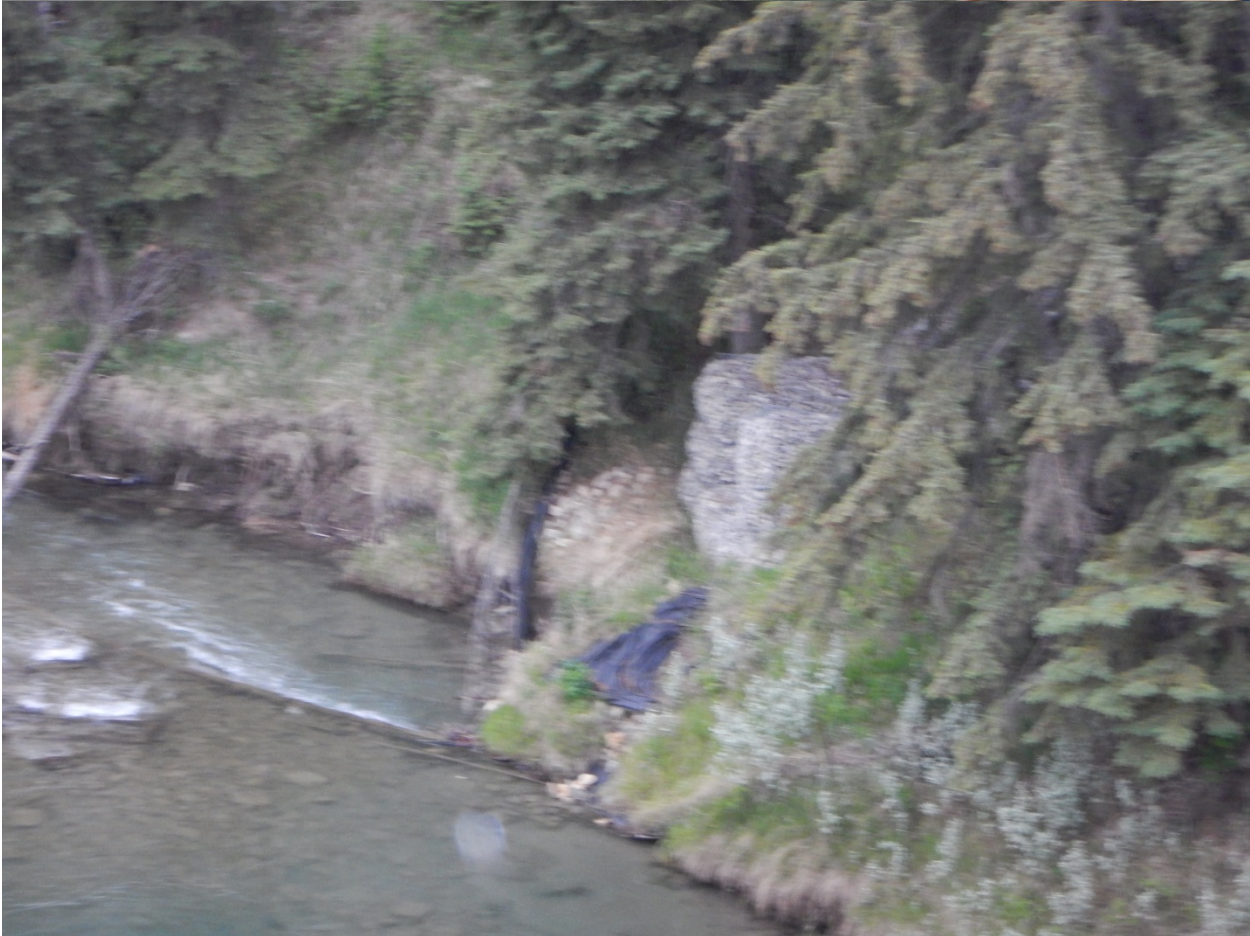
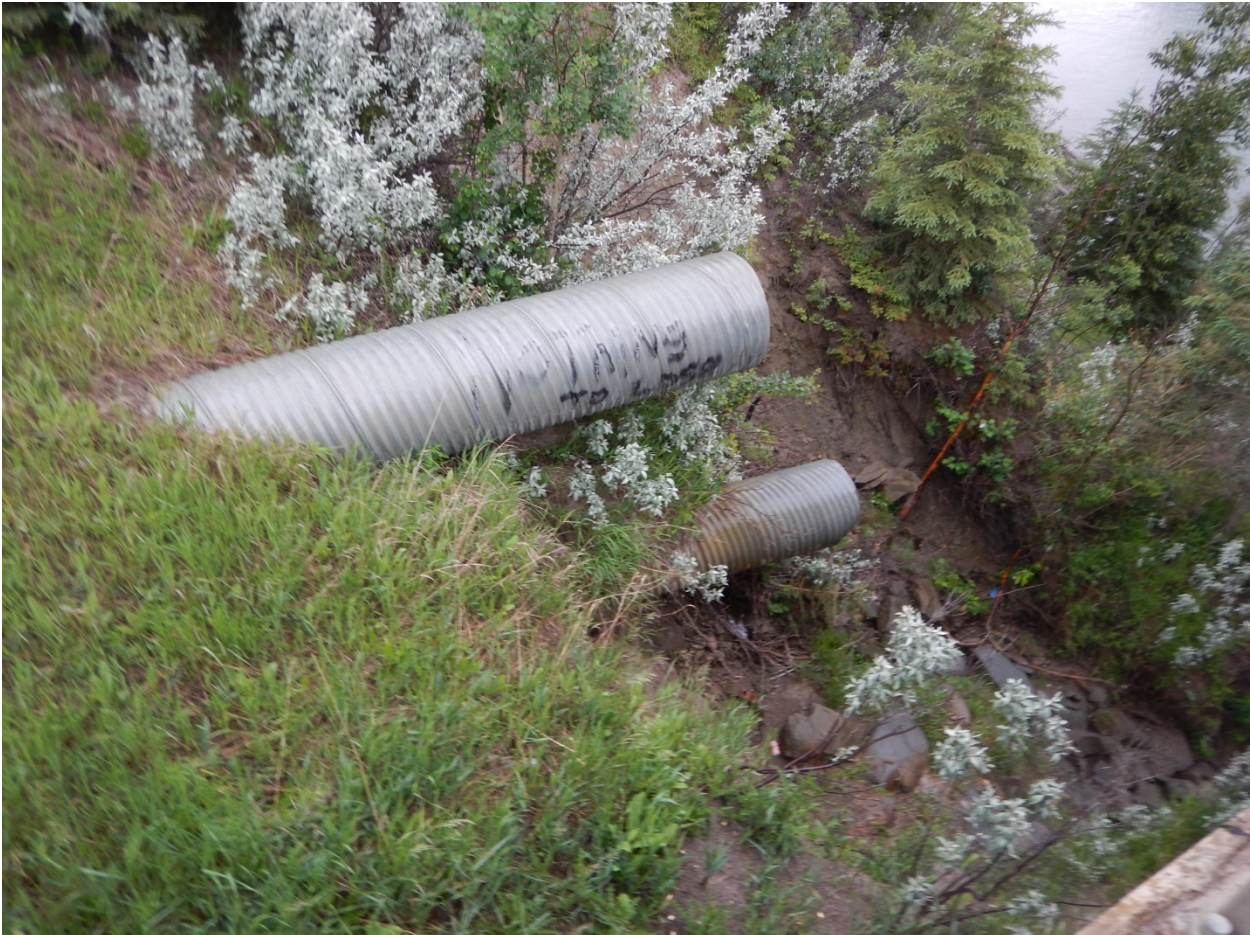
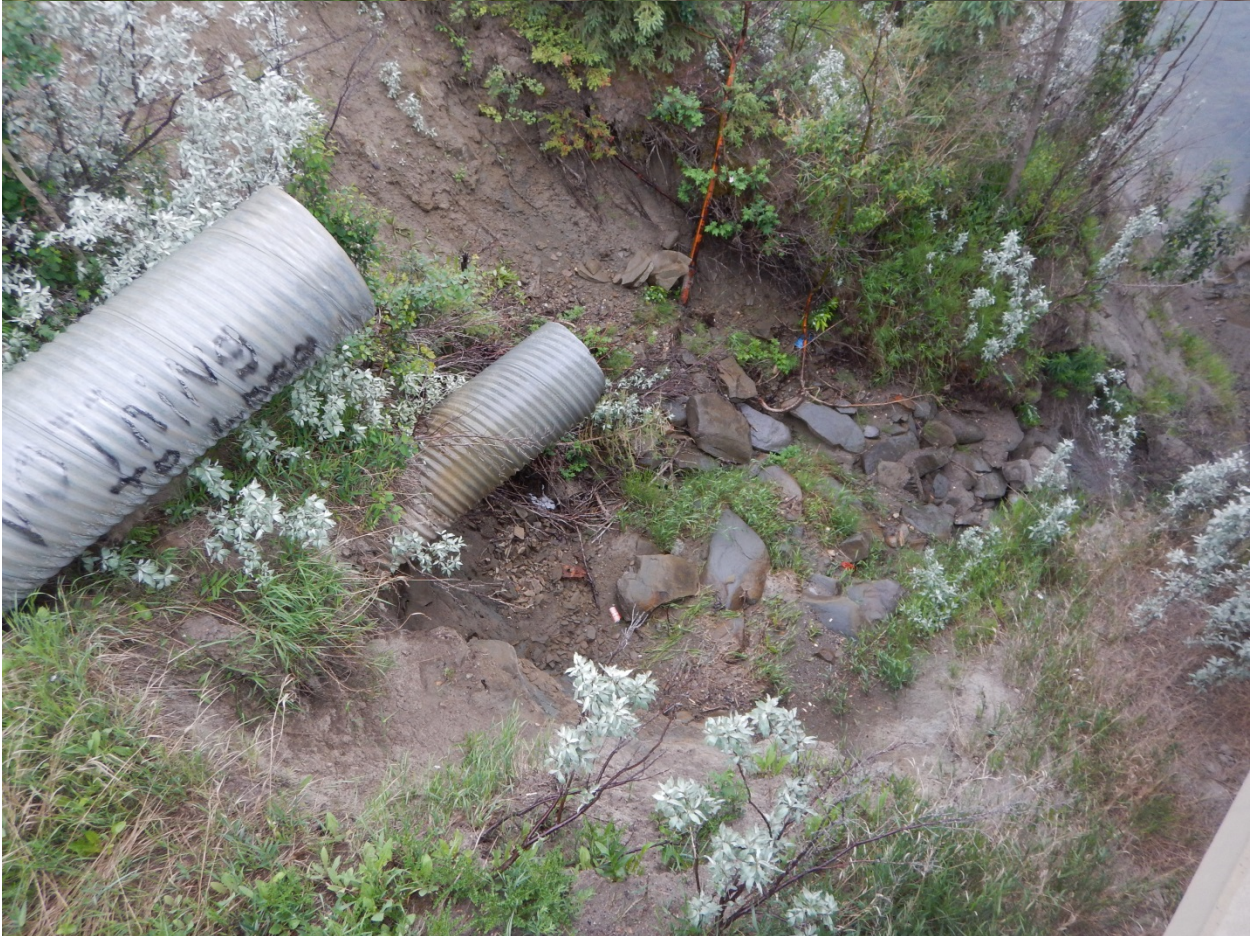
| ITEM | CONDITION EXISTS | | DESCRIPTION AND LOCATION | NOTICABLE CHANGE FROM LAST INSPECTION | |
|---|---|---|---|---|---|
| Erosion | X | X | No erosion is apparent since construction on west side. Slope is eroding below culvert on east side of bridge. | | X |

| ITEM | CONDITION EXISTS | | DESCRIPTION AND LOCATION | NOTICABLE CHANGE FROM LAST INSPECTION | |
|---|---|---|---|---|---|
| <p>The May 11, 2006 inspection encountered erosion damage on both sides of Highway 22 at the north abutment of the Clearwater River crossing. On the west side there was an eroded channel on the valley slope where surface water flowed to river level. On the east side, a buried 800 mm corrugated steel pipe (CSP) culvert, with concrete inlet structure experienced a separated joint behind the crest of the slope.</p> <p>Repair work was conducted in 2007 and included an HDPE pipe and gabion inlet and outlet structures on the west side of the road. The repair work on the east side of the road consisted of installing a second 800 mm CSP culvert at a relatively flat grade that connected to the inlet structure and replaced the original culvert outfall which was installed at a much steeper grade with a lower outlet elevation. Initially, it was proposed that the damaged culvert area be excavated, the pipe repaired and the ditch re-instated. However, it appears that the poor access and proximity of the work to a near vertical cliff precluded excavation of the original culvert. As a result, it was disconnected and left in place.</p> <p>West Abutment The gabion structures are in good condition. The ditch and slope to the river are well vegetated with no indications of erosion. Minor erosion of the riverbank is occurring below the gabion outlet structure. Riprap placement at this location is recommended.</p> <p>East Abutment Erosion has created a gully downslope of the upper 800 mm diameter culvert outfall and has removed shrubs and ground cover vegetation. The erosion is offset to the west from the culvert outfall which could indicate that the outflow from the upper culvert is landing on the lower decommissioned culvert and being deflected to the west. The horizontal distance from the river bank slope at the upper culvert location to edge of river is approximately 17 m. The estimated height of the upper culvert invert above river level was approximately 13 m.</p> <p>Erosion has created a gully on the slope face by eroding clay or silt till and colluvium. The top of bedrock is located approximately one third of the slope height below the crest of the slope and is exposed in the base of the erosion gully on the lower two thirds of the slope. The depth of the erosion gully is minimal on the lower half of the slope where bedrock is close to or at surface. The erosion present below the outfall is due to the height that water is dropped from the upper culvert. The extent of erosion varies on the slope due to the presence of unconsolidated colluvial deposits on the slope face and underlying till and colluvium which is more erodible than the underlying bedrock.</p> <p>The erosion at this site could be mitigated by conveying the water from the upper culvert outlet down to the point where bedrock is exposed on the slope face. Extending a slope drain to river level may run the risk of high water or ice action causing dislocation, damage or loss of the slope drain. The bedrock is a relatively non-erodible surface. If erosion continues (albeit at a slower rate), an extension could be added to the slope drain to release water closer to river water level; however, the high water level for the river should be considered in locating the elevation of the outlet.</p> | | | | | |
