May 24, 2001

**Central Region Landslide Assessment Site C1**  
**H27:10 Ghostpine Creek Slide**  
**2001 Annual Inspection Report**

This report was prepared by Klohn Crippen Consultants Ltd. for Alberta Transportation Central Region under Contract No. CE053/2000.

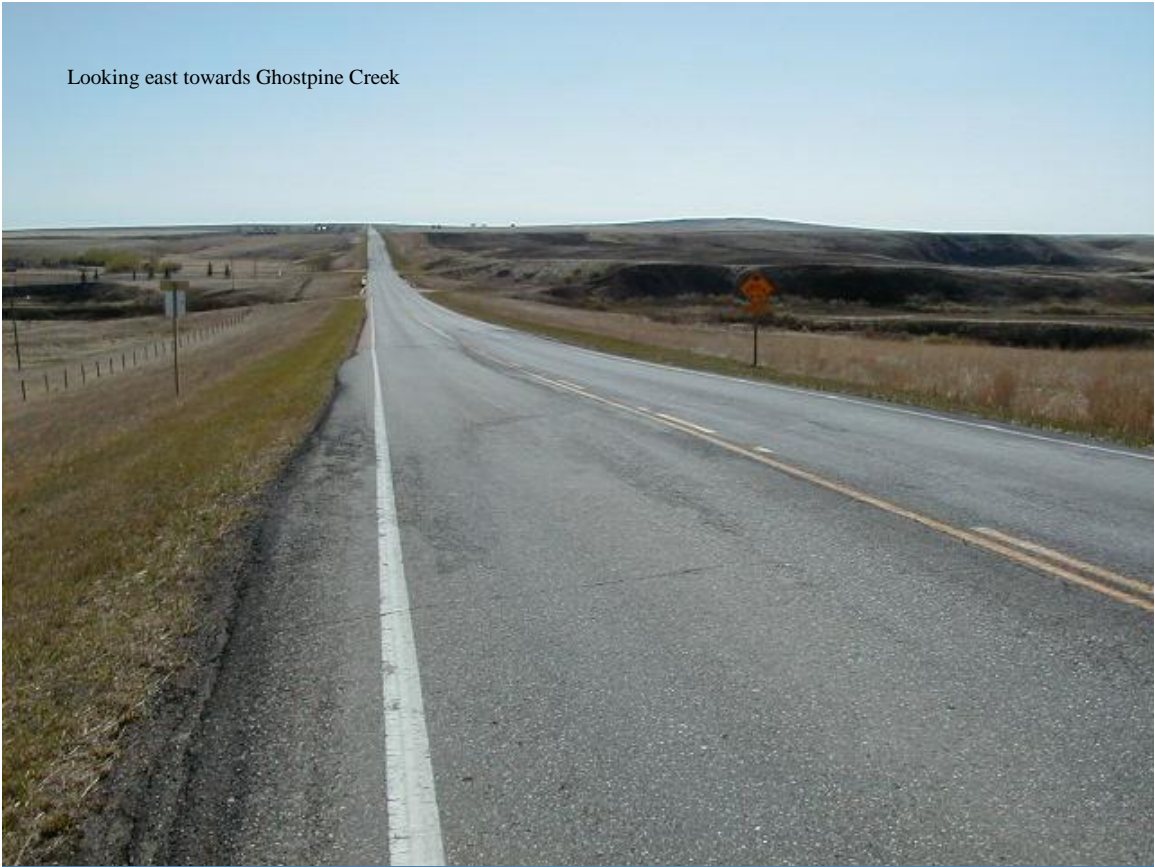
Looking east towards Ghostpine Creek

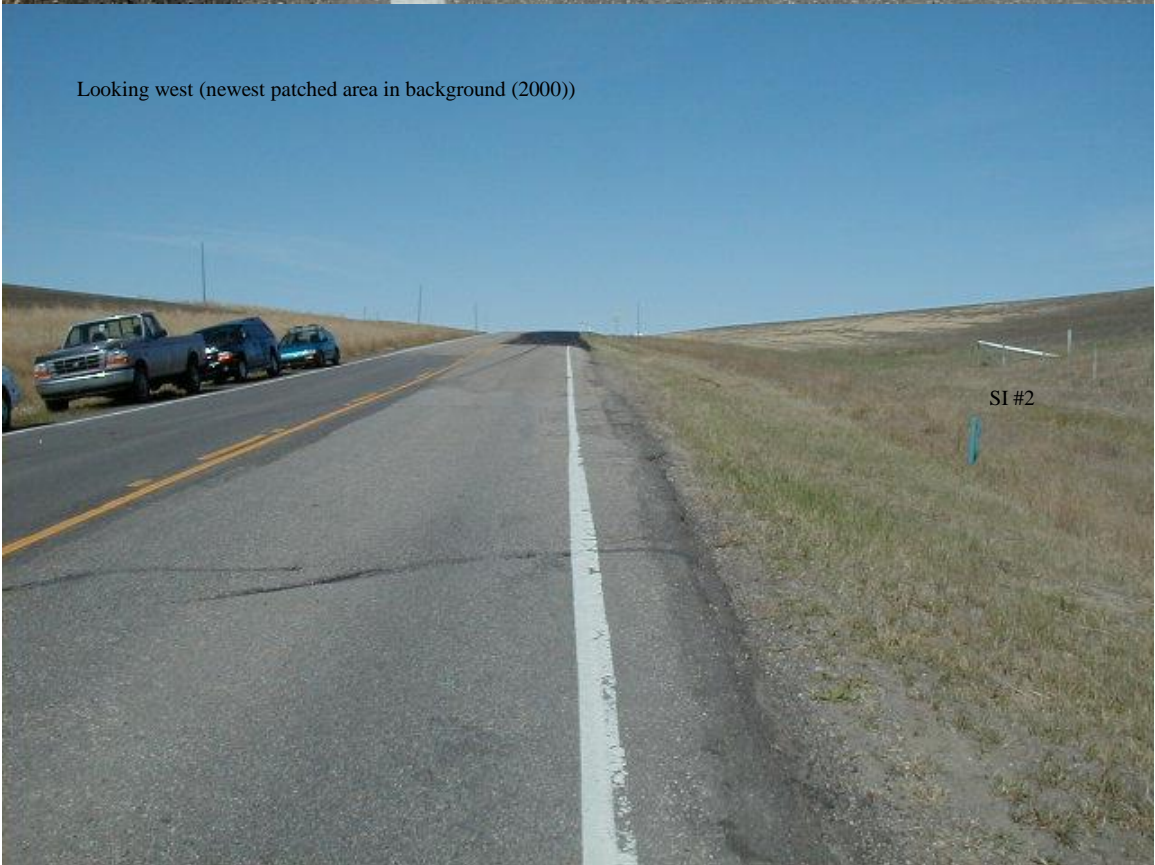
The cracking of highway pavement and slopes is summarized on Figure 1. Essentially there has been no change in the crack pattern since the last inspection in May 2000. Dips and bumps are present in the highway pavement as a result of repeated patching in the area. A new patch was placed in 2000 on the north lane on the west side of the movement site.

Looking west (newest patched area in background (2000))

- As the movement in the area is very slow, it is recommended that highway pavement be milled down and patched to remove the cracks, dips and bumps in this road section as part of the overlay construction.

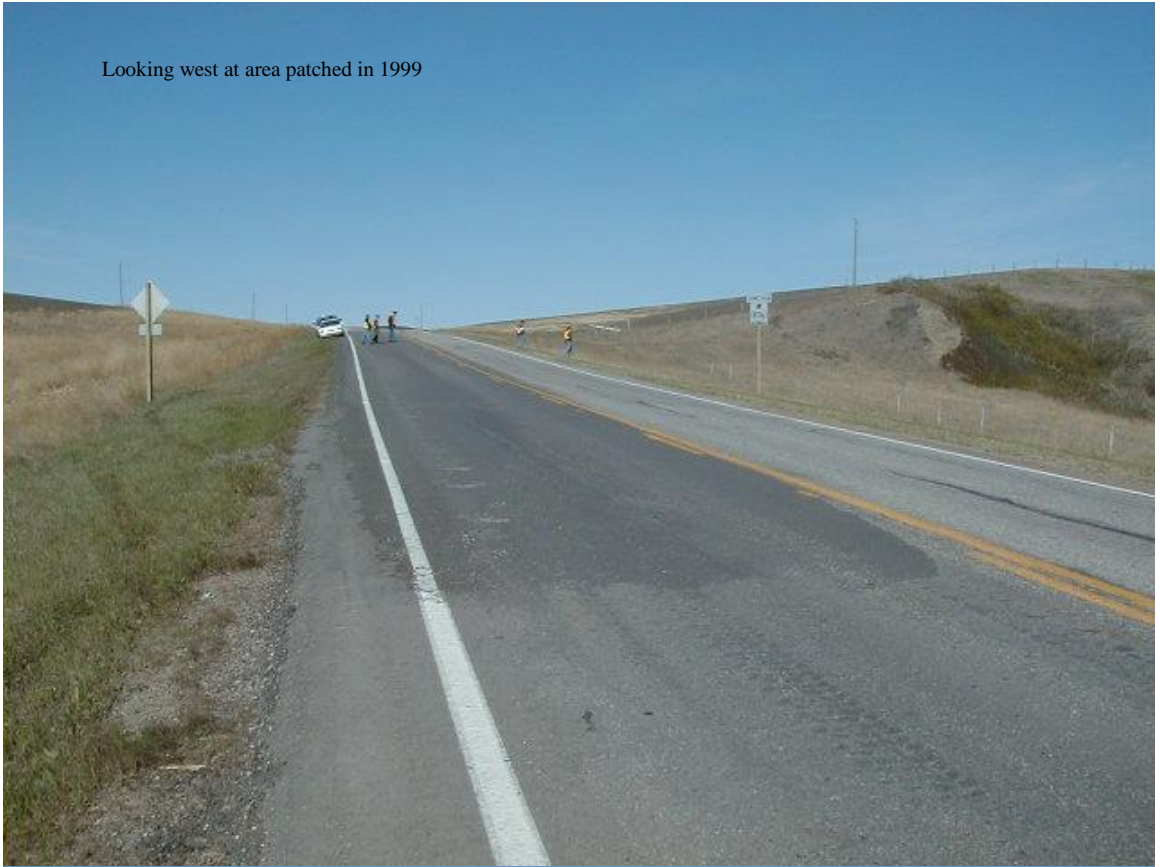
Looking west at area patched in 1999

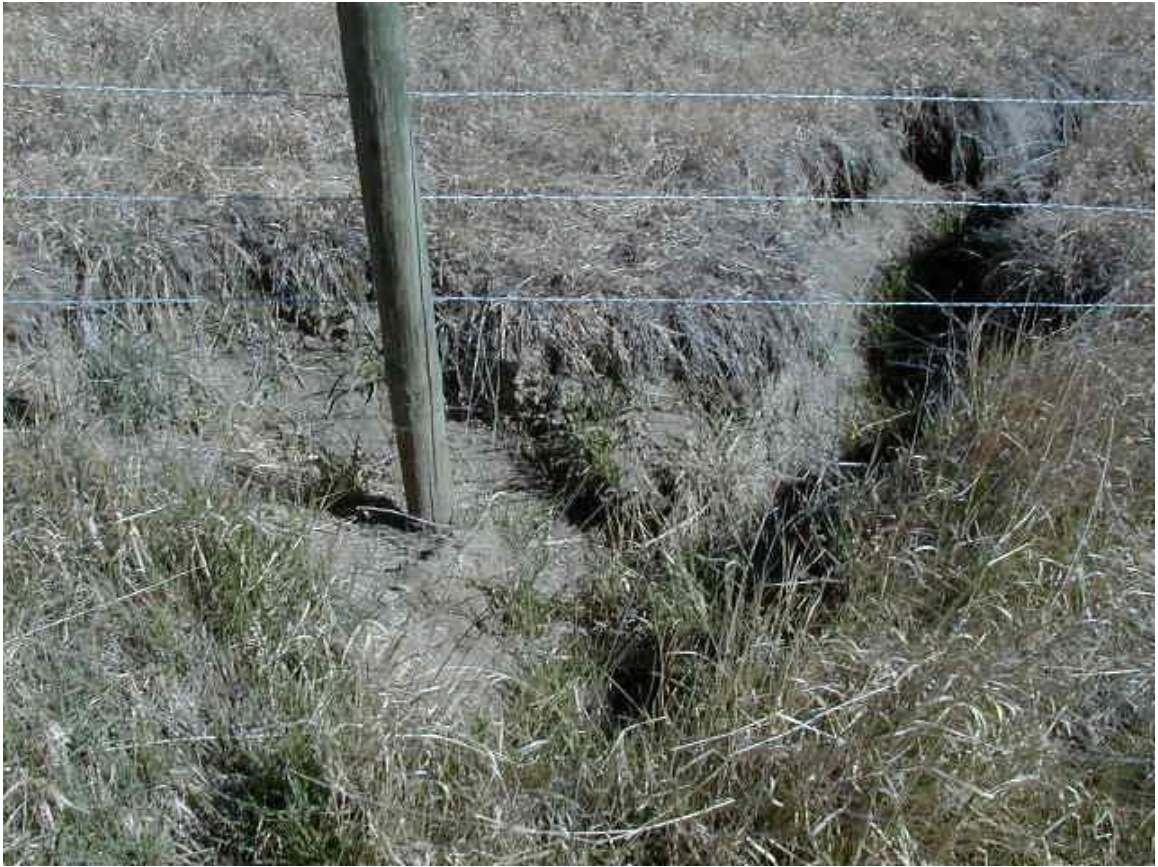
On the north side of the highway, ditch flows have eroded channels terminating in a large eroded gully down to the creek. Although the gully does not affect the highway at this time, it may become a significant problem in the future particularly after erosion further increases due to a series of heavy rainfall events.

Looking west at small erosion channel forming on north side of highway

- The eroded cracks on the north side of the highway should be repaired by constructing drainage channels, say 0.5 m wide, with similar cobble size erosion protection as the south side. For the large eroded gully down the steeper portion of the side slope, it is recommended that a 600 mm CSP be provided in the gully for

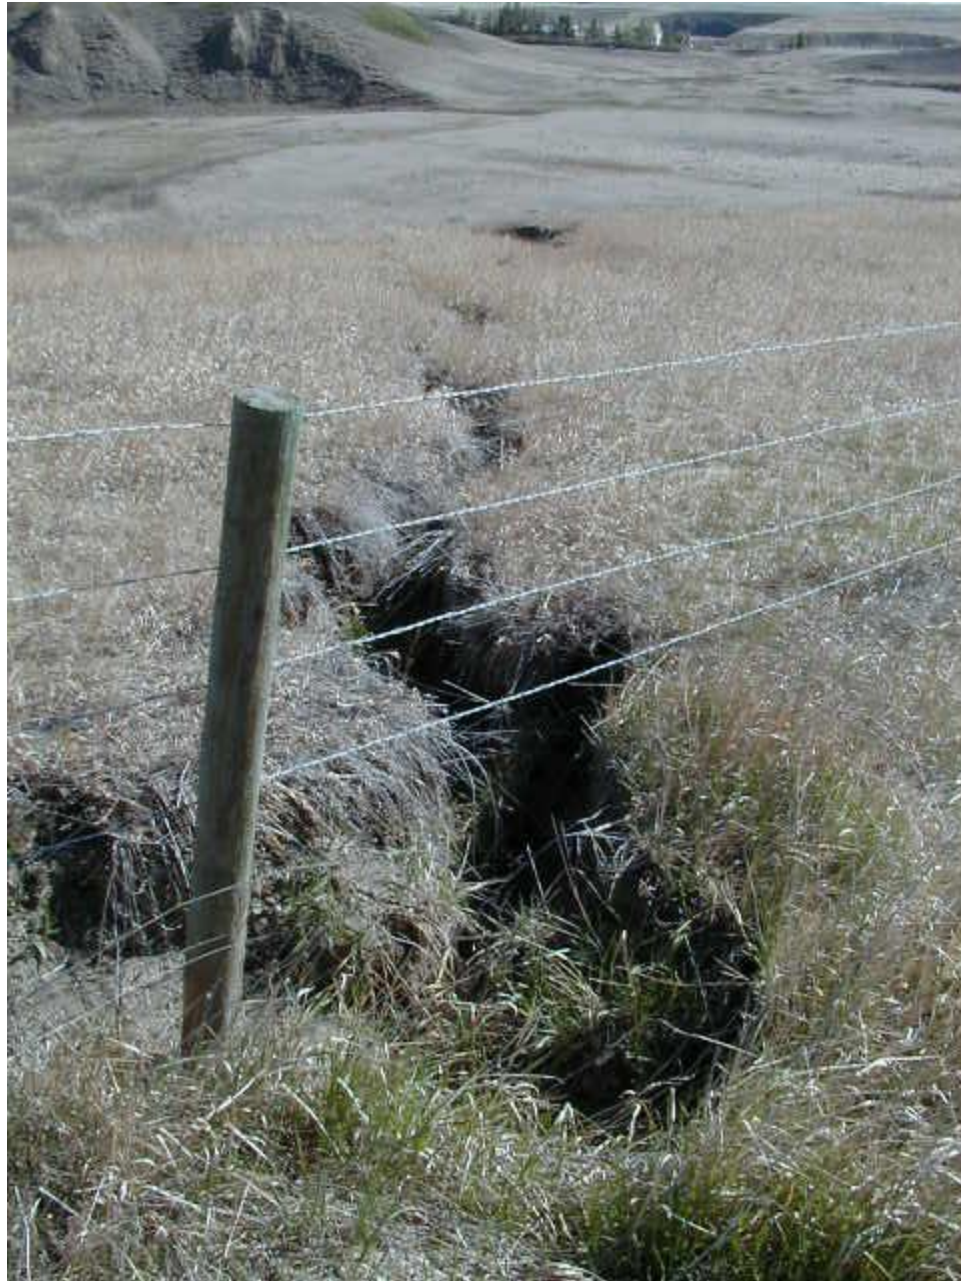
Erosion channel at fenceline

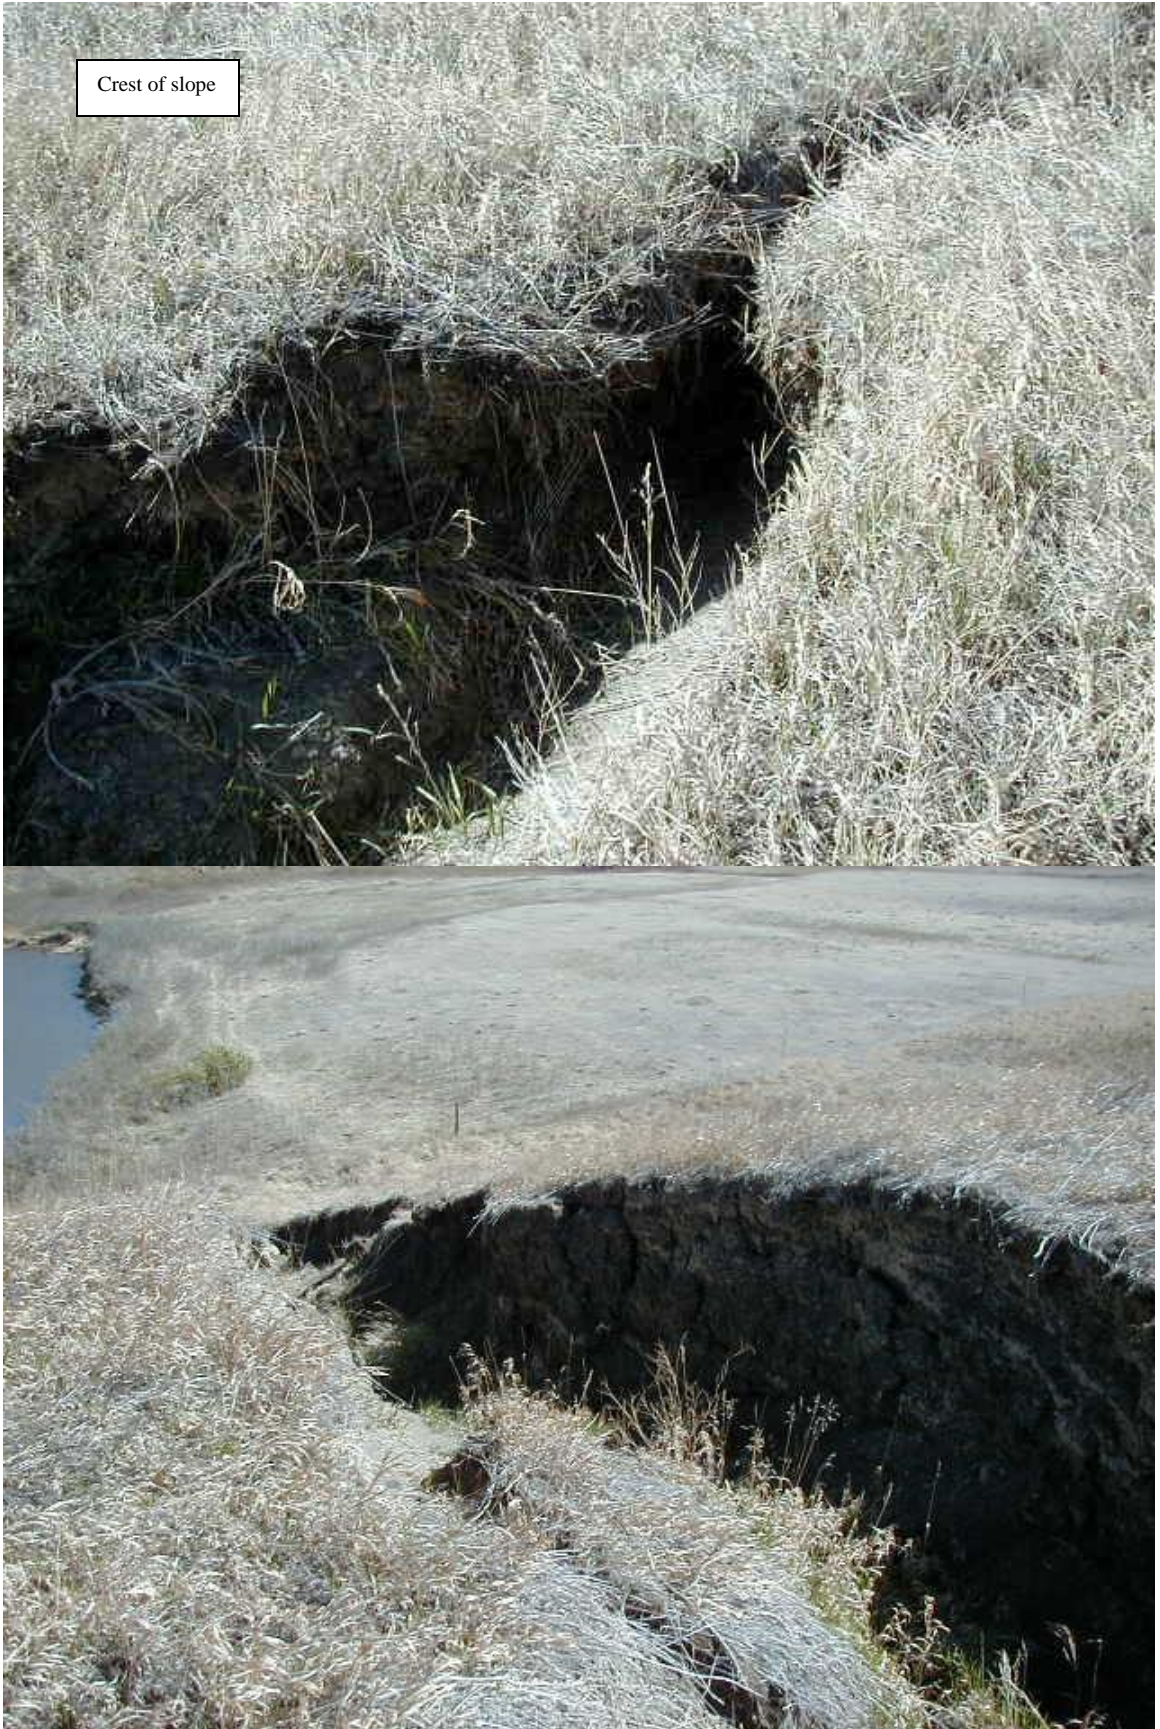
Looking north at erosion channel leading to large gully down to the toe of the embankment

the full length of the slope section. An impervious plug should be provided at the top of the slope to ensure that water is directed into the pipe rather than the slope. The remainder of the slope over the pipe can be reinstated with common fill and re-vegetated. At the downstream end of the pipe where it discharges into the creek, a gabion mat should be provided to form a discharge apron of minimum dimensions 2 m by 2m.

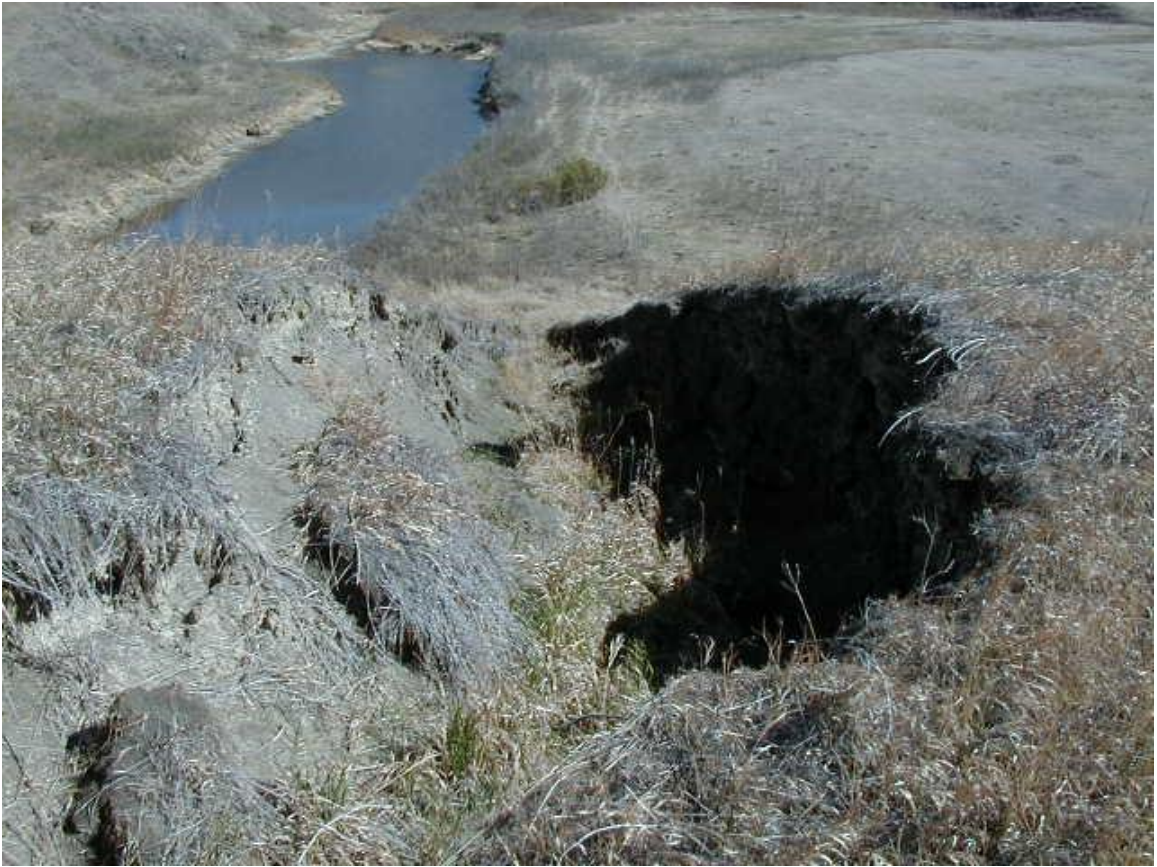
View down gully

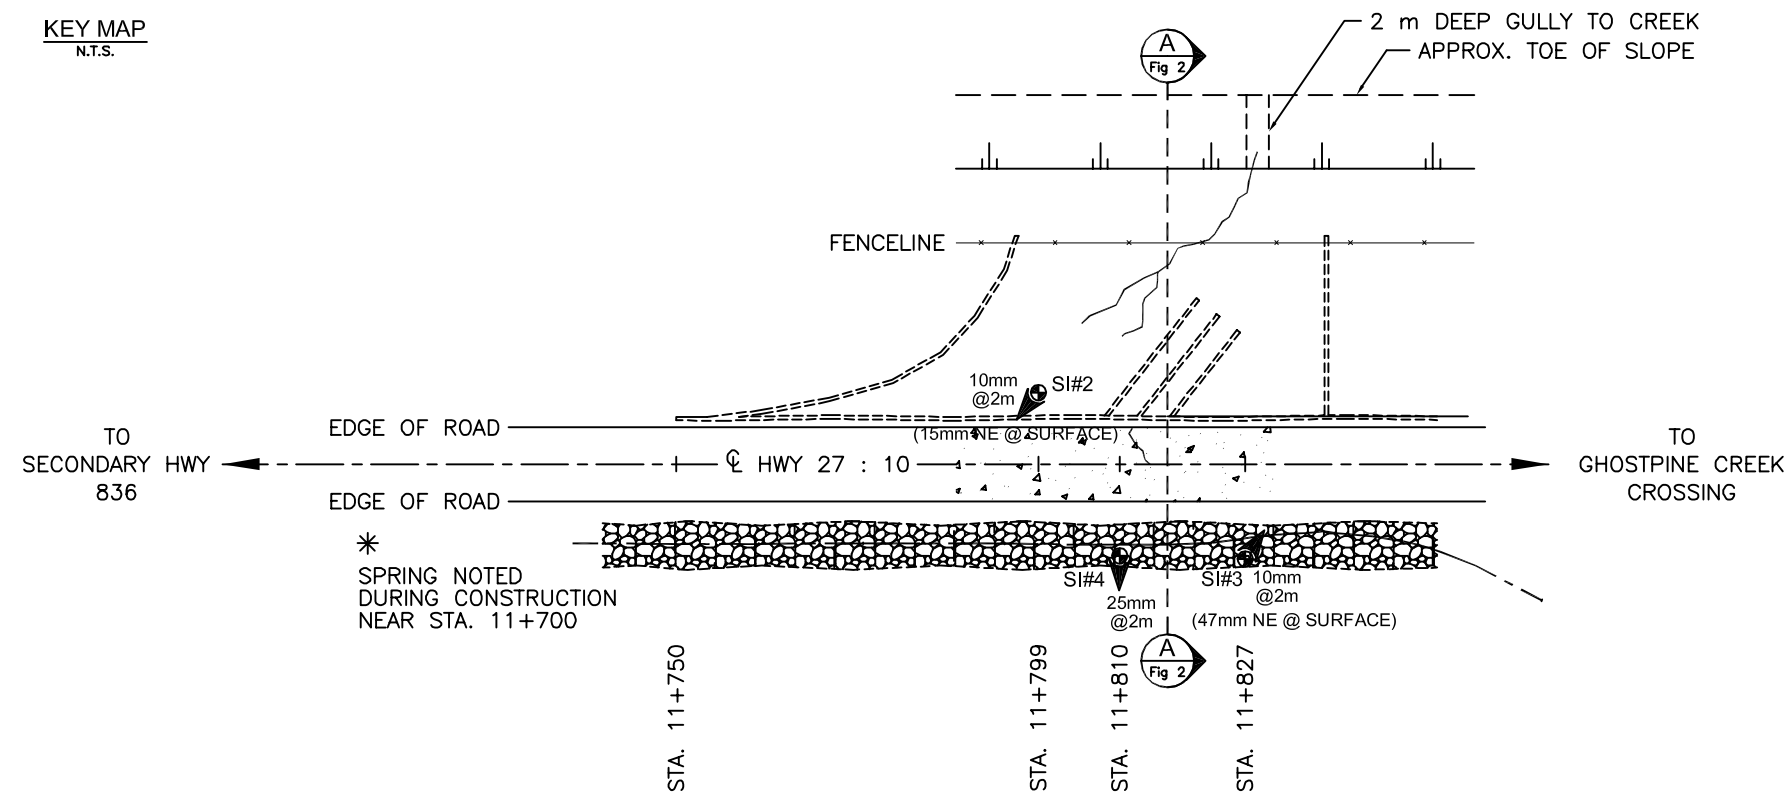
PLAN  
1:1 000

Three slope inclinometers are operational at this site with locations as shown on Figure 1. The instruments were read on May 29, 2001 and the following observations were noted:

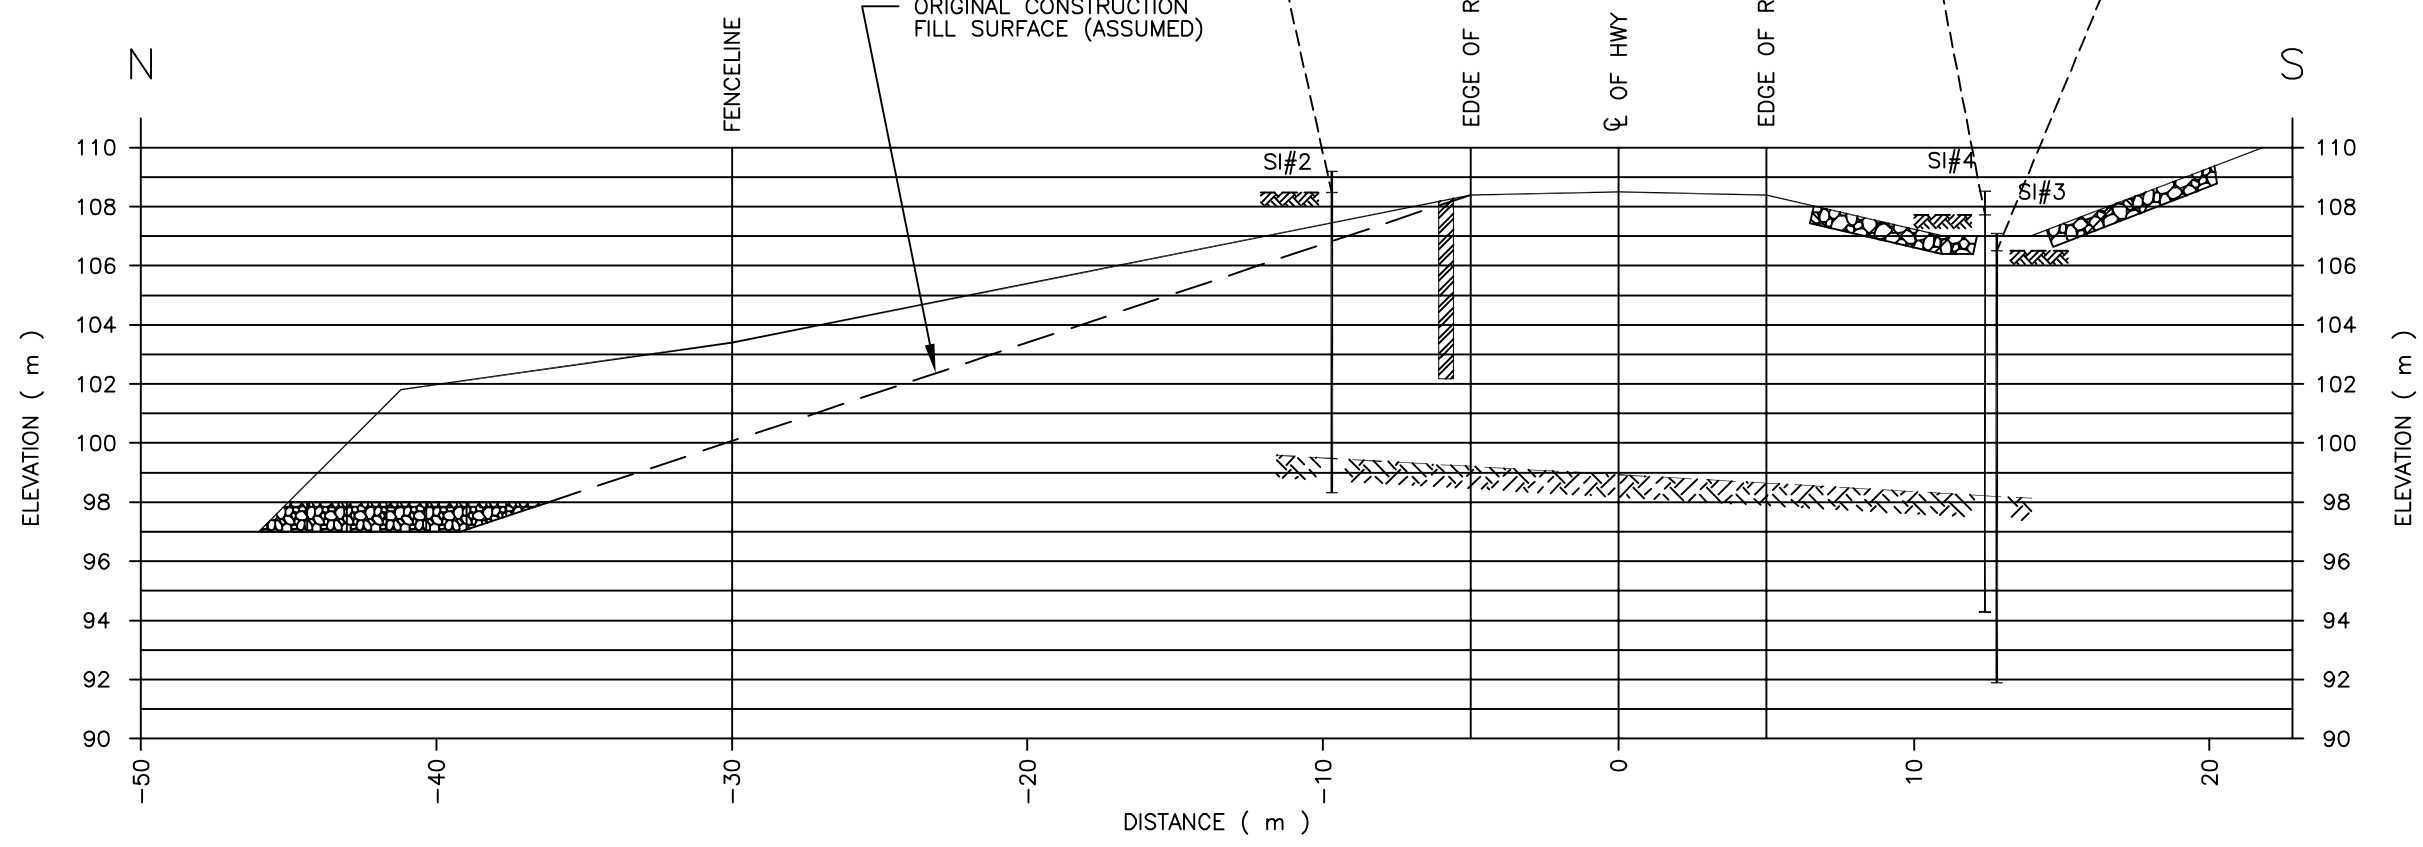
The slide location, site plan, instrument locations and cross-section are illustrated on Figures 1 and 2. The slide features are also illustrated in the attached photographs.

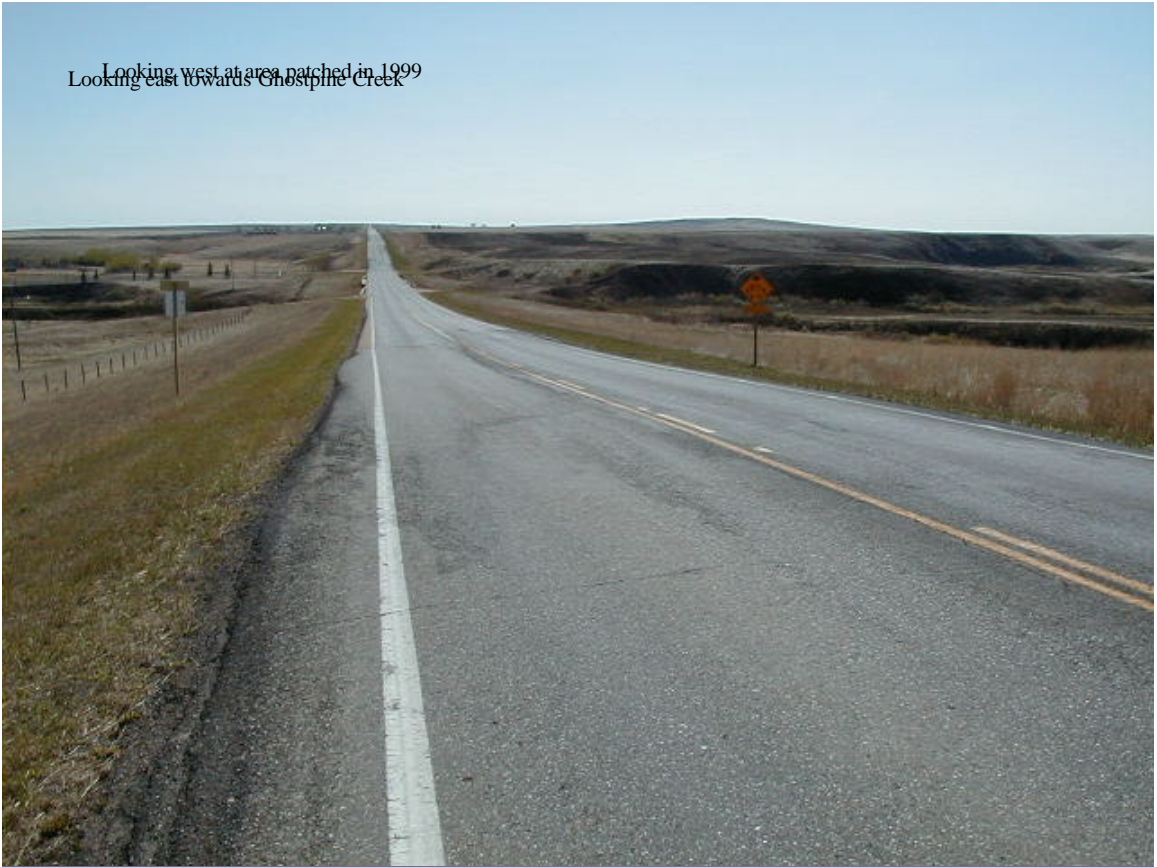
Looking west at area patched in 1999  
Looking east towards Ghostpine Creek

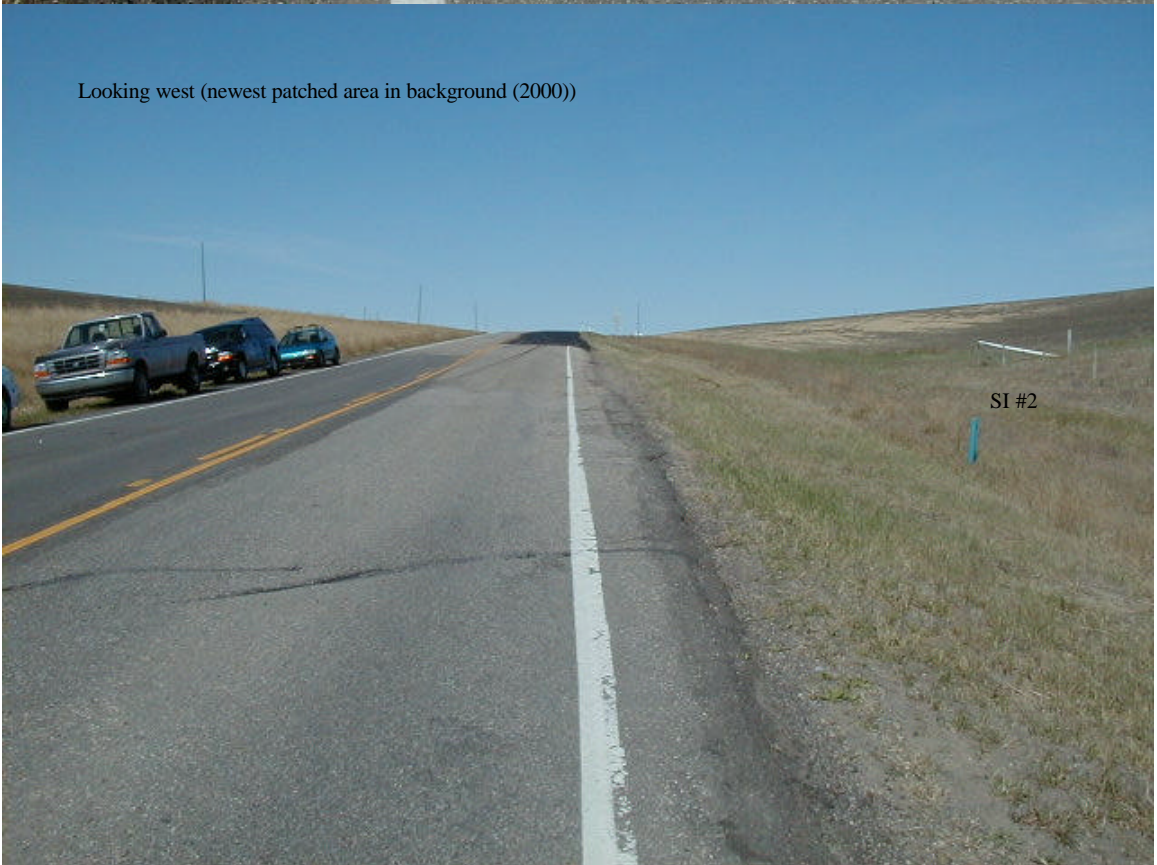
Looking west (newest patched area in background (2000))

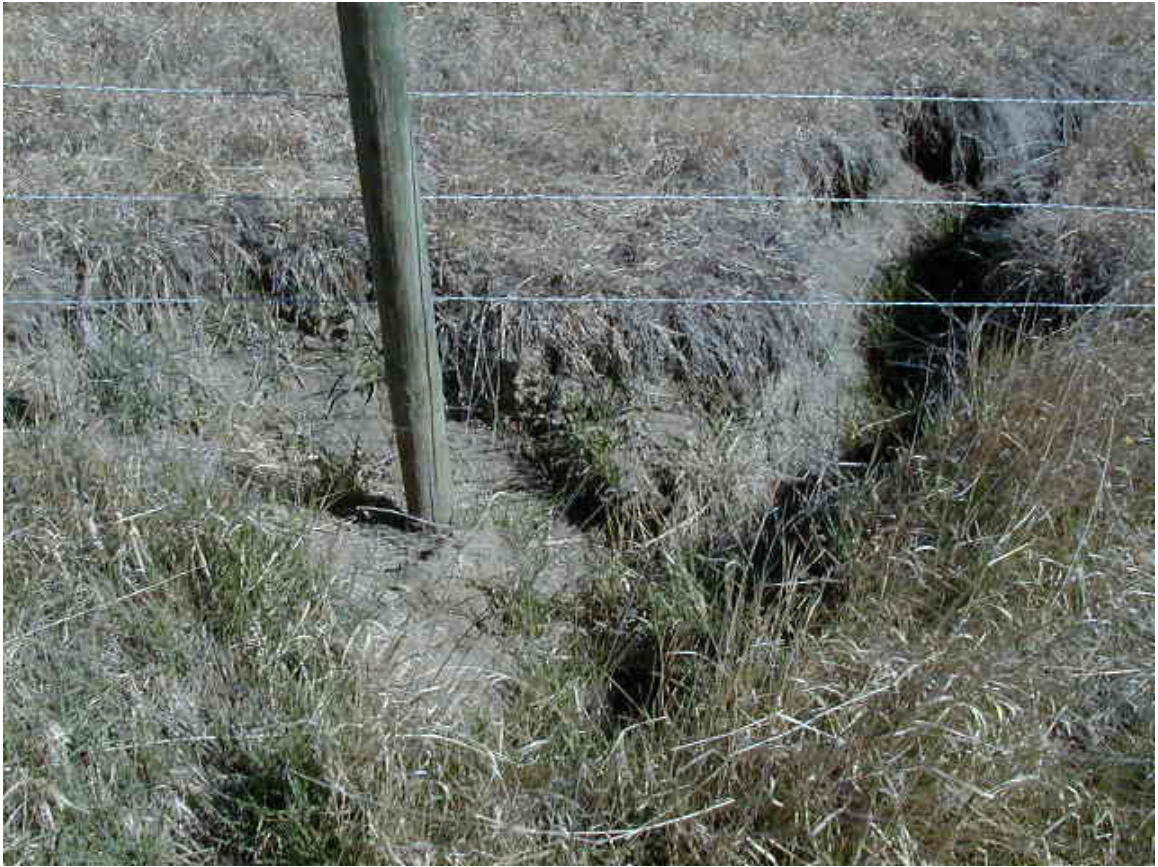
Looking west at small erosion channel forming on north side of highway

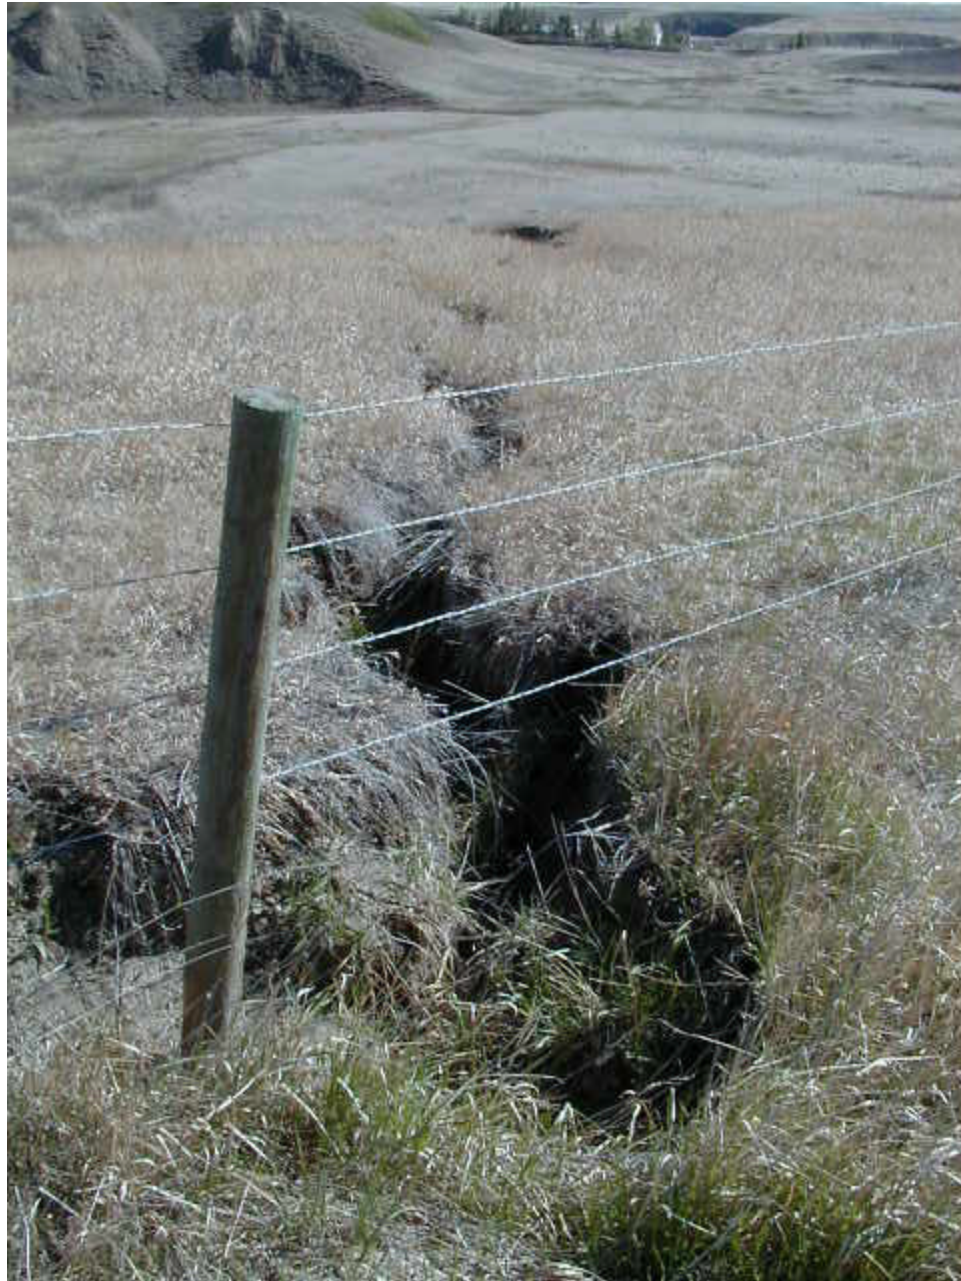
Erosion channel at fenceline

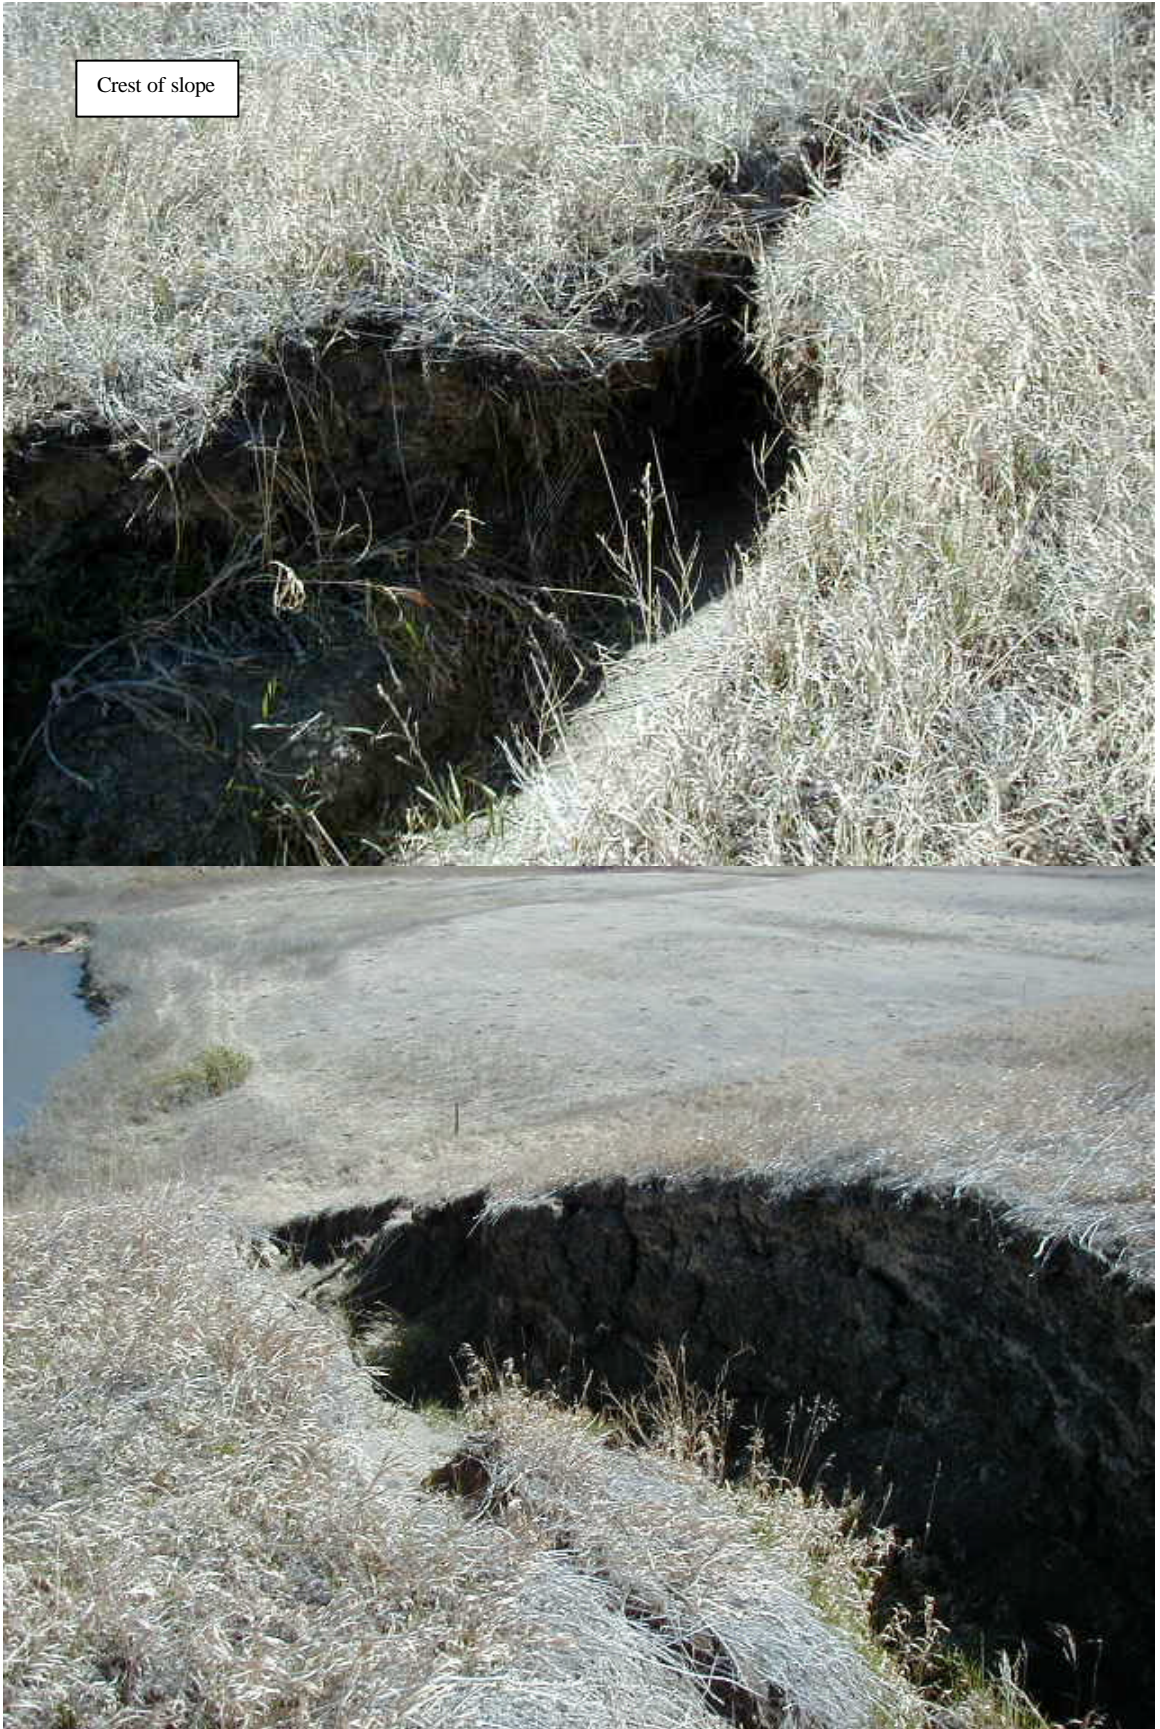
Looking north at erosion channel leading to large gully down to the toe of the embankment

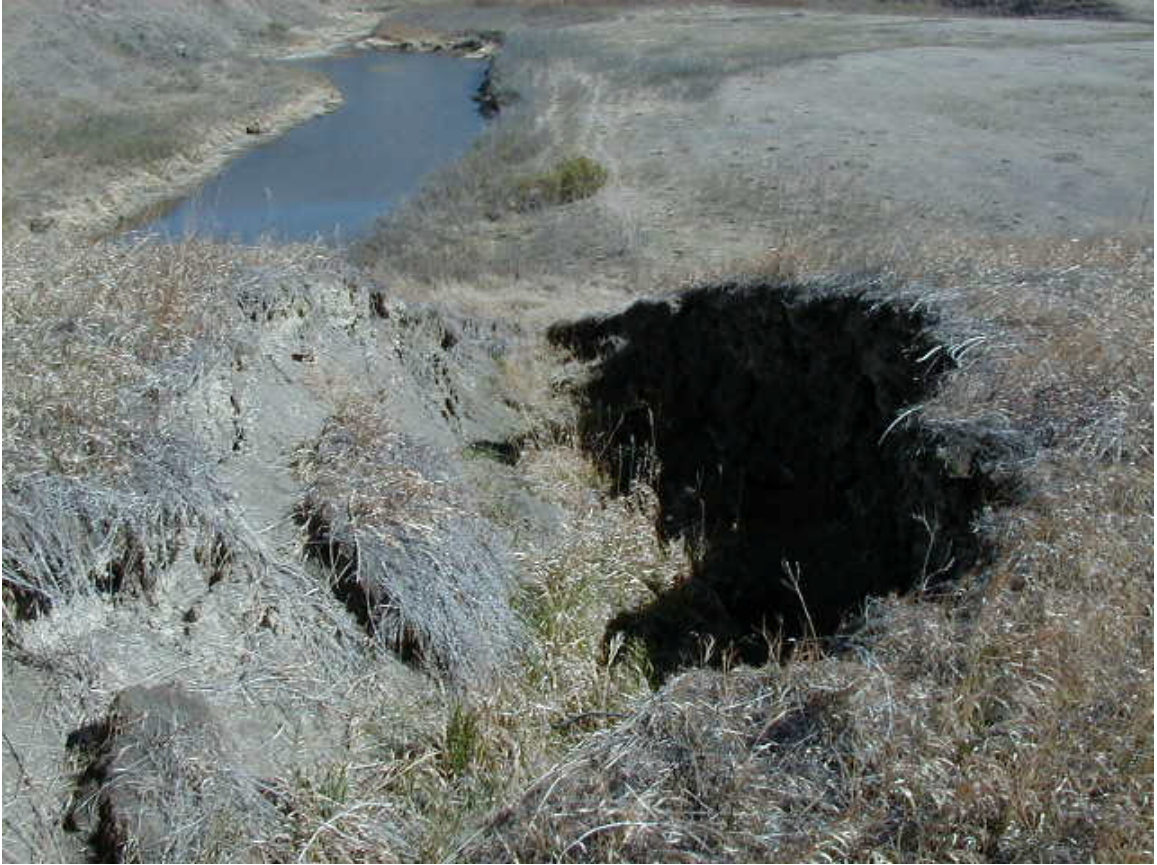
View down gully
