**CENTRAL REGION
GEOHAZARDS RISK ASSESMENT
SITE INSPECTION FORM**

SITE NUMBER AND NAME C5 H27:10 Cream Coulee		HIGHWAY & KM	PREVIOUS INSPECTION DATE May 21, 2003	INSPECTION DATE May 18, 2004
LEGAL DESCRIPTION SW 17-31-22-W4	NAD 83 COORDINATES N 5724120 E 354750	RISK ASSESMENT PF: 1 CF: 1 TOTAL: 1

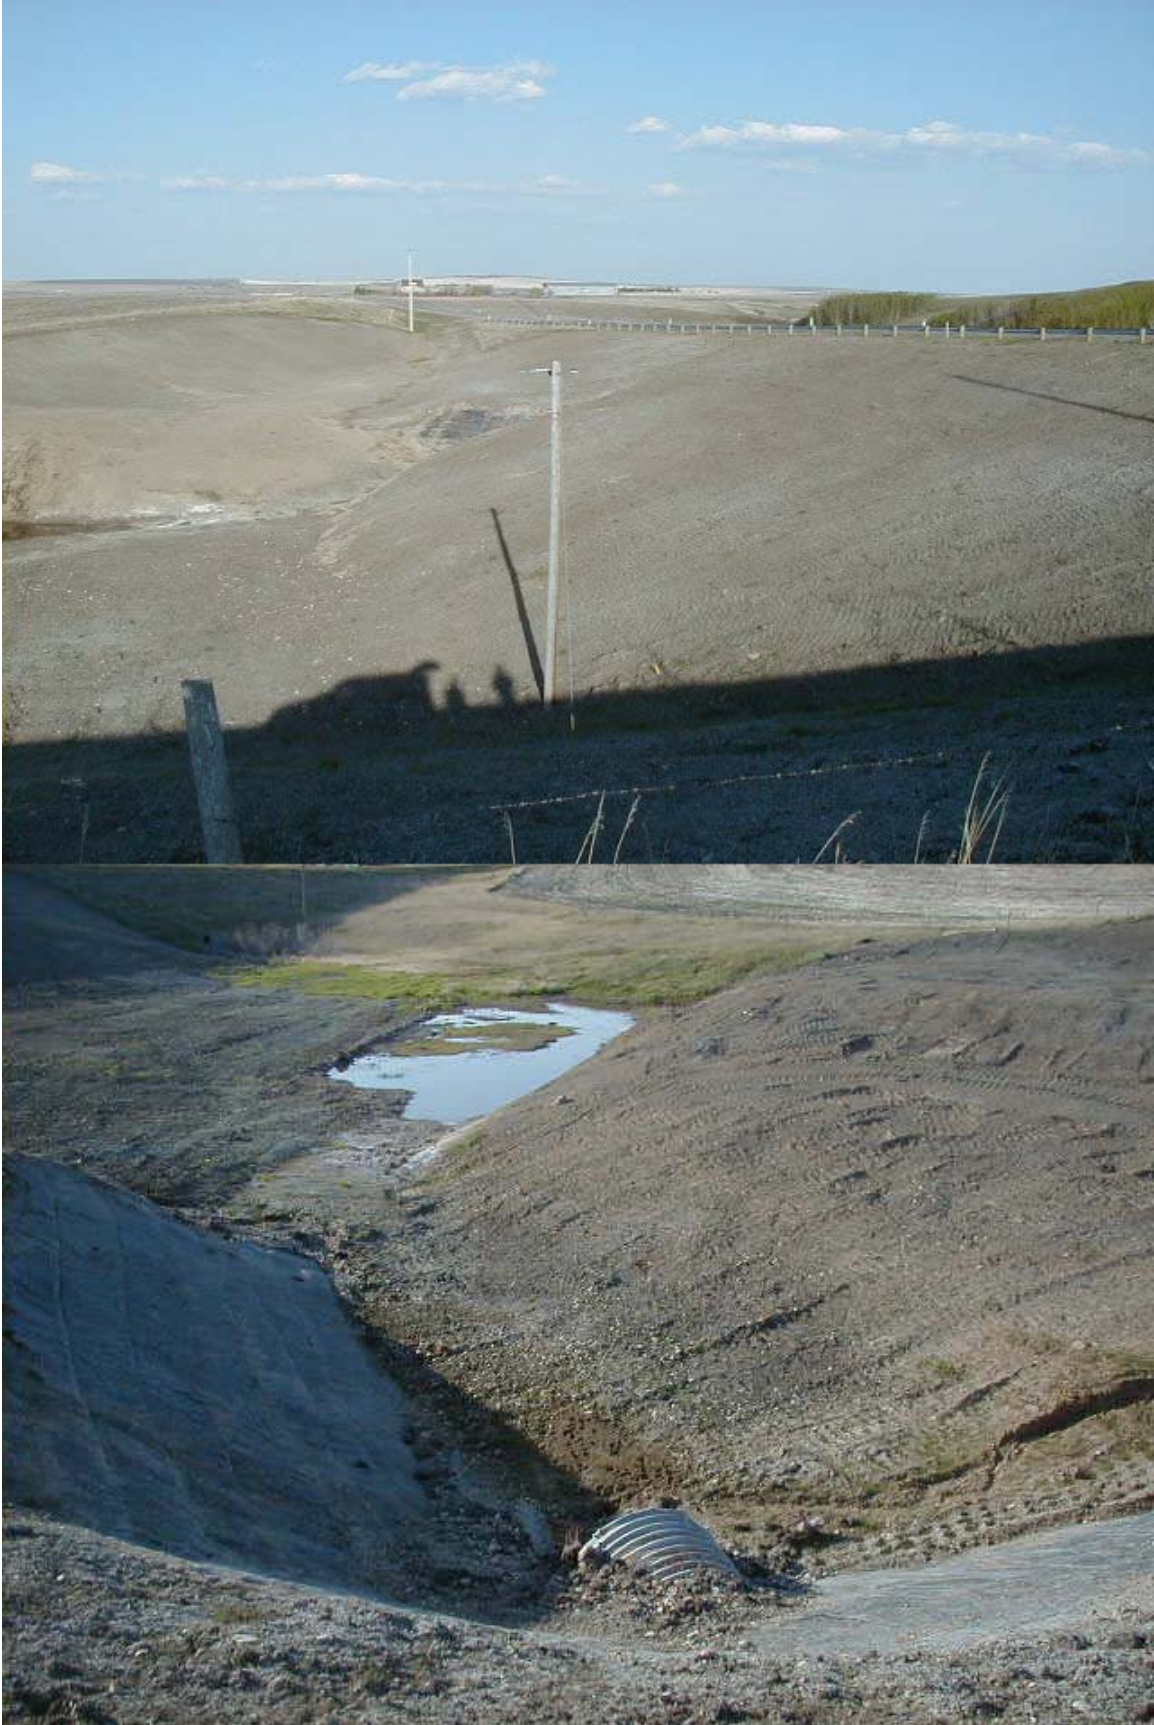
ITEM	CONDITION EXISTS		DESCRIPTION AND LOCATION	NOTICABLE CHANGE FROM LAST INSPECTION	
	YES	NO		YES	NO
Pavement Distress					
Slope Movement		X			
Erosion	X		Minor erosion is occurring close to culvert inlet.		
Seepage					
Culvert Distress		X

COMMENTS
Refer to previous inspection reports for site history and attached photos.
Repaired area has no signs of cracks and grass is starting to grow.
The minor erosion should be repaired by re-grading the area appropriately and reseeding. A small section of riprap or erosion protection matting may be required to protect the area while the grass is growing.
It is recommended that this site be deleted from the GeoHazard Monitoring Program.
