CENTRAL REGION GEOHAZARDS RISK ASSESMENT SITE INSPECTION FORM

HIGHWAY & KM PREVIOUS SITE NUMBER AND NAME INSPECTION DATE INSPECTION DATE C5 H27:10 Cream Coulee May 27, 2005 May 18, 2004 LEGAL DESCRIPTION NAD 83 COORDINATES **RISK ASSESMENT** SW 17-31-22-W4 N 5724120 PF: TOTAL: E 354750 1 CF: 1

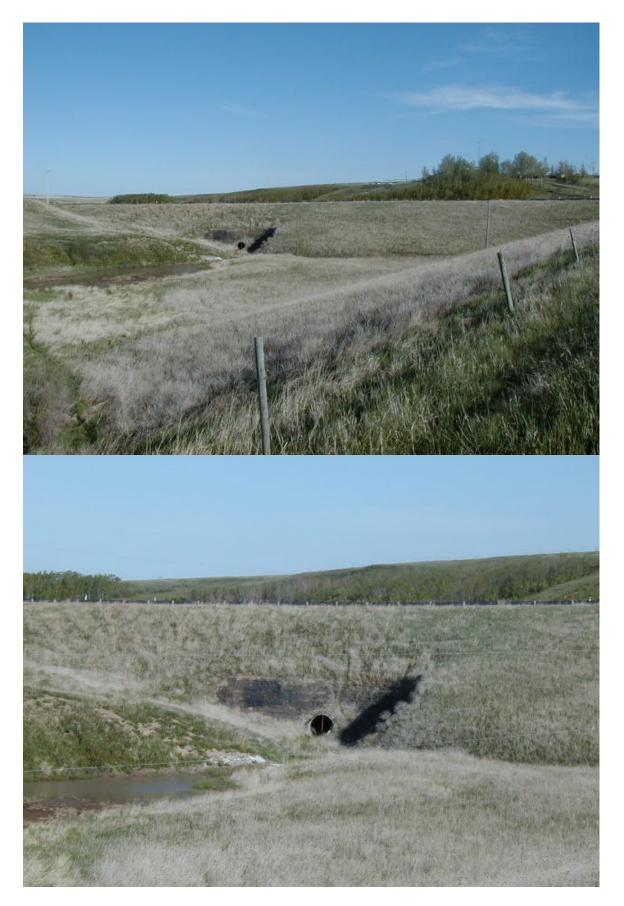
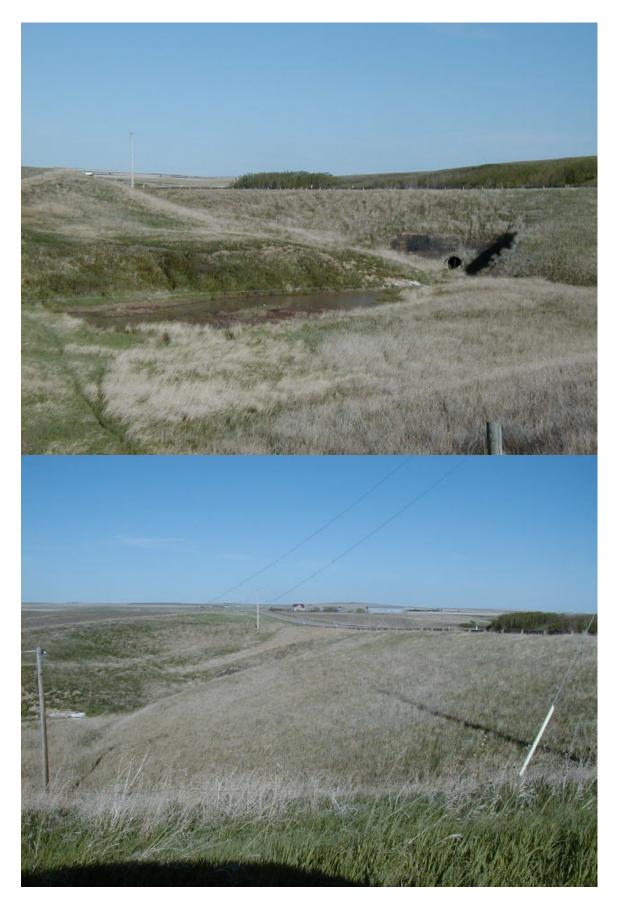
ITEM	CONDITION EXISTS		DESCRIPTION AND LOCATION	NOTICABLE CHANGE FROM LAST INSPECTION YES NO	
Pavement Distress					
Slope Movement					
Erosion					
Seepage					
Culvert Distress					
COMMENTS					
Refer to previous inspection reports for site history and attached photos.					
Repaired area has no signs of cracks and grass is starting to grow.					
It is recommended that this site be deleted from the GeoHazard Monitoring Program.
