SITE NUMBER AND NAME C47 H27:10 Ditch Gabions		HIGHWAY & KM 21 to 25	PREVIOUS INSPECTION DATE June 13, 2008	INSPECTION DATE June 15, 2012
LEGAL DESCRIPTION SW 16-31-21-W4	NAD 83 COORDINATES N 5723839 E 367863		RISK ASSESMENT PF: 9 CF: 4 TOTAL: 36

LAST READING DATE:	
PRIMARY SITE ISSUE: Storm events in the spring of 2007 displaced existing gabion ditch structures resulting in extensive erosion features and damage to gabions over a 2 km length.	
APPROXIMATE DIMENSIONS: Approx. 2 km long section with severe damage.	
DATE OF ANY REMEDIAL ACTION:

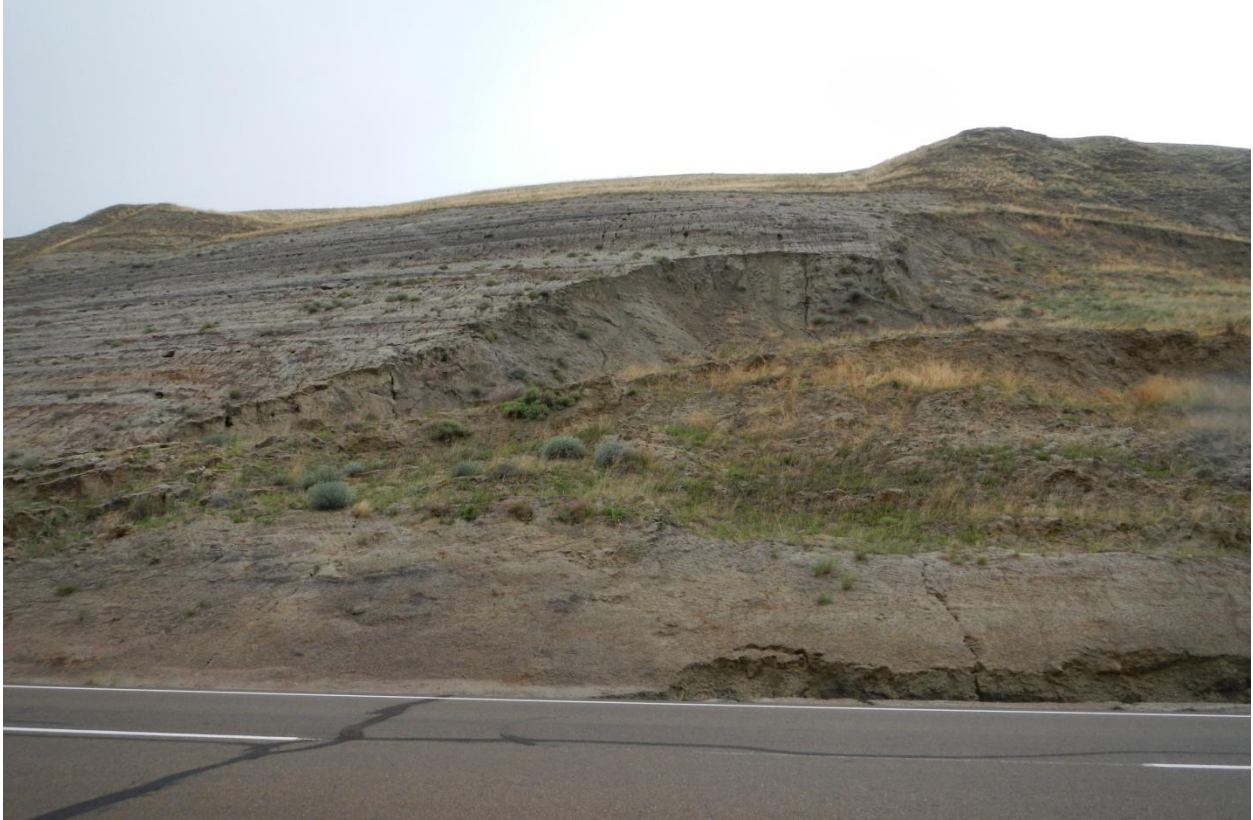
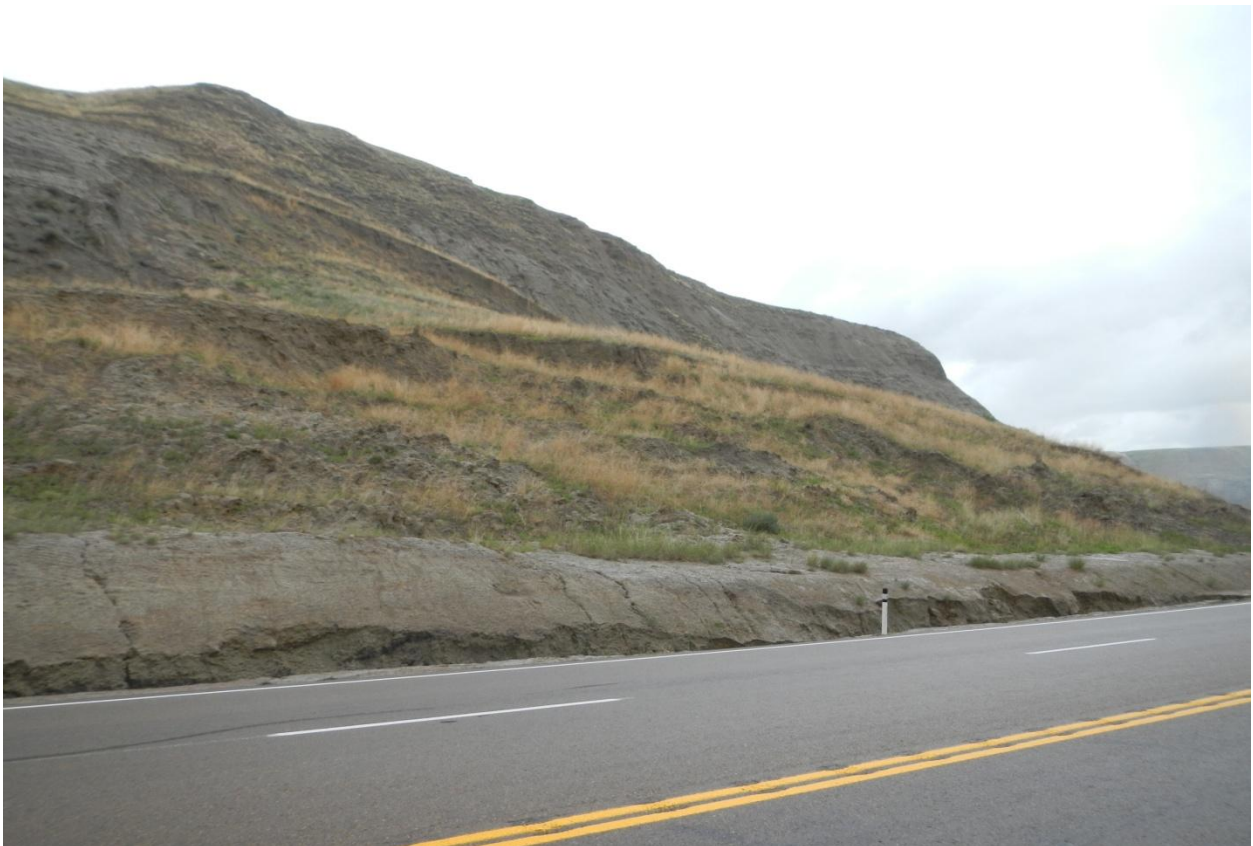
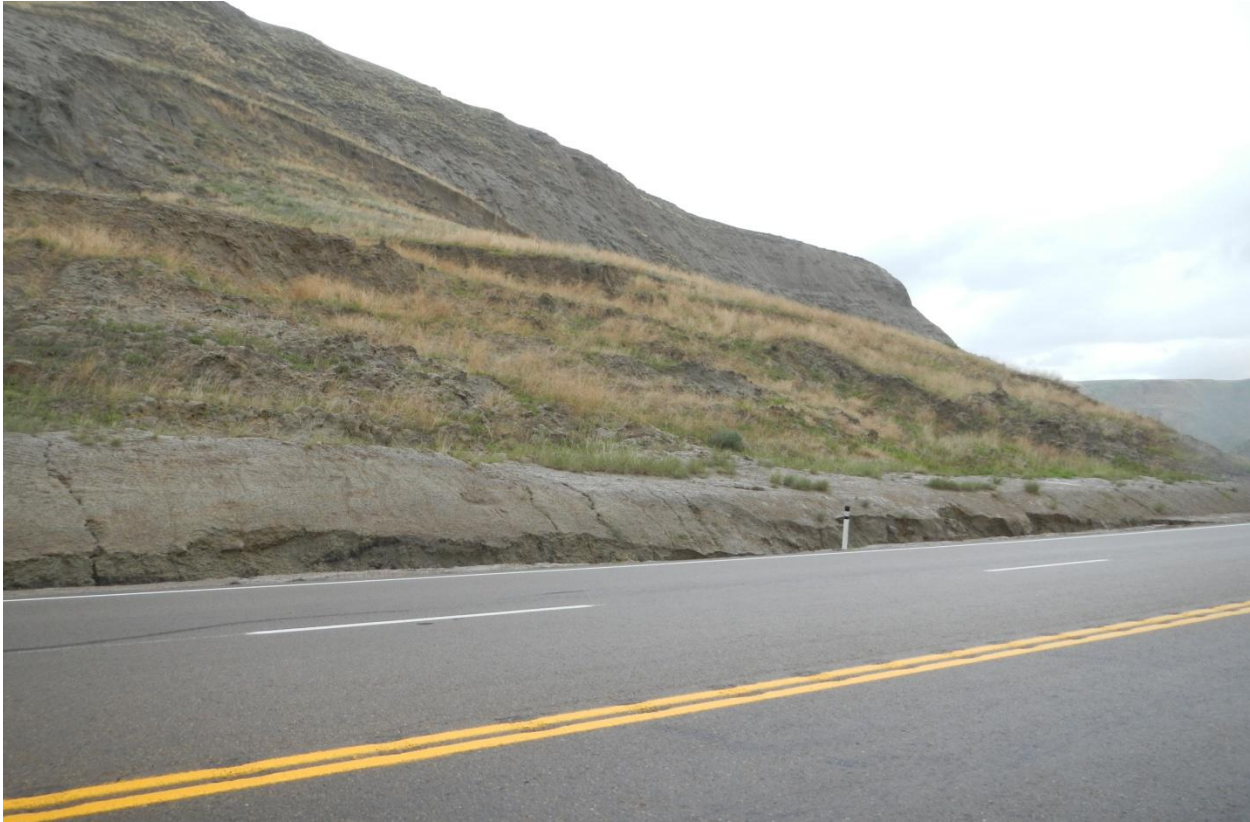
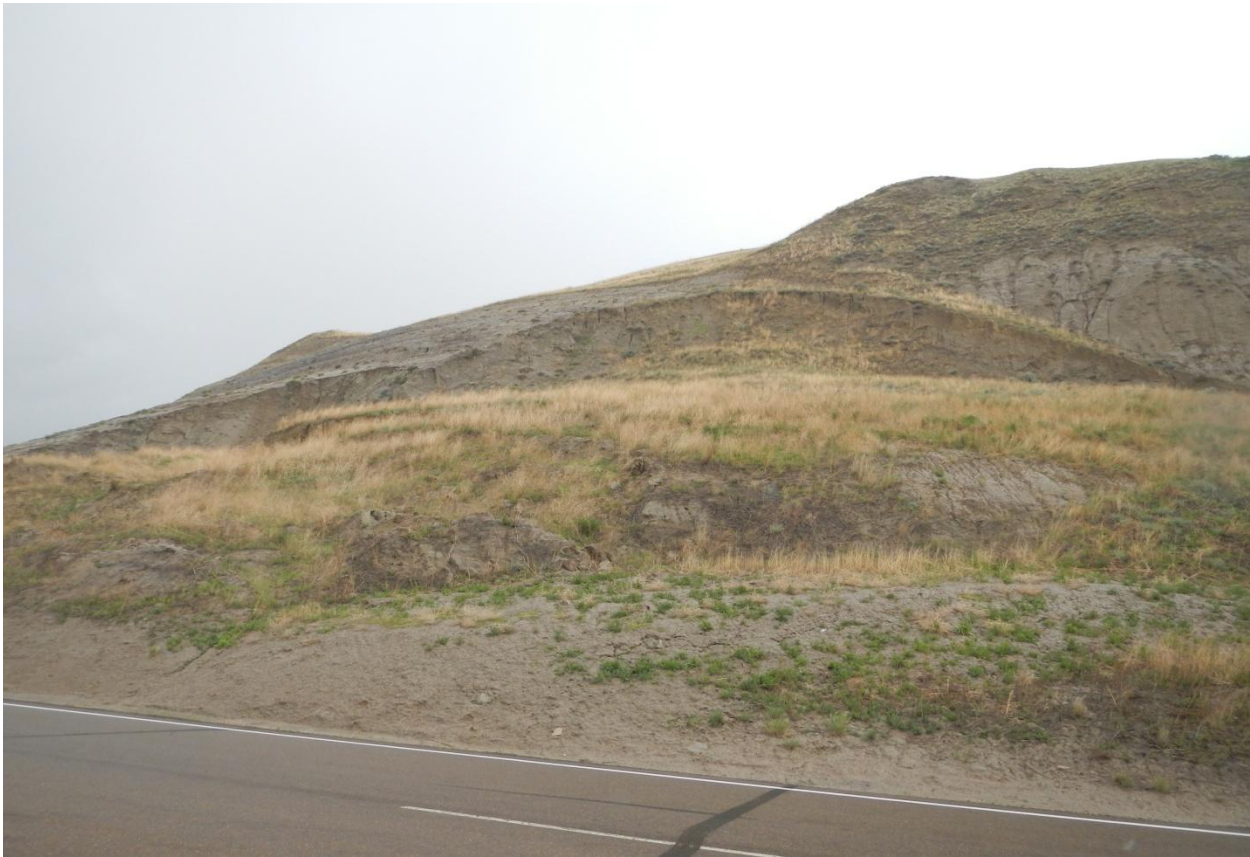
Site C47 H27
June 15, 2012

COMMENTS
Refer to attached photos.
Significant damage to the existing gabion structures occurred during spring 2007 storm events. Rocks inside of gabion baskets were displaced and several entire gabion mats were lifted and relocated downstream.
Significant repairs are required to the ditch protection system. It is recommended that a survey and condition assessment of the gabion structures be performed to determine the remedial action required.
It is understood that this work is being performed by another Consultant.
