SITE NUMBER AND NAME C57 H41:14 Pavement Distress		HIGHWAY & KM km 22	PREVIOUS INSPECTION DATE October 23, 2009	INSPECTION DATE May 18, 2010
LEGAL DESCRIPTION SE18-37-6-W4	NAD 83 COORDINATES N 5780380 E 510040		RISK ASSESMENT PF: 9 CF: 4 TOTAL: 36

Central Region GeoHazard Assessments
Site C57 H41:14 km 22 Pavement Distress
May 2010 Site Assessment Report

Site C57 H41:14 Pavement Distress
May 18, 2010

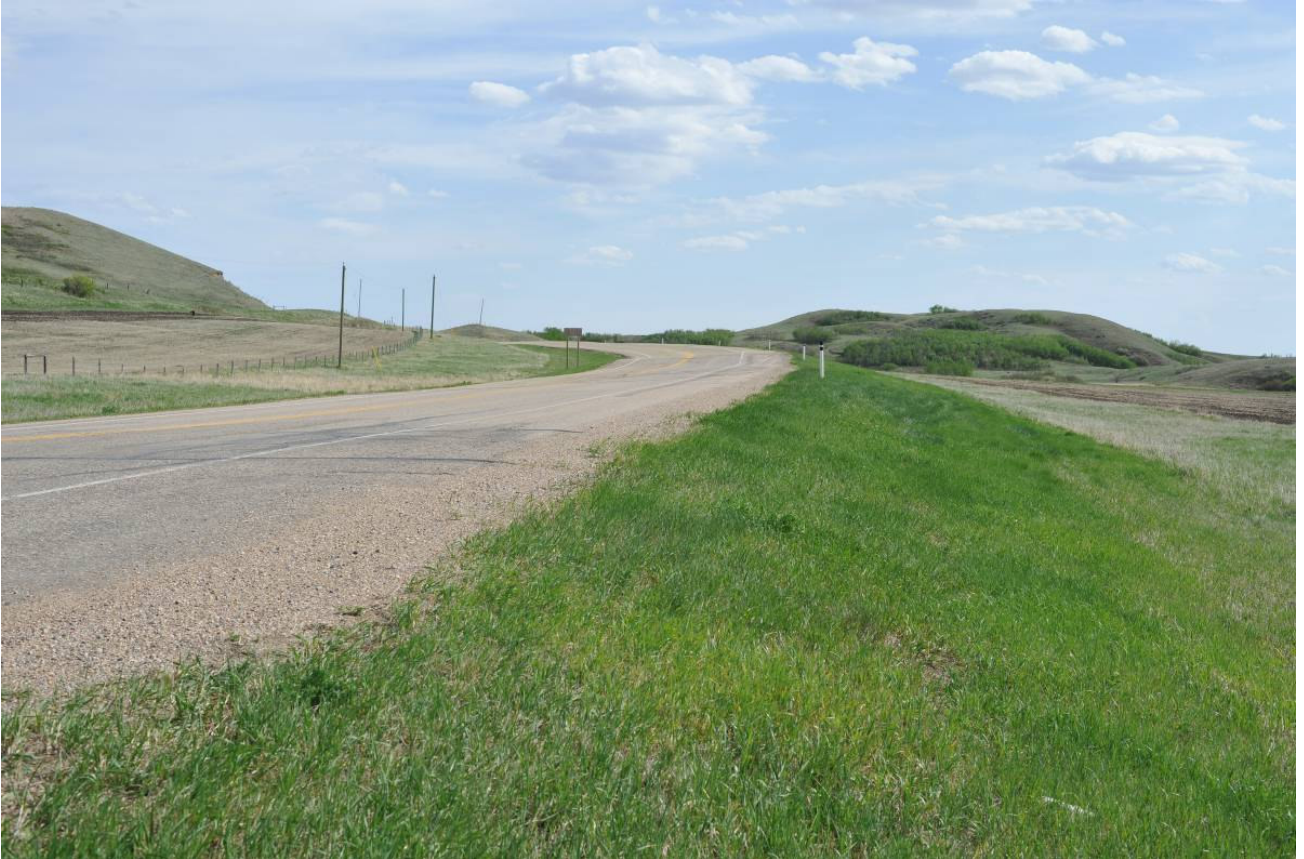
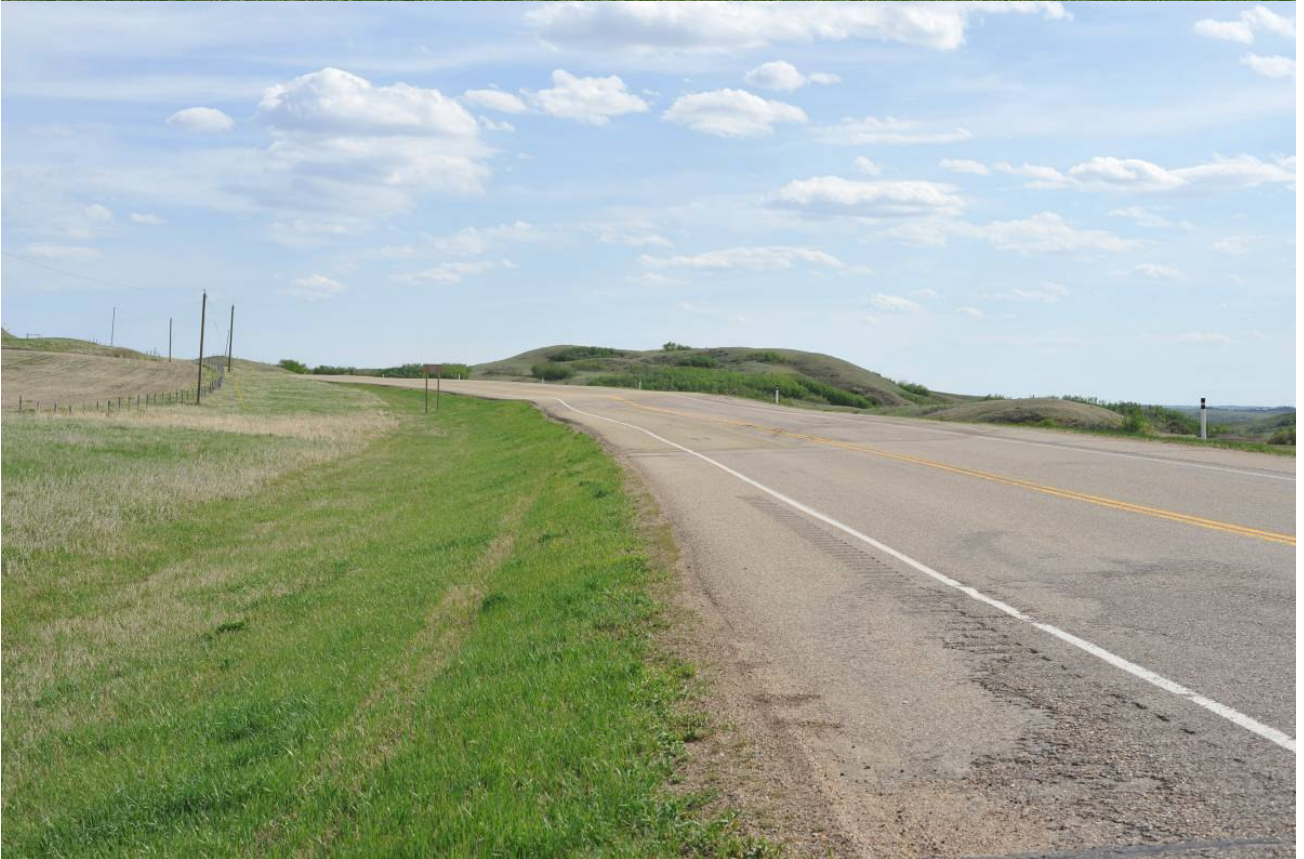
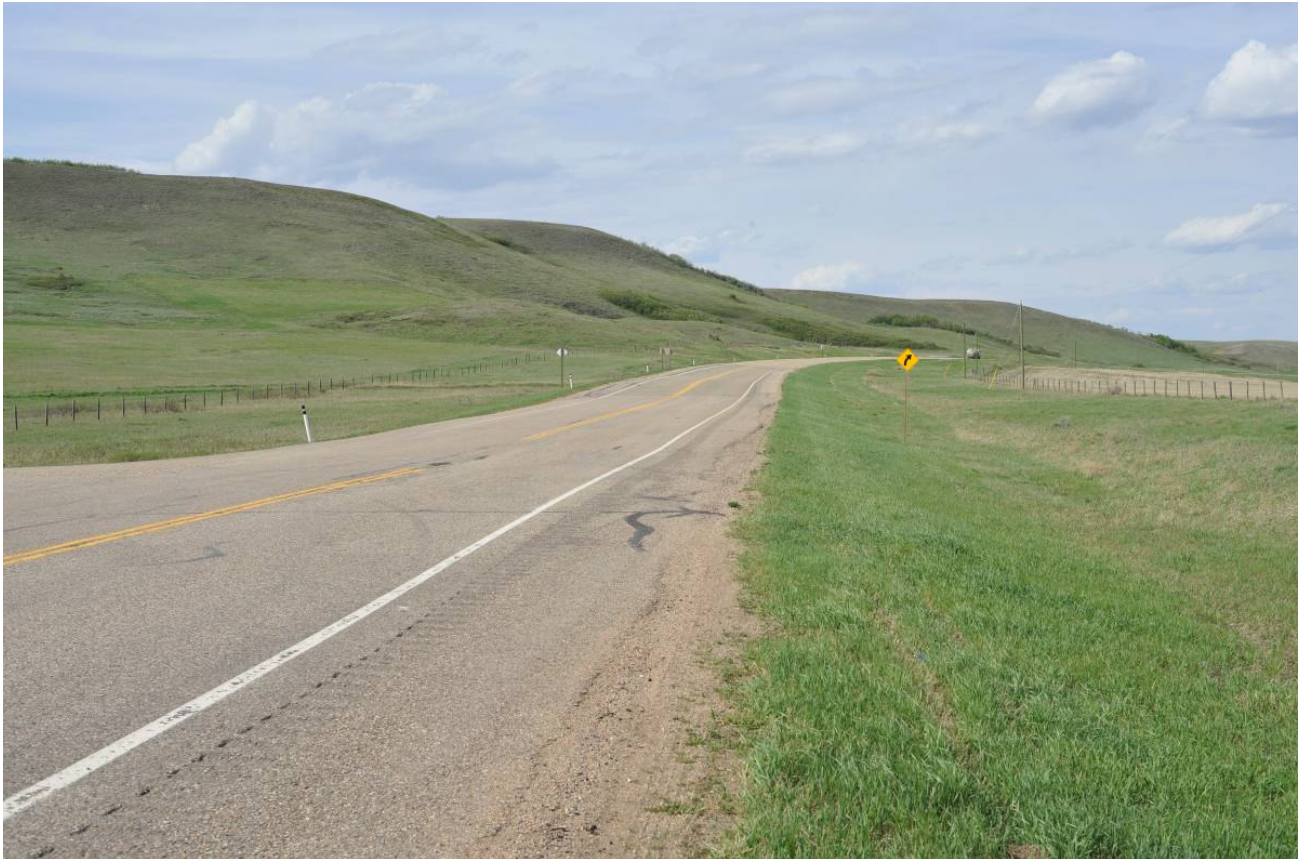
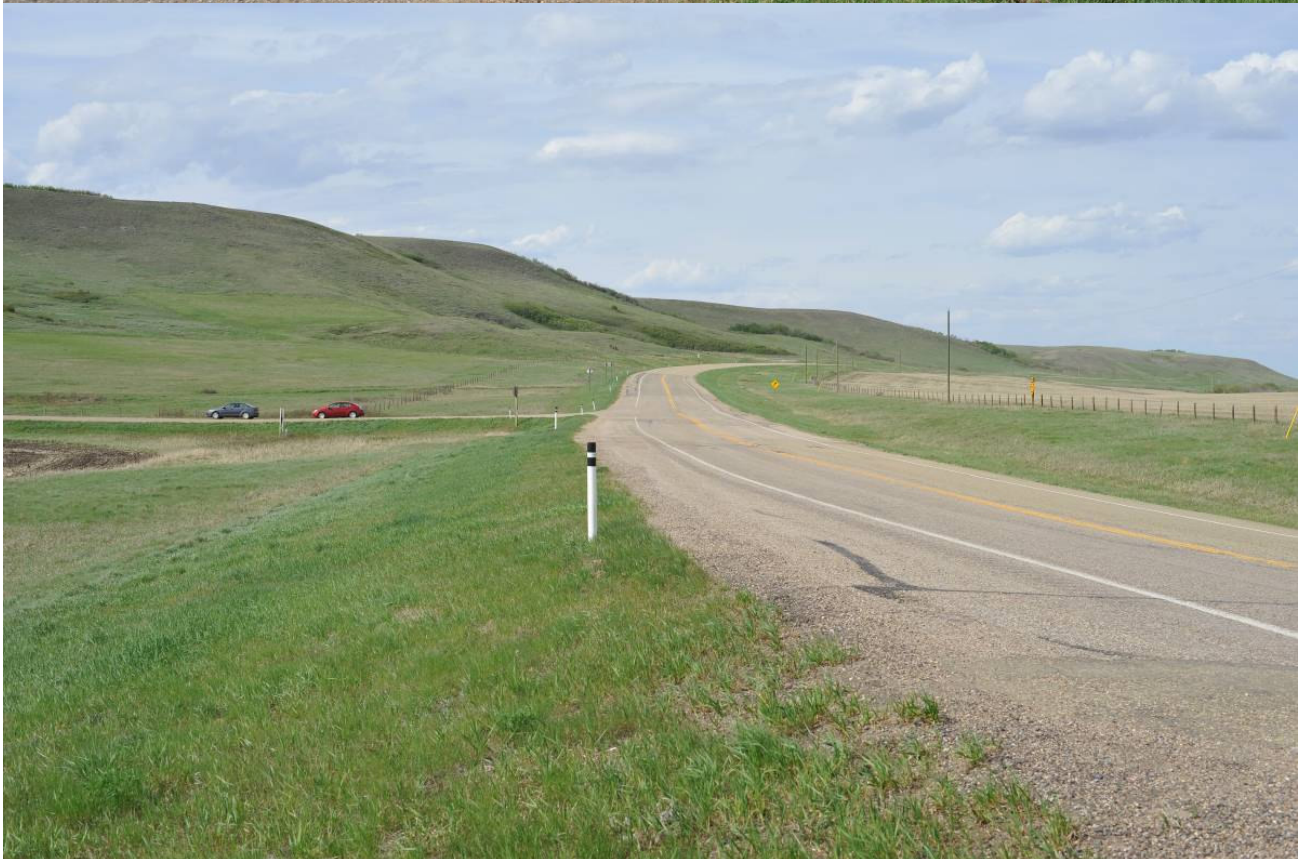
- Despite a number of full width patches, the road surface is highly uneven and a 70 km/hr speed restriction is in effect. The greatest dip is located at the south end of the site and is adjacent to a large bulge in the east ditch slope.
- Deep cracks were observed in the highway surface
- The ditch vegetation was relatively dense and indicative of wet soil conditions.
- A single culvert was located and discharges to the west. The downstream end was blocked with soil and vegetation.

Based on the requirement for regular patching and the uneven nature of the road surface, it is considered that an unsuitable or poor quality sub-grade material in combination with poor drainage is the main issue at the site.

- The inlet and outlet areas of the culvert should be cleared of vegetation and graded to permit drainage.
- A site investigation should be conducted to determine the subsurface conditions of the road, including soil type and groundwater levels. It is recommended that about 6 standpipes to a depth of about 6 m to 8 m be installed along alternate sides of the shoulder of the highway. The cost of this investigation is estimated to be about [REDACTED] as shown in Table 1. As part of this investigation, an existing data review will be undertaken including a review of historical air photographs and Department records. The work will be summarized in a brief letter report including recommendations for future action.
