SITE NUMBER AND NAME <b>C57 H41:14 Pavement Distress</b>		HIGHWAY & KM km 22	PREVIOUS INSPECTION DATE May 18, 2010	INSPECTION DATE <b>June 19, 2012</b>
LEGAL DESCRIPTION SE18-37-6-W4	NAD 83 COORDINATES N 5780380 E 510040		RISK ASSESMENT PF: 9    CF: 2    TOTAL: <b>18</b>

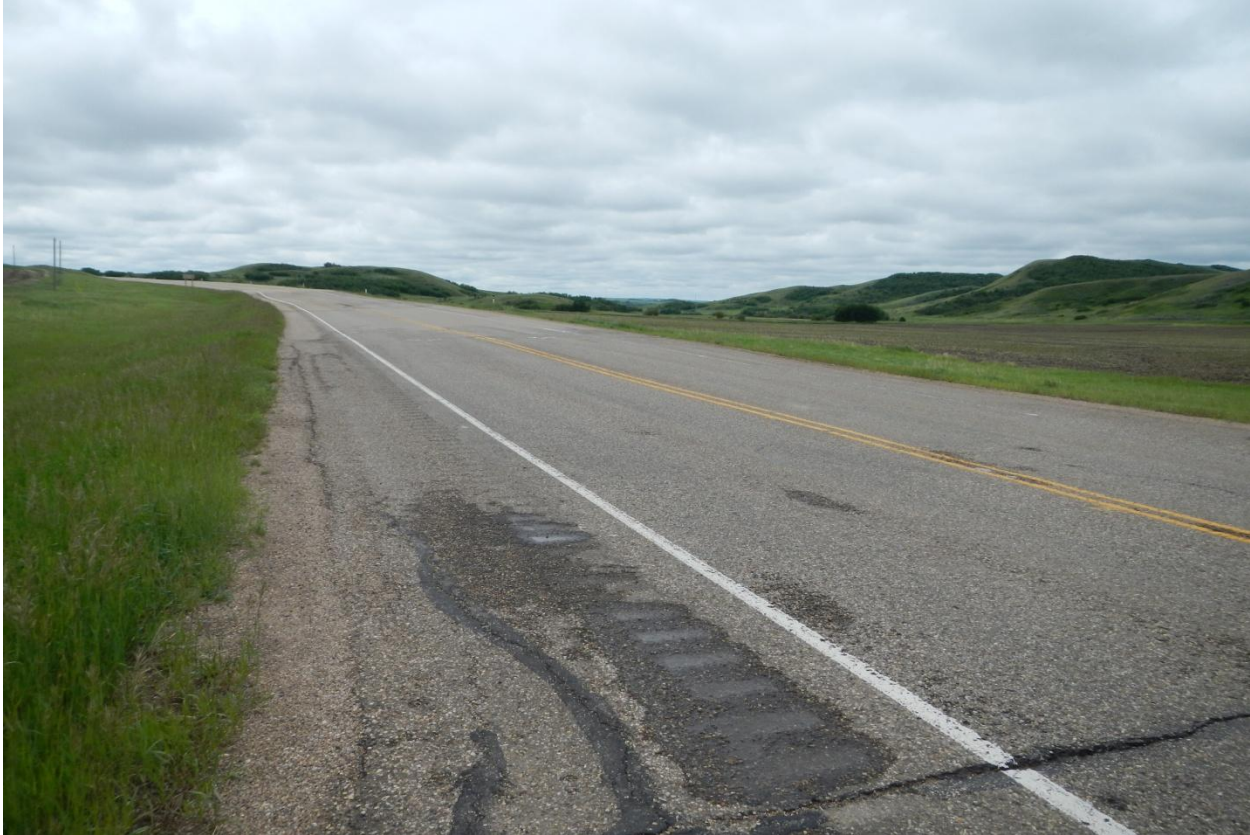
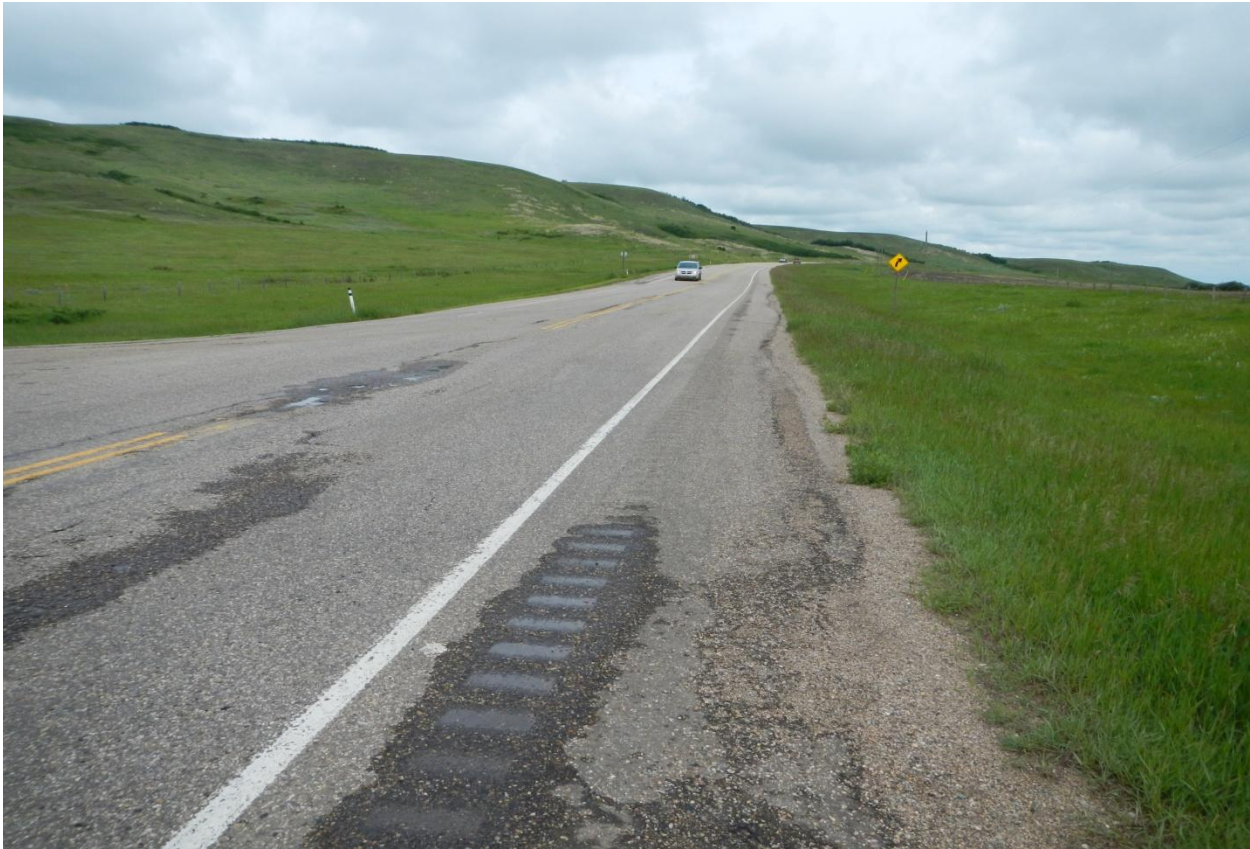
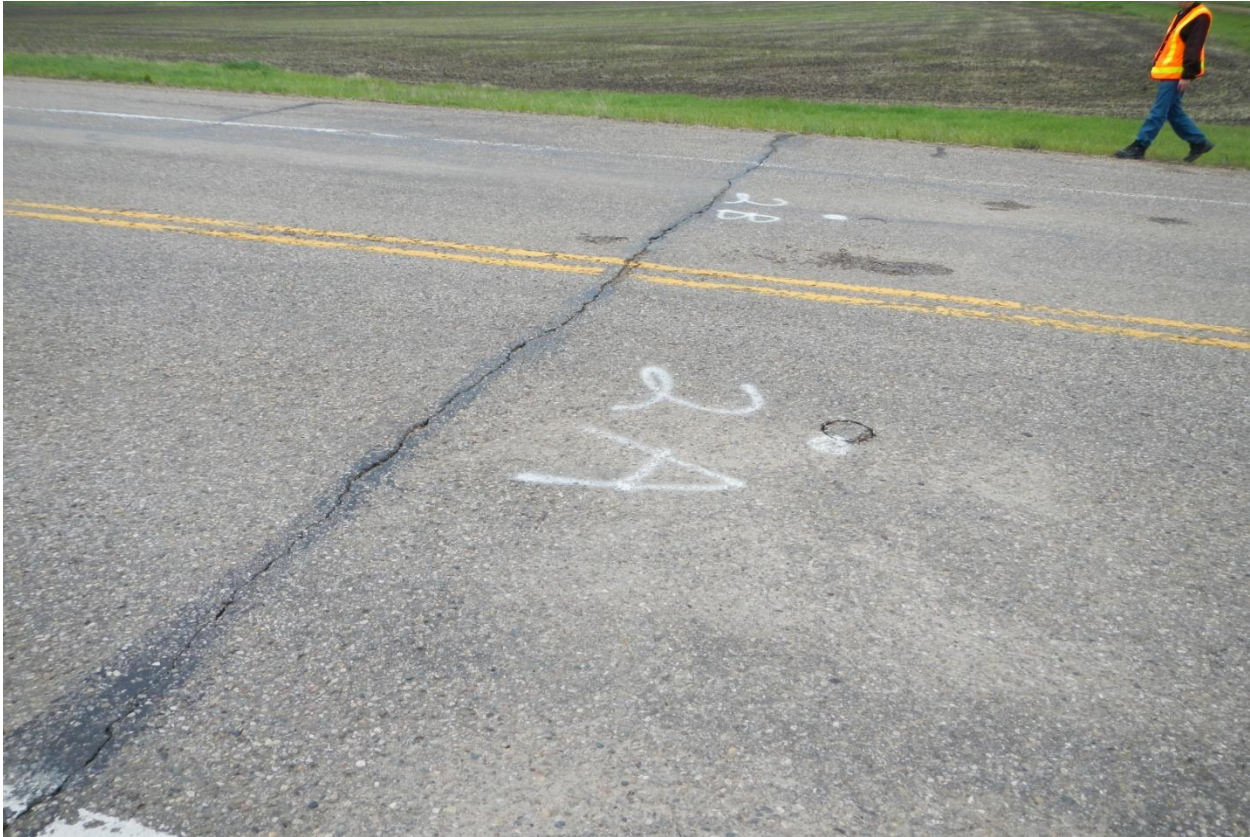
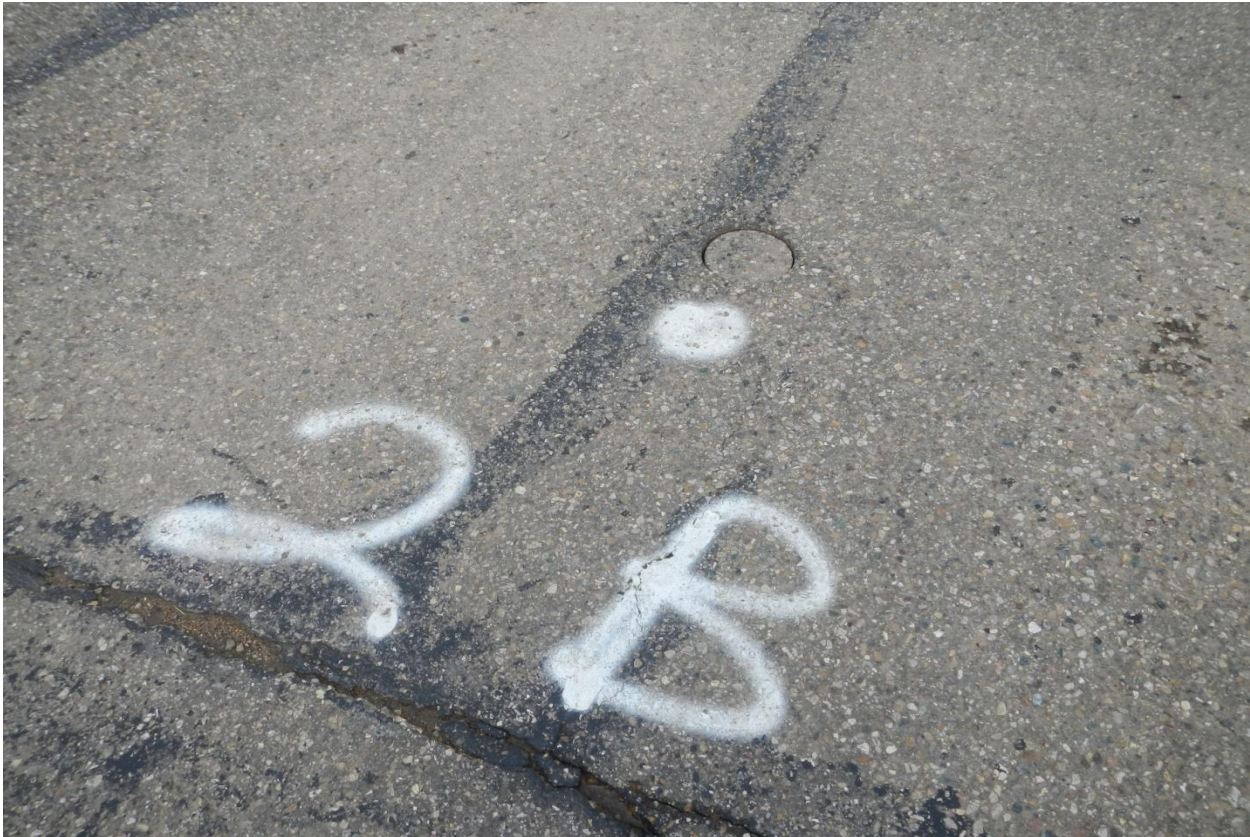
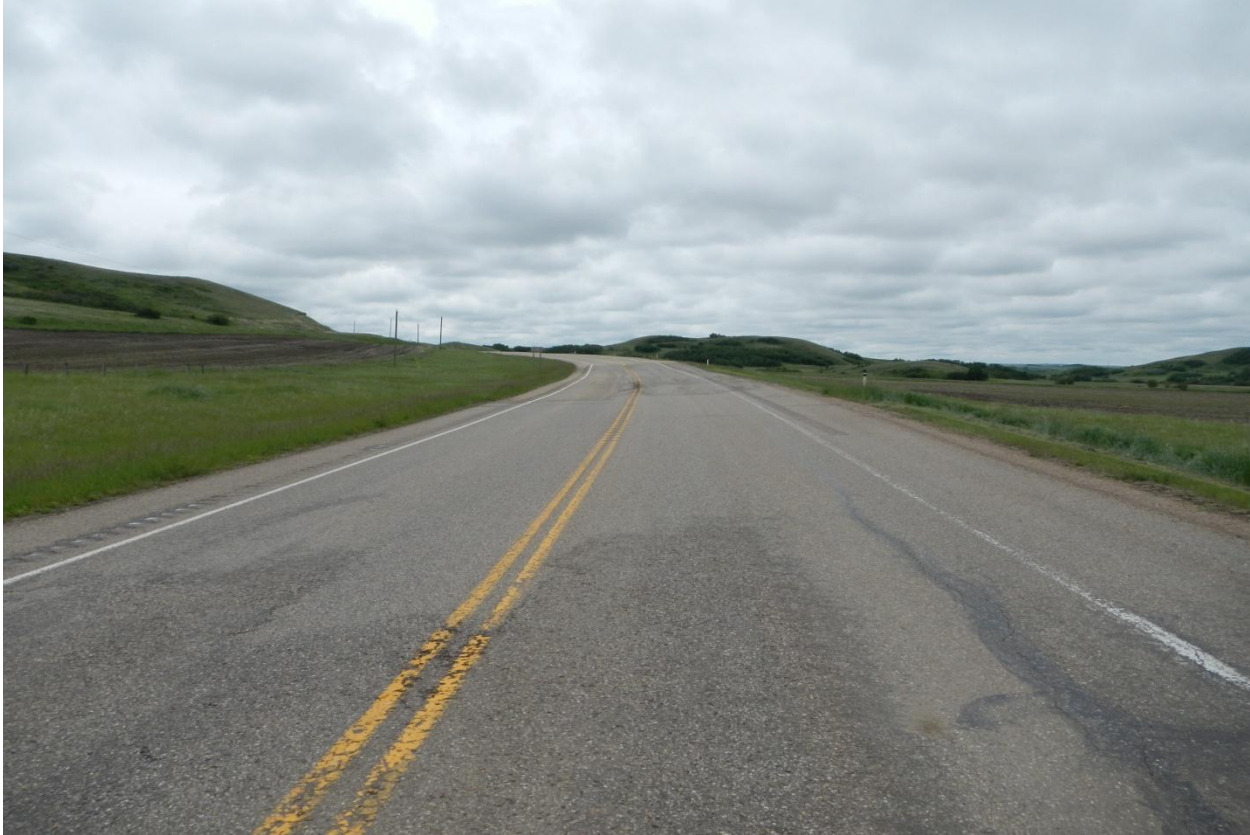
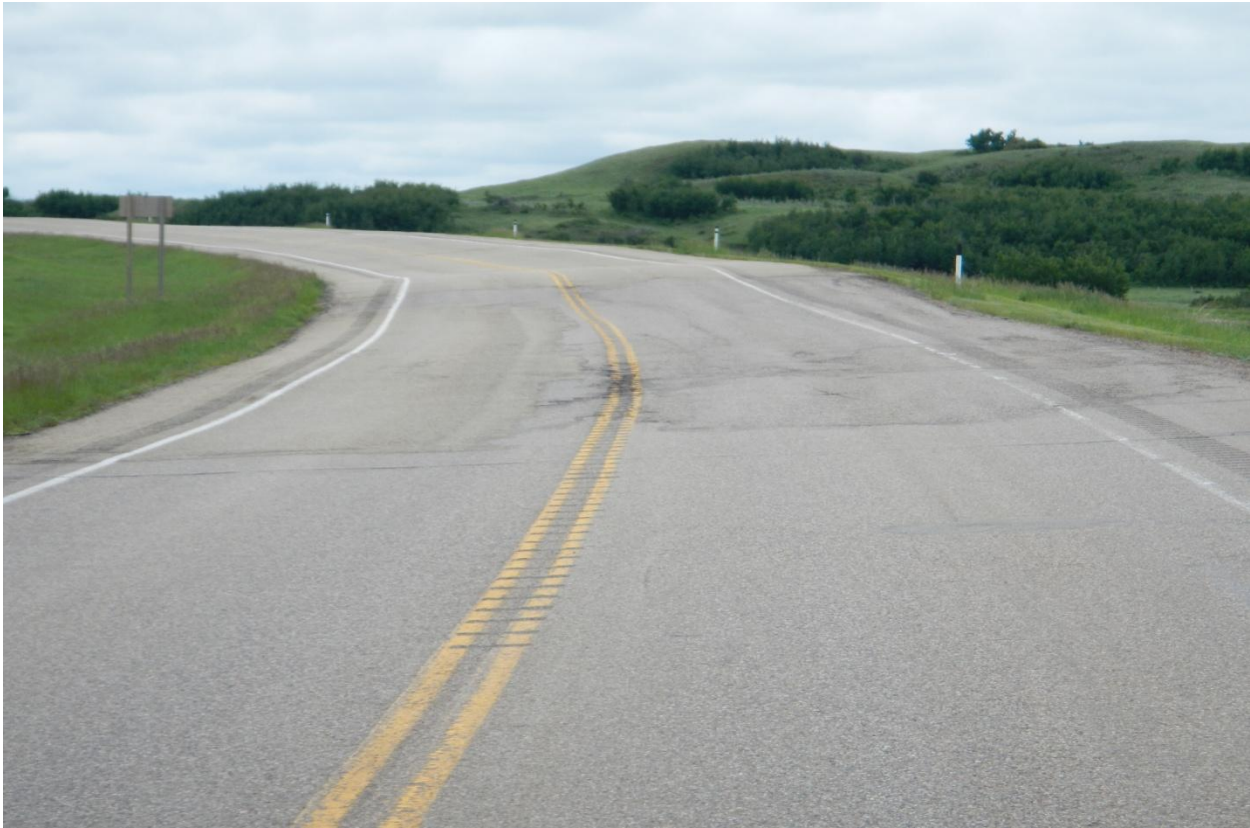
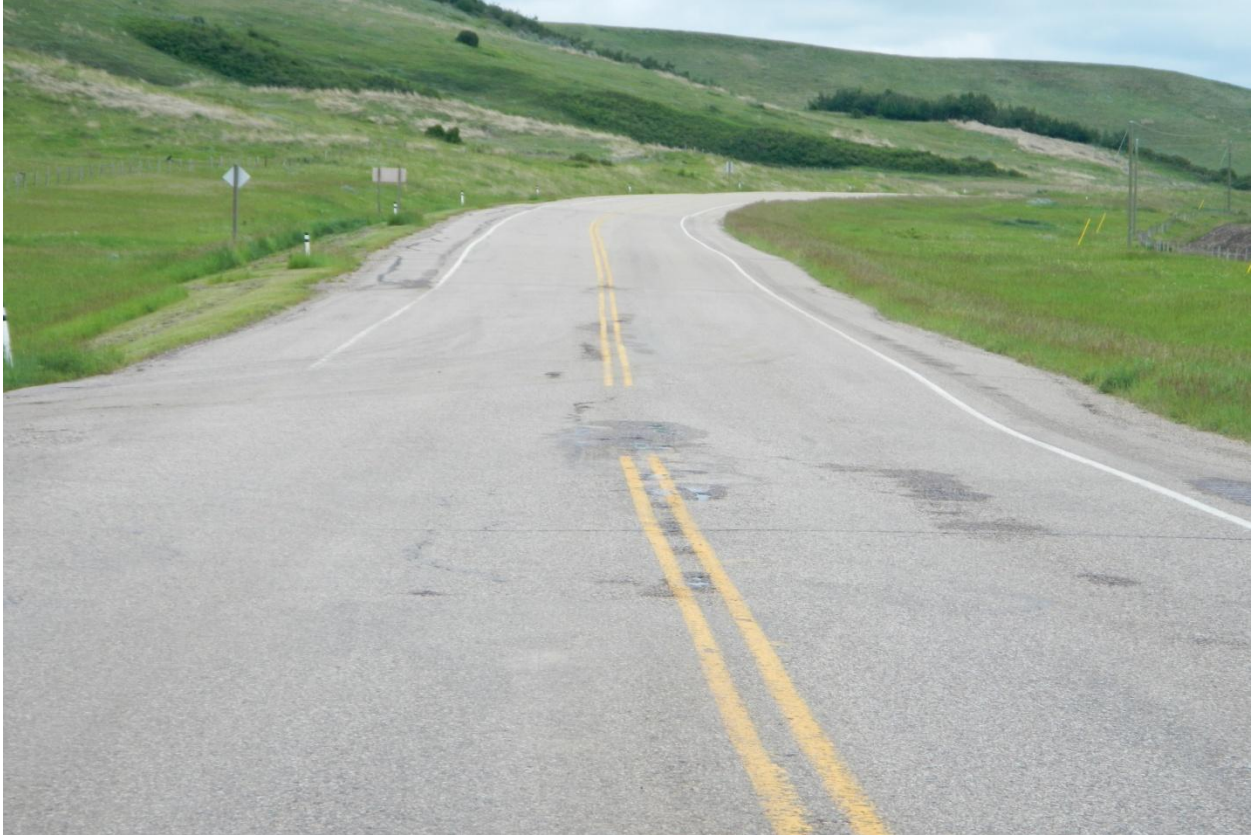
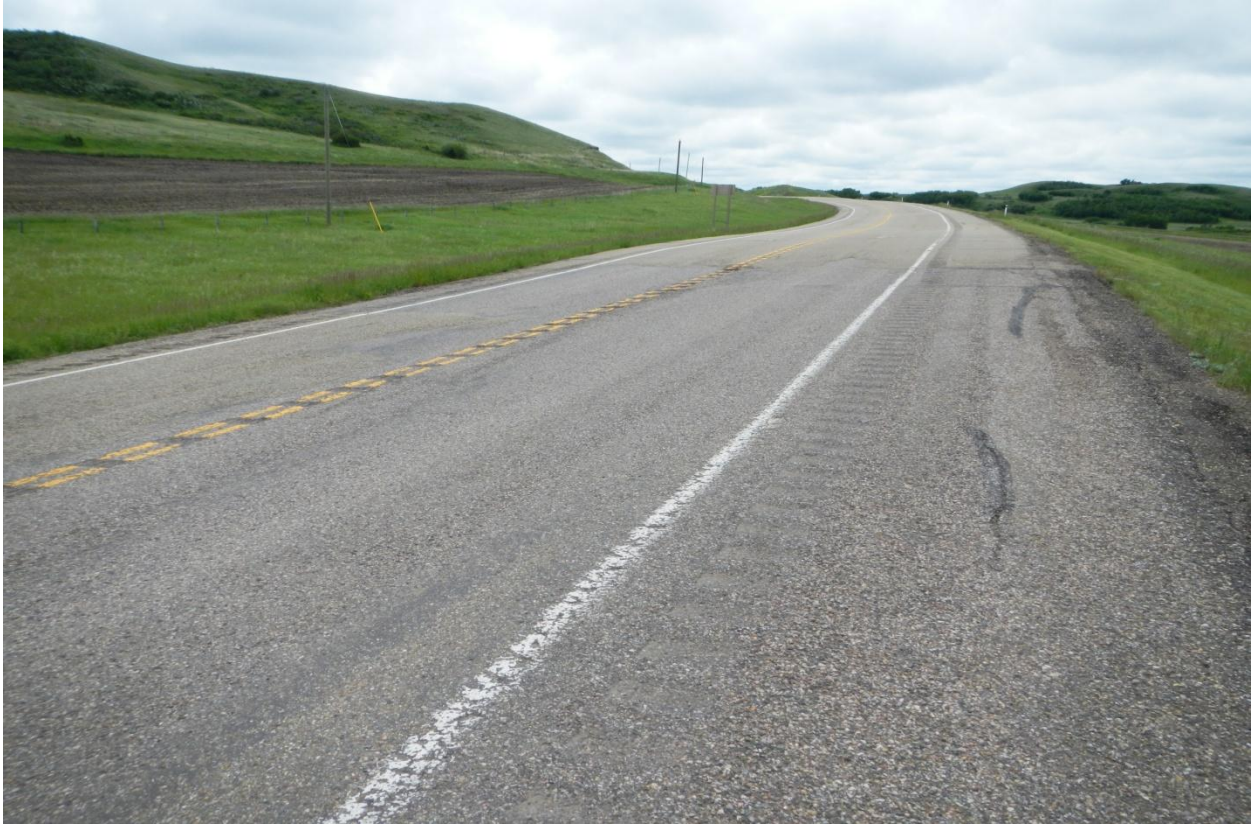
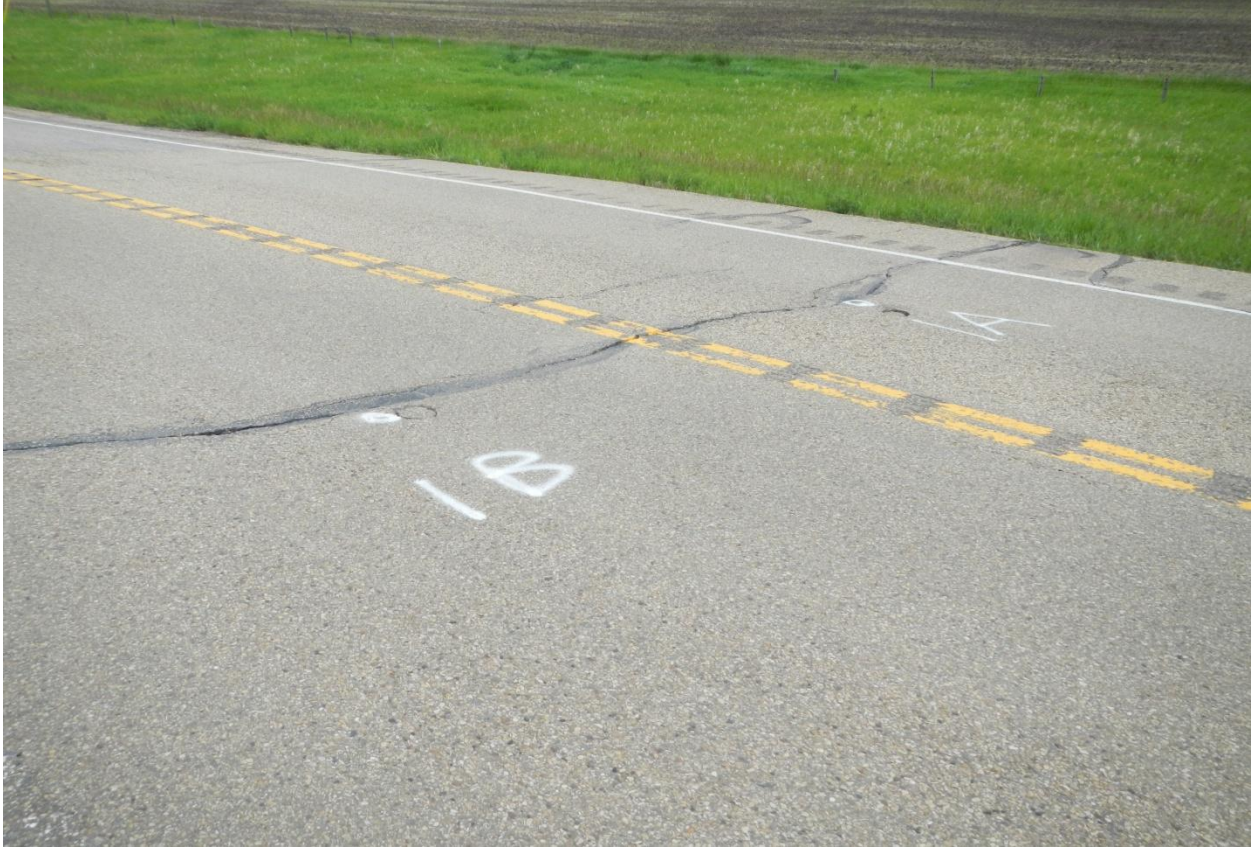
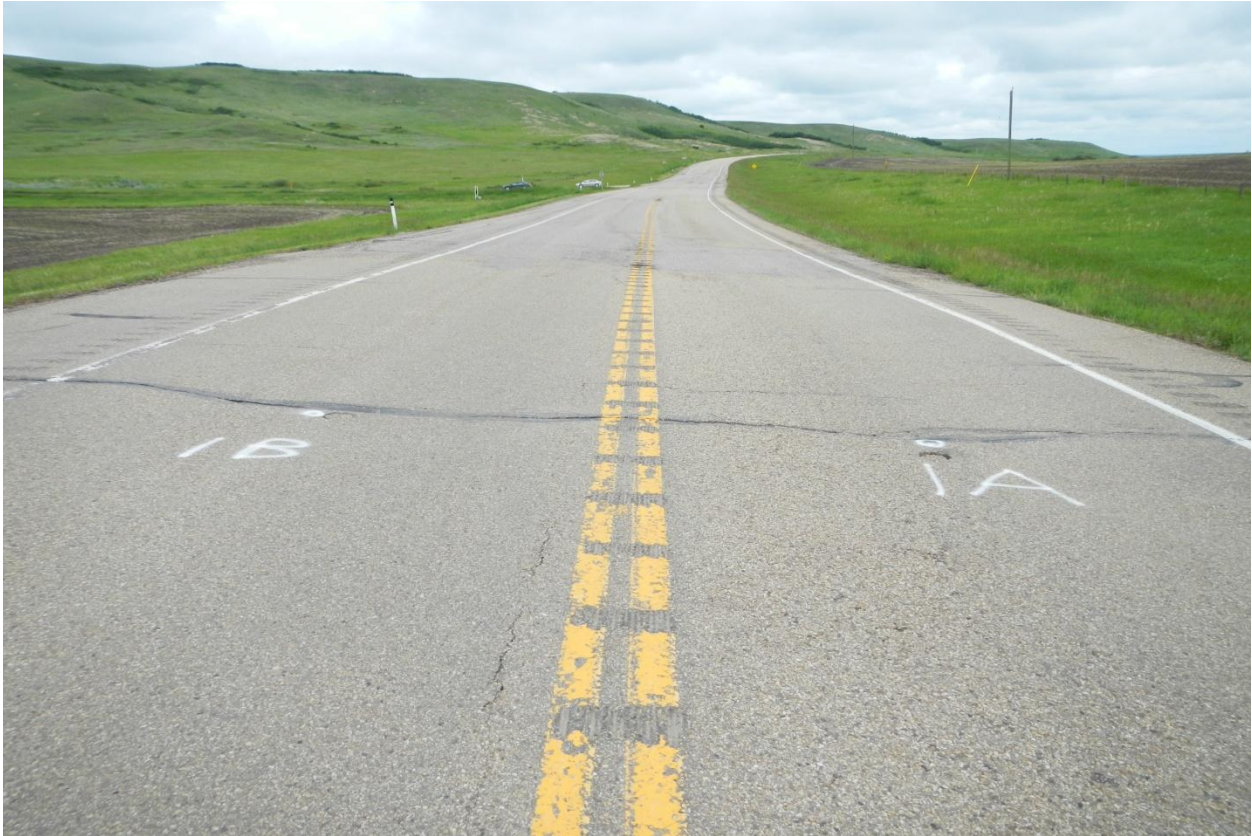
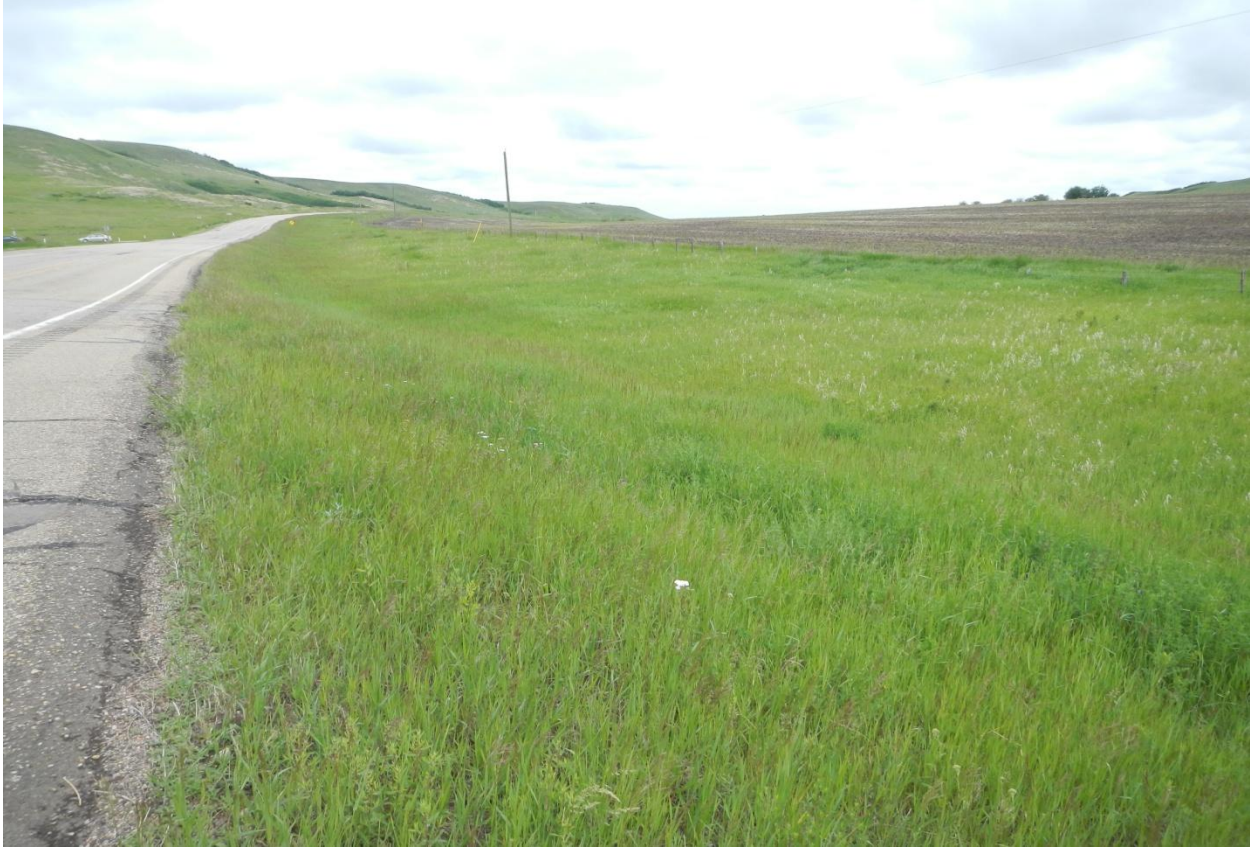
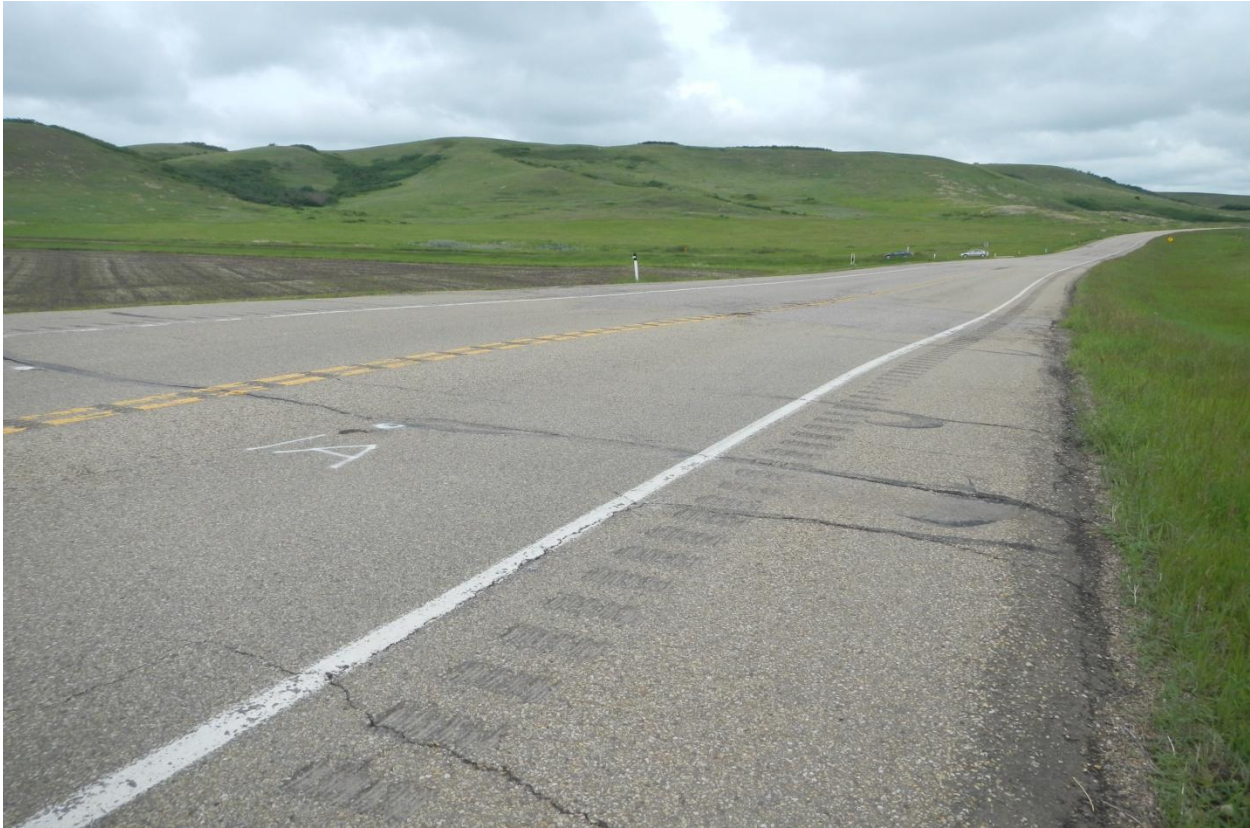
ITEM	CONDITION EXISTS		DESCRIPTION AND LOCATION	NOTICABLE CHANGE FROM LAST INSPECTION	
	YES	NO		YES	NO
Pavement Distress	X		There are several bumps and dips in the pavement.		X
Slope Movement		X			
Erosion		X			
Seepage		X			
Culvert Distress	X		One end of the culvert is damaged and partially blocked.		X

COMMENTS
See attached photos and previous callout report.
The distressed areas should be repaired with deep patches during the next overlay program.
MCI to monitor – remove from geohazard tour.
