SITE NUMBER AND NAME C10B H53:04 Erosion		HIGHWAY & KM 1.2 km east of H22	PREVIOUS INSPECTION DATE June 26, 2007	INSPECTION DATE May 20, 2014
LEGAL DESCRIPTION SE 7-43-6-W5	NAD 83 COORDINATES N 5839935 E 644634		RISK ASSESMENT PF: 6 CF: 2 TOTAL: 12

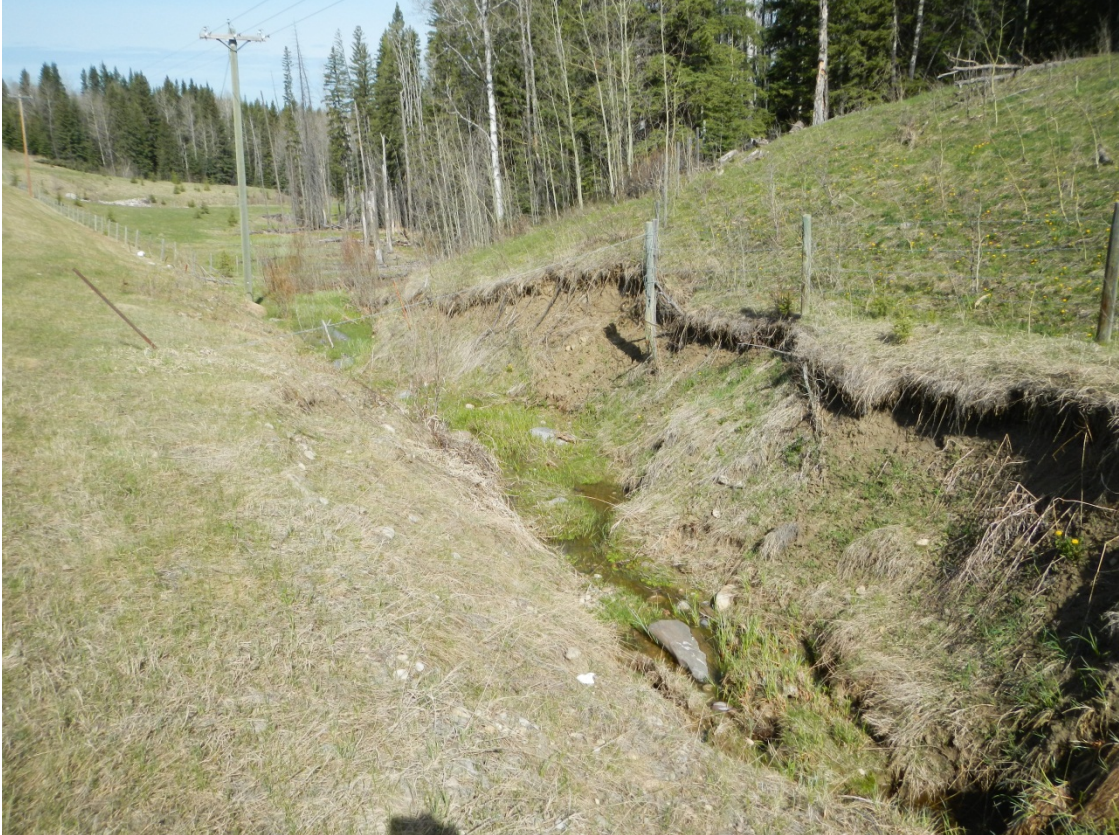
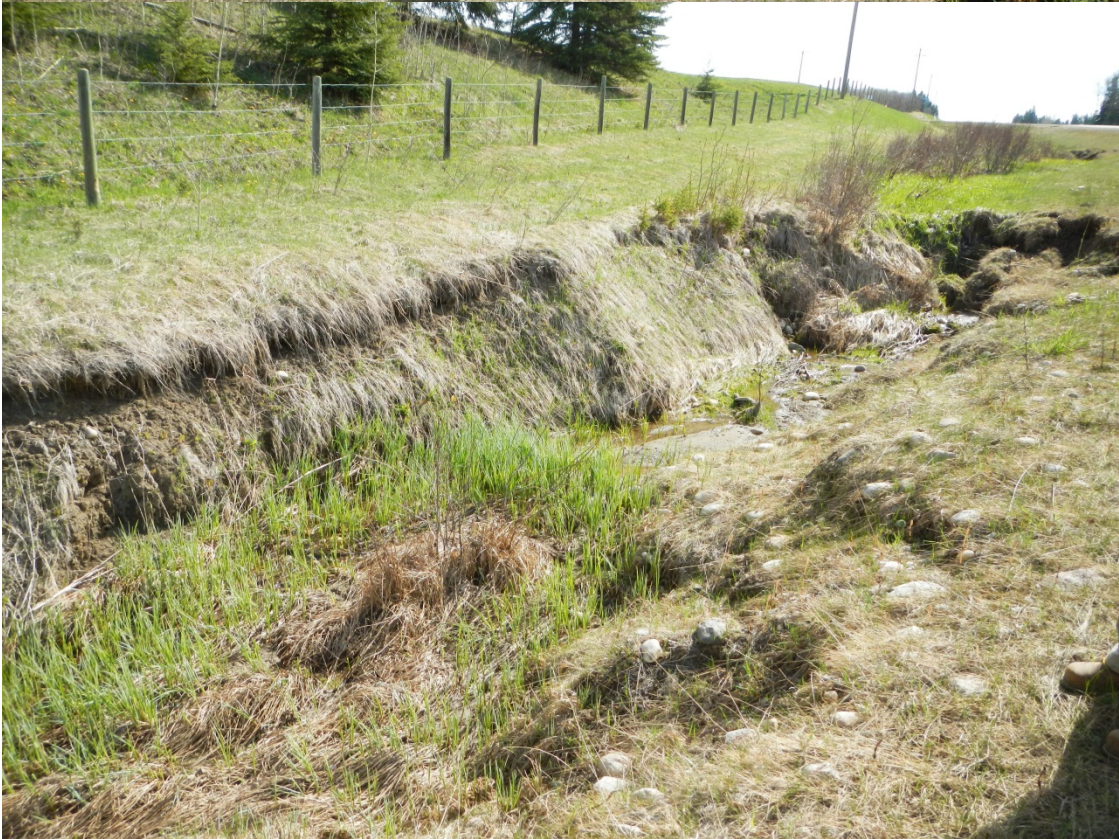
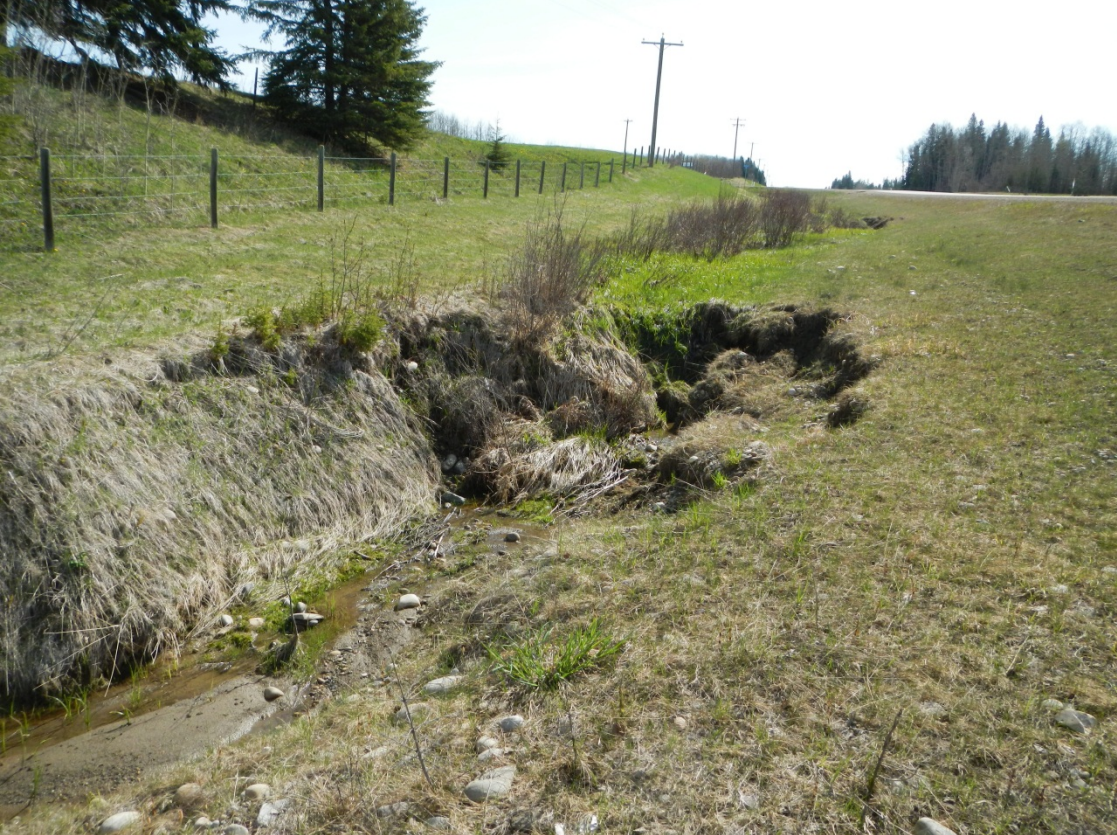
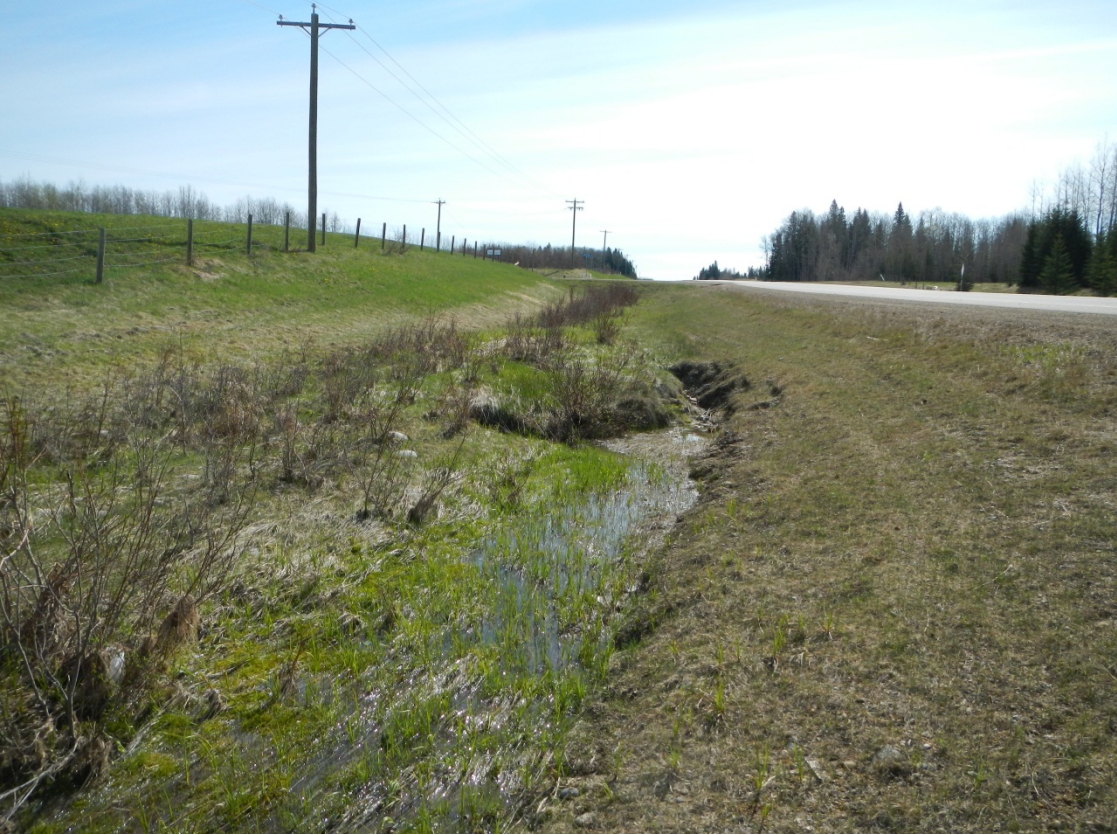
LAST READING DATE:	
PRIMARY SITE ISSUE: Ditch Erosion & Instability	
APPROXIMATE DIMENSIONS: Erosion channel about 50 m in length, 4 m to 6 m wide and 2 m to 3.5 m deep.	
DATE OF ANY REMEDIAL ACTION:

ITEM	CONDITION EXISTS		DESCRIPTION AND LOCATION	NOTICABLE CHANGE FROM LAST INSPECTION	
	YES	NO		YES	NO
Pavement Distress					
Slope Movement		X	Instability in bank slopes due to toe erosion.		X
Erosion	X		An erosion channel has developed in the north ditch of H53. Fence posts are being undermined.		X
Seepage					
Culvert Distress

COMMENTS
Refer to previous reports and attached photos
No significant change over last 7 years.
Rip rap channel proposed for repair.
