SITE NUMBER AND NAME C10A H53:04 Erosion		HIGHWAY & KM 5 km east of H22	PREVIOUS INSPECTION DATE May 20, 2014	INSPECTION DATE June 23, 2015
LEGAL DESCRIPTION SW 10-43-6-W5	NAD 83 COORDINATES N 5840057 E 648688		RISK ASSESSMENT PF: 1 CF: 1 TOTAL: 1

LAST READING DATE:	
PRIMARY SITE ISSUE: Ditch Erosion & Instability	
APPROXIMATE DIMENSIONS:	
DATE OF ANY REMEDIAL ACTION: "Living Wall" (compost filled tubes) and rip rap installed September 2006

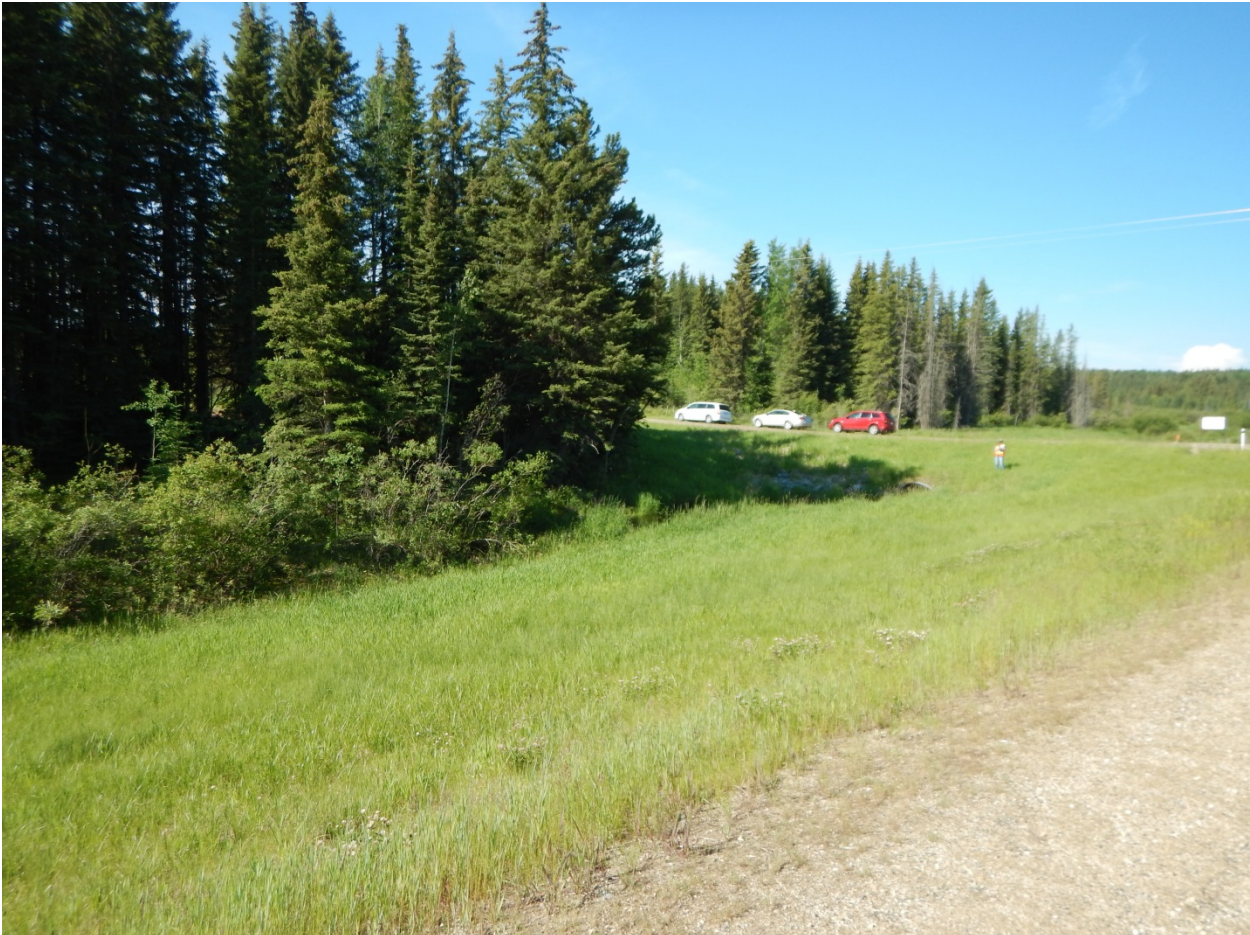
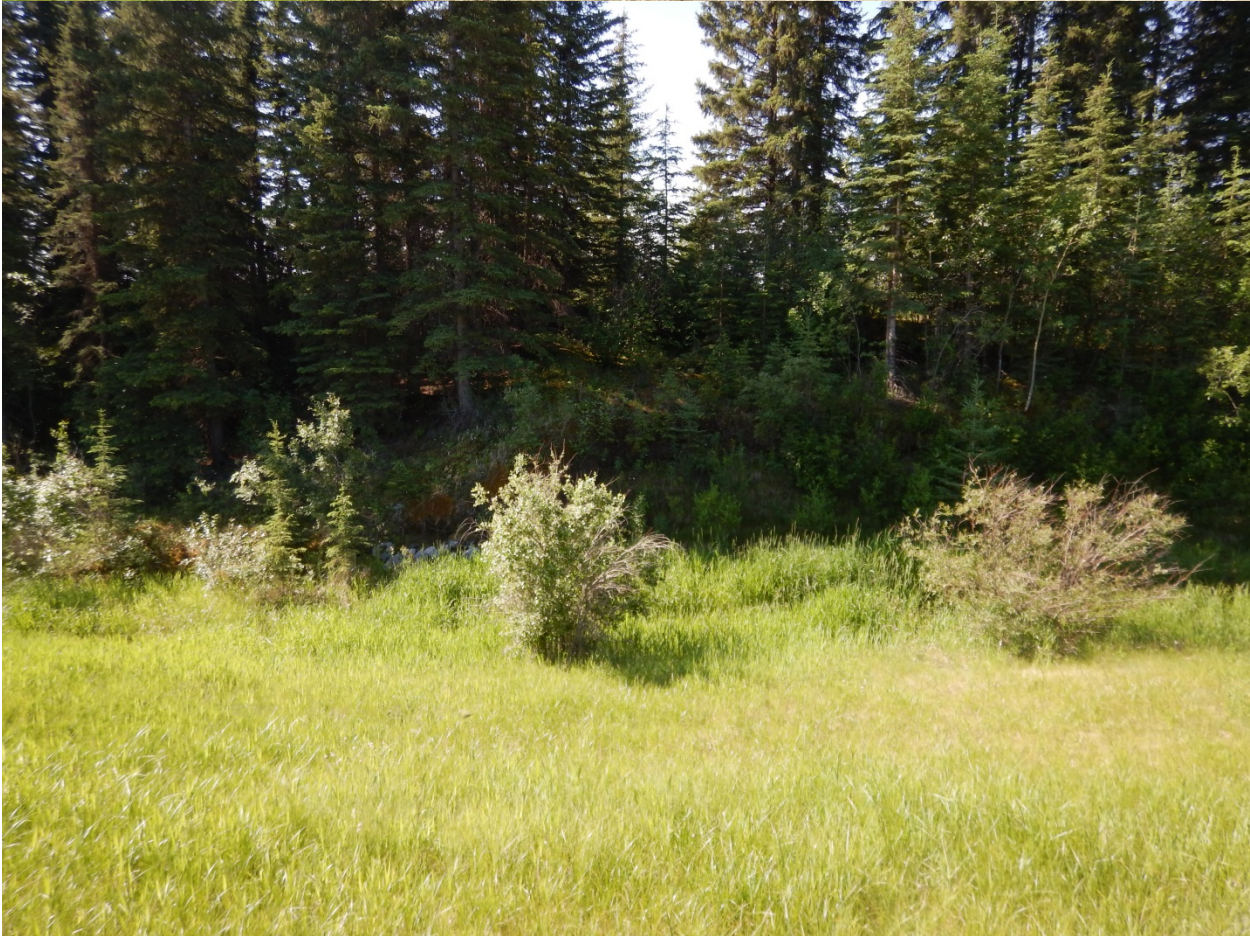
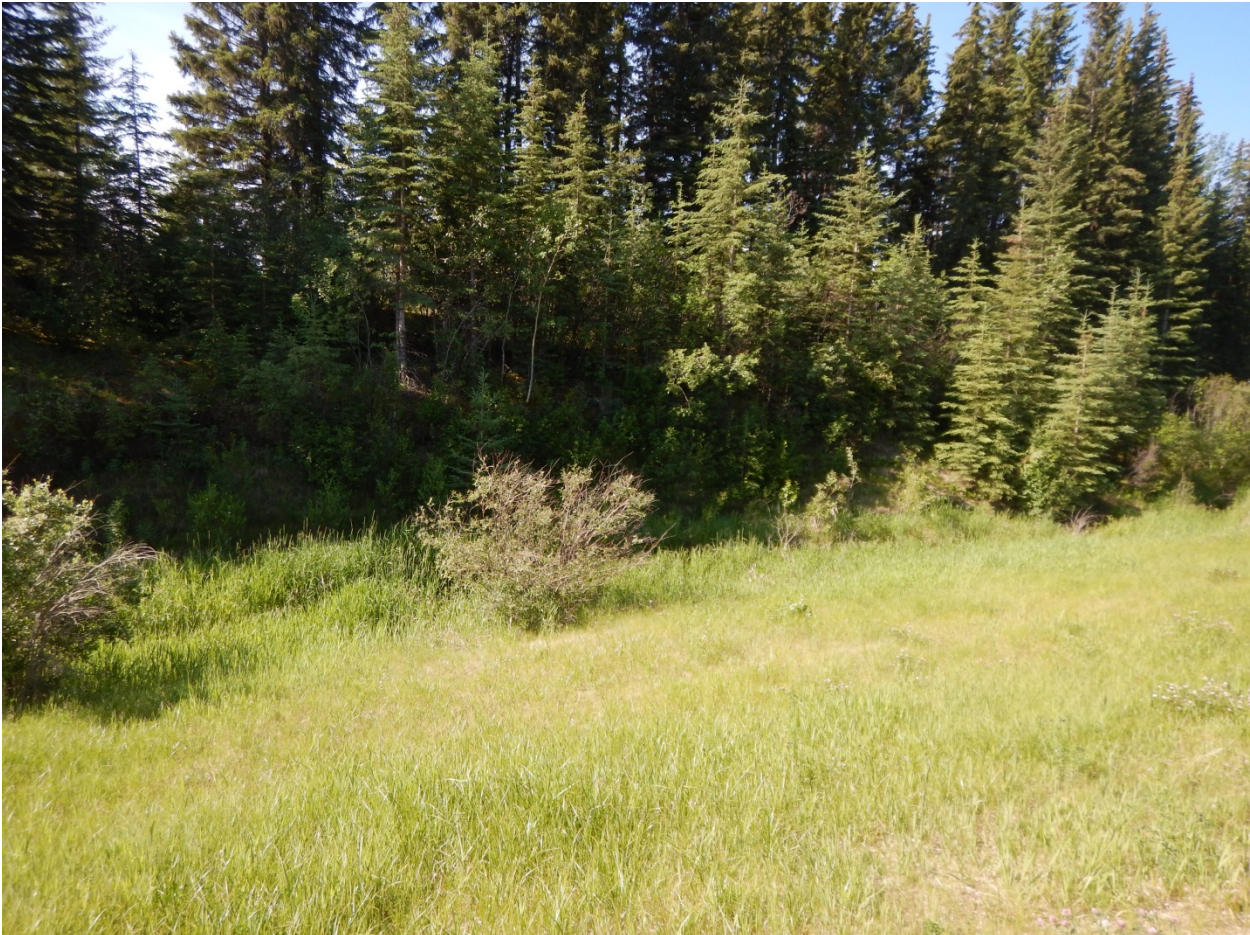
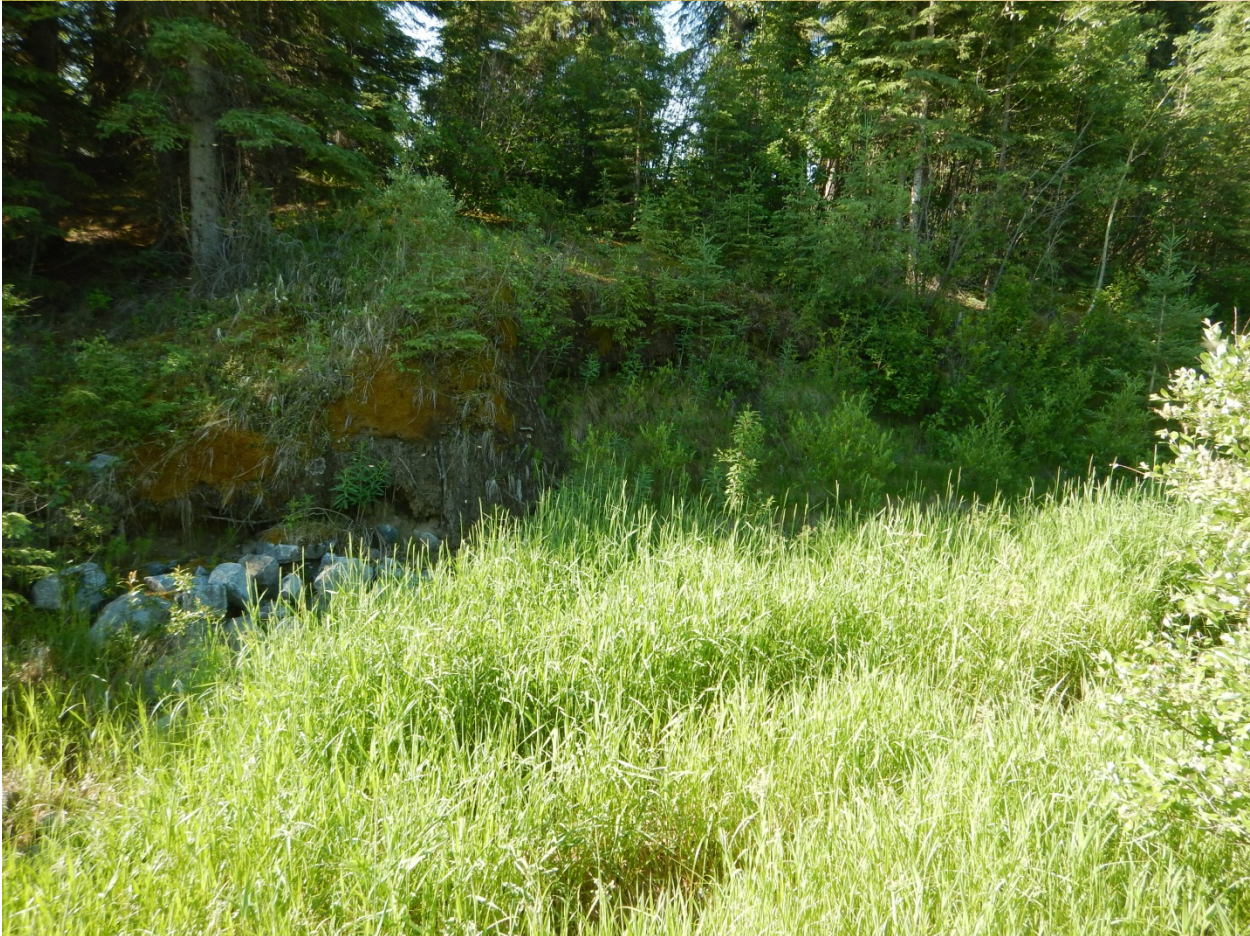
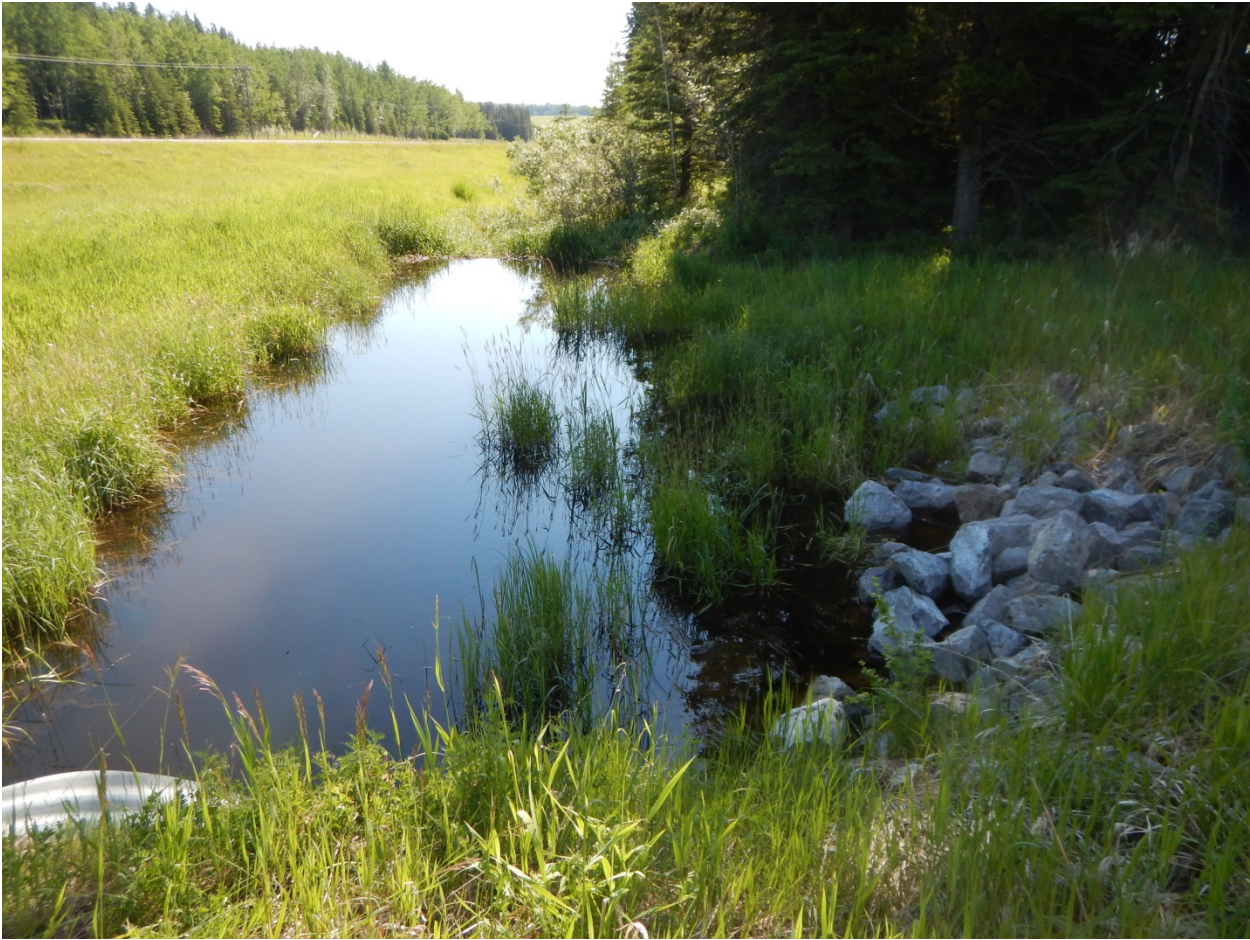
ITEM	CONDITION EXISTS		DESCRIPTION AND LOCATION	NOTICABLE CHANGE FROM LAST INSPECTION	
	YES	NO		YES	NO
Pavement Distress					
Slope Movement		X	Instability in bank slopes due to toe erosion repaired with rip rap and compost filled tubes.		X
Erosion		X	Toe and bank erosion occurring due to flows from culverts over a length of about 100 m.		X
Seepage					
Culvert Distress					
COMMENTS					
Refer to previous reports and attached photos					
Culvert was replaced in 2005 and rip rap installed in 2006.					
Bank is now well vegetated. Beaver dam located downstream of culvert.					
Remove from GRMP
