SITE NUMBER AND NAME C10B H53:04 Erosion		HIGHWAY & KM 1.2 km east of H22	PREVIOUS INSPECTION DATE May 20, 2014	INSPECTION DATE June 23, 2015
LEGAL DESCRIPTION SE 7-43-6-W5	NAD 83 COORDINATES N 5839935 E 644634		RISK ASSESMENT PF: 1 CF: 1 TOTAL: 1

LAST READING DATE:	
PRIMARY SITE ISSUE: Ditch Erosion	
APPROXIMATE DIMENSIONS: Erosion channel about 50 m in length, 4 m to 6 m wide and 2 m to 3.5 m deep.	
DATE OF ANY REMEDIAL ACTION: December 2014 – ditch regraded with riprap protection

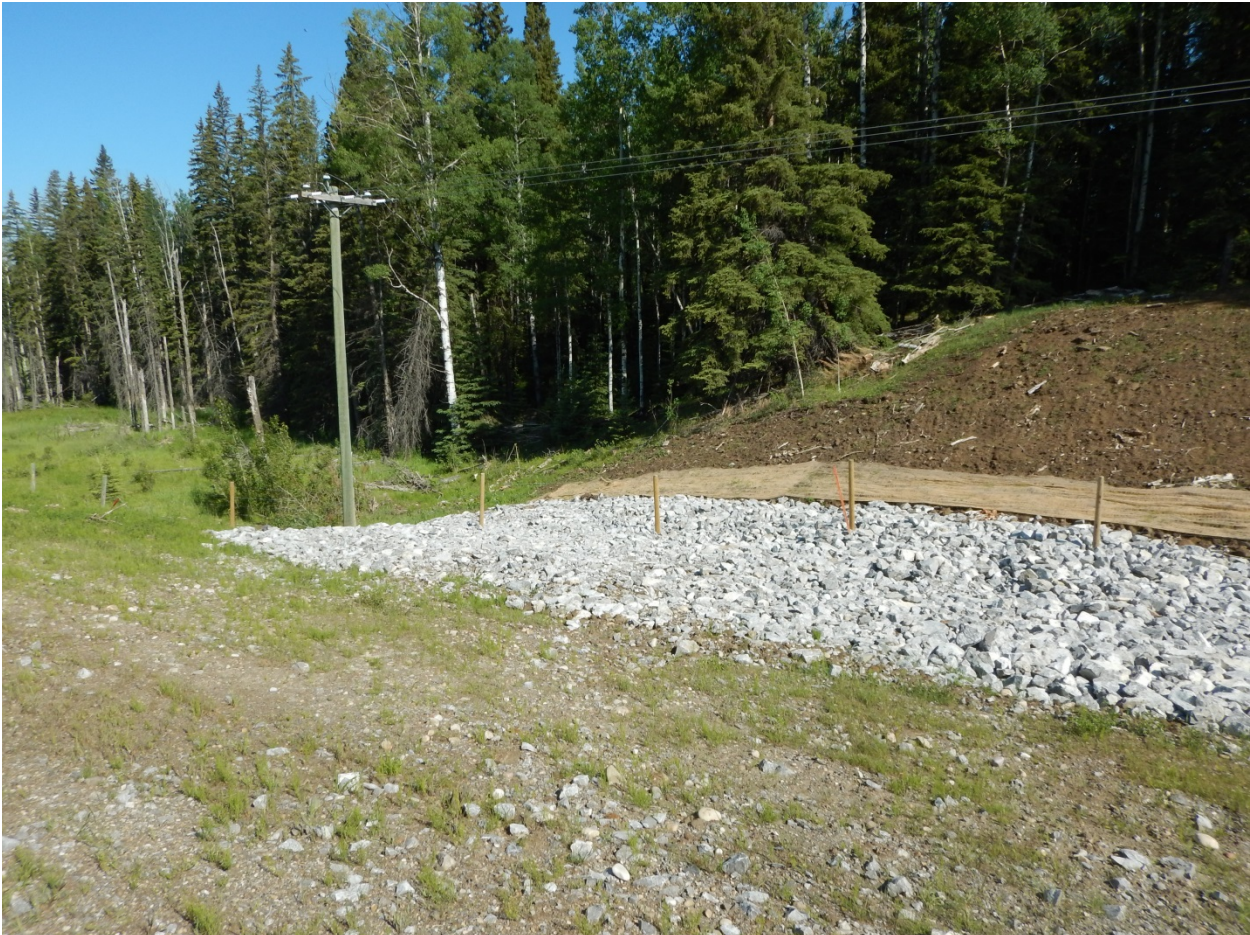
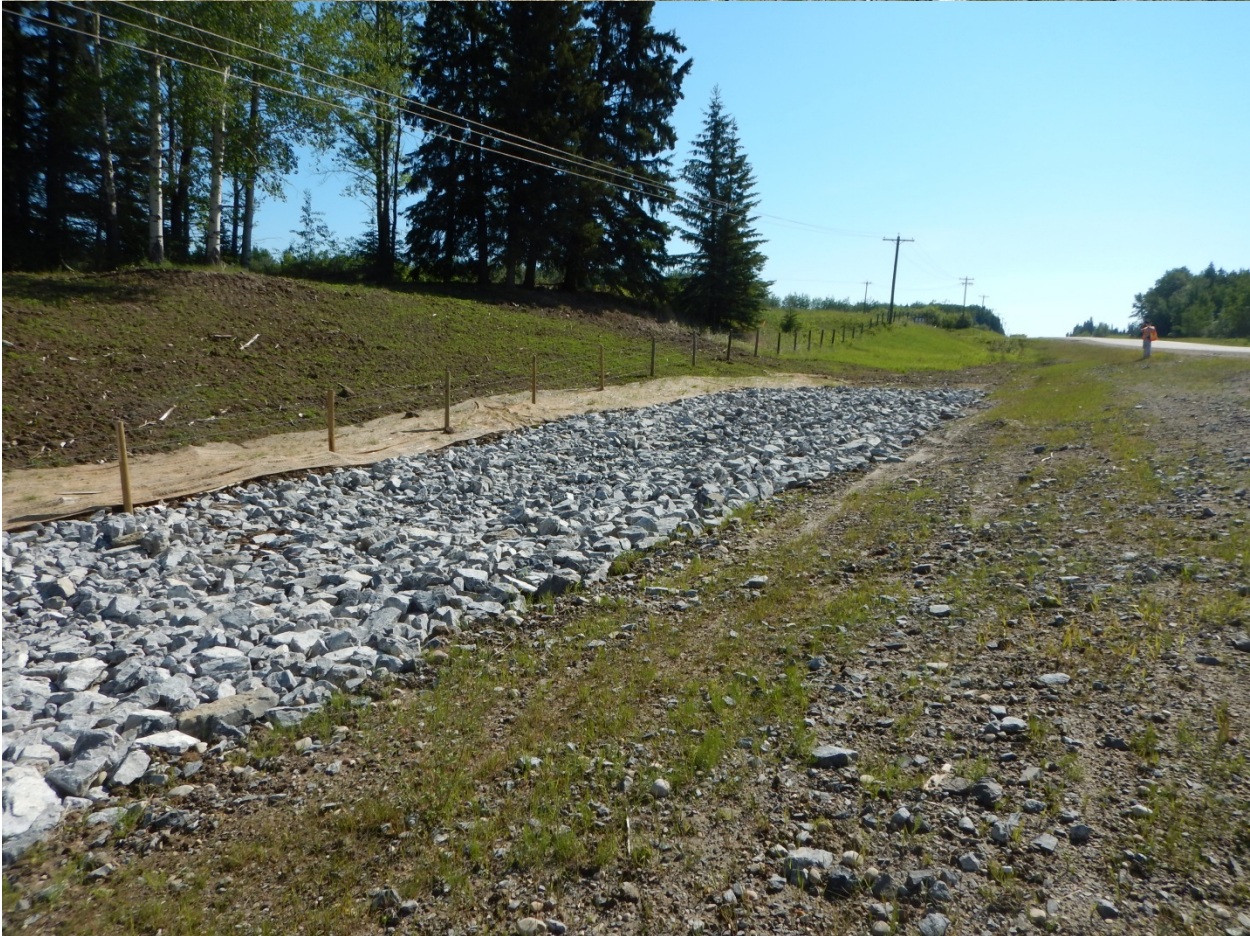
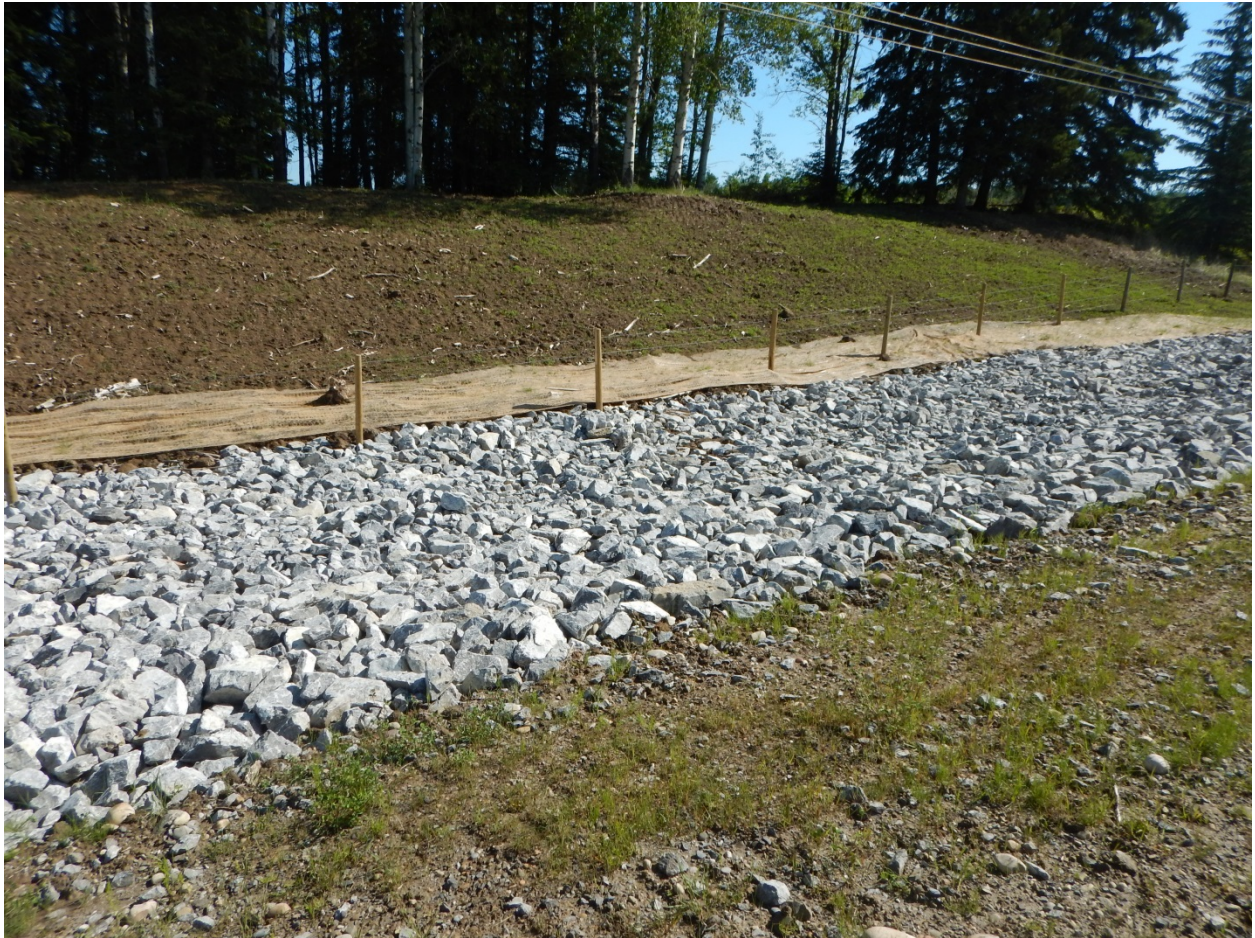
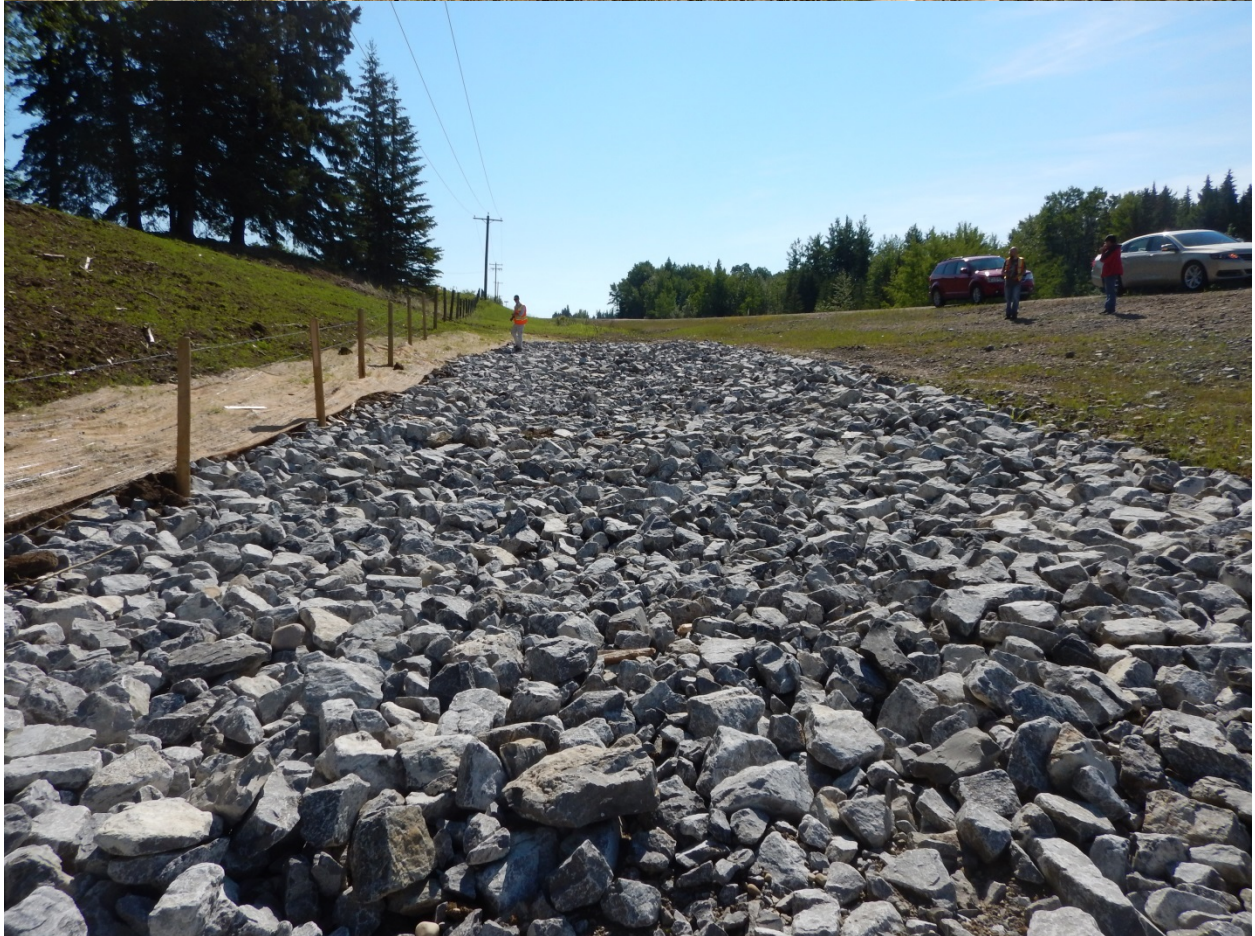
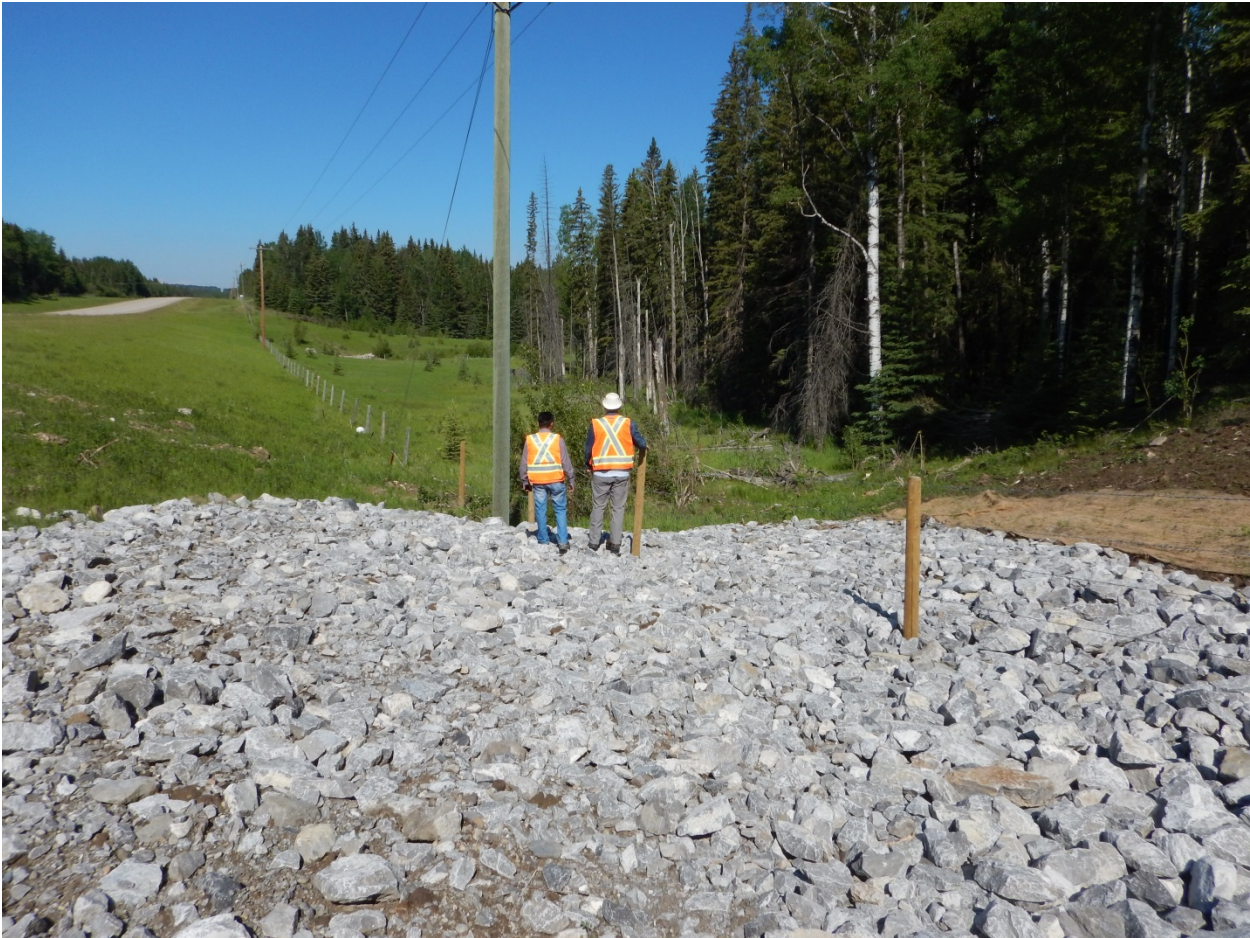
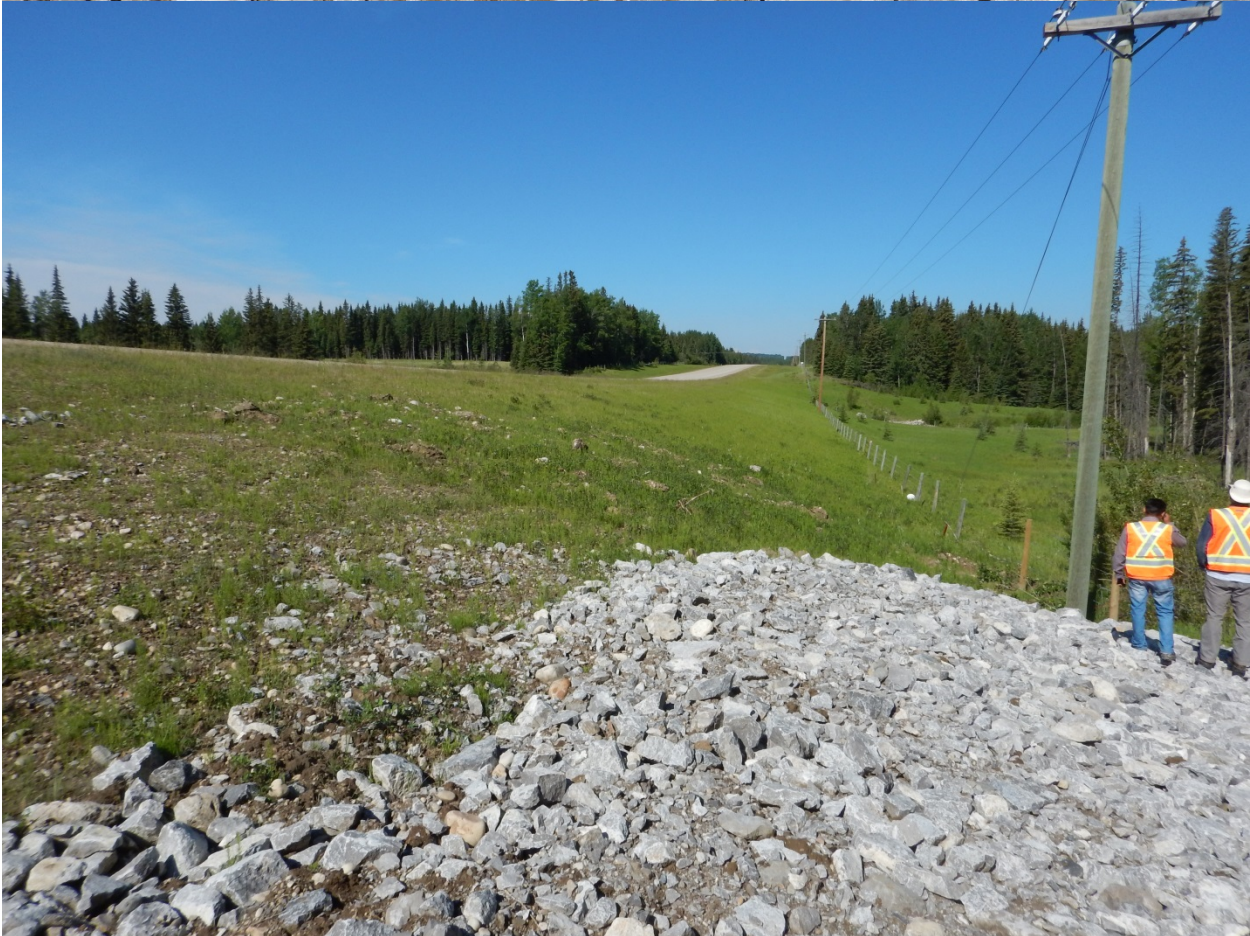
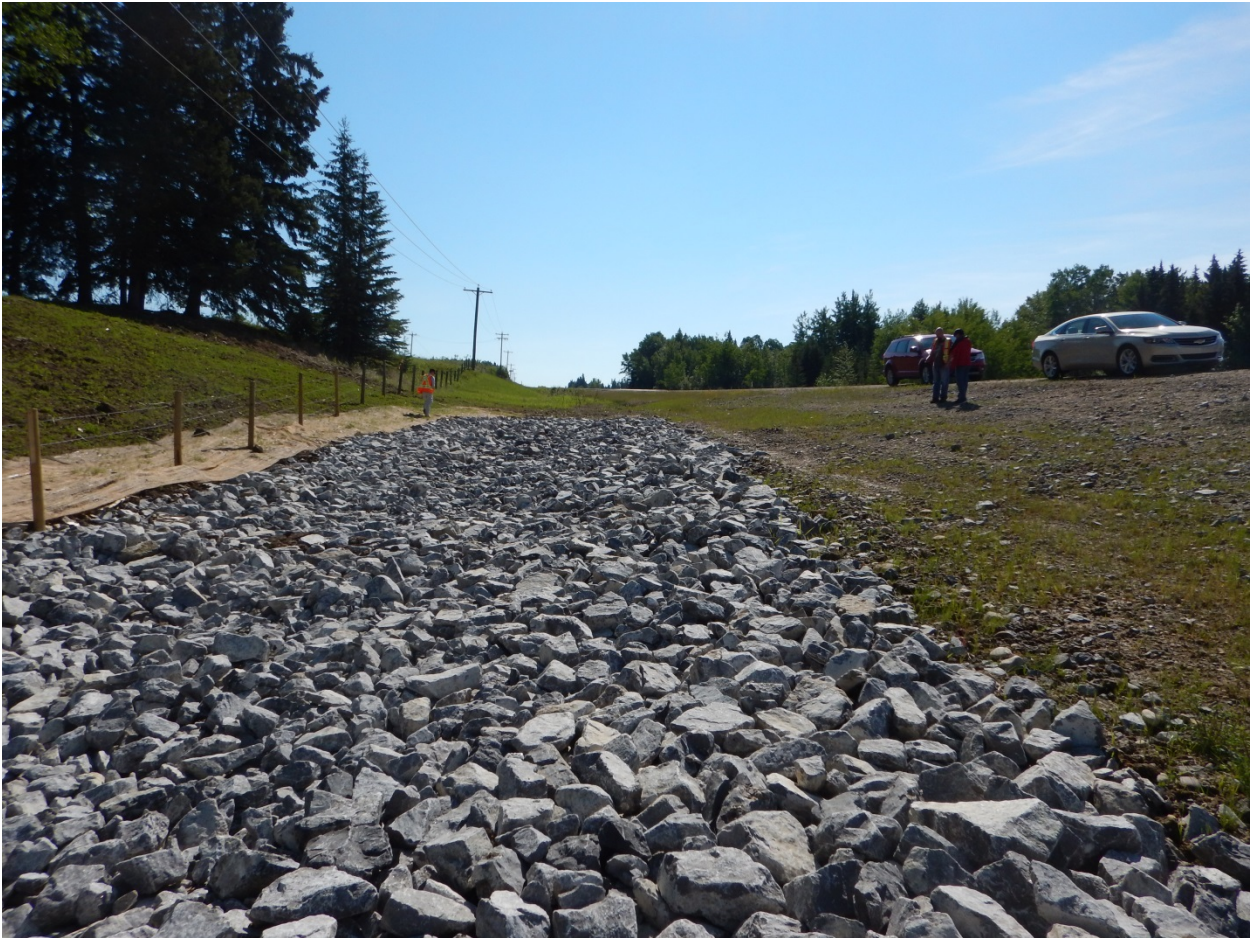
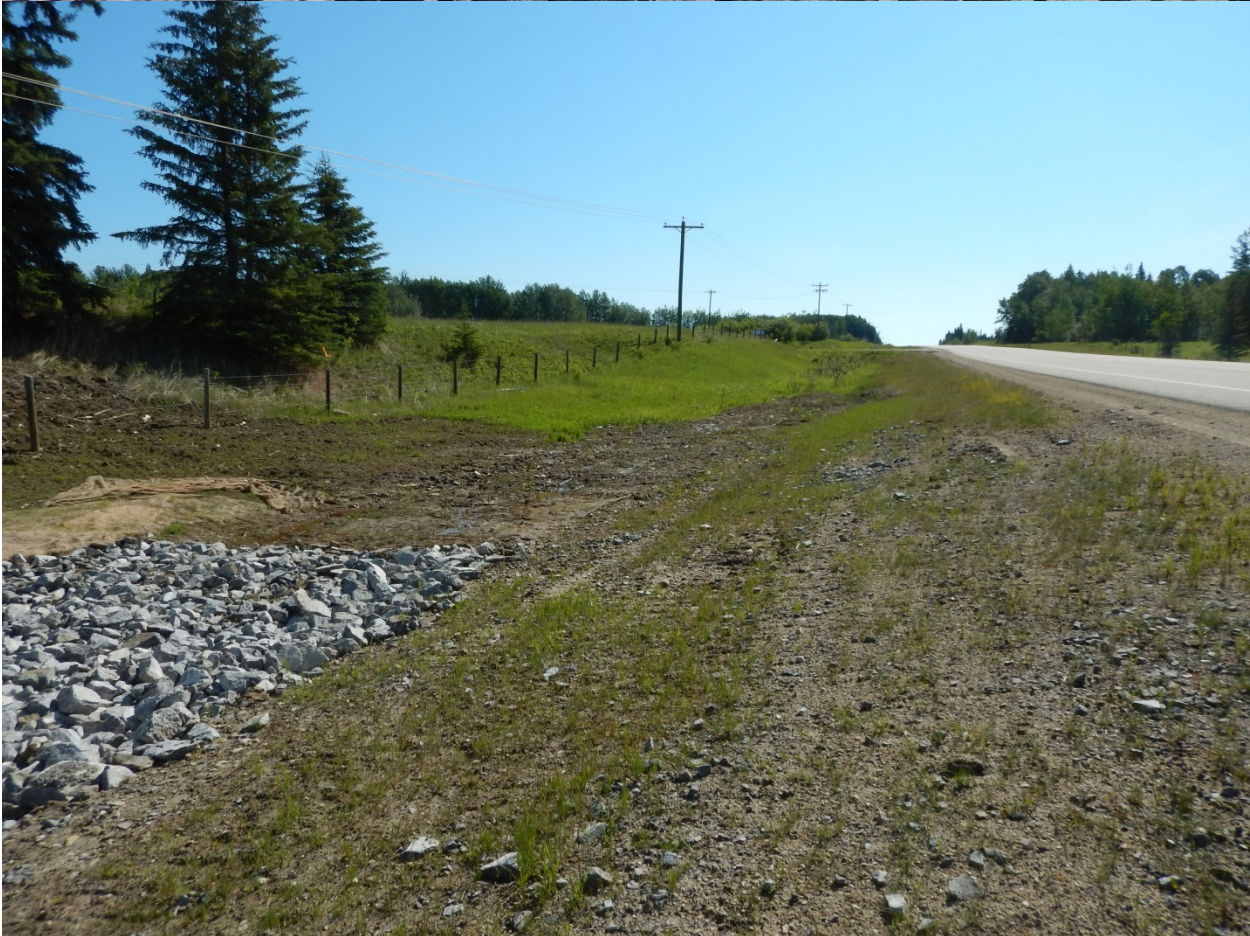
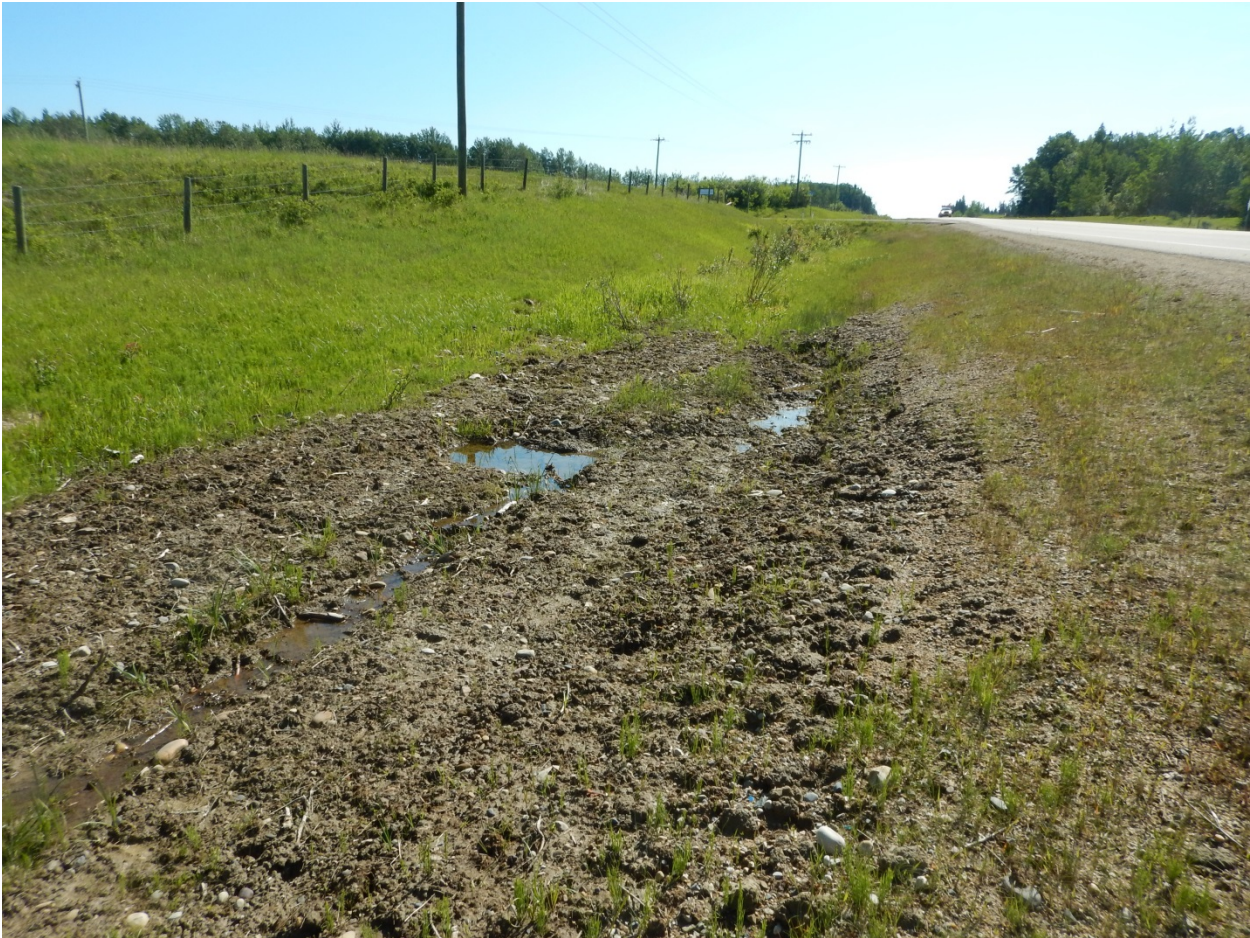
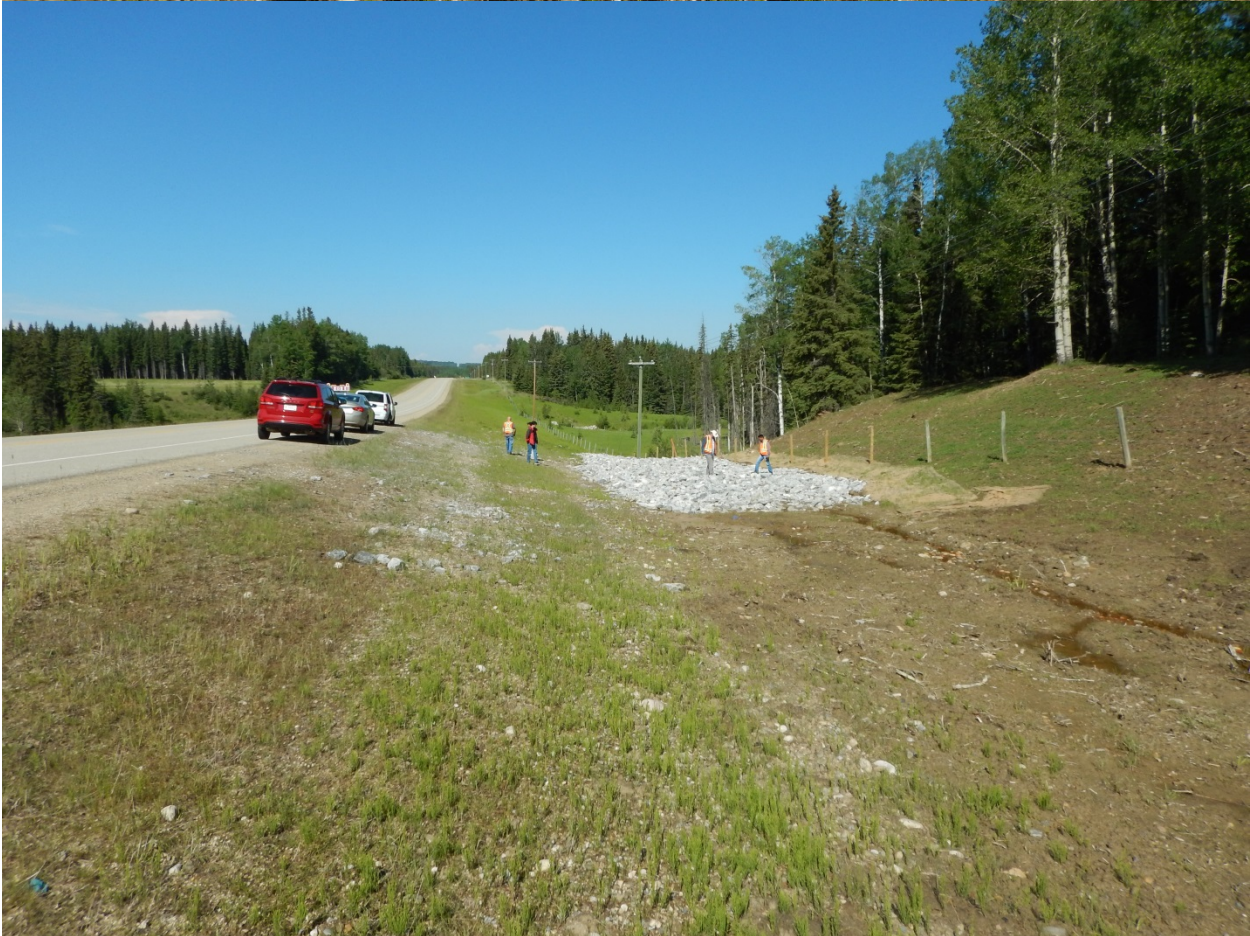
ITEM	CONDITION EXISTS		DESCRIPTION AND LOCATION	NOTICABLE CHANGE FROM LAST INSPECTION	
	YES	NO		YES	NO
Pavement Distress					
Slope Movement		X	Instability in bank slopes due to toe erosion.		
Erosion		X	An erosion channel had developed in the north ditch of H53. Repaired December 2014		
Seepage					
Culvert Distress

COMMENTS
Repaired under High Water Mitigation Program. Erosion protection looks sufficient – MCI to monitor following storm events
Remove from GRMP
