**CENTRAL REGION  
GEOHAZARD RISK ASSESMENT  
SITE INSPECTION FORM**

SITE NUMBER AND NAME <b>C28 H53:06</b>		HIGHWAY & KM 4 km west of Highway 2	PREVIOUS INSPECTION DATE May 23, 2003	INSPECTION DATE <b>May 12, 2004</b>
LEGAL DESCRIPTION NW 4-43-26-W4	NAD 83 COORDINATES* N 5839575 E 317020		RISK ASSESMENT PF: 9 CF: 1 TOTAL: <b>9</b>

LAST READING DATE:	
PRIMARY SITE ISSUE: Ditch Erosion/Frost Heave	
APPROXIMATE DIMENSIONS: Ditch erosion length about 80 m, frost heave about 3 m wide across road	
DATE OF ANY REMEDIAL ACTION: Drains in 1980's, gravel in frost heave area in 1999

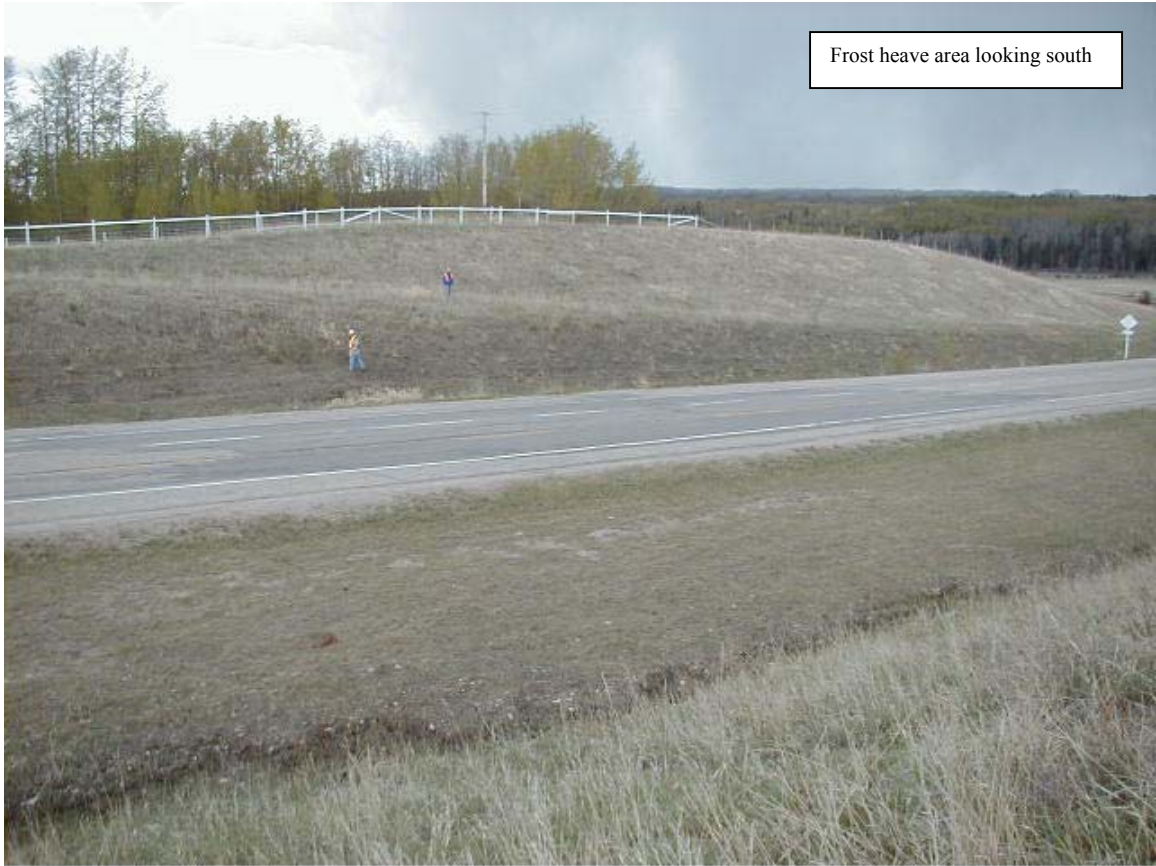
The lateral drains were not effective in controlling the frost heave and in 1999 about 1 m depth of road embankment was excavated in a slot across the full width of the highway and replaced with compacted pitrun gravel. This has reduced the amount of frost heave, but not eliminated it completely. It is considered that a deeper excavation is required, possibly tied in to the existing lateral drain. This should be addressed in a future overlay project.

Frost heave area looking south

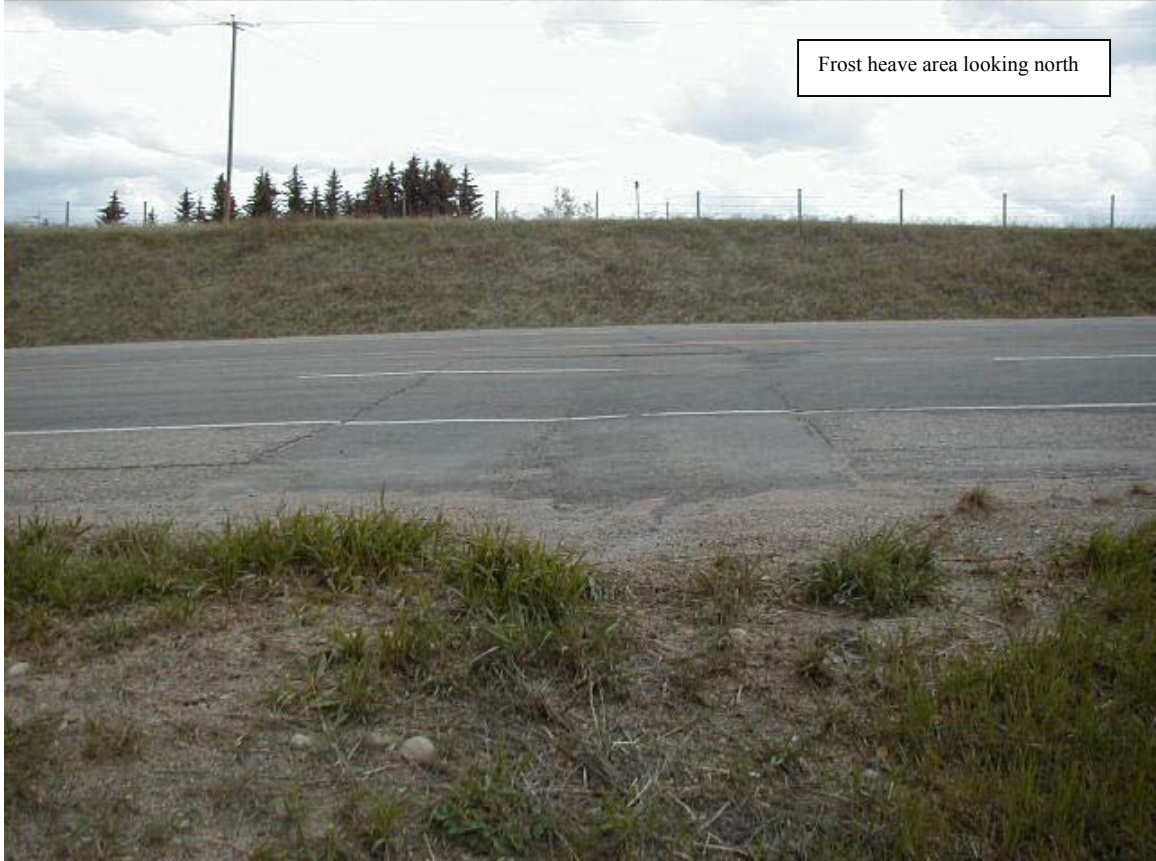
Frost heave area looking north

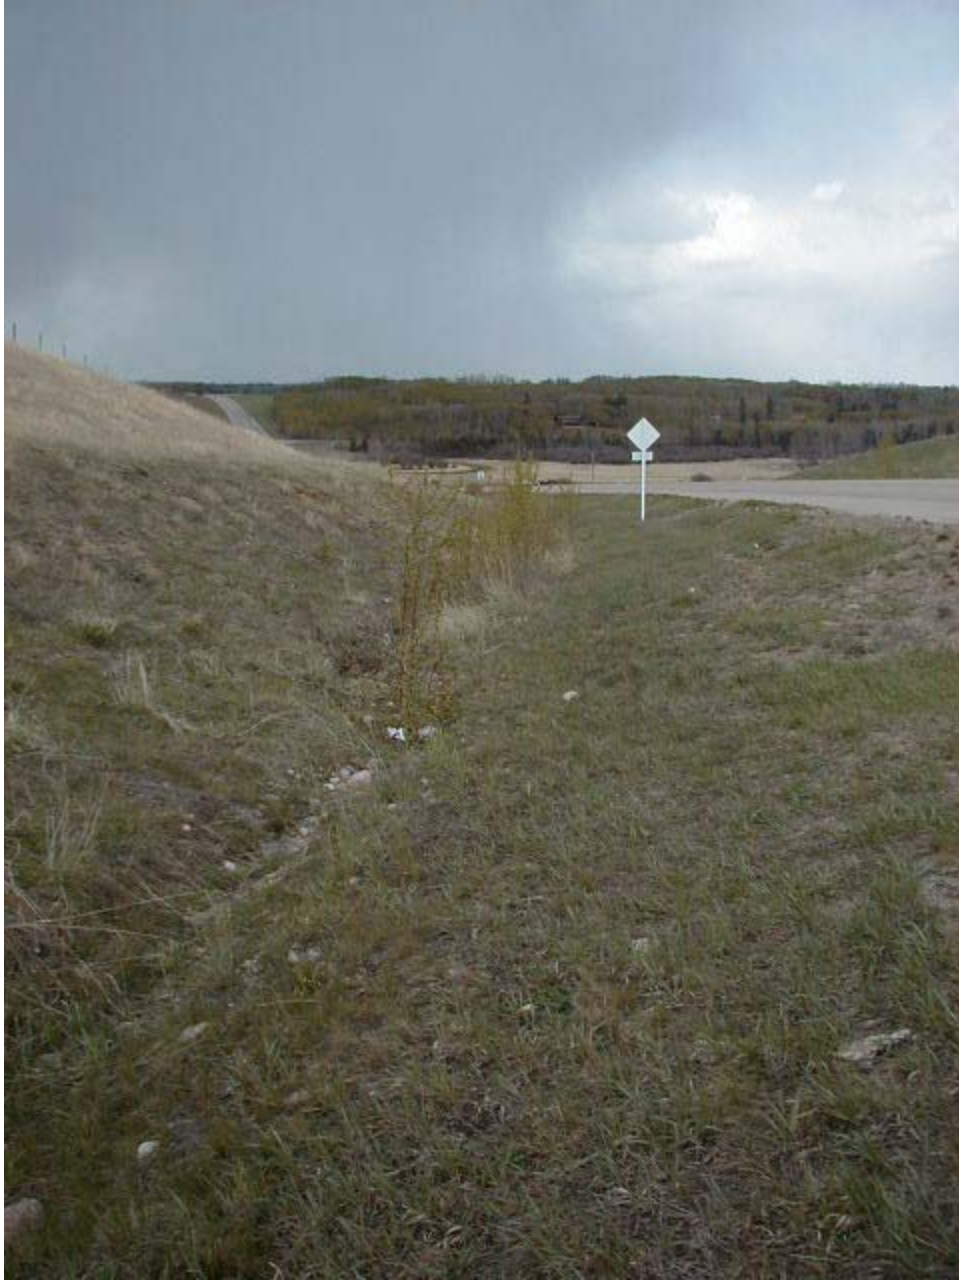
In the winter of 2002/03, a car slid off the highway and became entrapped in the ditch erosion to the southwest of the frost heave area. The total length of the erosion is about 80 m. It is recommended that the erosion area close to the highway edge over a length of about 25 m be remediated with a "Tri-Lock" block approach and delivered in a future overlay project.

Looking west along south ditch

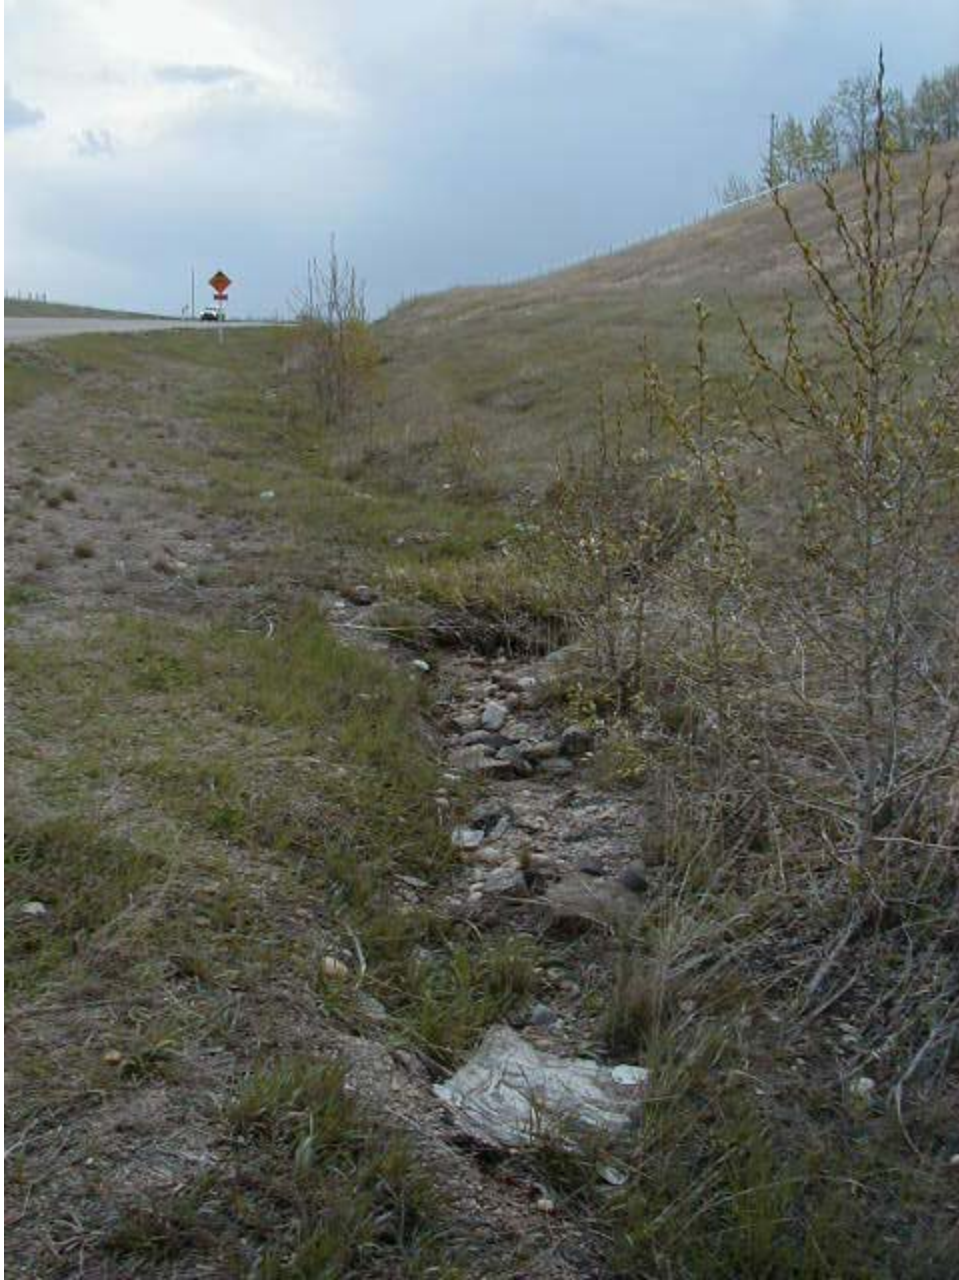
Looking east along south ditch

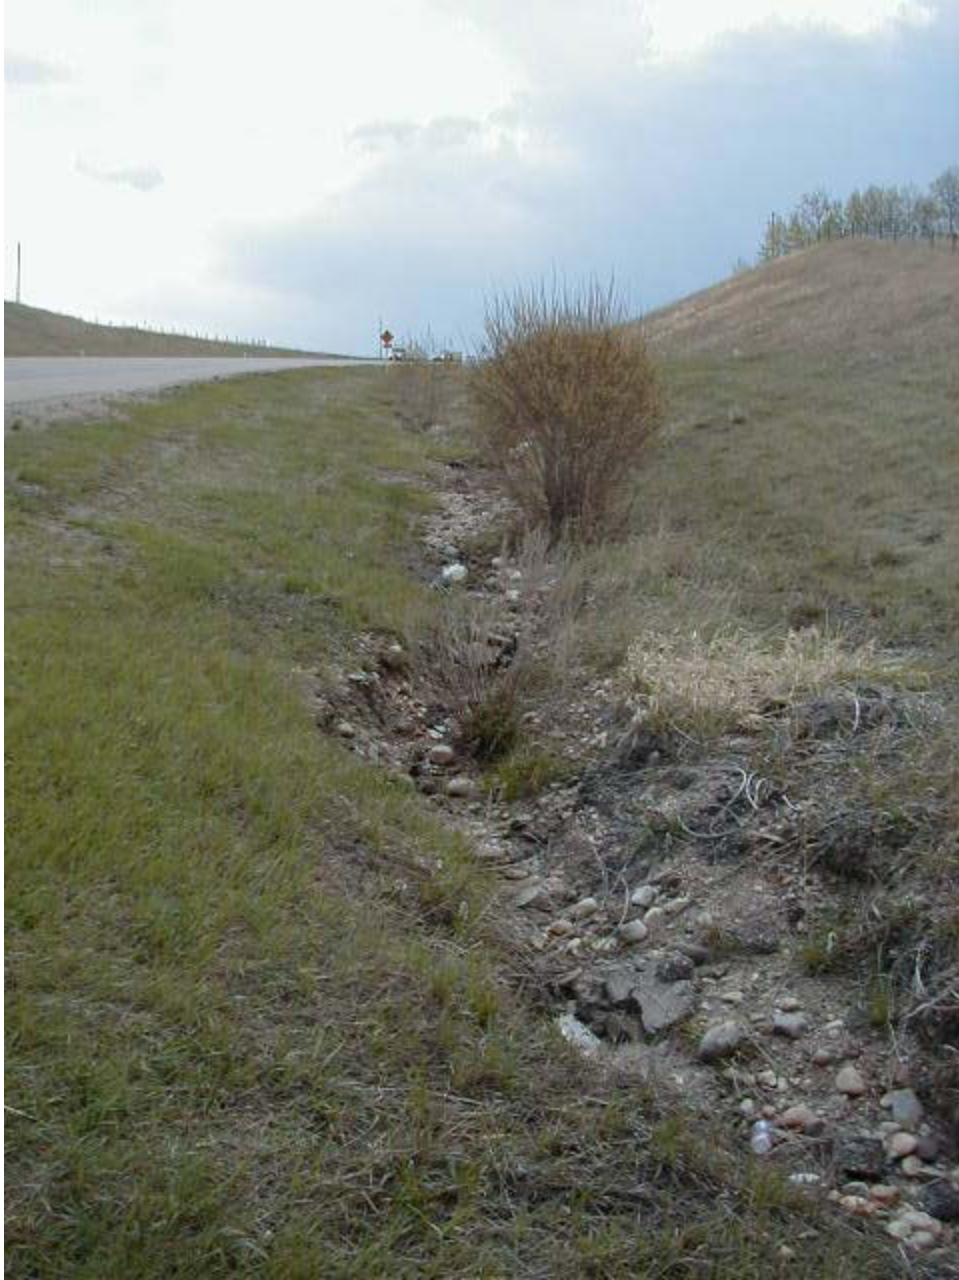
Looking east along south ditch

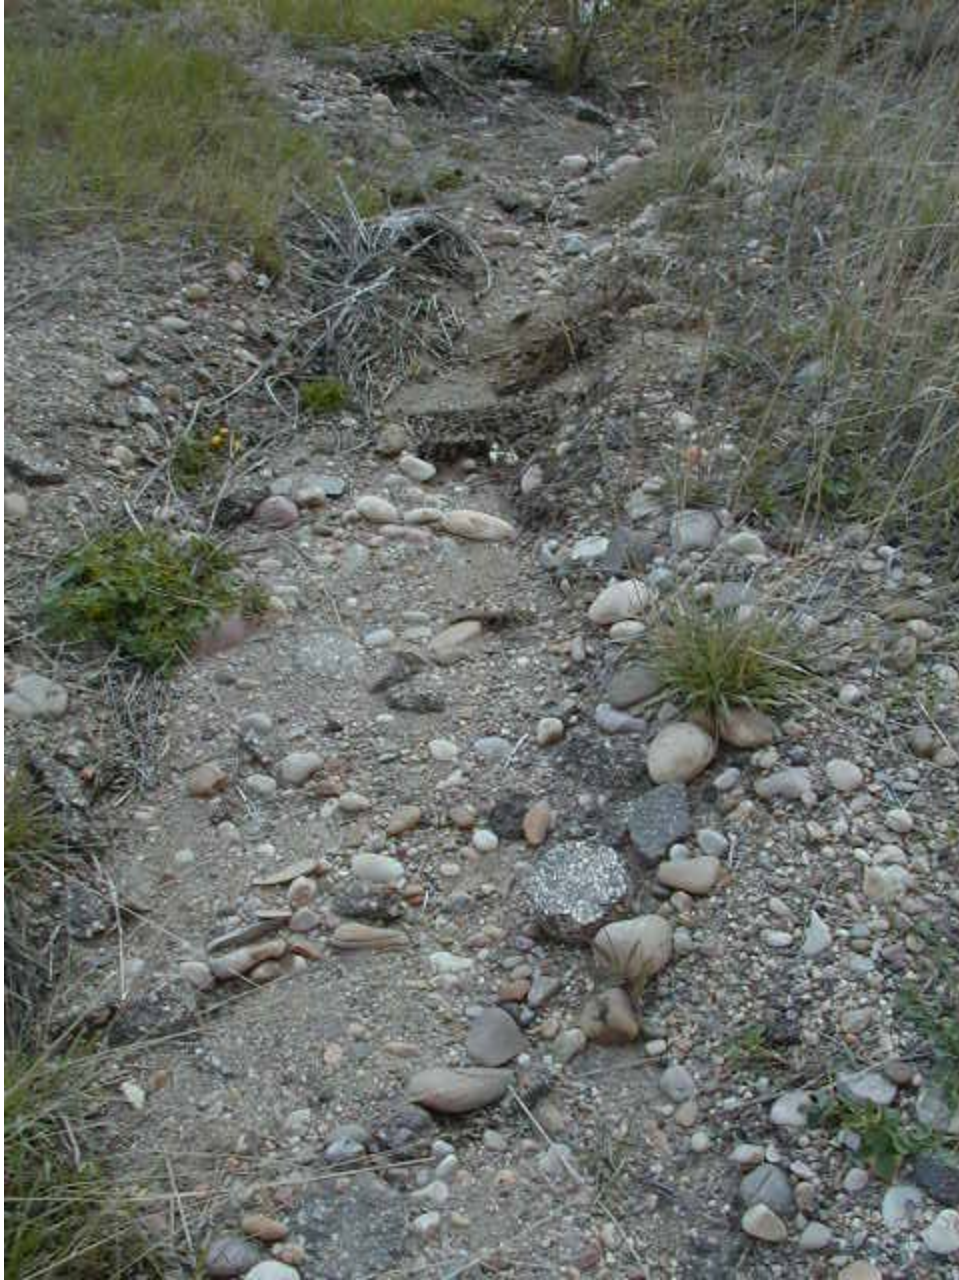
ITEM	CONDITION EXISTS		DESCRIPTION AND LOCATION	NOTICABLE CHANGE FROM LAST INSPECTION	
	YES	NO		YES	NO
Pavement Distress	X		Very narrow frost heave area on pavement (<2 m wide). Road patch about 20 m wide.		X
Slope Movement					
Erosion	X		Erosion on-going in ditches on both sides of the highway. The area about 80 m long to the southwest of the frost heave. Random fill (including rubble and cores) has been placed in the erosion ditch.		X
Seepage					
Culvert Distress

Close-up of ditch infill material (1)

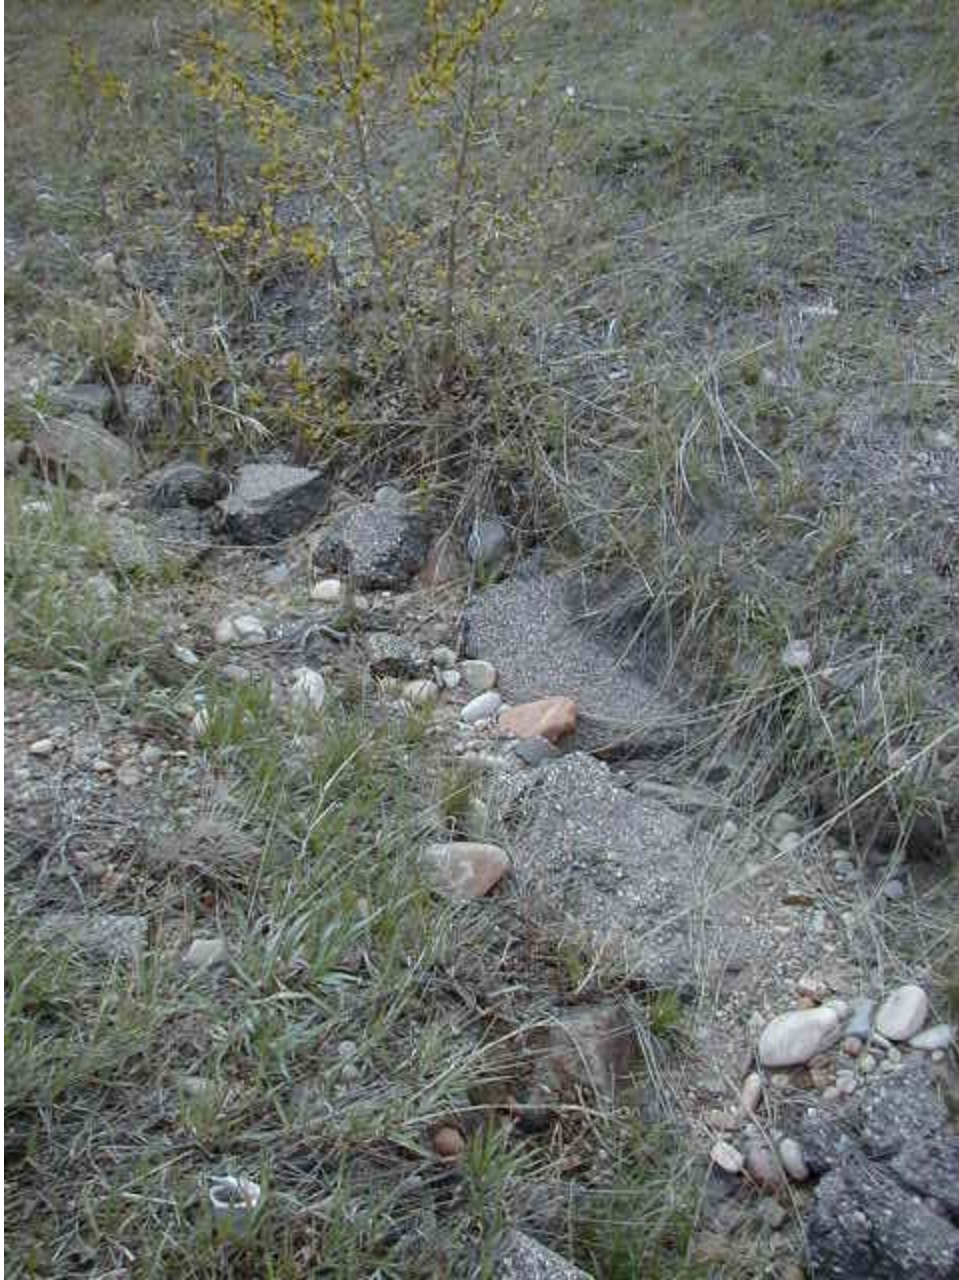
Close-up of ditch infill material (2)

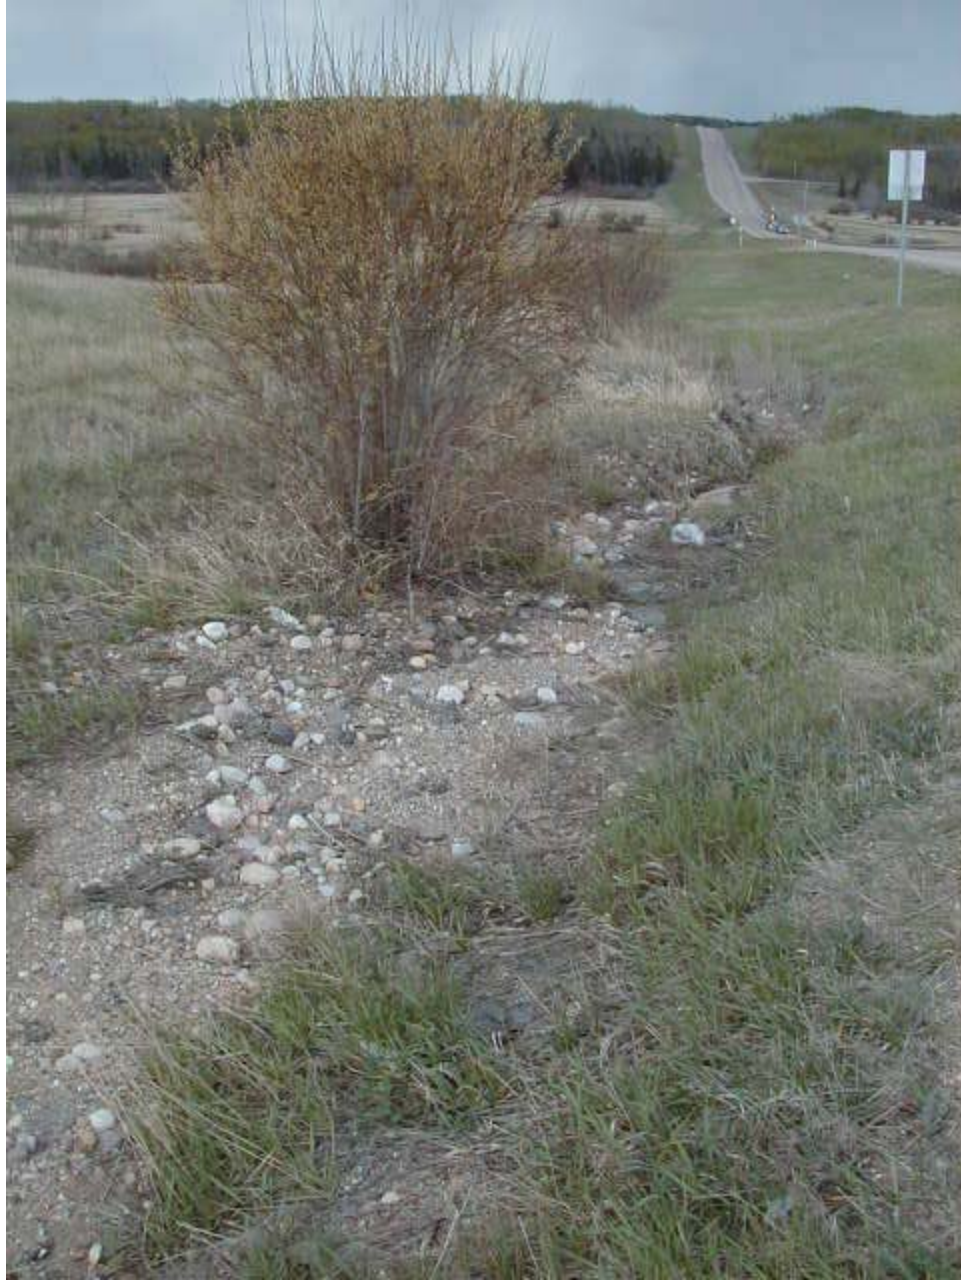
Looking west

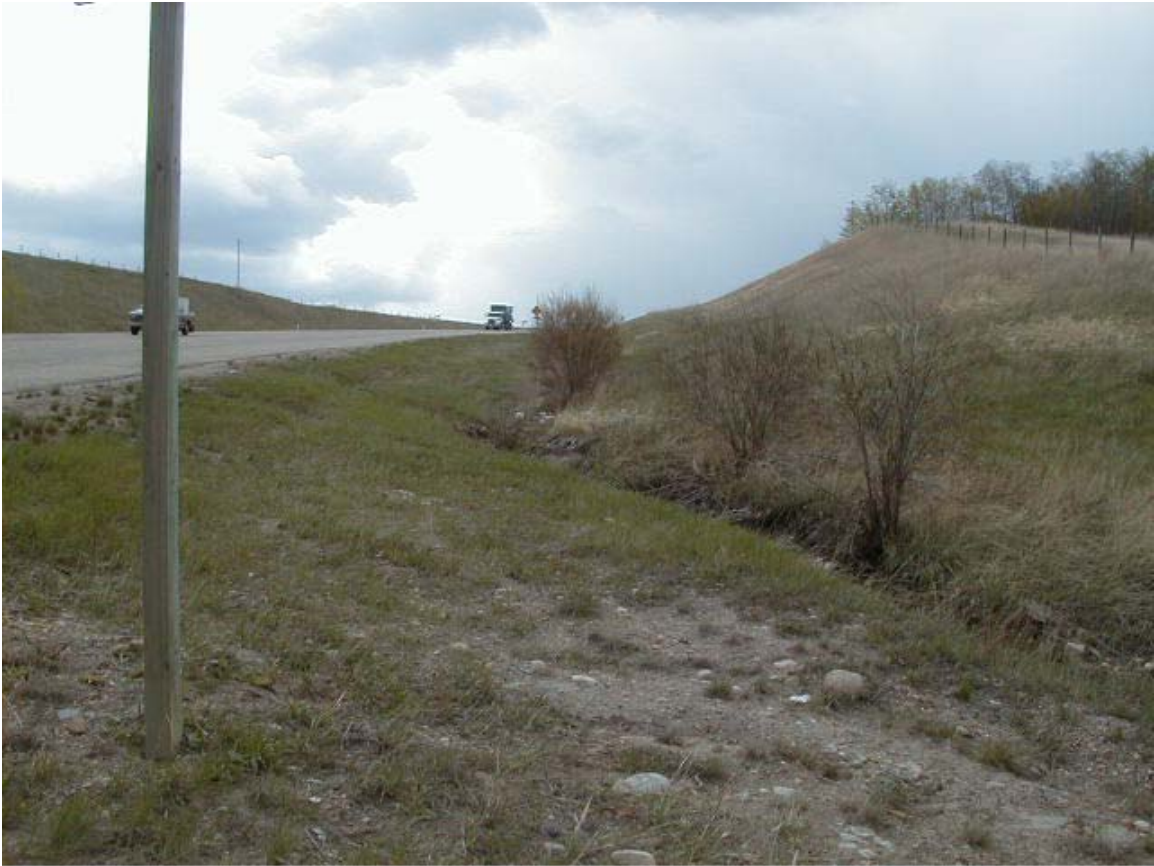
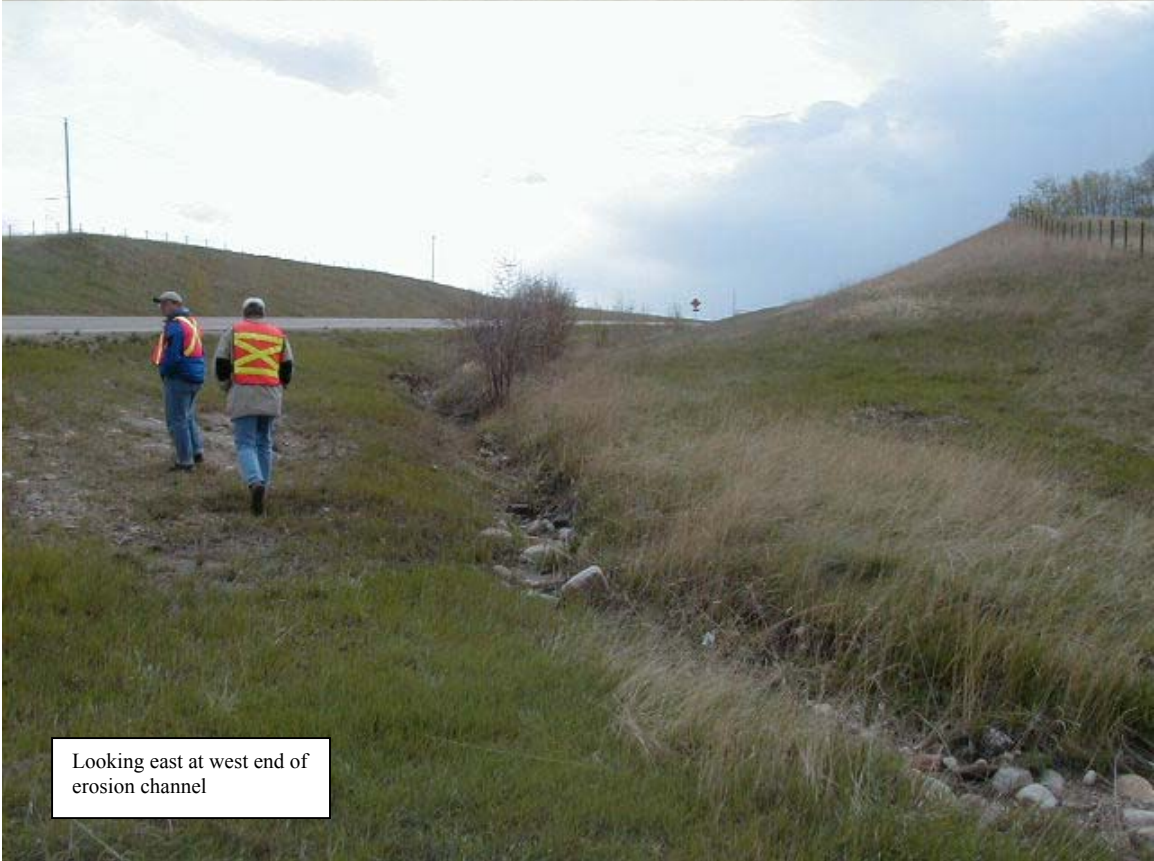
Looking east at west end of erosion channel

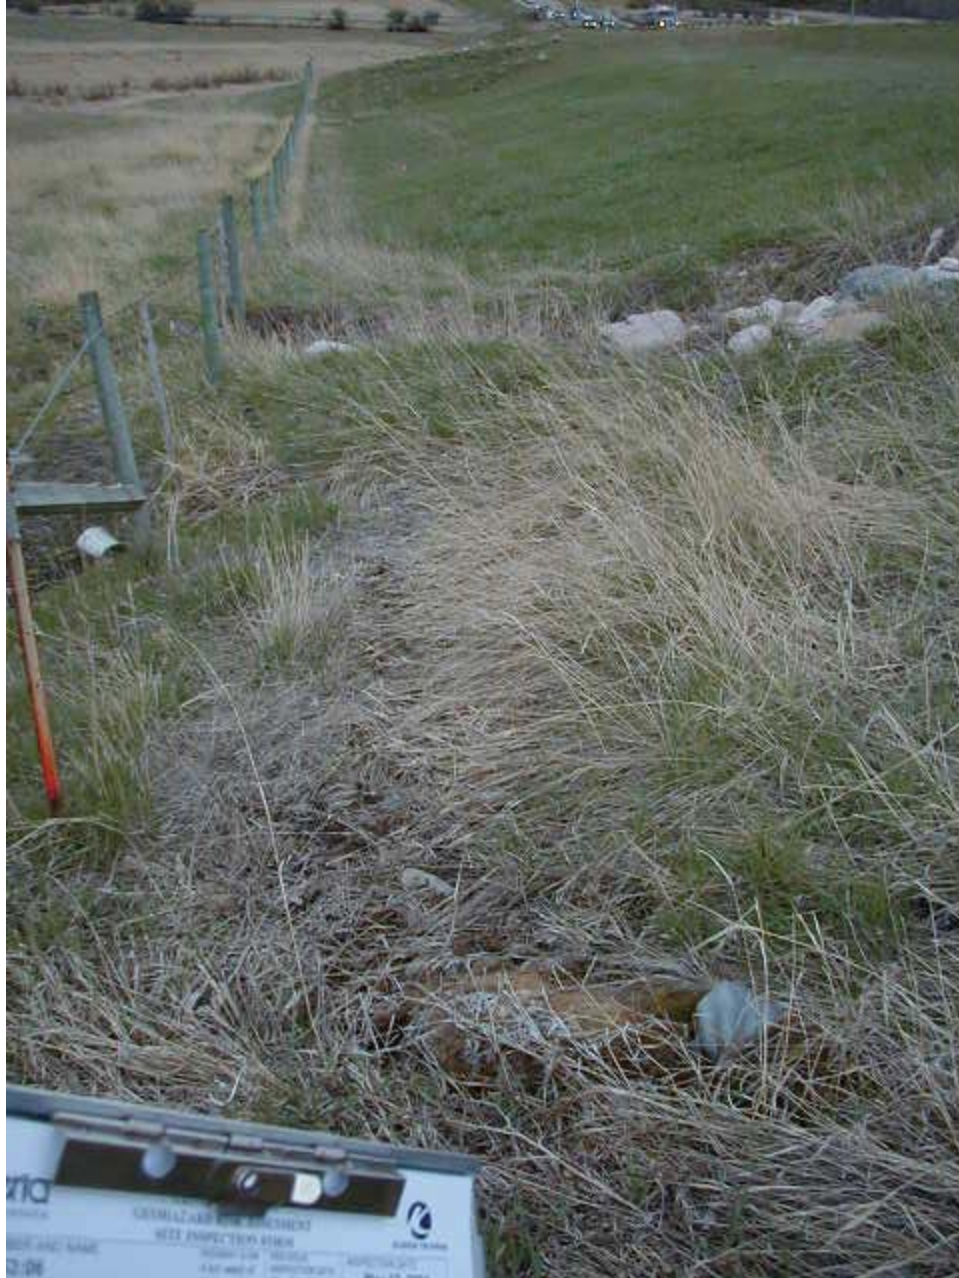
Looking west at end of riprap channel and exposed drain outlet north of fenceline

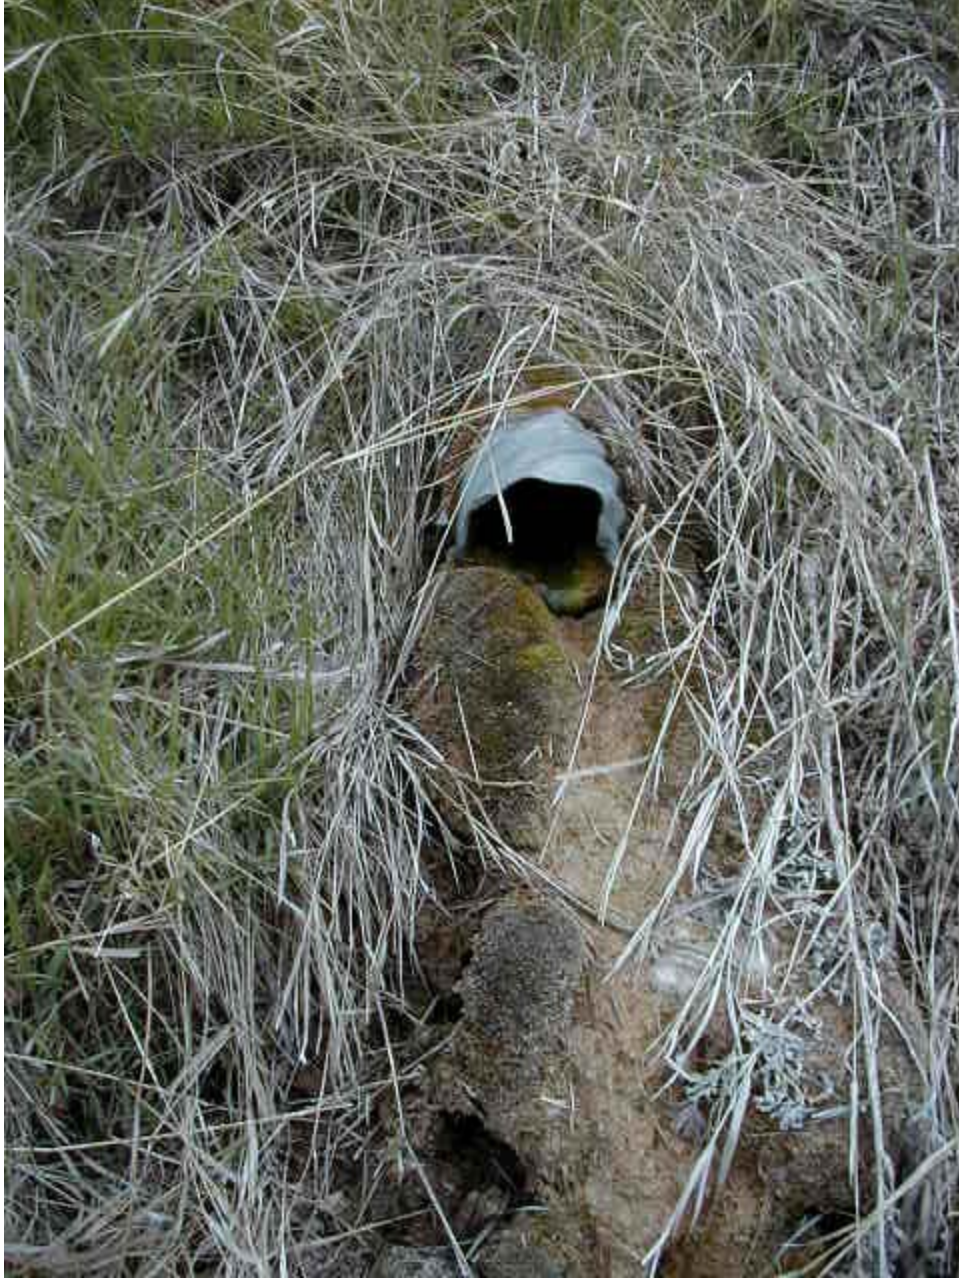
Drain outlet

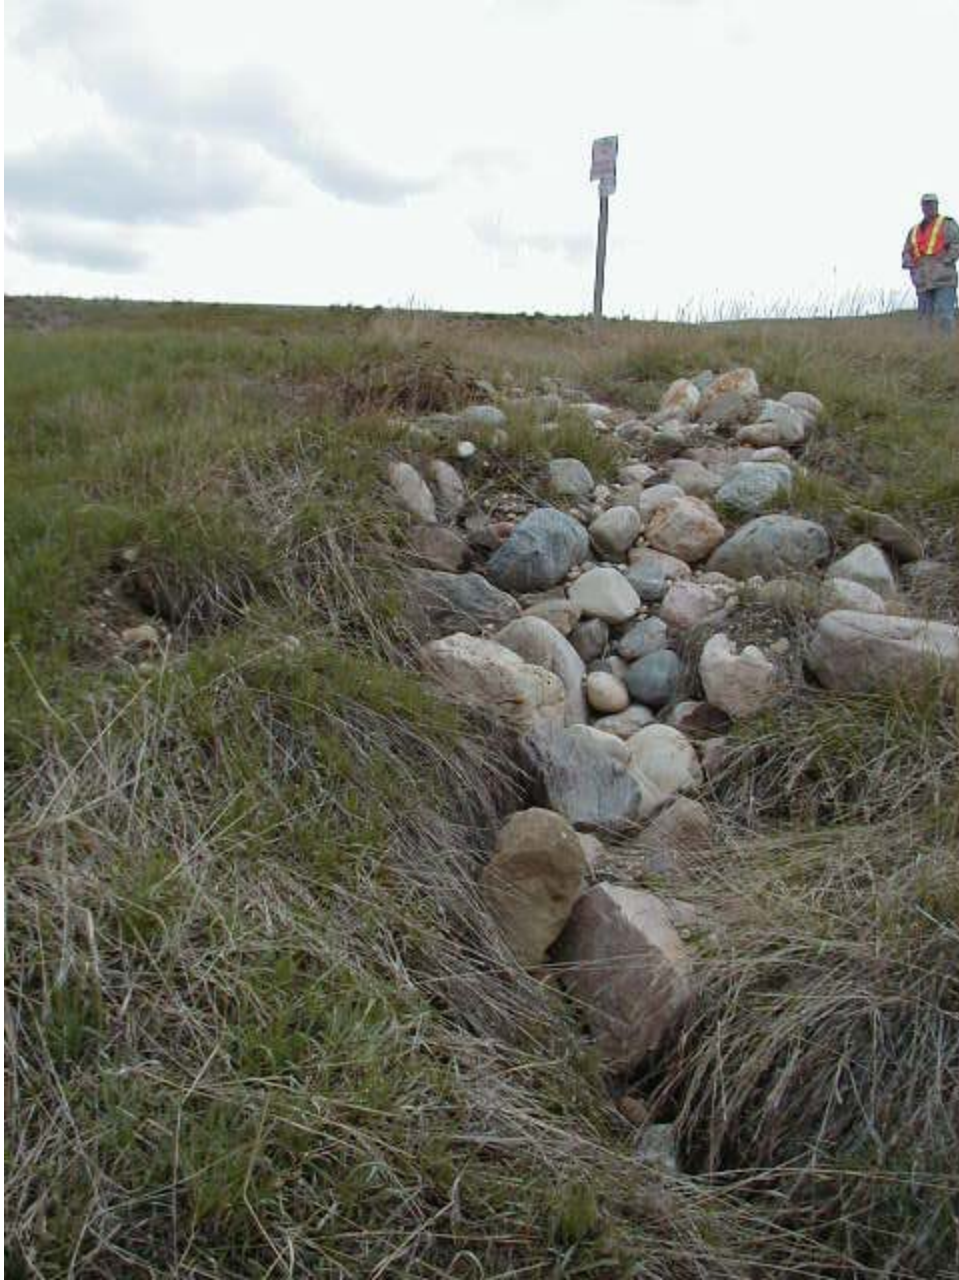
Riprap channel north of fenceline

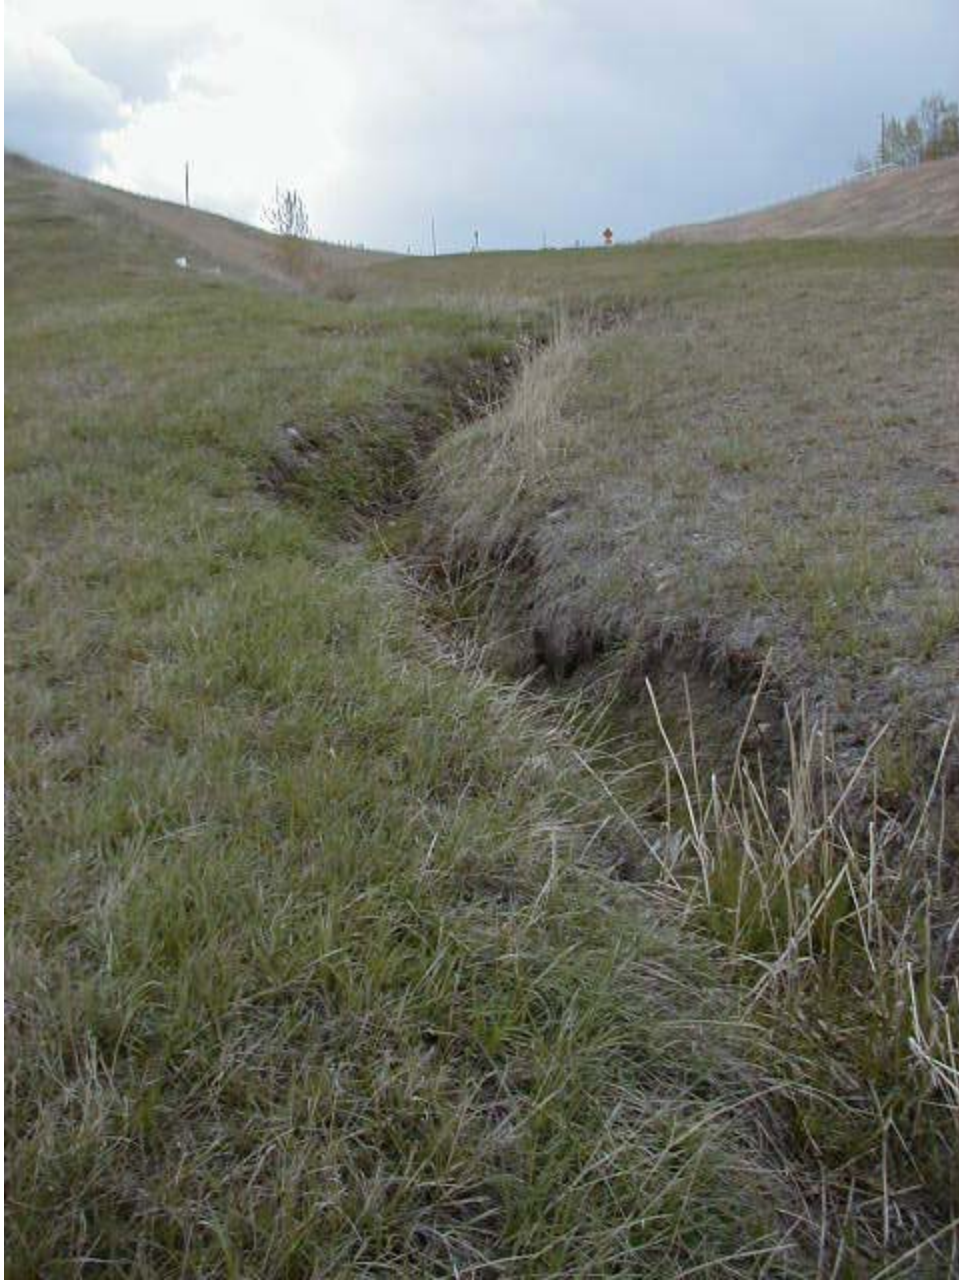
Looking east at west end of north ditch.
