SITE NUMBER AND NAME C13 H56:08 Slide		HIGHWAY & KM	PREVIOUS INSPECTION DATE May 27, 2005	INSPECTION DATE May 15, 2006
LEGAL DESCRIPTION SE 20-28-19-W4	NAD 83 COORDINATES N 5695784 E 387155	RISK ASSESMENT PF: 9 CF: 1 TOTAL: 9

LAST READING DATE:	
PRIMARY SITE ISSUE: Slope failure	
APPROXIMATE DIMENSIONS: 20 m wide and about 3 m high, extending about 15 m up the slope from the toe	
DATE OF ANY REMEDIAL ACTION:

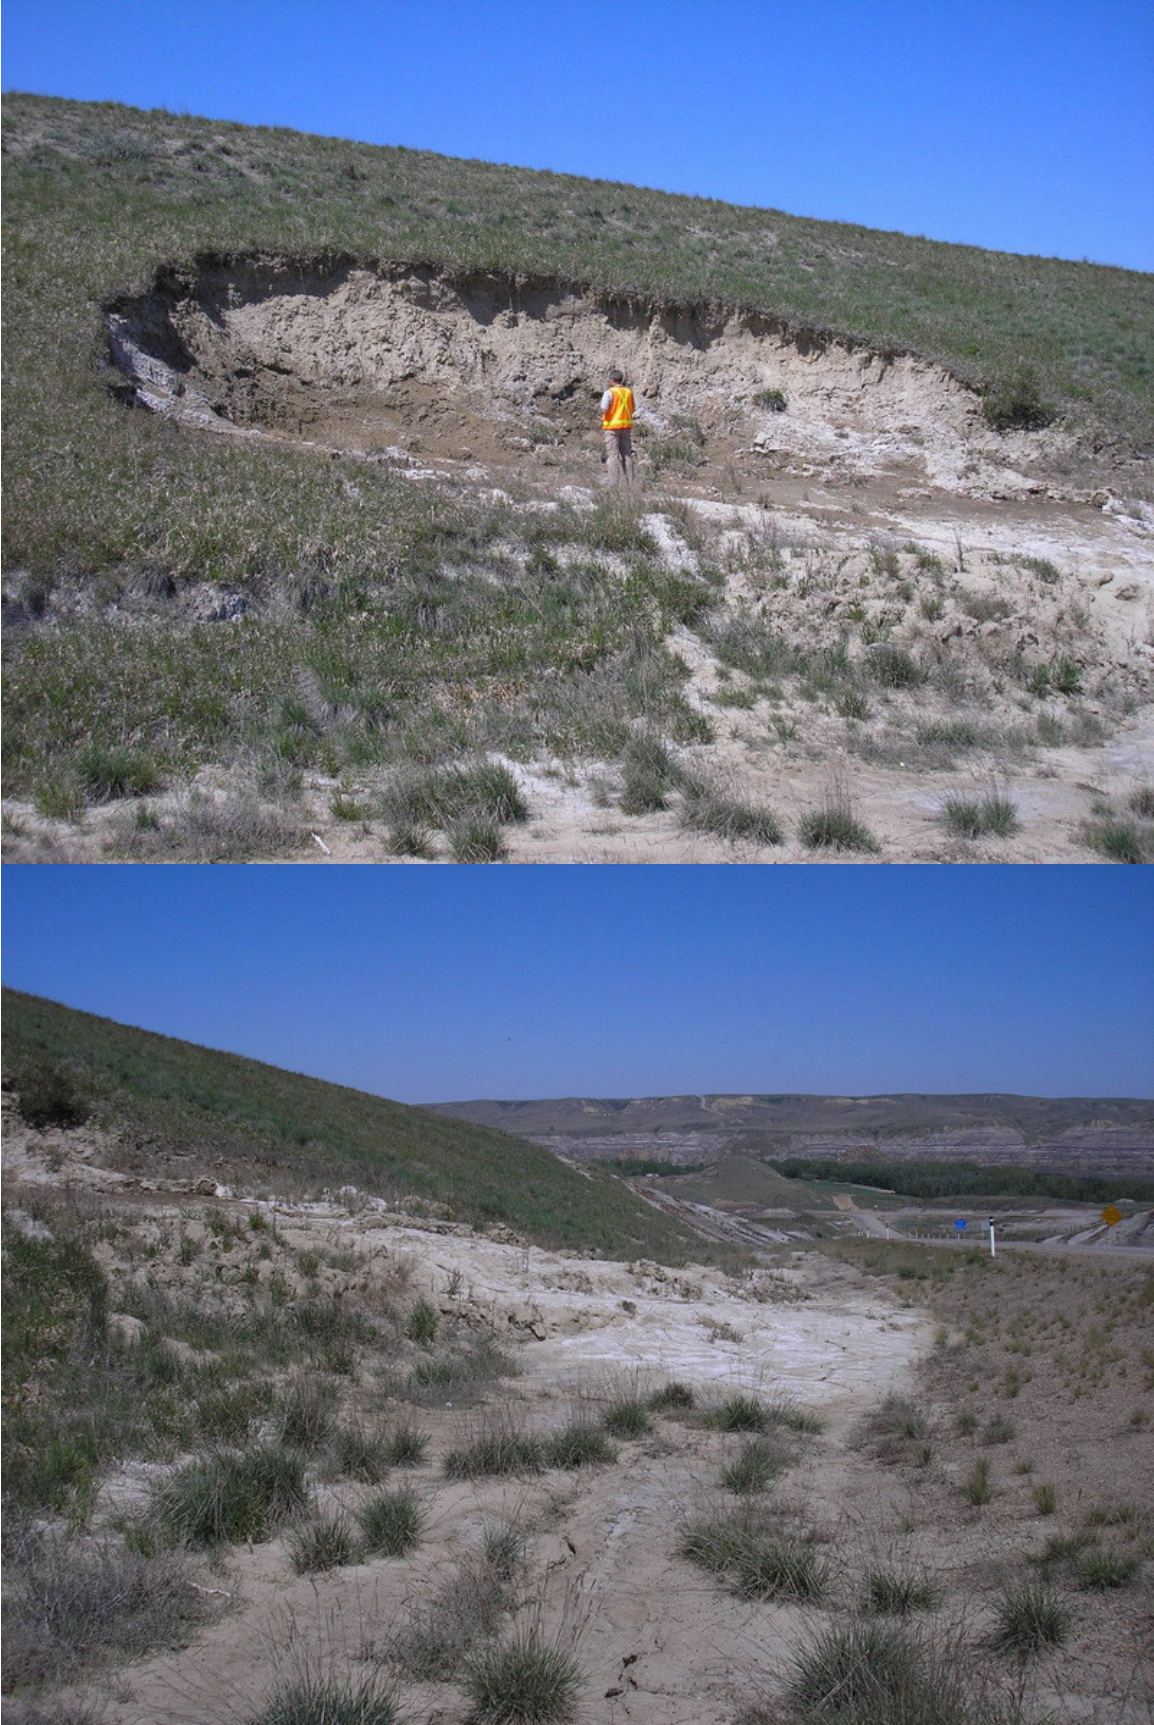
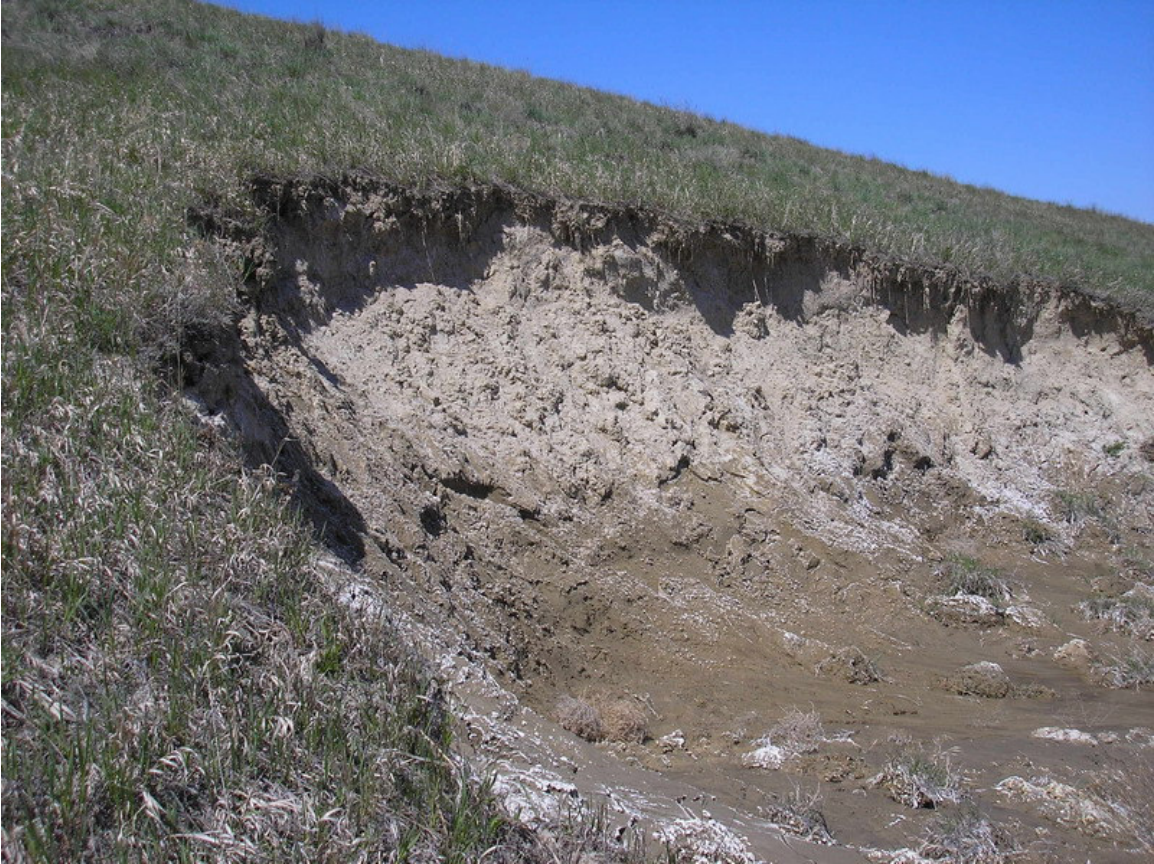
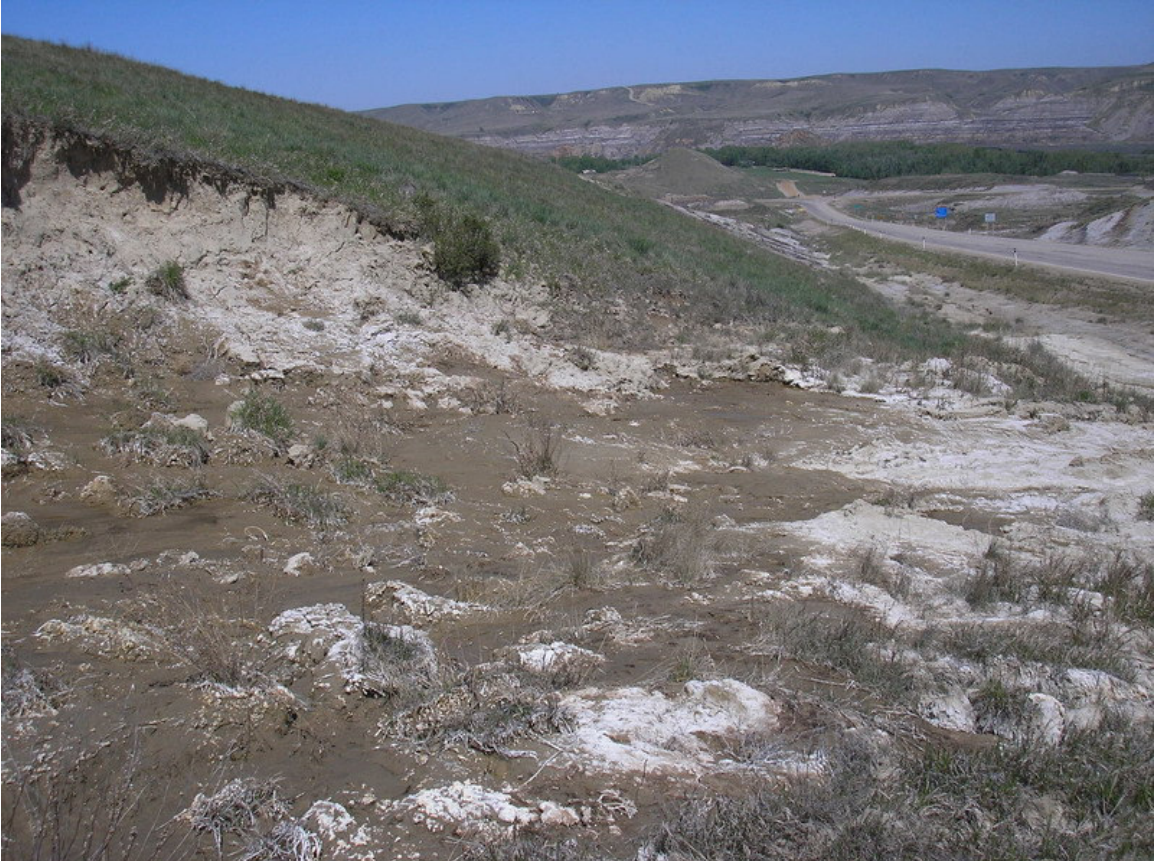
COMMENTS
Refer to previous inspection reports and attached photos
Even in dry weather, a distinct seepage zone is apparent at the base of the slide. The native material appears to be a light brown silt that is being softened by the water flow and creating the instability. The proposed repair for the site is to construct a gravel drain to carry the water from the backscarp to the ditch and reinstate the slope. At the time of the inspection, the ditch area had been cleaned as shown in the photos. Material should be excavated from the slide area and temporarily stockpiled in the ditch. The intent is to be able to install the gravel drain on a smooth clean surface that is well graded to the ditch area.
Filter cloth is to be placed for the full width over the base area and extending from the slope toe up the slide area to about 0.5 m above the seepage zone. The approximate required dimensions are 10 m by 20 m. A 0.2 m thick pit run gravel layer is then to be placed on the filter cloth. Approx. quantity 40 m ³ . A second layer of filter cloth is then to be placed over the gravel ensuring that the gravel is completely enclosed. The slope can then be reinstated over the drain. Care should be taken not to bury the drain outlet at the toe of the slope.
