SITE NUMBER AND NAME C13 H56:08 Slide		HIGHWAY & KM	PREVIOUS INSPECTION DATE Oct 20, 2006	INSPECTION DATE June 1, 2007
LEGAL DESCRIPTION SE 20-28-19-W4	NAD 83 COORDINATES N 5695784 E 387155		RISK ASSESMENT PF: 1 CF: 1 TOTAL: 9

Site C13 H56:08 Slide
June 1, 2007

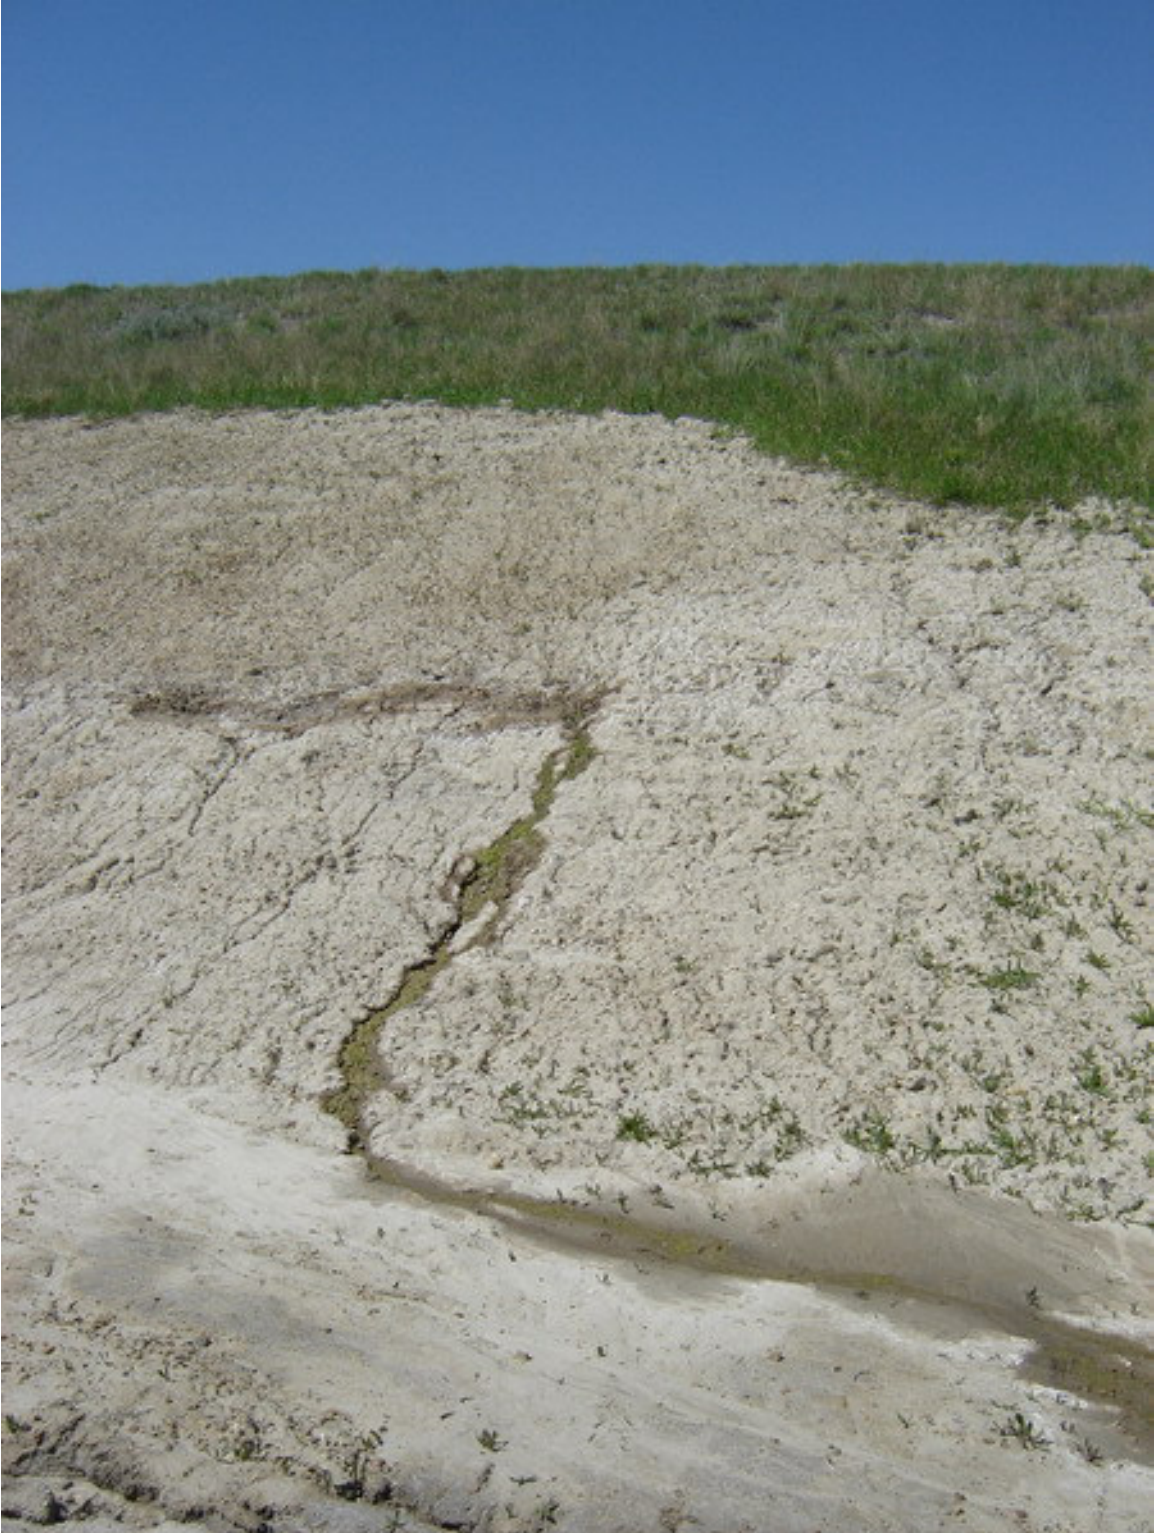
ITEM	CONDITION EXISTS		DESCRIPTION AND LOCATION	NOTICABLE CHANGE FROM LAST INSPECTION	
	YES	NO		YES	NO
Pavement Distress		X			X
Slope Movement		X			X
Erosion		X			X
Seepage	X				X
Culvert Distress		X			X
COMMENTS					
Refer to previous inspection reports and attached photos.					
The slope was reinstated with reinforced gravel in October 2006.					
Small seepage flow is draining from face of the slope indicating the spring location. No significant erosion is apparent. Vegetation is currently poor. Consideration should be given to spraying seeded compost on the slope area.
