**KLOHN CRIPPEN**

**Central Region Landslide Assessment Site C15**  
**SH575 Carbon Creek Embankment**  
**October 2003 Instrumentation Monitoring Report**

This Instrumentation Monitoring report was prepared by Klohn Crippen Consultants Ltd. for Alberta Transportation Central Region under Contract No. CE053/2000. The instruments were read by Mr. Joel Hilderman, EIT, of Klohn Crippen Consultants Ltd. on October 31, 2003.

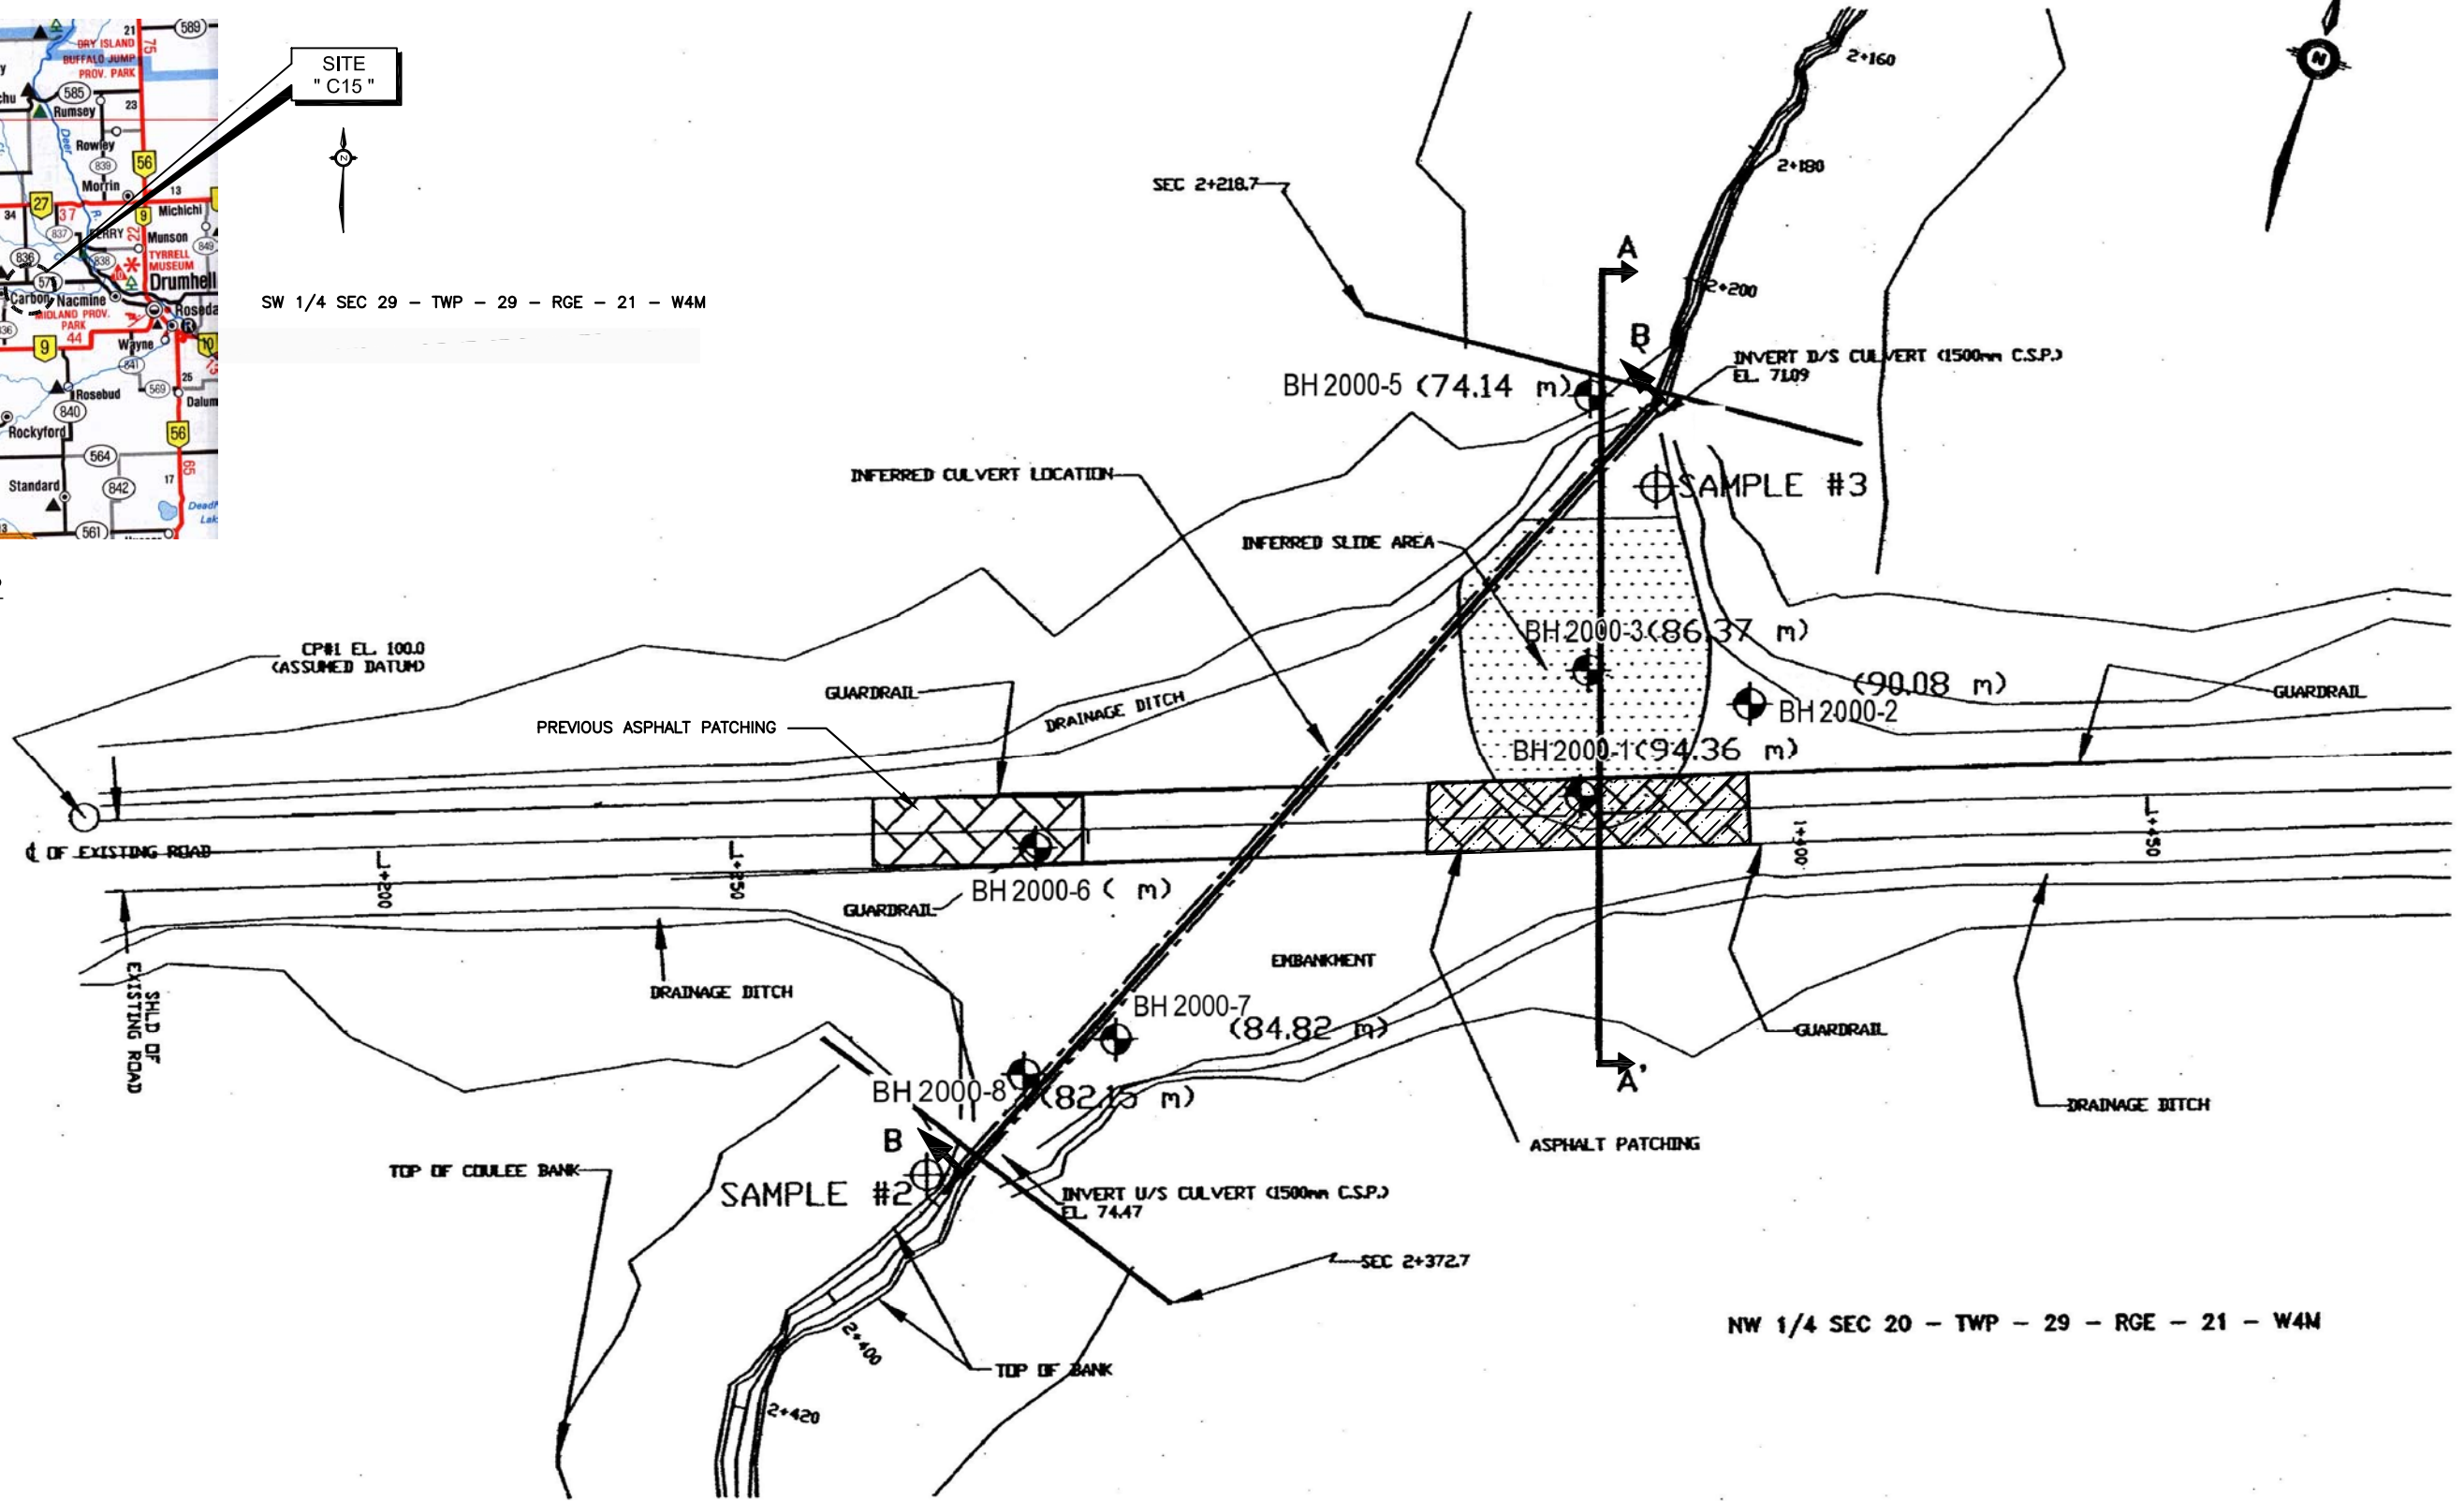
PLAN

An embankment located on SH575 about 16 km east of Carbon, Alberta across a steep narrow gully is experiencing slope instability and erosion problems which has affected the pavement on top of the embankment. The slope instability on the north side of the embankment appears to have been caused by seepage saturating the fill. Another area of concern is the deep vertical erosion channel present along the southwest side in the area of cut to fill interface.

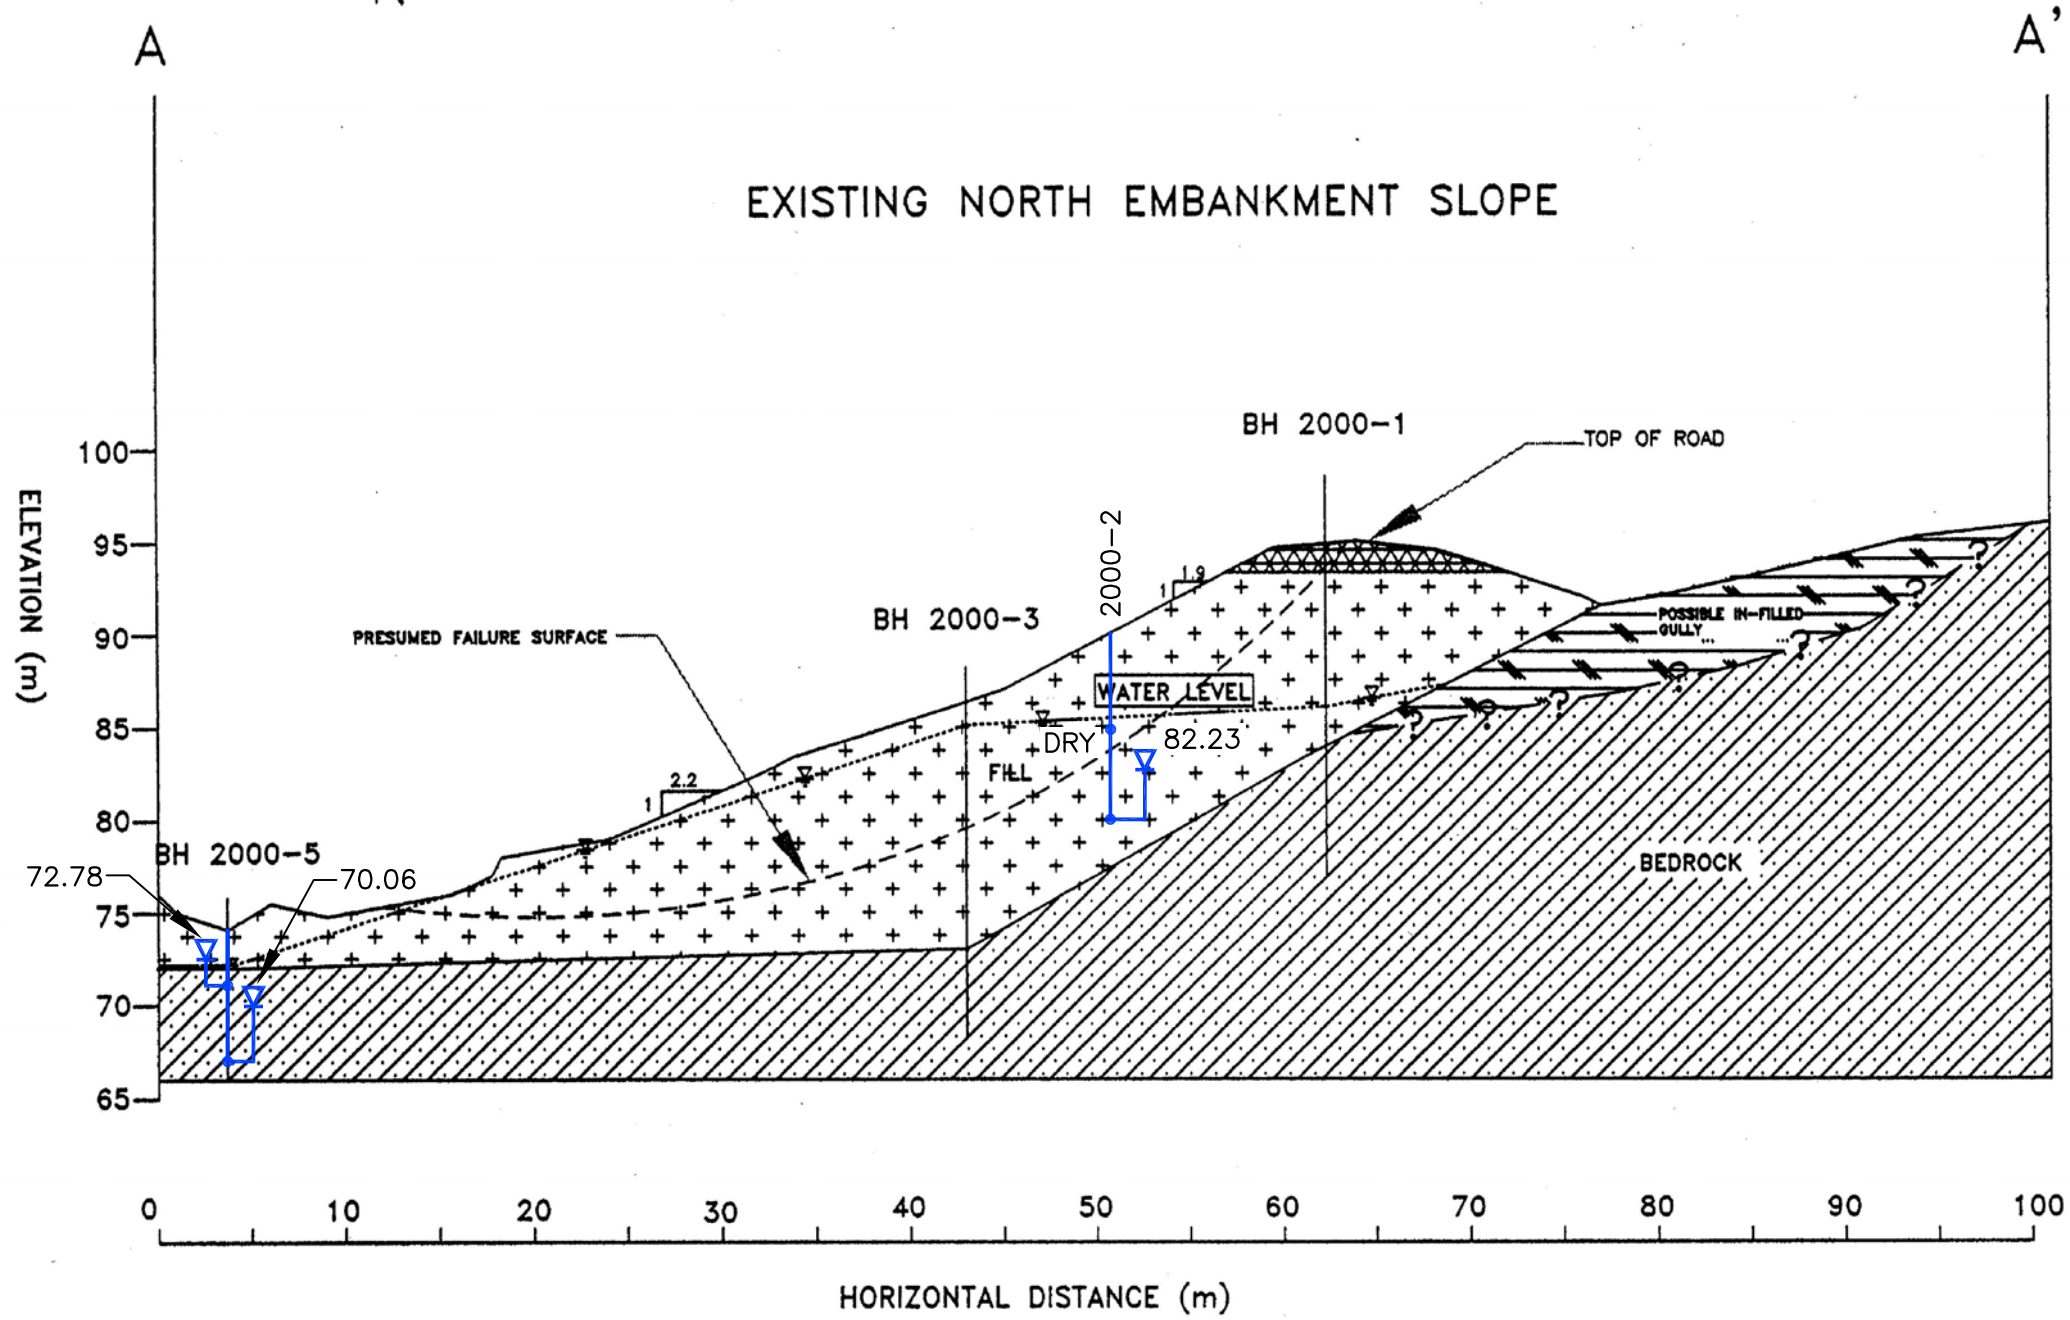
SECTION A  
N.T.S. Fig 1

82.23 RESPONSE ZONE & WATER LEVEL ON OCT. 31, 2003 SHOWN THUS

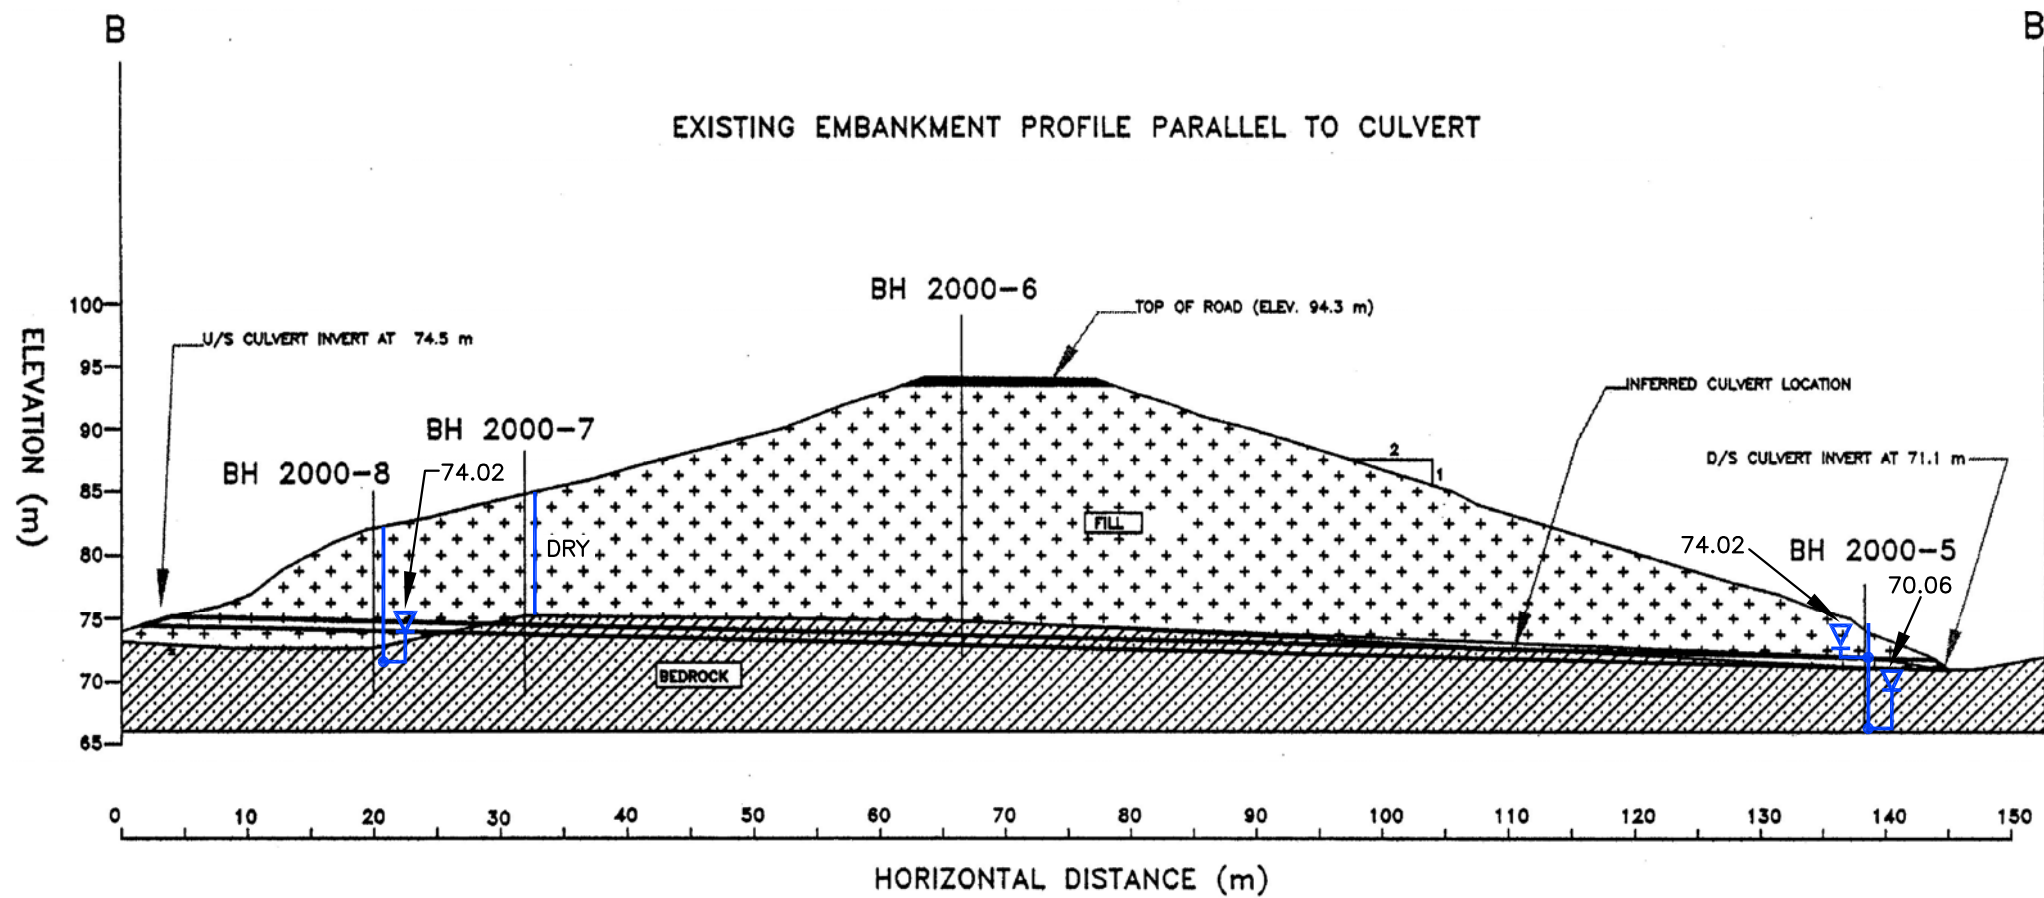
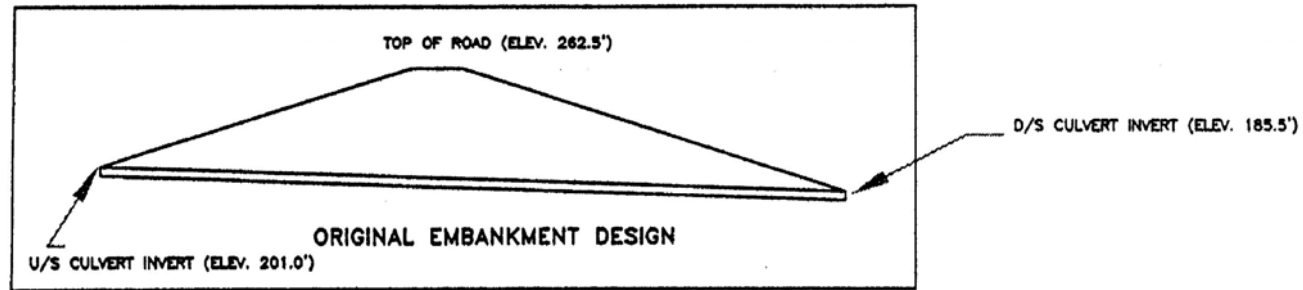
SECTION B  
N.T.S. Fig 1

RESPONSE ZONE &  
WATER LEVEL ON  
OCT. 31, 2003  
SHOWN THUS
