November 14, 2003

Central Region Landslide Assessment Site C2
SH575:04 Nacmine Slide
November 2003 Instrumentation Monitoring Report

This report was prepared by Klohn Crippen Consultants Ltd. for Alberta Transportation Central Region under Contract No. CE053/2000.

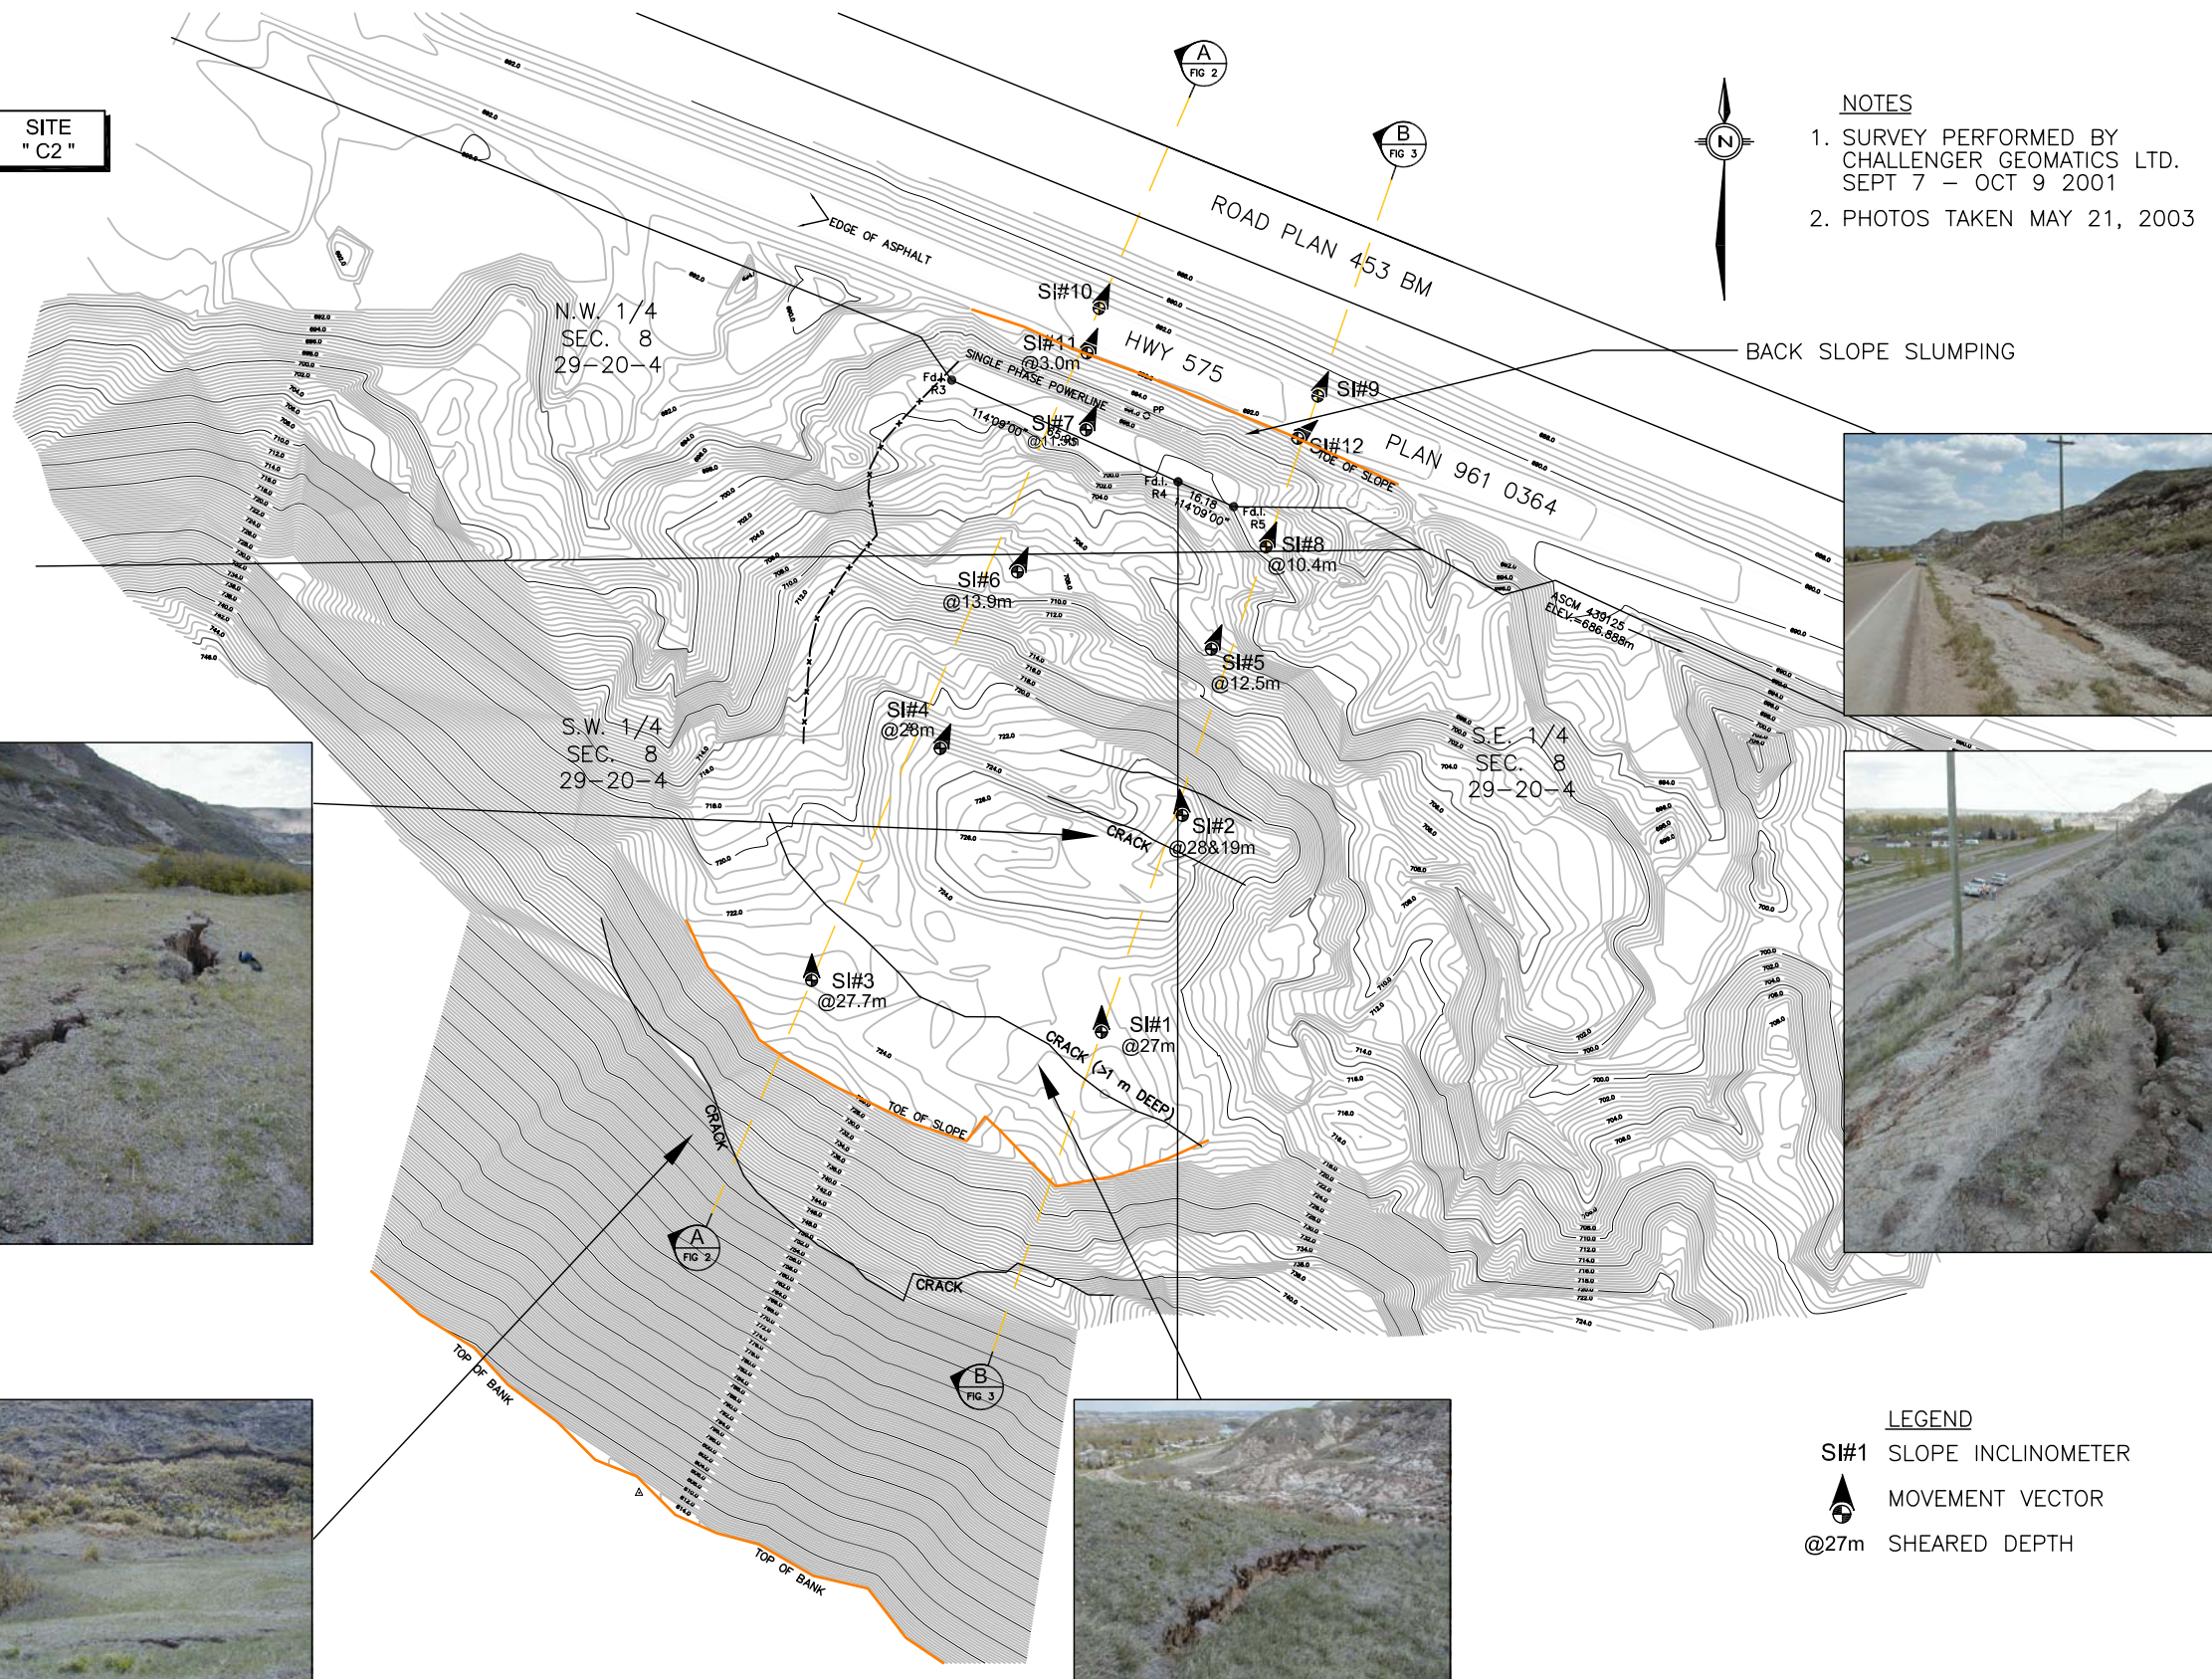
The slide location, site plan, instrument location plan and cross sections are illustrated on Figures 1 to 3.

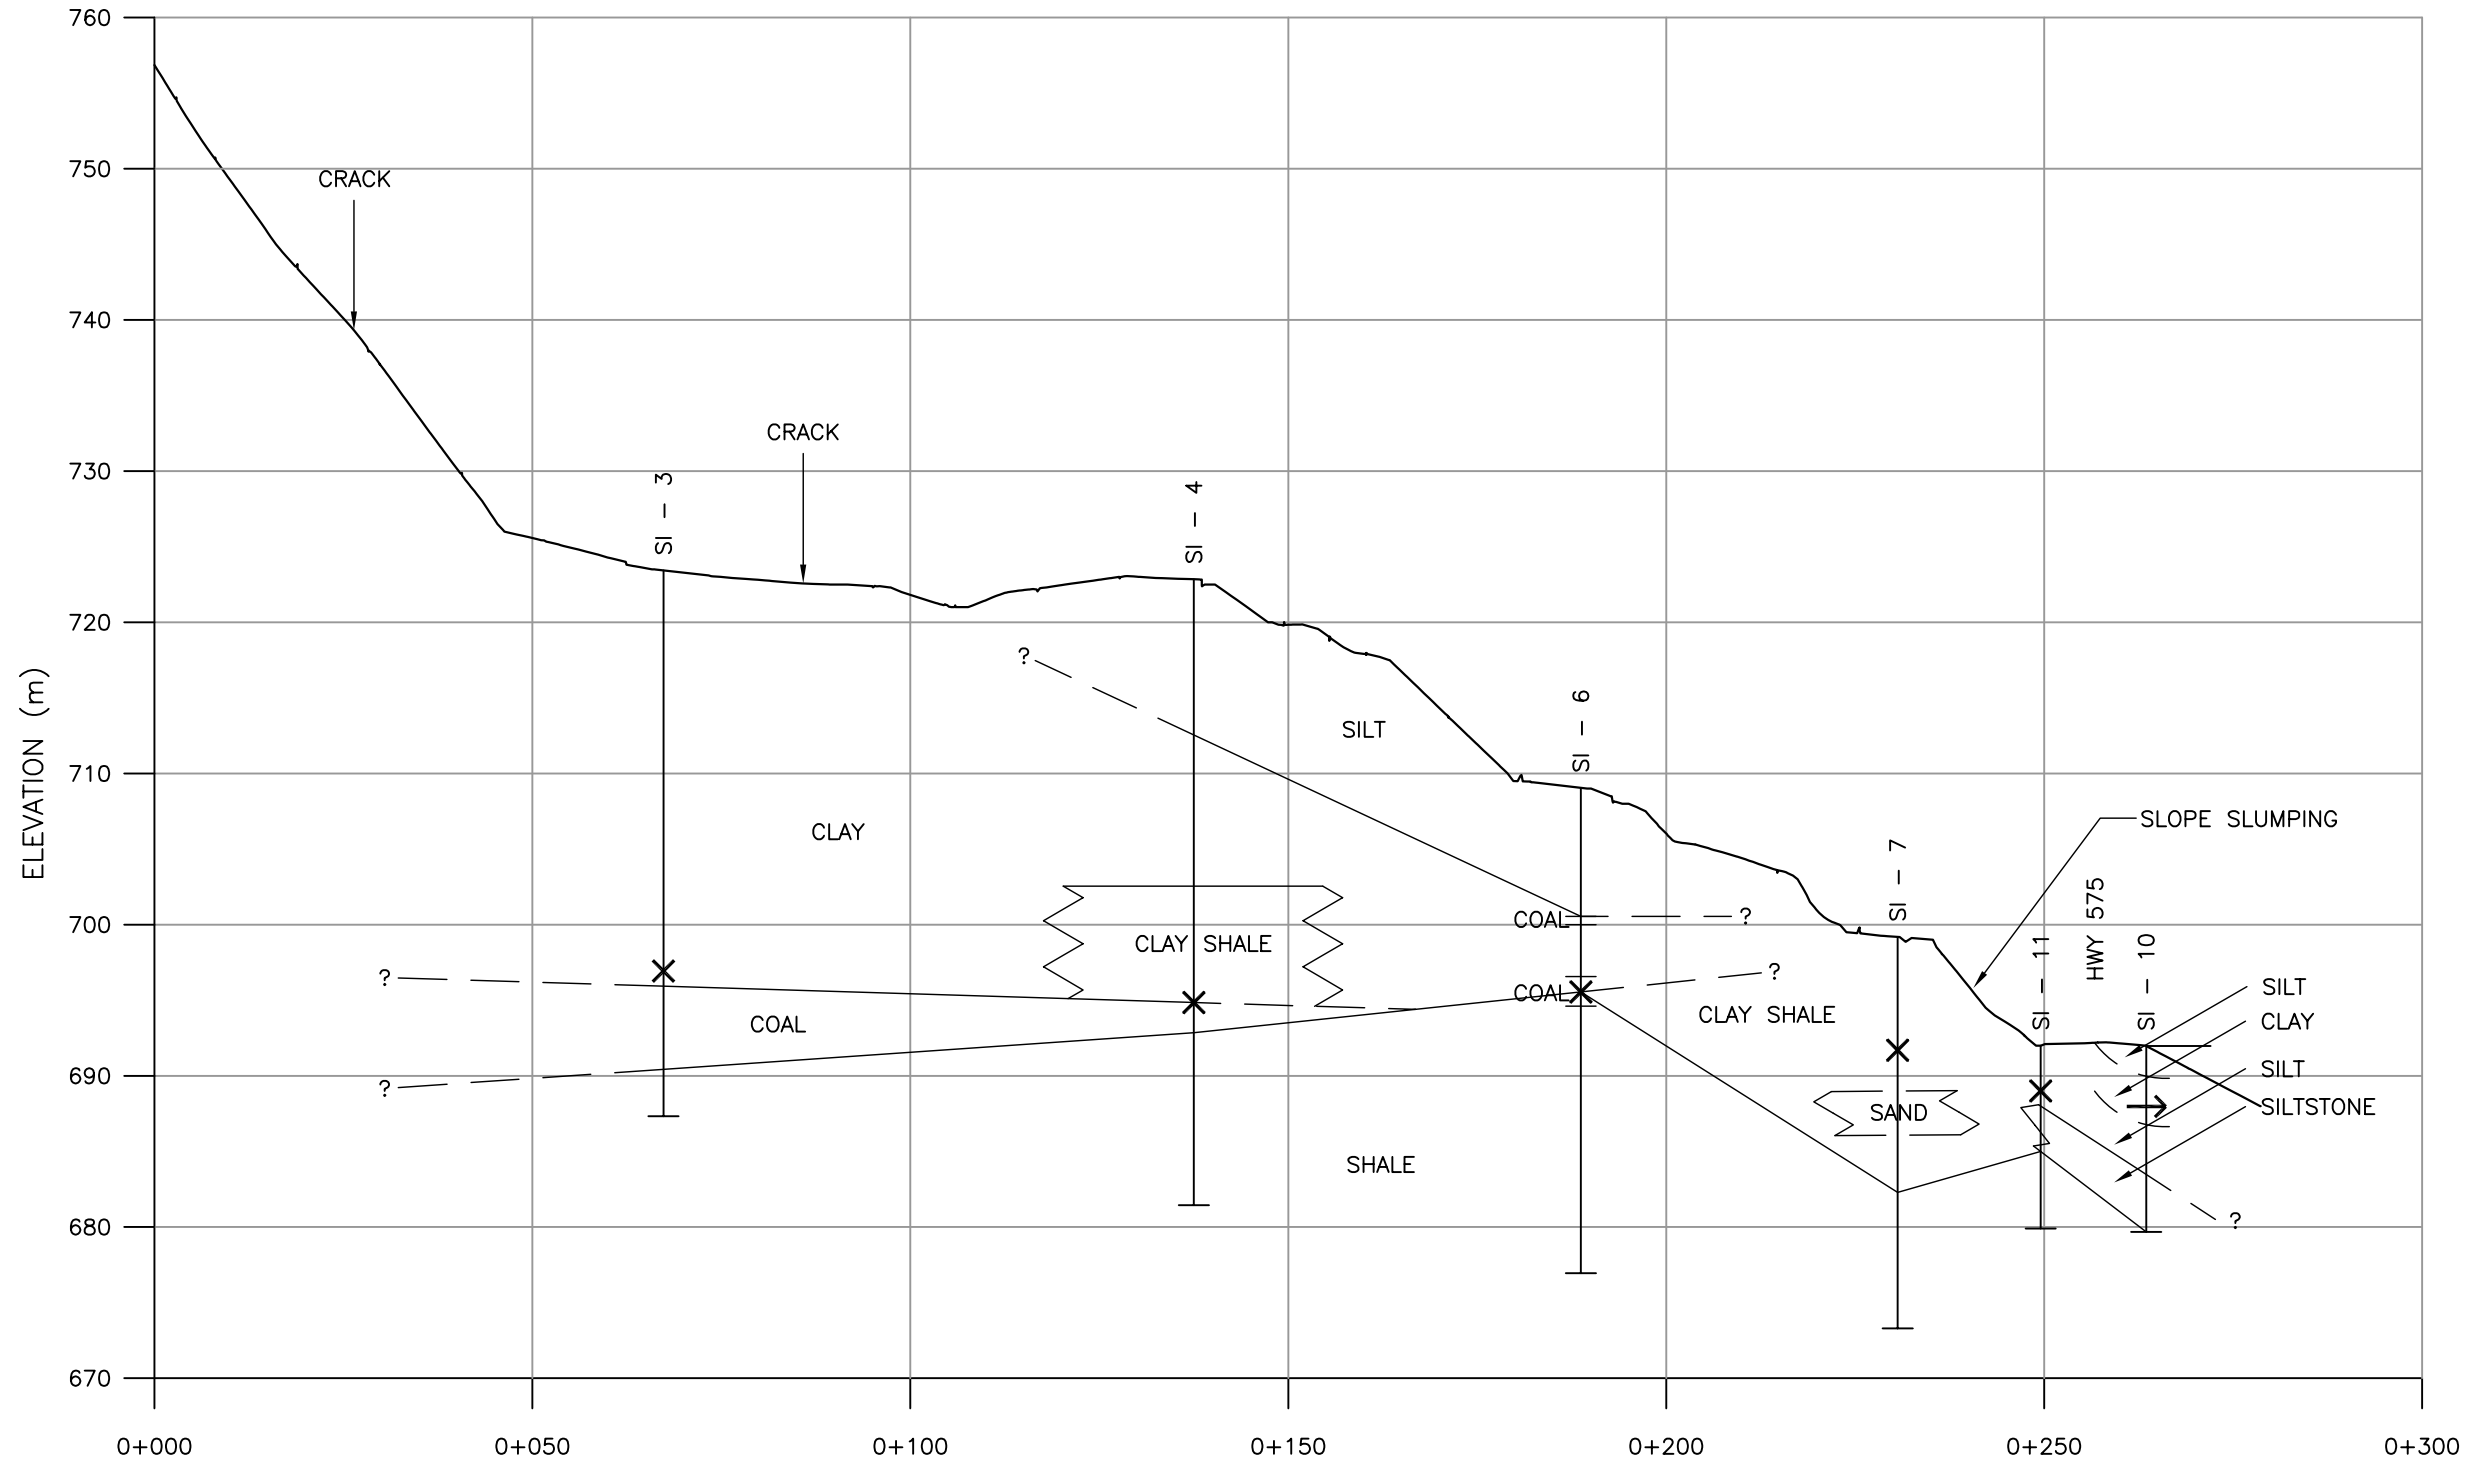
PROJECT				CENTRAL REGION			
				LANDSLIDE RISK ASSESSMENT			
TITLE				SITE : C2 NACMINE SLIDE SECTION ' A '			
DATE	SHEET	DRAWING No.	REV.	DATE	SHEET	DRAWING No.	REV.
NOV. 2003	2 of 3	FIGURE 2	D

In total, twelve inclinometers were installed in 1993-1994, designated as SI #1 to SI #12 inclusive. SI #1 to #8 and #11 have sheared due to slope movements at the depths shown on Figures 2 and 3.
