SITE NUMBER AND NAME C2 H575:04 Nacmine Slide		HIGHWAY & KM	PREVIOUS INSPECTION DATE June 13, 2008	INSPECTION DATE June 4, 2009
LEGAL DESCRIPTION SE 8-29-20-W4	NAD 83 COORDINATES N 5703250 E 376180		RISK ASSESMENT PF: 7 CF: 2 TOTAL: 14

Site C02 H575:04 Nacmine Slide
June 4, 2009

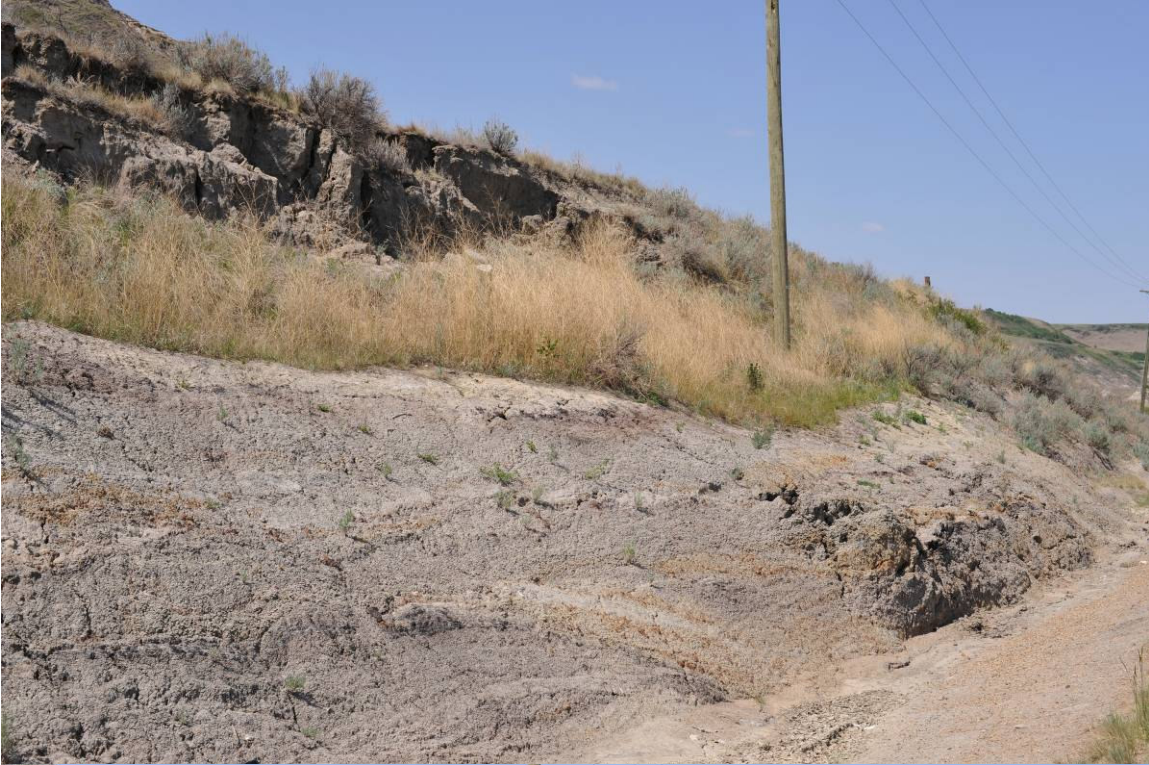
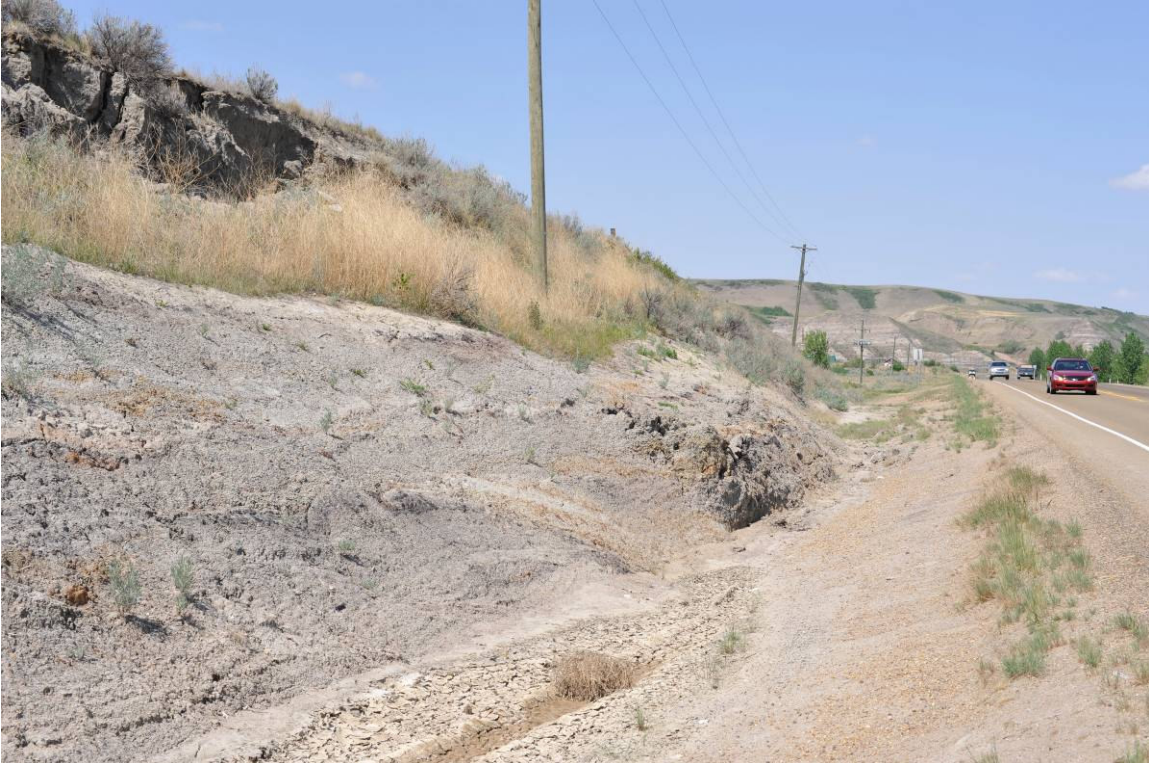
ITEM	CONDITION EXISTS		DESCRIPTION AND LOCATION	NOTICABLE CHANGE FROM LAST INSPECTION	
	YES	NO		YES	NO
Pavement Distress					
Slope Movement	X		Power pole has been relocated. Slumping at toe of slope continues.		X
Erosion					
Seepage					
Culvert Distress					
COMMENTS					
Refer to previous reports and attached photographs.

- There is evidence of subsidence cracking in the slopes, possibly related to the collapse of old mine rooms. There is also extensive evidence of historic landslide activity in the valley slopes above highway level, but no indication that instability has occurred below the highway level.
- The movements to date in the inclinometers immediately adjacent to the highway have been relatively small and cannot be seen as a deflection in the highway alignment. Movements have occurred above the highway on the south side most likely as a result of ditch excavation work in recent years. Instruments are not read as part of the inspection since 2007.
- The toe section of the slope is showing signs of localized cracking and slumping that is likely related to seepage softening the steep lower zone of the slope.

Due to the on-going slumping of the steep toe slope, it is recommended that the slope above the ditch be flattened by trimming the slope to the back of the first bench. It should be noted that a power pole is located in this area and the clean up work of the slope and ditch should be performed appropriately to prevent the undermining of the pole. The waste material should be removed from the immediate vicinity and not placed anywhere on the slope above the trimmed area. Although the overall stability of the slope should not be significantly affected, the ditch area should be monitored for movement after trimming.
