SITE NUMBER AND NAME <b>C2 H575:04 Nacmine Slide</b>		HIGHWAY & KM	PREVIOUS INSPECTION DATE June 4, 2009	INSPECTION DATE <b>May 18, 2010</b>
LEGAL DESCRIPTION SE 8-29-20-W4	NAD 83 COORDINATES N 5703250 E 376180		RISK ASSESMENT PF: 7 CF: 2 TOTAL: <b>14</b>

Site C02 H574:04 Nacmine Slide  
May 18, 2010

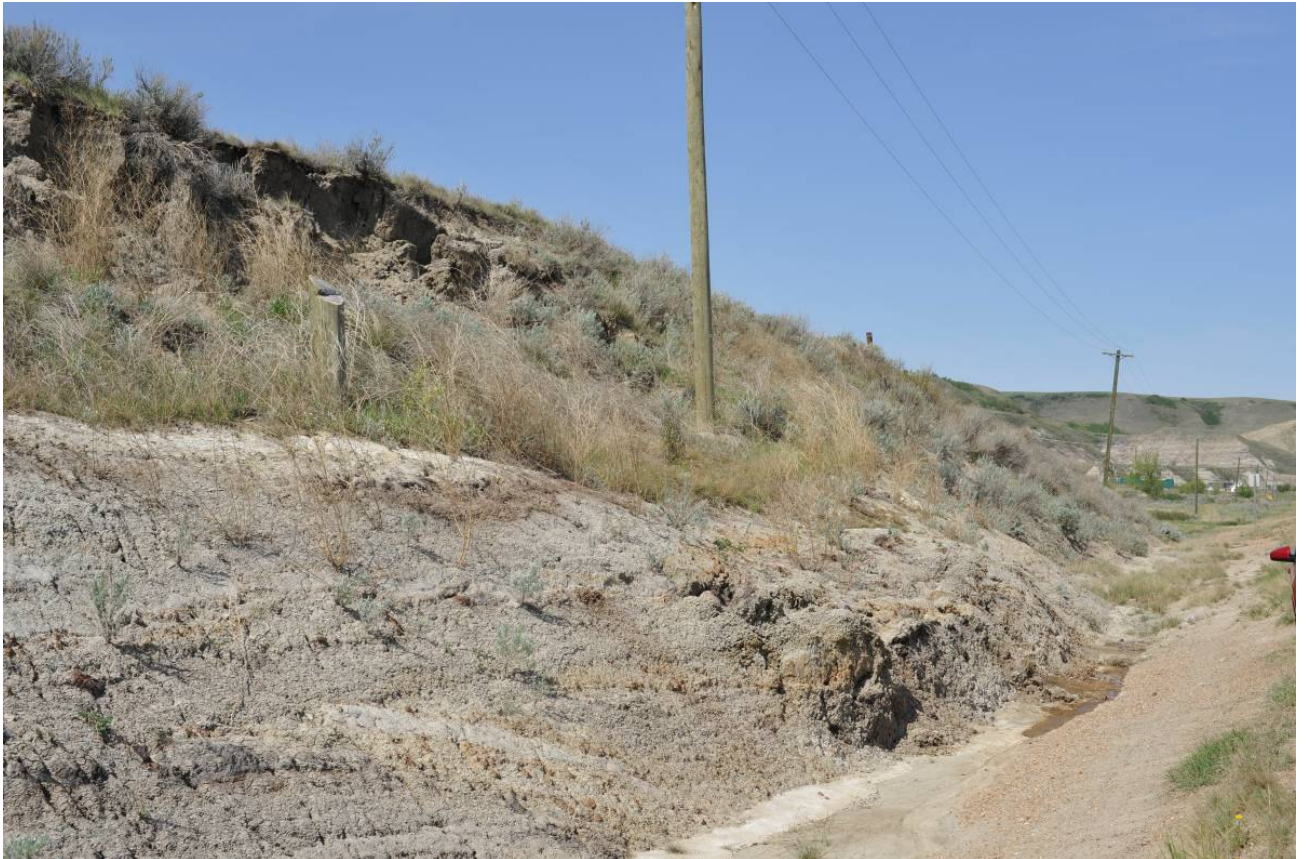
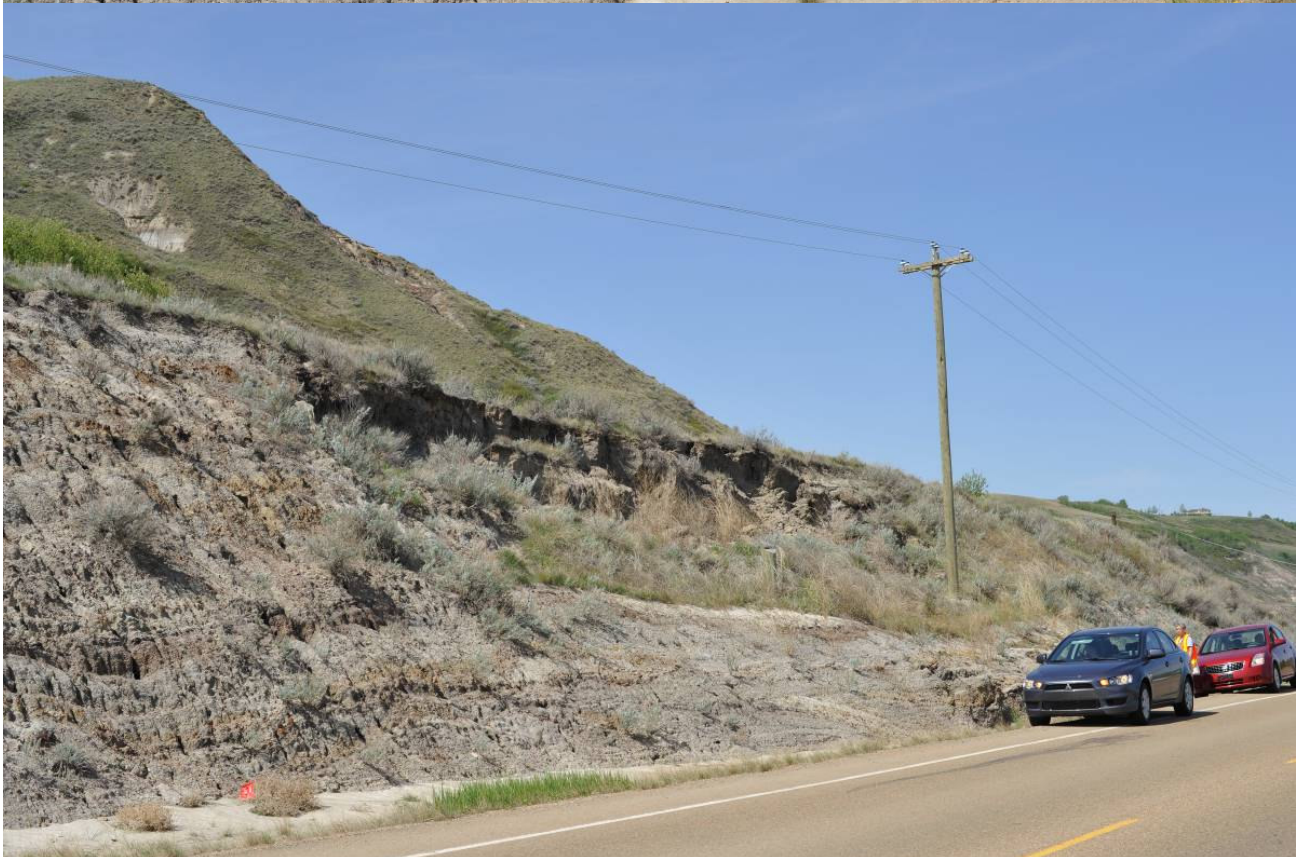
ITEM	CONDITION EXISTS		DESCRIPTION AND LOCATION	NOTICABLE CHANGE FROM LAST INSPECTION	
	YES	NO		YES	NO
Pavement Distress					
Slope Movement	X		Power pole has been relocated. Slumping at toe of slope continues.		X
Erosion					
Seepage					
Culvert Distress					
COMMENTS					
Refer to previous reports and attached photographs.

- There is evidence of subsidence cracking in the slopes, possibly related to the collapse of old mine rooms. There is also extensive evidence of historic landslide activity in the valley slopes above highway level, but no indication that instability has occurred below the highway level.
- The movements to date in the inclinometers immediately adjacent to the highway have been relatively small and cannot be seen as a deflection in the highway alignment. Movements have occurred above the highway on the south side most likely as a result of ditch excavation work in recent years. Instruments are not read as part of the inspection since 2007.
- The toe section of the slope is showing signs of localized cracking and slumping that is likely related to seepage softening the steep lower zone of the slope.

Due to the on-going slumping of the steep toe slope, it is recommended that the slope above the ditch be flattened by trimming the slope to the back of the first bench. It should be noted that a power pole is located in this area and the clean up work of the slope and ditch should be performed appropriately to prevent the undermining of the pole. The waste material should be removed from the immediate vicinity and not placed anywhere on the slope above the trimmed area. Although the overall stability of the slope should not be significantly affected, the ditch area should be monitored for movement after trimming.
