**CENTRAL REGION
LANDSLIDE RISK ASSESMENT
SITE INSPECTION FORM**

SITE NUMBER AND NAME C26 H585:02		HIGHWAY & KM 18.98-20.19	PREVIOUS INSPECTION DATE	INSPECTION DATE May 21, 2003
LEGAL DESCRIPTION	NAD 83 COORDINATES Refer to individual sites		RISK ASSESMENT PF: 9 CF: 4 TOTAL: 36

LAST READING DATE:	
PRIMARY SITE ISSUE: Pavement distress due to slope movement/Ditch erosion	
APPROXIMATE DIMENSIONS:	
DATE OF ANY REMEDIAL ACTION:

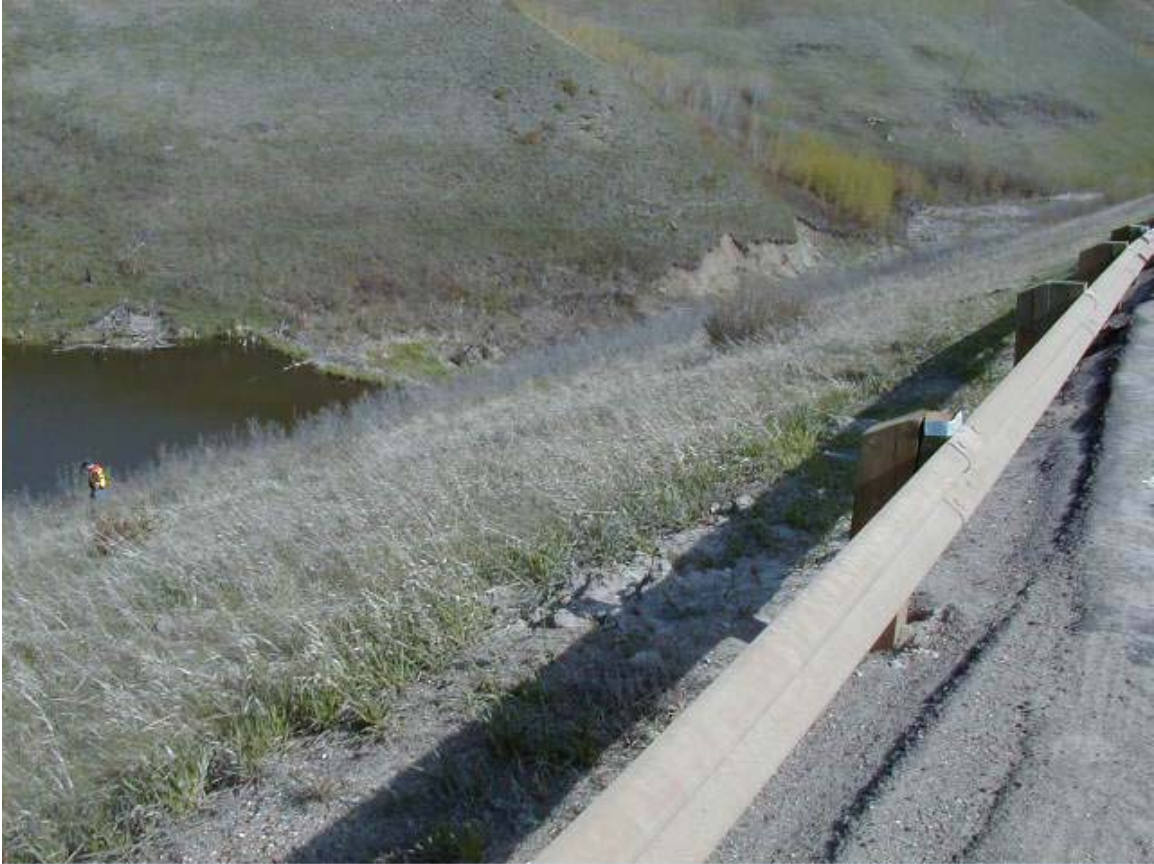
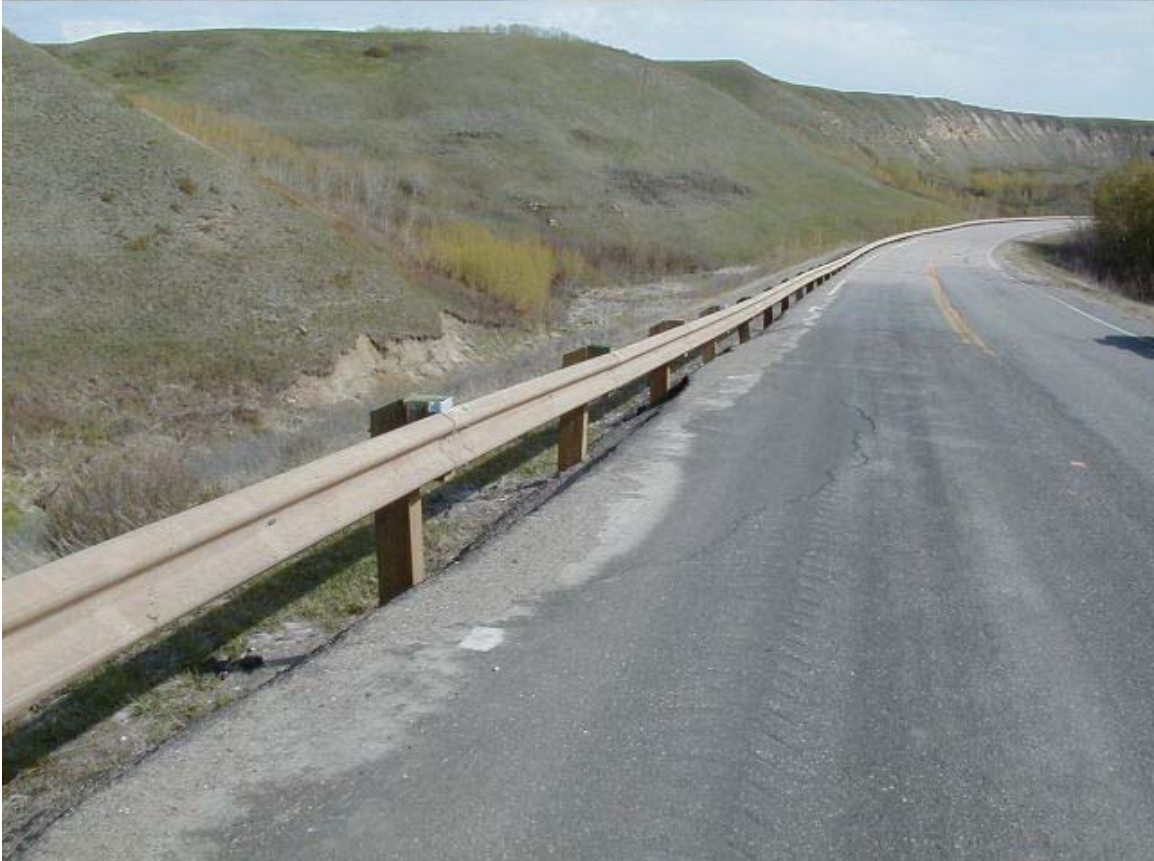
Site A (N 5745785, E 358606)

Pavement distress due to downslope movement. Slope about 15 m high above pond at about 3H:1V. Highway last patched in the summer of 2002 (previous patch lasted about 3 years) – now about a 0.6 m thick asphalt layer in this area about 5 m long. No apparent bulging of the slope was observed and it would appear that the mechanism is more likely a shallow slumping of the fill slope. This highway may be scheduled for work in 2005.

It is recommended that the remediation work comprise the removal of the total thickness of asphalt in this location and replace with lightweight fill, such a dense foam, to reduce the weight at the top of the slope before repaving.

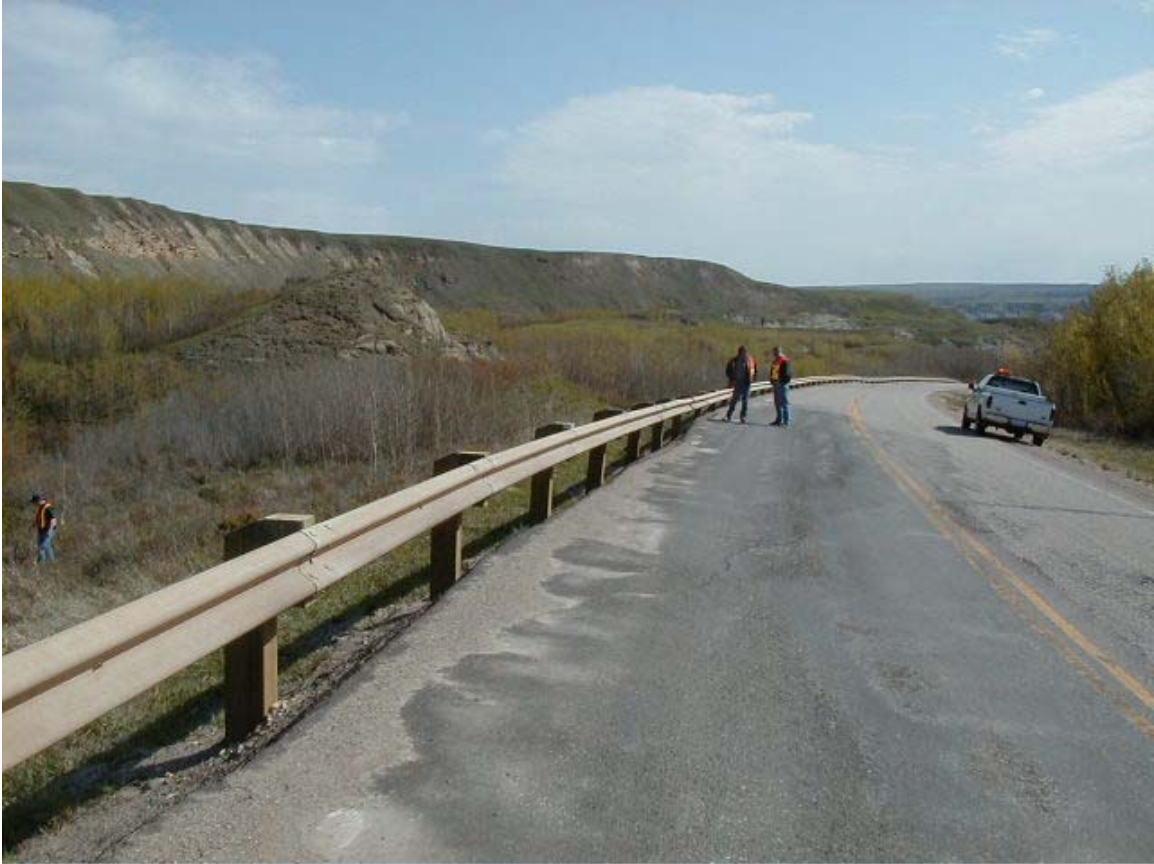
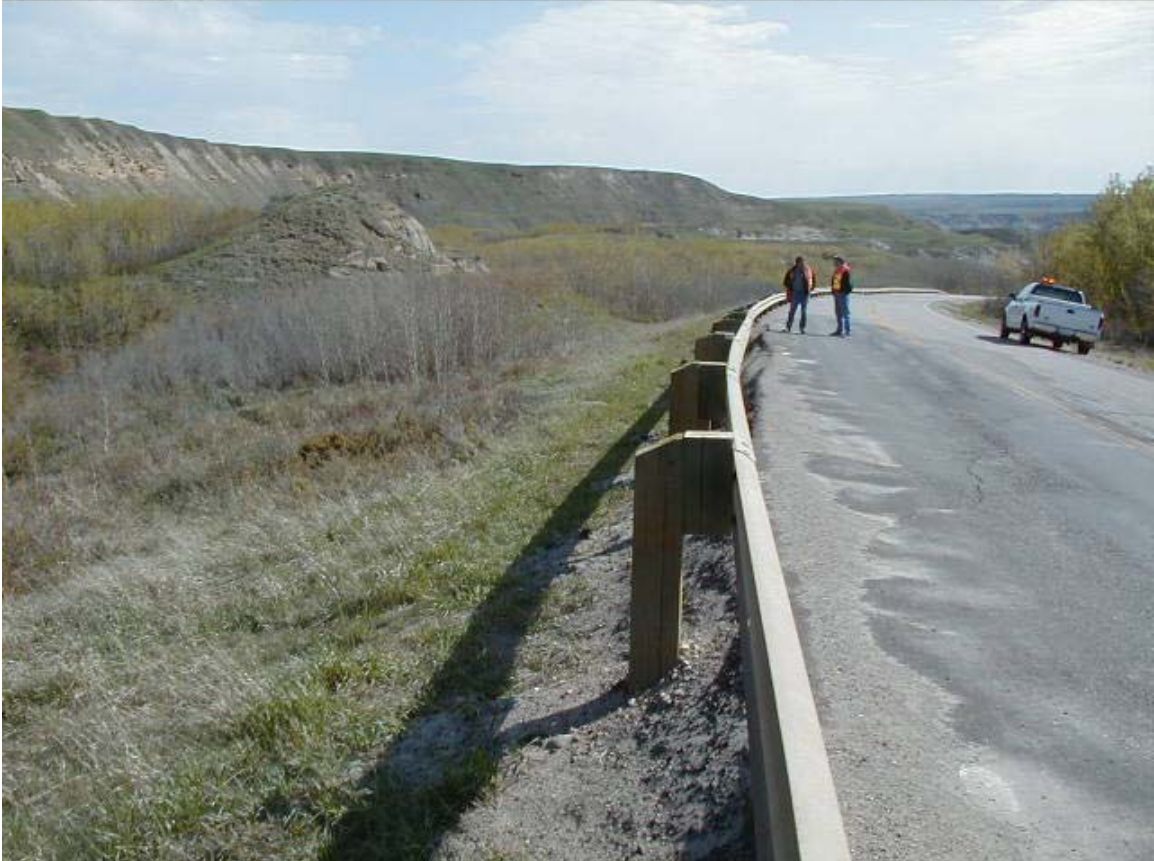
Site B (N 5746032, E 358750)

Similar pavement distress to Site A measuring about 15 m long and extending back to the road centerline. Similar remedial measures are recommended.

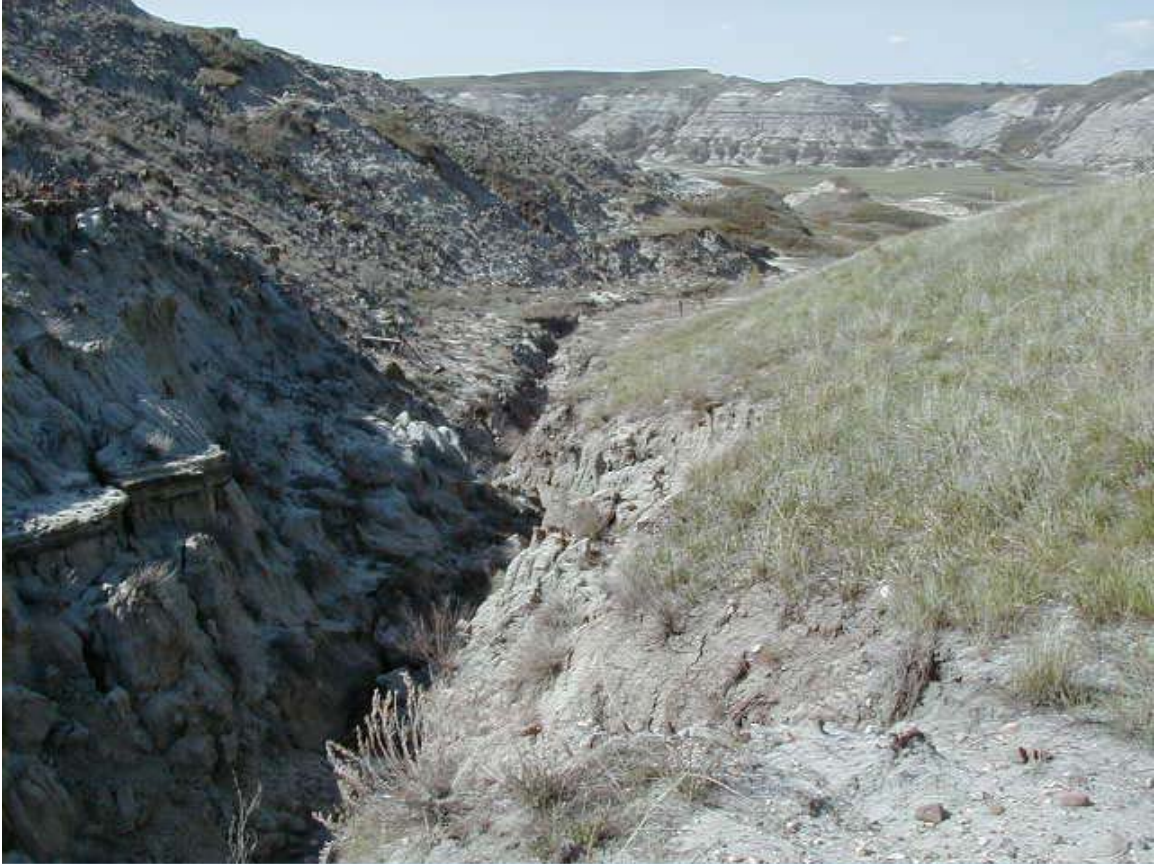
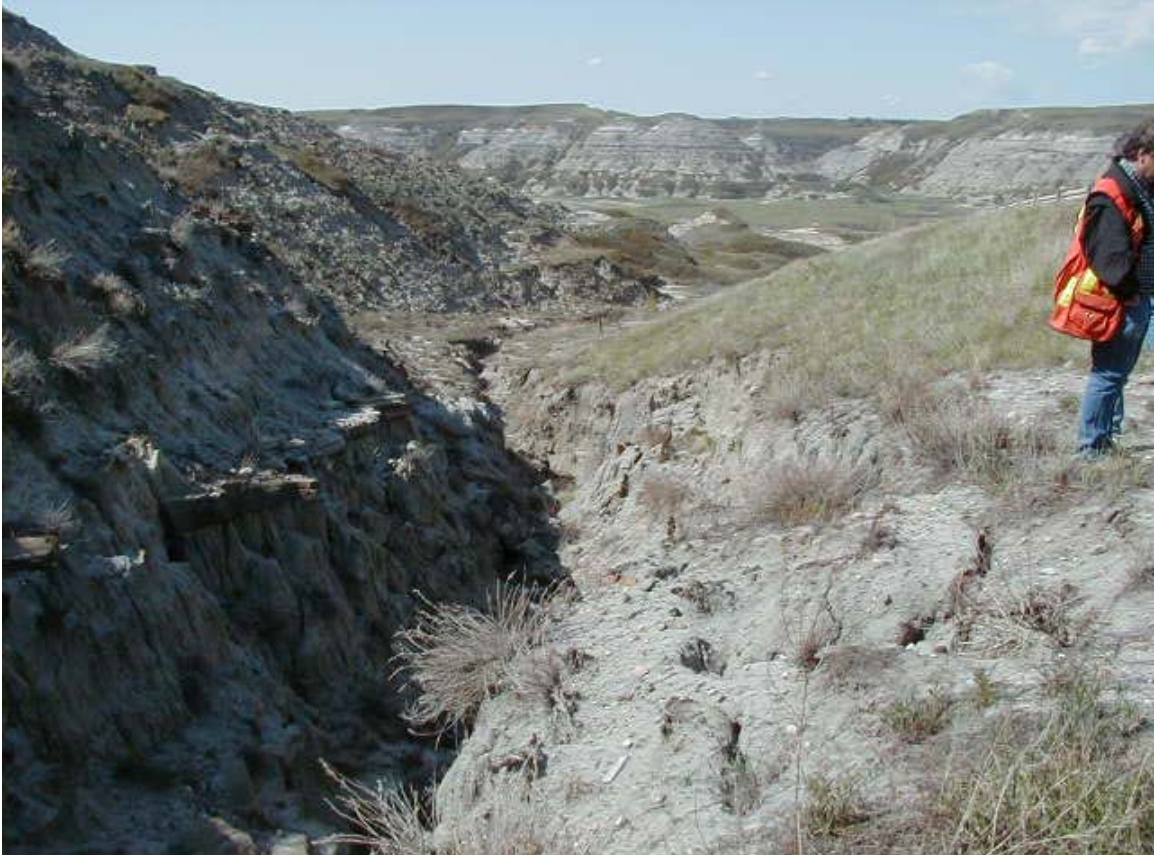
Site C (Spring @ N 5744526, E 362400 leading to N 5744835, E 362620)

A large erosion ditch has been formed by a spring in the valley slope. The spring has been observed to flow year-round. Some slumping was observed in the erosion channel sides, however, the ditch is currently outside the clear zone of the highway.

It is recommended that the rate and extent of the erosion be observed to determine the required remedial work. Mapping of the existing features would be useful tool in conjunction with a review of the Department's files. It is likely that the required remediation will involve the infilling of the eroded ditch with a "hard" protective layer as the potential for good vegetation growth would appear poor.
