**CENTRAL REGION
GEOHAZARDS RISK ASSESMENT
SITE INSPECTION FORM**

SITE NUMBER AND NAME C26 H585:02		HIGHWAY & KM 18.98-20.19	PREVIOUS INSPECTION DATE May 21, 2003	INSPECTION DATE May 18, 2004
LEGAL DESCRIPTION	NAD 83 COORDINATES Refer to individual sites		RISK ASSESMENT PF: 9 CF: 2 TOTAL: 18

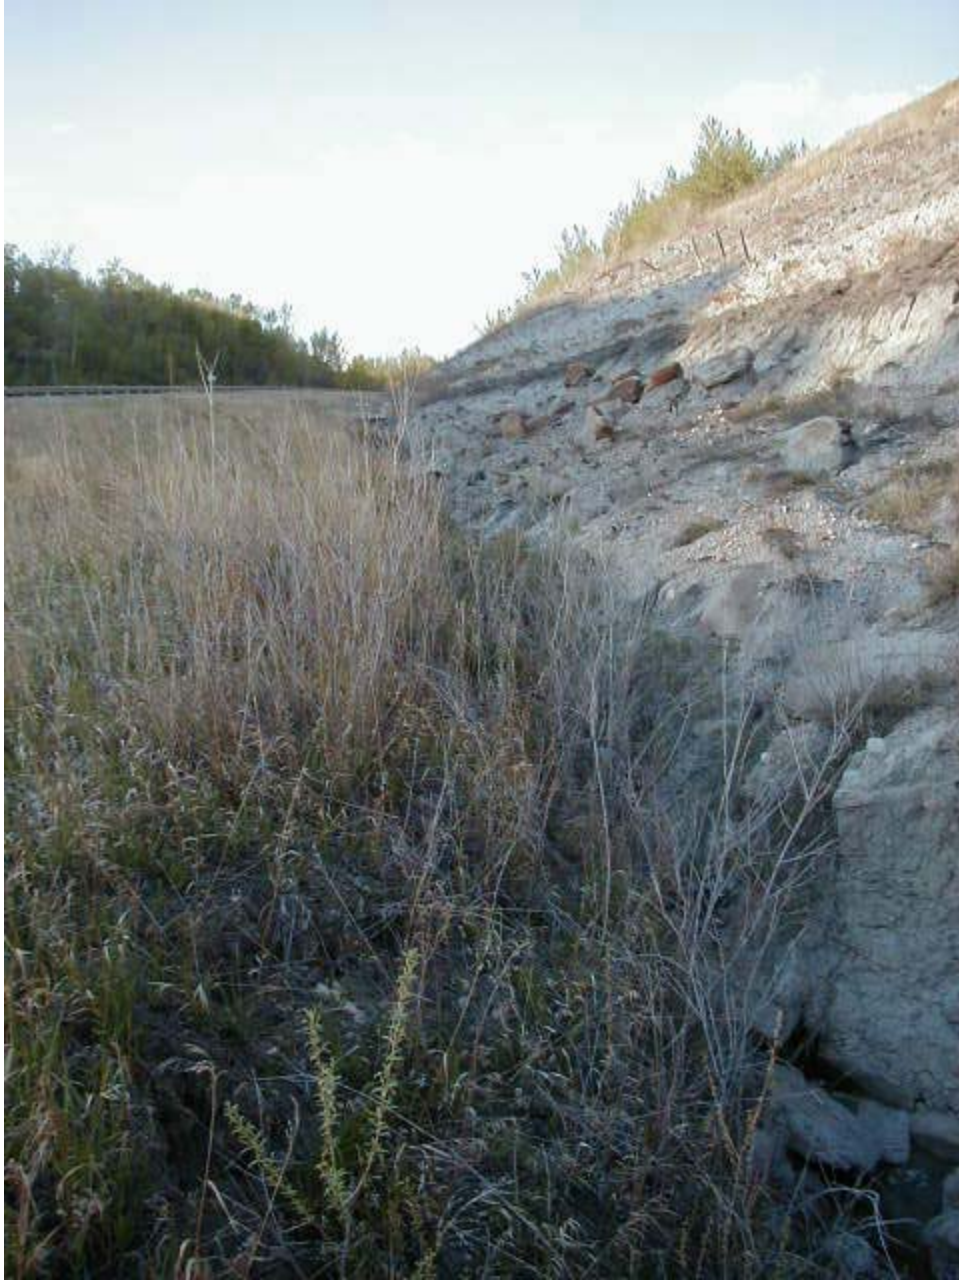
Pavement distress due to downslope movement. Slope about 15 m high above pond at about 3H:1V. Highway last patched in the summer of 2002 (previous patch lasted about 3 years) – now about a 0.6 m thick asphalt layer in this area about 5 m long. No apparent bulging of the slope was observed and it would appear that the mechanism is more likely a shallow slumping of the fill slope. This highway may be scheduled for work in 2005.

It is recommended that the remediation work comprise the removal of the total thickness of asphalt in this location and replace with lightweight fill, such a dense foam, to reduce the weight at the top of the slope before repaving.

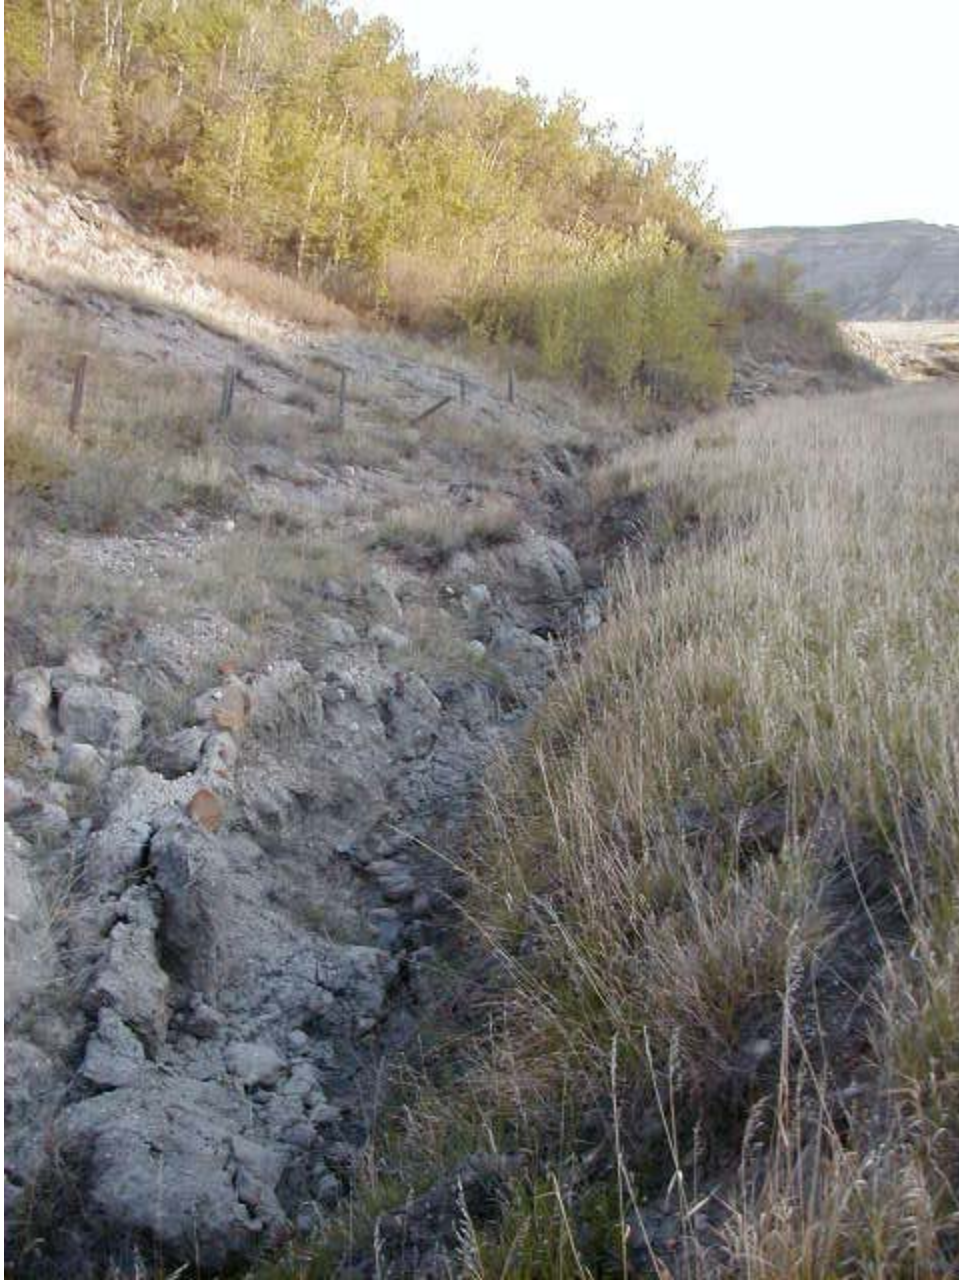
Similar pavement distress to Site A measuring about 15 m long and extending back to the road centerline. Similar remedial measures are recommended.

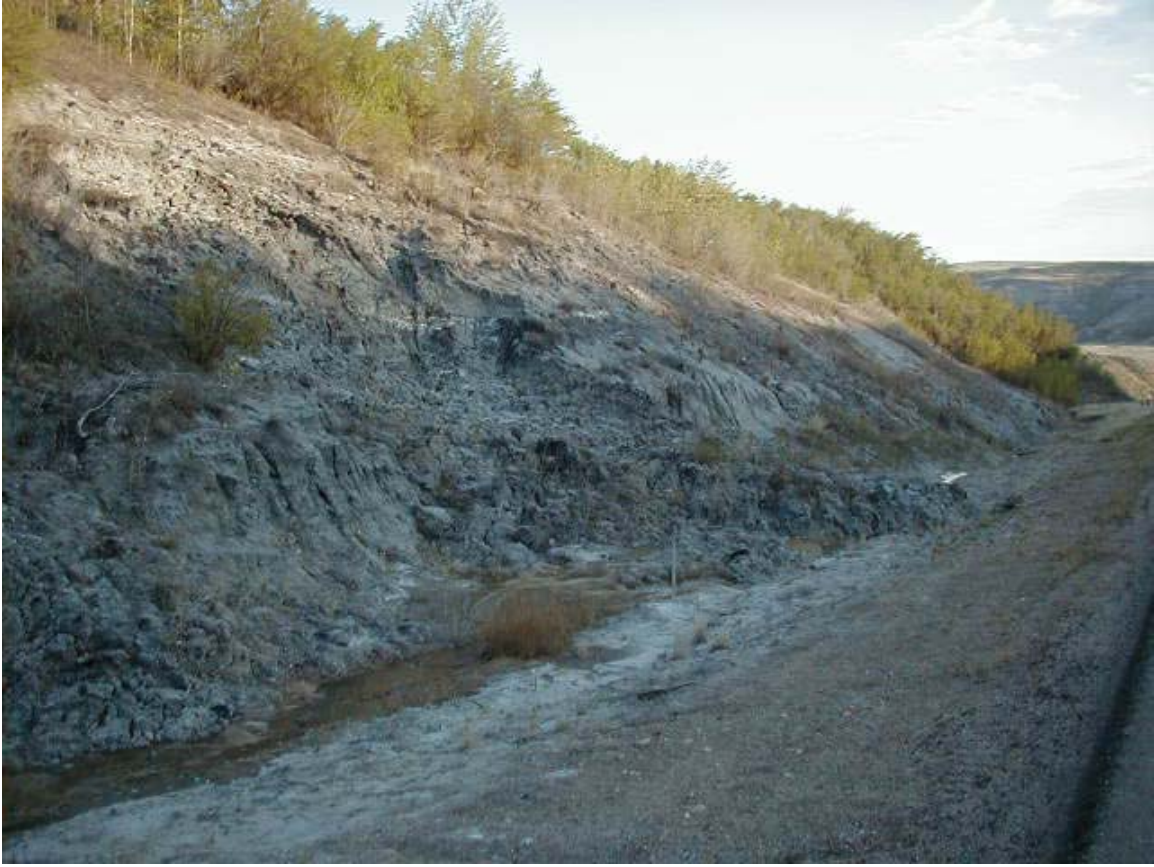
A large erosion ditch has been formed by a spring in the valley slope. The spring has been observed to flow year-round. Some slumping was observed in the erosion channel sides, however, the ditch is currently outside the clear zone of the highway.

Spring area and slumped material in ditch

It is recommended that the rate and extent of the erosion be observed to determine the required remedial work. It is likely that the required remediation will involve the infilling of the eroded ditch with a “hard” protective layer as the potential for good vegetation growth would appear poor. It is considered that this site is relatively low priority.
