SITE NUMBER AND NAME C8 H597:02 Slide		HIGHWAY & KM	PREVIOUS INSPECTION DATE June 4, 2009	INSPECTION DATE May 19, 2010
LEGAL DESCRIPTION NE 9-39-26-W4	NAD 83 COORDINATES N 5803030 E 317080	RISK ASSESMENT PF: 6 CF: 2 TOTAL: 12

Site C08 H597:02 Blackfalds
May 19, 2010

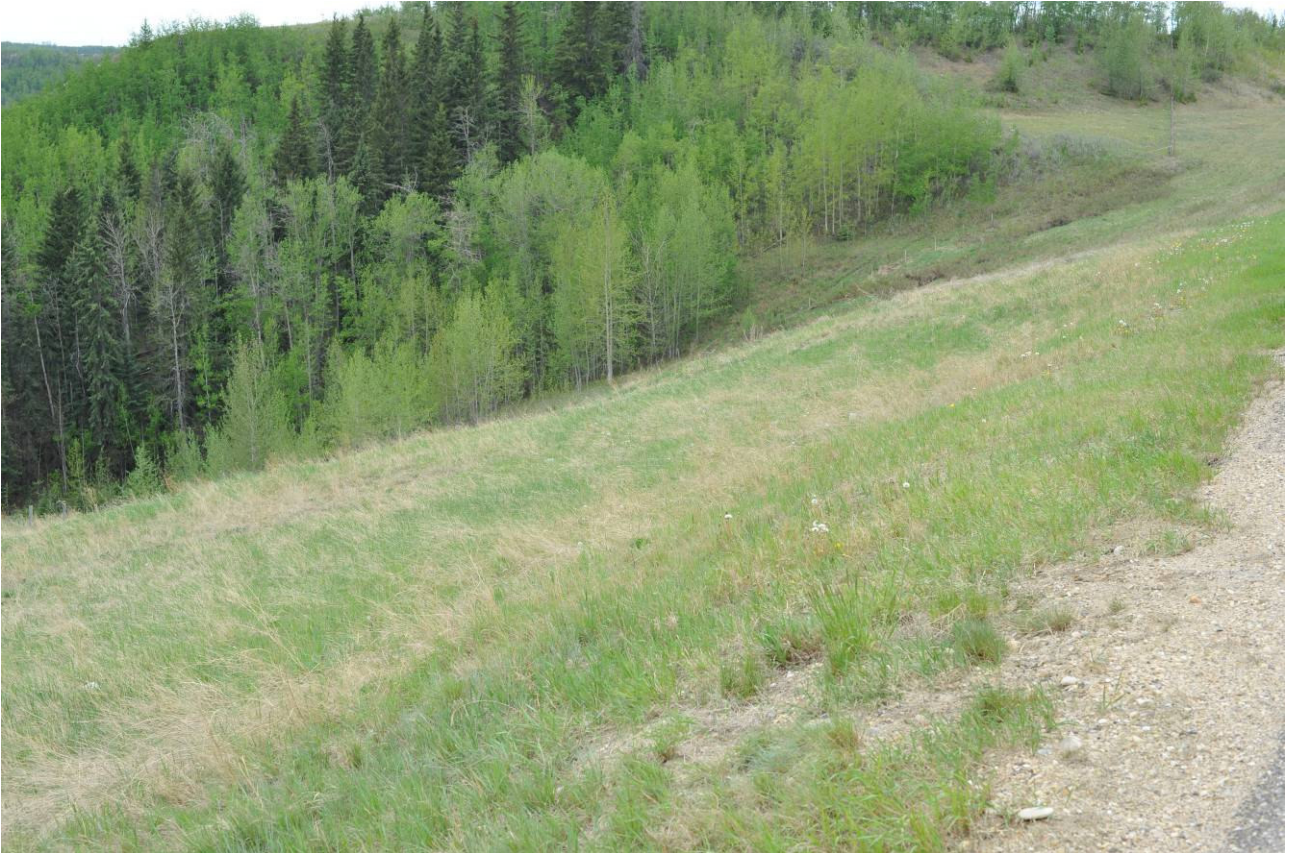
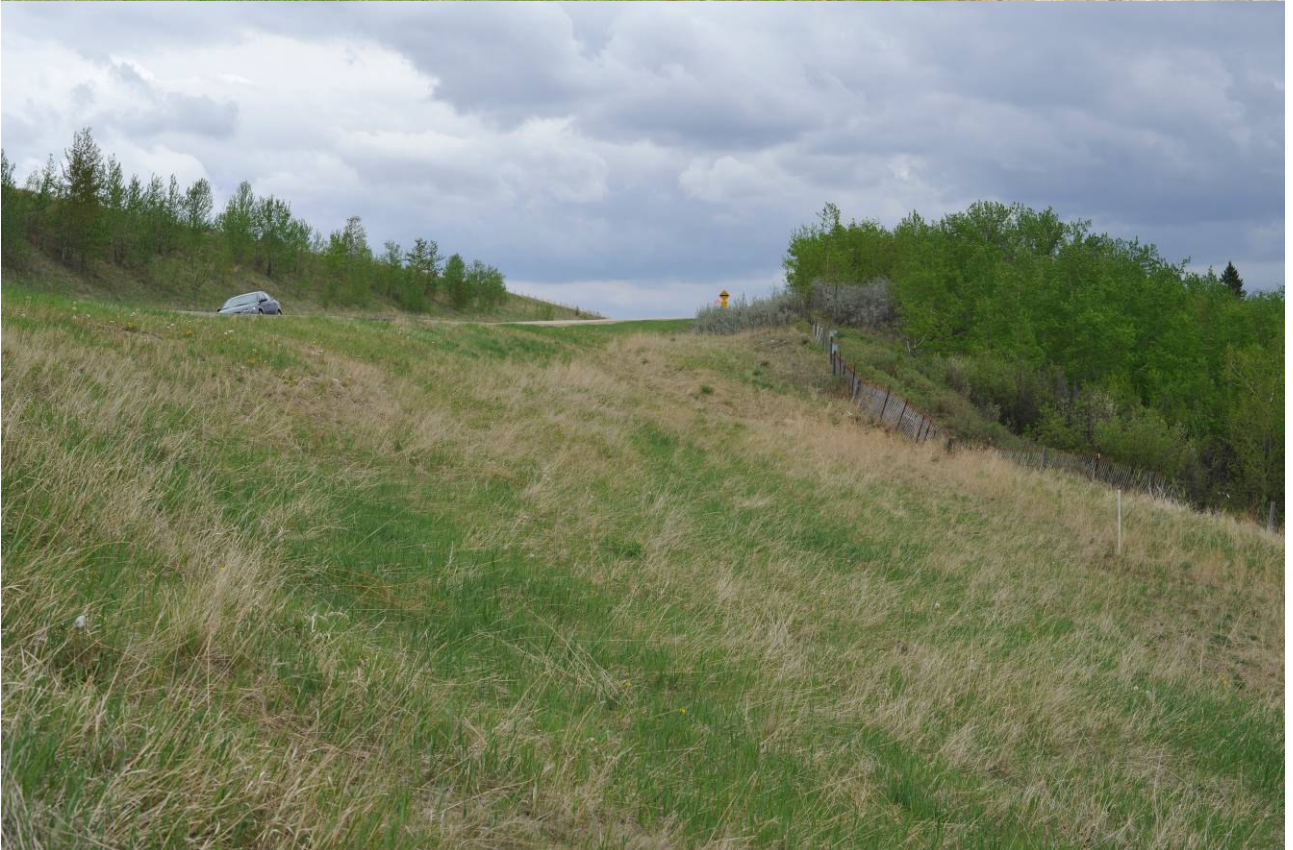
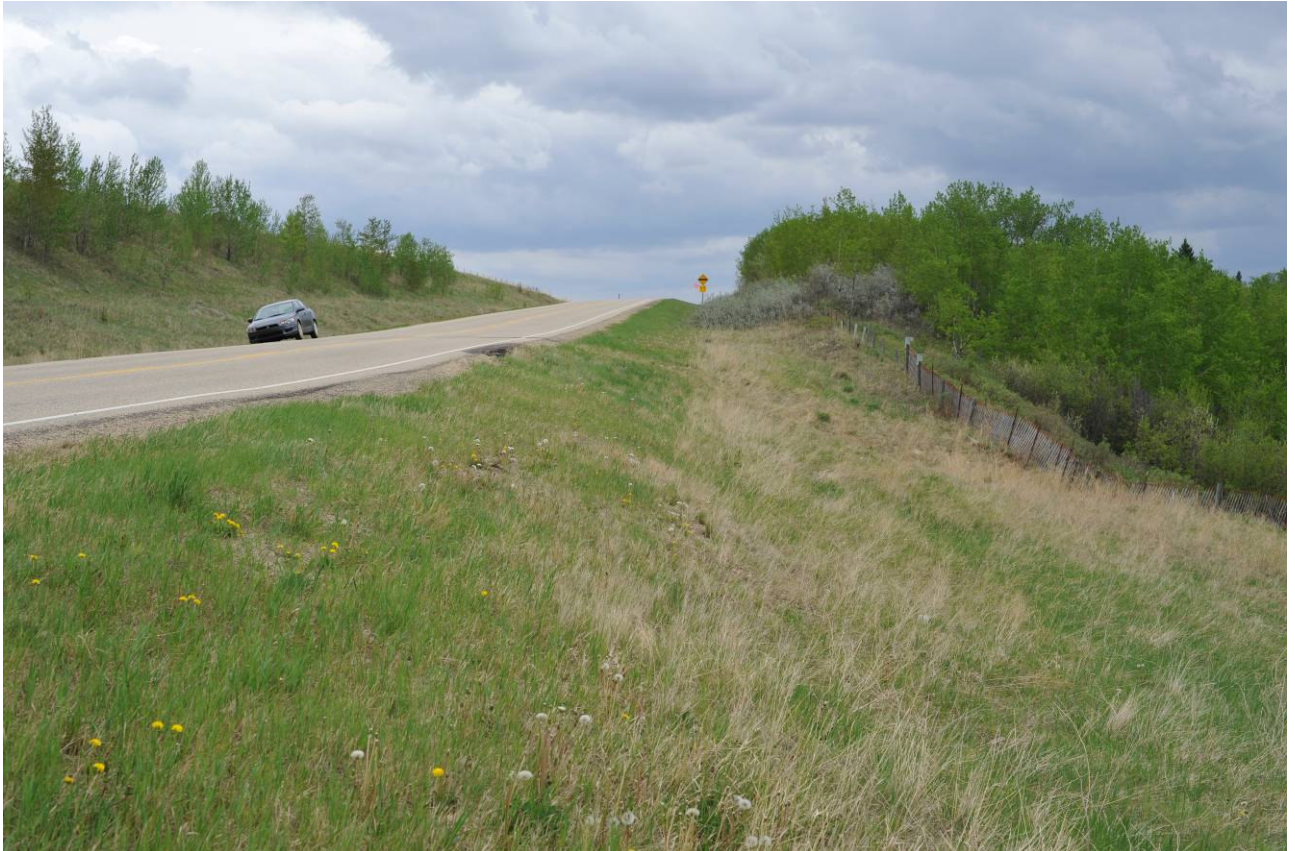
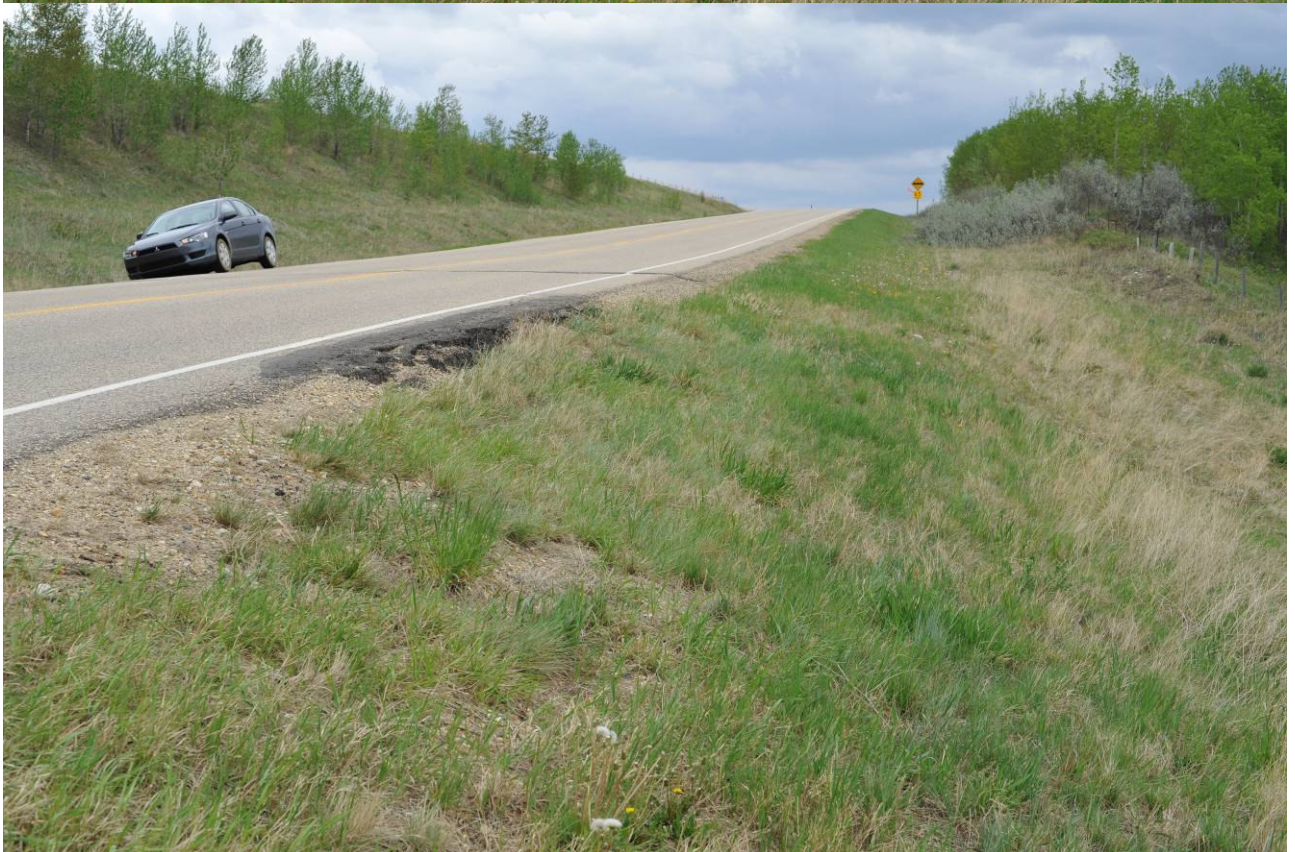
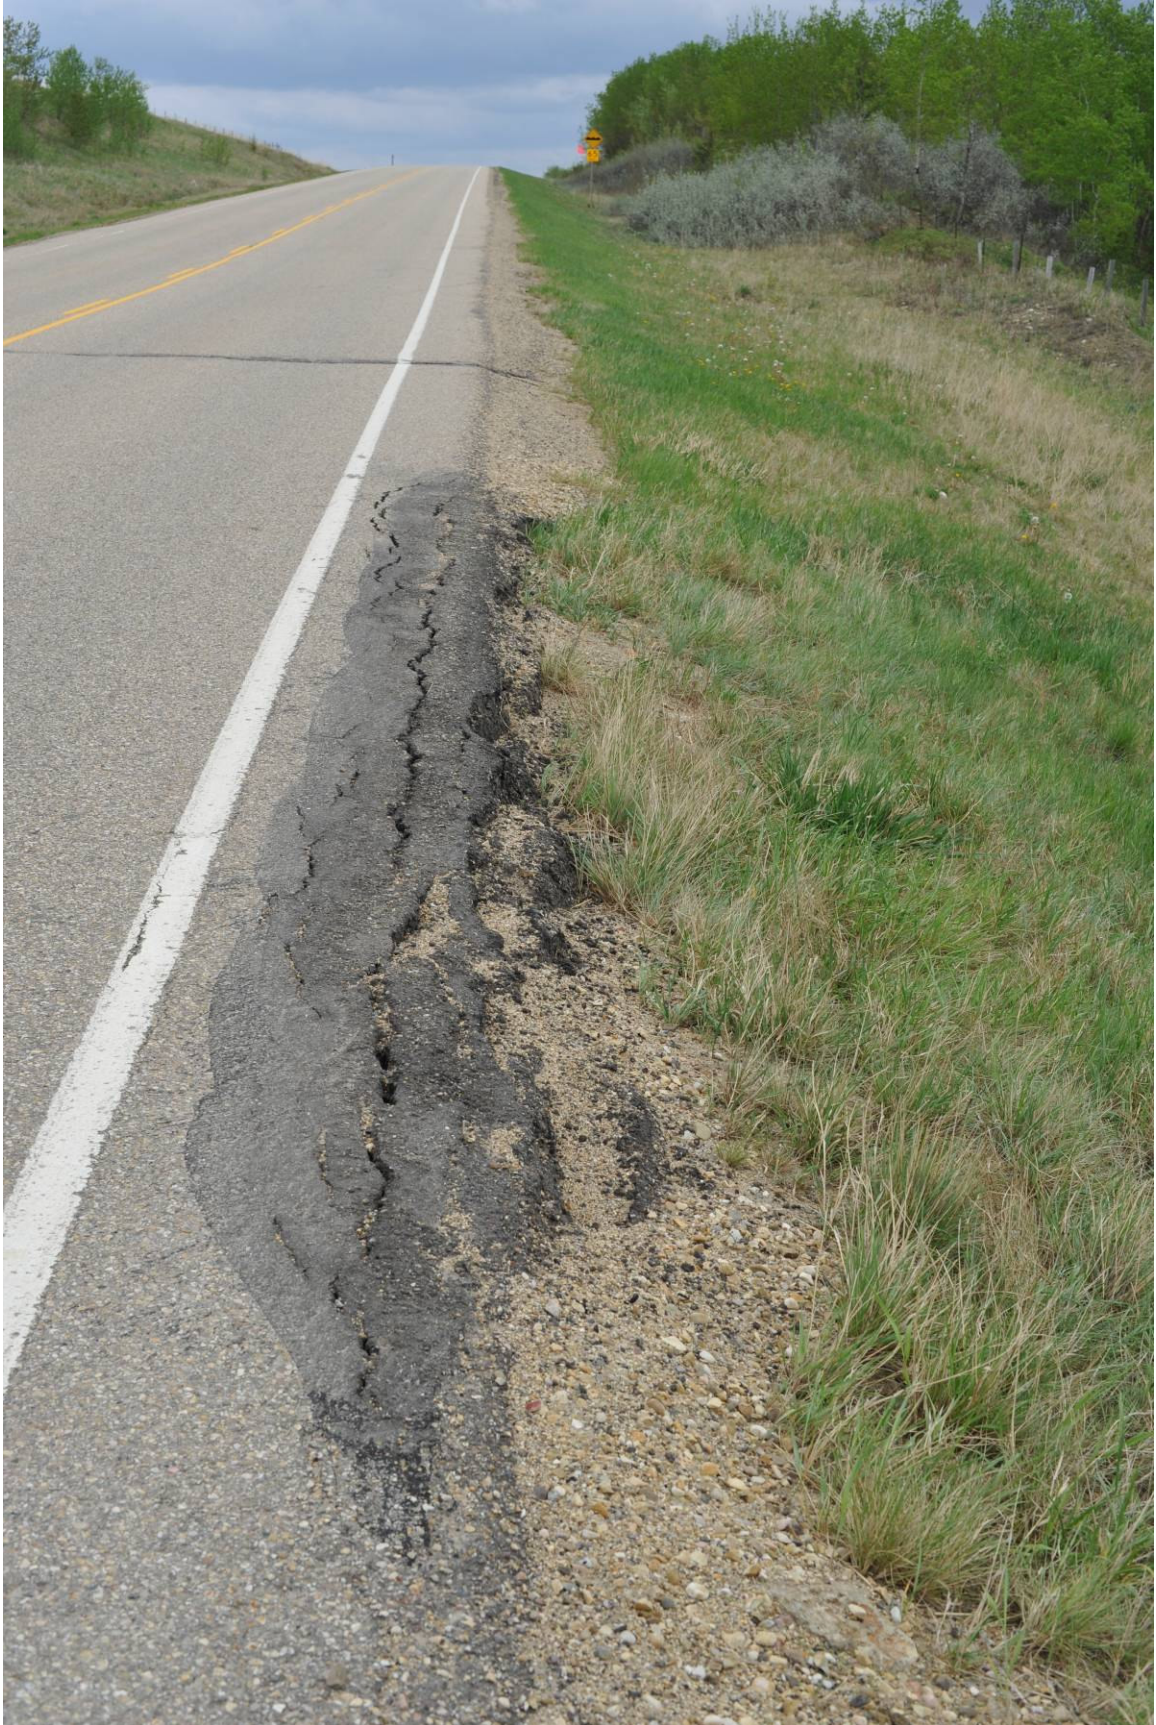
ITEM	CONDITION EXISTS		DESCRIPTION AND LOCATION	NOTICABLE CHANGE FROM LAST INSPECTION	
	YES	NO		YES	NO
Pavement Distress	X				X
Slope Movement	X		SIs indicated ongoing movement since 2000; however, little surficial evidence was visible until the spring of 2007 when the road edge dropped by about 2 m. The slide was remediated in June 2007 with soils nails. Approximately 150 mm of settlement at the road edge has occurred since construction.		X
Erosion		X			X
Seepage		X			X
Culvert Distress		X			X

COMMENTS Refer to attached photos, previous inspection reports and 2007 construction report for site history. It is recommended that gravel fill be placed at the edge of the highway to reinstate the shoulder and remove the sharp edge.
