SITE NUMBER AND NAME C08 H597:02 Blackfalds		HIGHWAY & KM	PREVIOUS INSPECTION DATE May 19, 2010	INSPECTION DATE May 18, 2011
LEGAL DESCRIPTION NE 9-39-26-W4	NAD 83 COORDINATES N 5803030 E 317080		RISK ASSESMENT PF: 1 CF: 1 TOTAL: 1

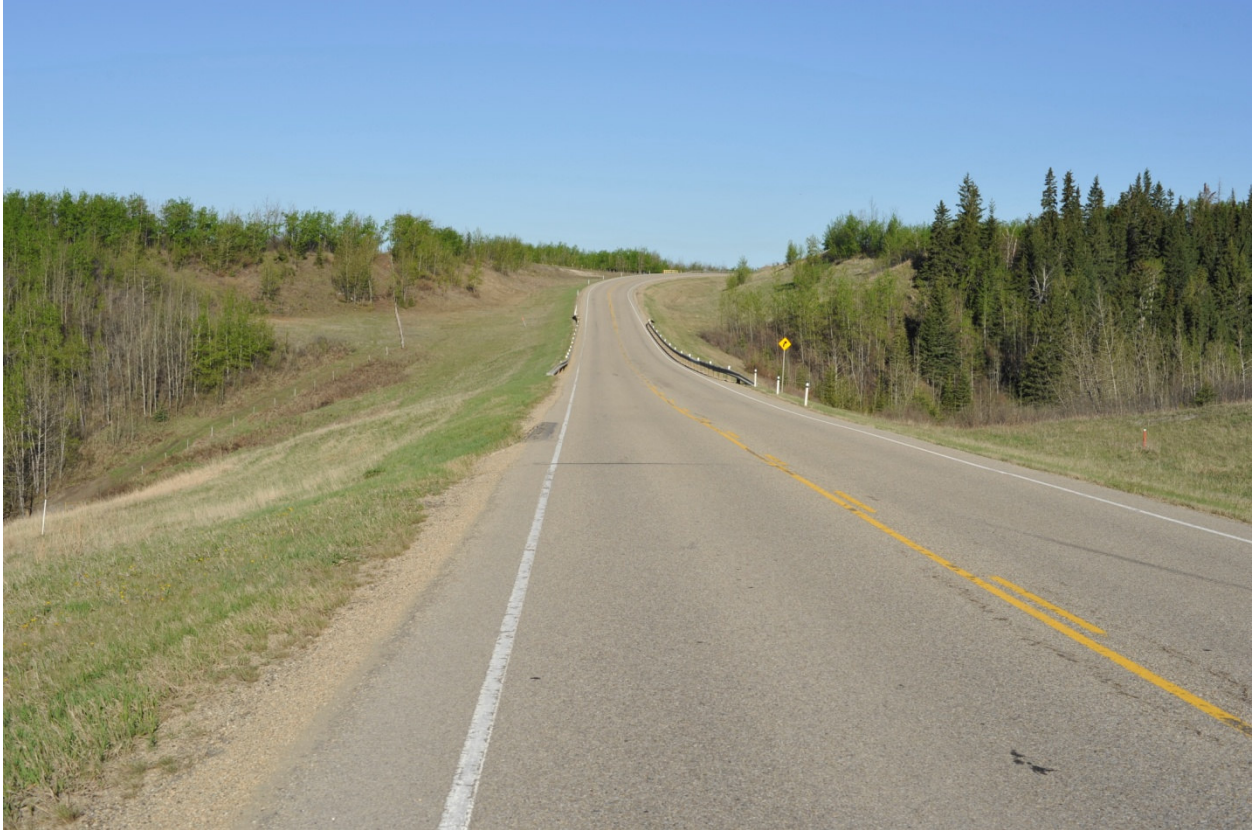
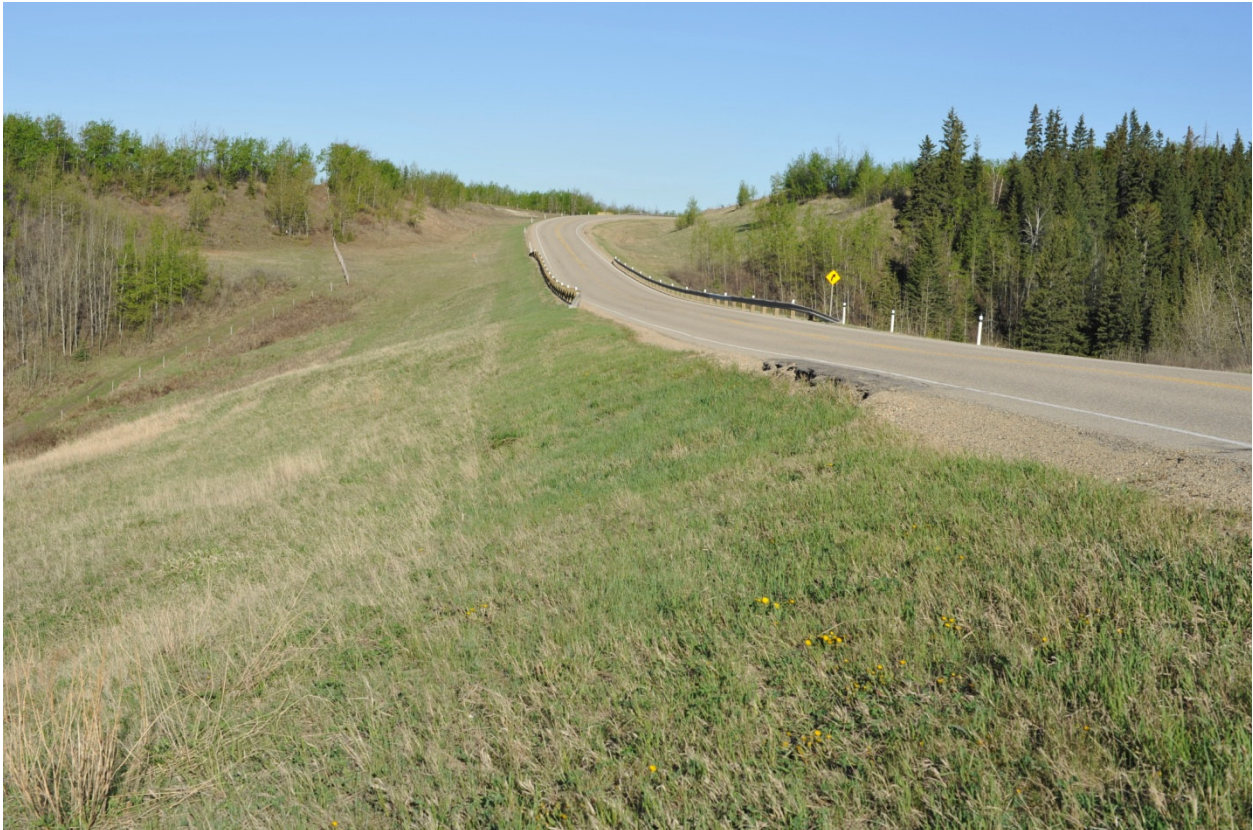
COMMENTS
Refer to attached photos, previous inspection reports and 2007 construction report for site history. MCI to monitor – remove from Geohazard program
