SITE NUMBER AND NAME H614:02 Ditch Erosion		HIGHWAY & KM	PREVIOUS INSPECTION DATE	INSPECTION DATE May 14, 2007
LEGAL DESCRIPTION	NAD 83 COORDINATES	RISK ASSESMENT PF: 9 CF: 2 TOTAL: 18

LAST READING DATE:	
PRIMARY SITE ISSUE: <p style="text-align: center;">Ditch erosion at two locations</p>	
APPROXIMATE DIMENSIONS:	
DATE OF ANY REMEDIAL ACTION:

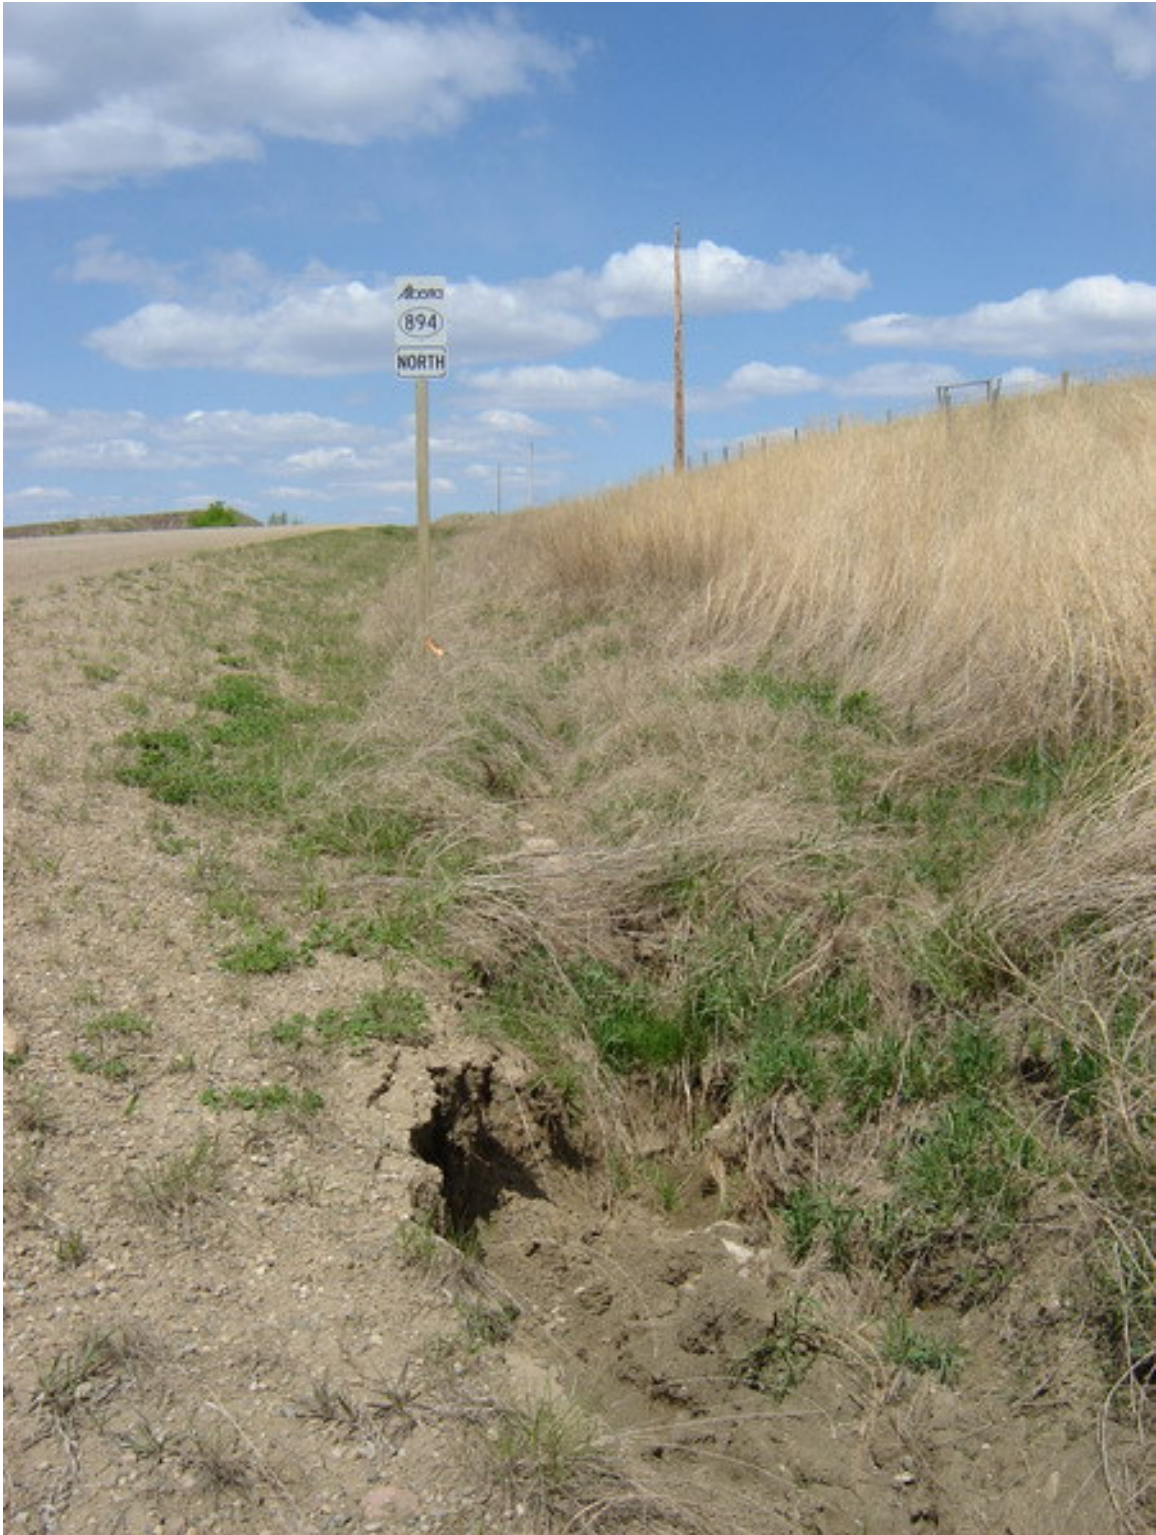
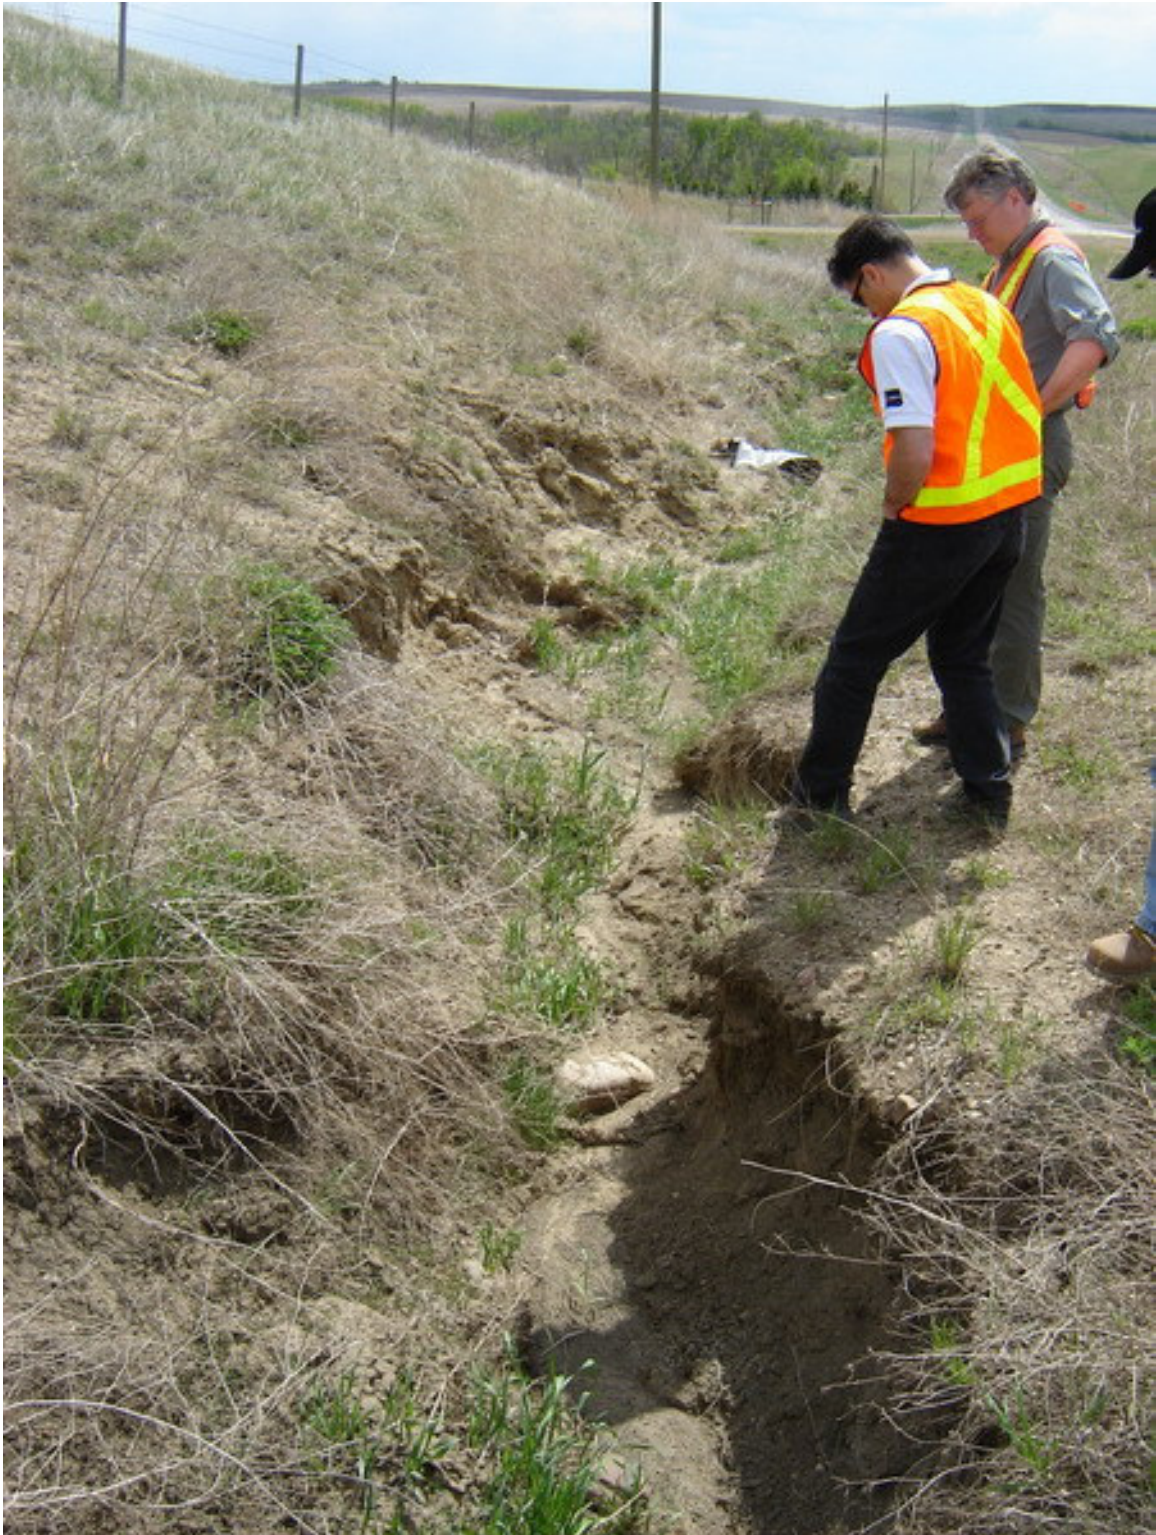
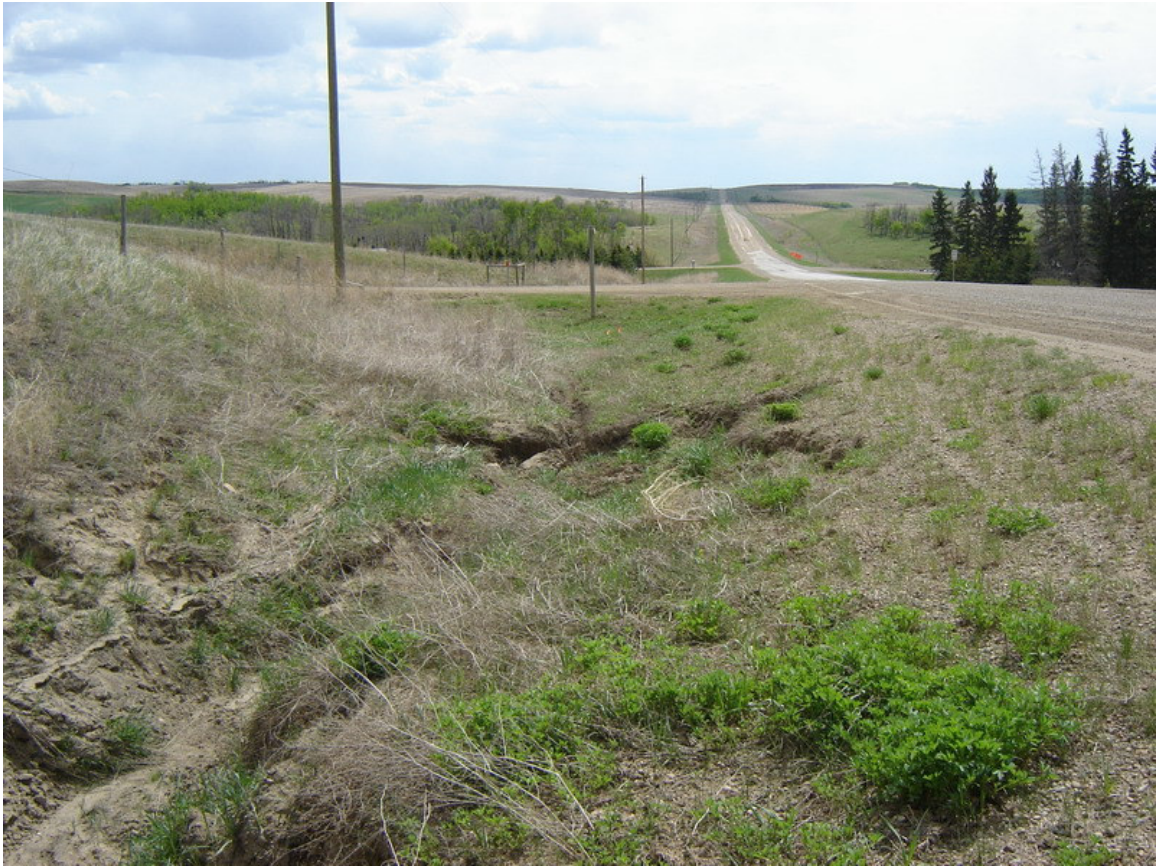
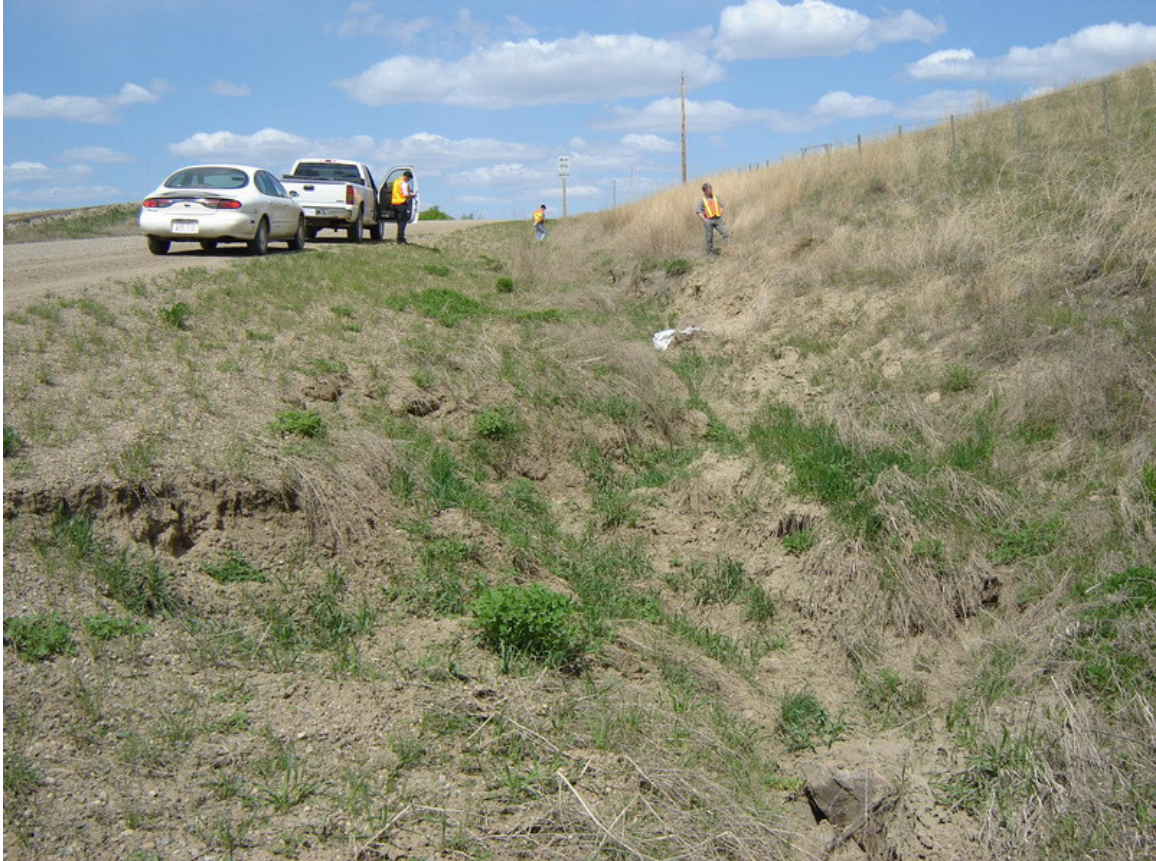
Site 1 (Northeast ditch of intersection between H614:02 & H894:02)

Refer to photo pages 1 – 4.

A shallow erosion channel has formed in the east highway ditch over a length of about 30 m. The channel is up to about 1 m wide and about 0.3 m deep. The channel is at least 4 m from the highway edge and does not represent a hazard to traffic.

It is recommended that the ditch be trimmed and protected with gravel armor as required.

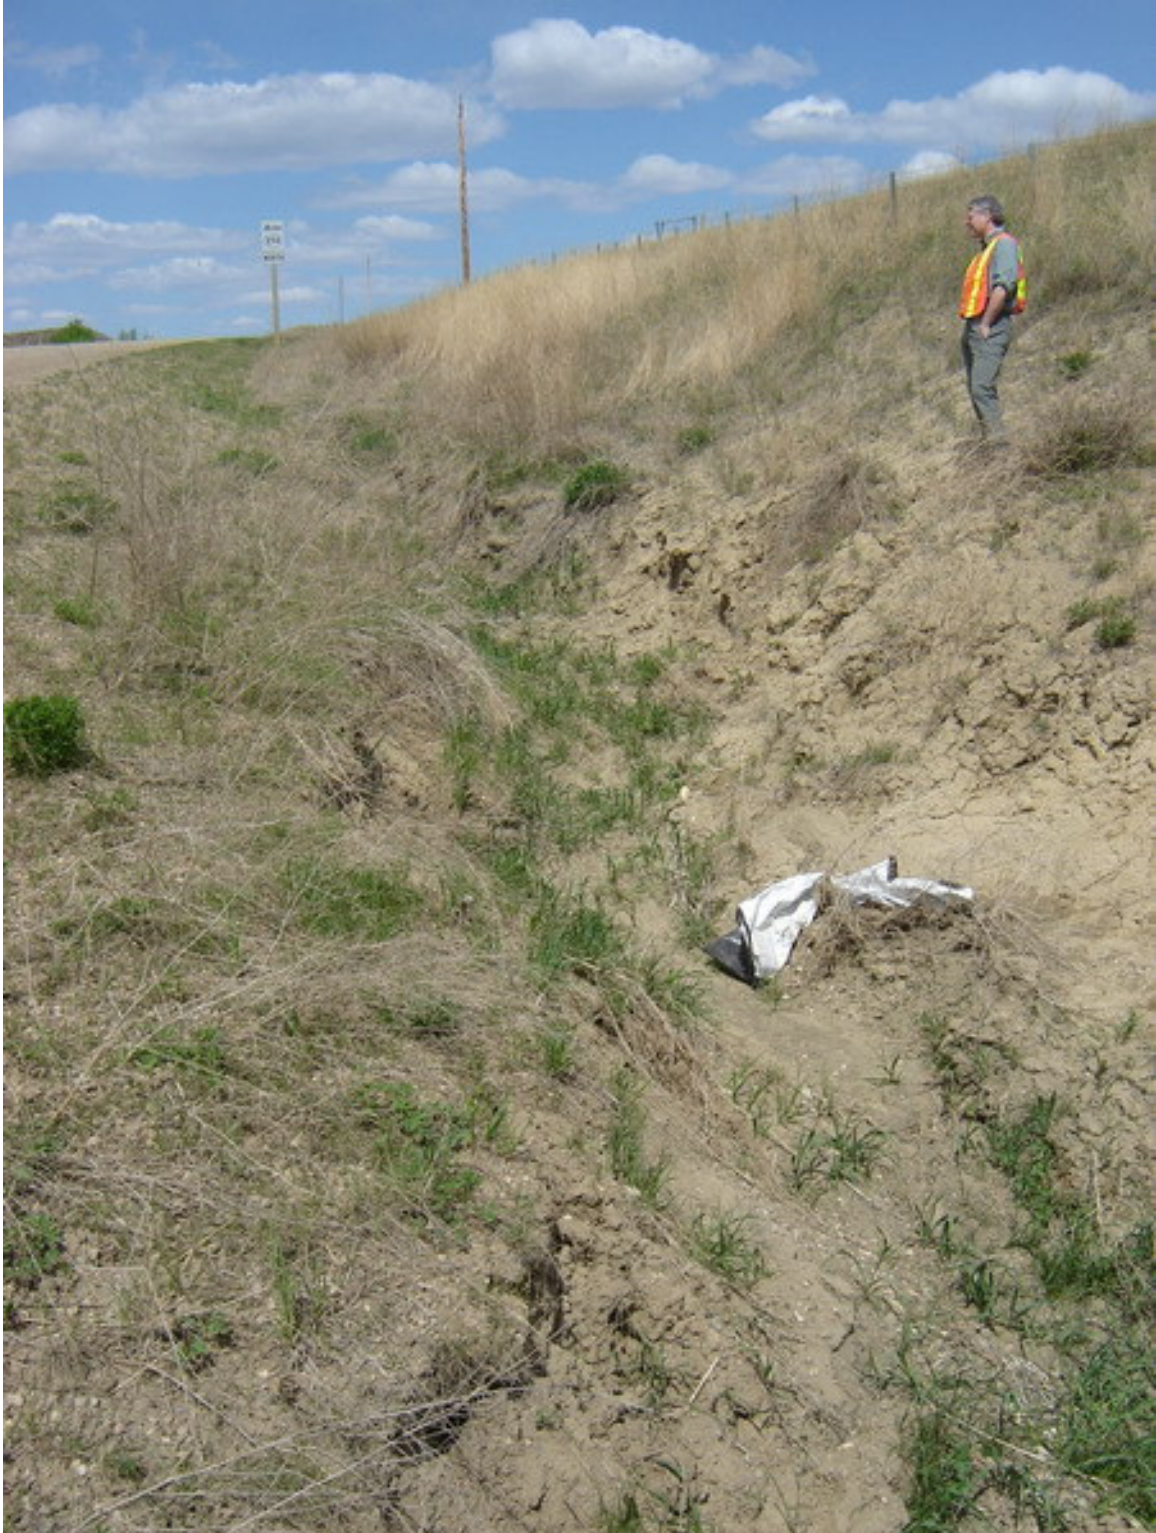
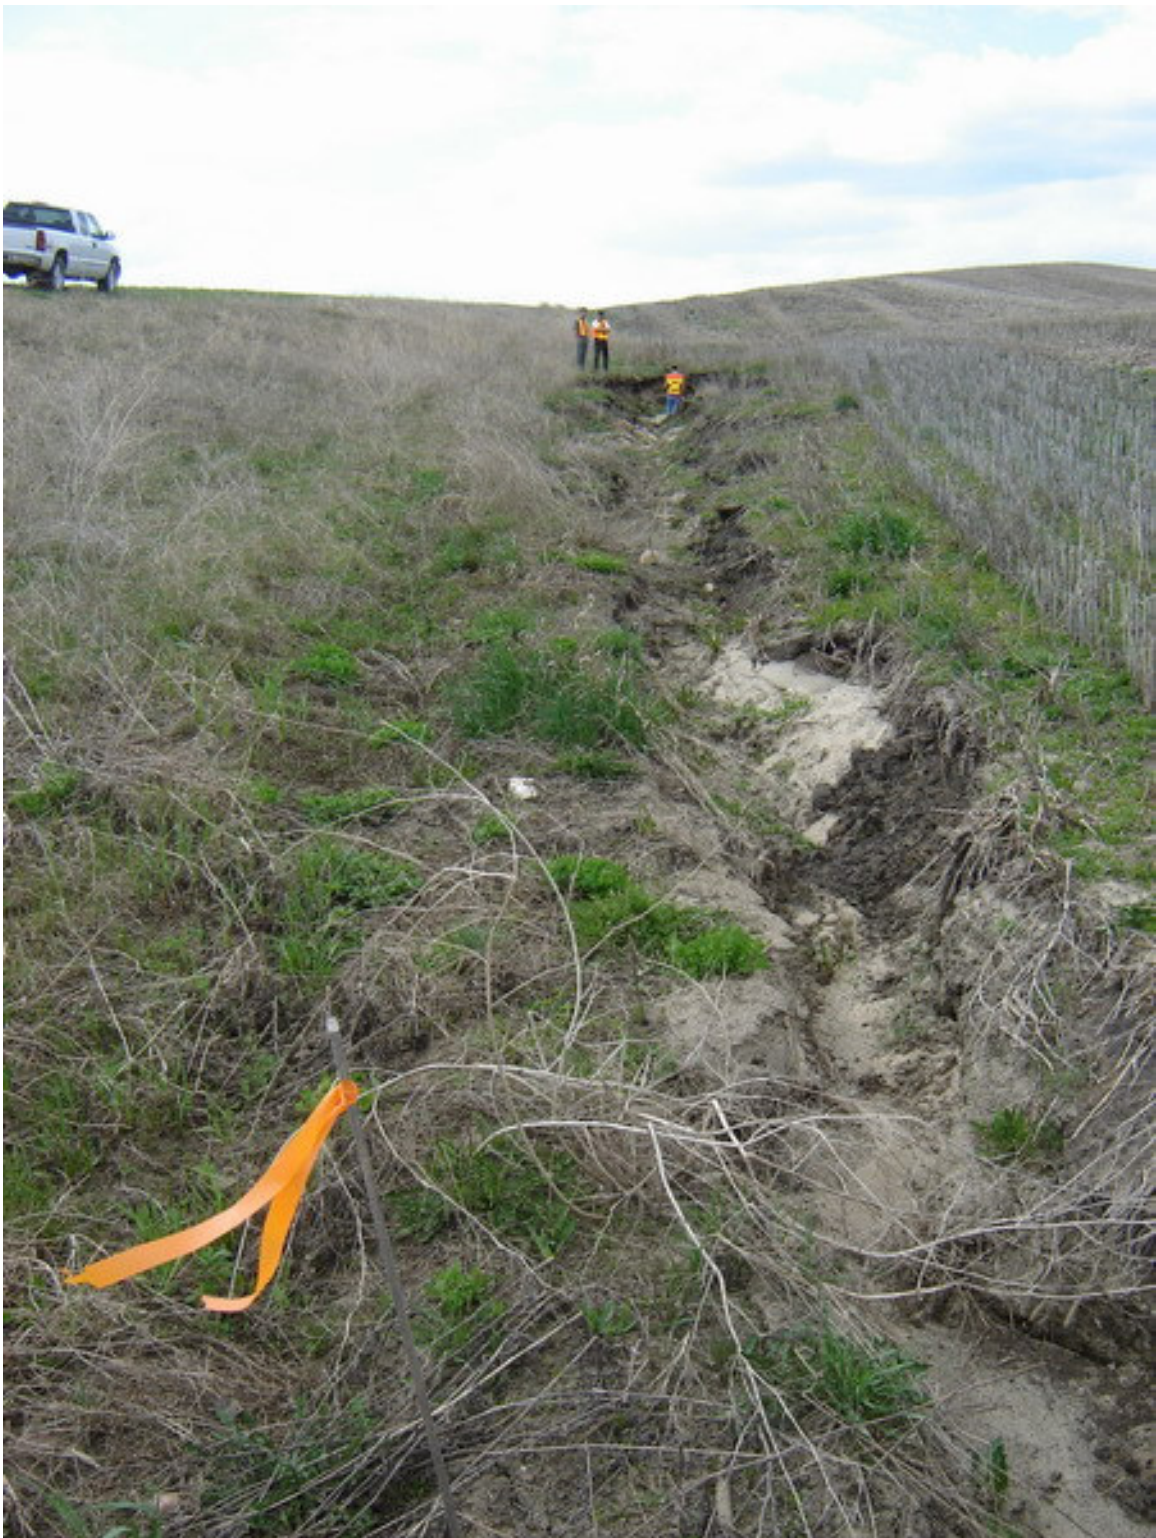
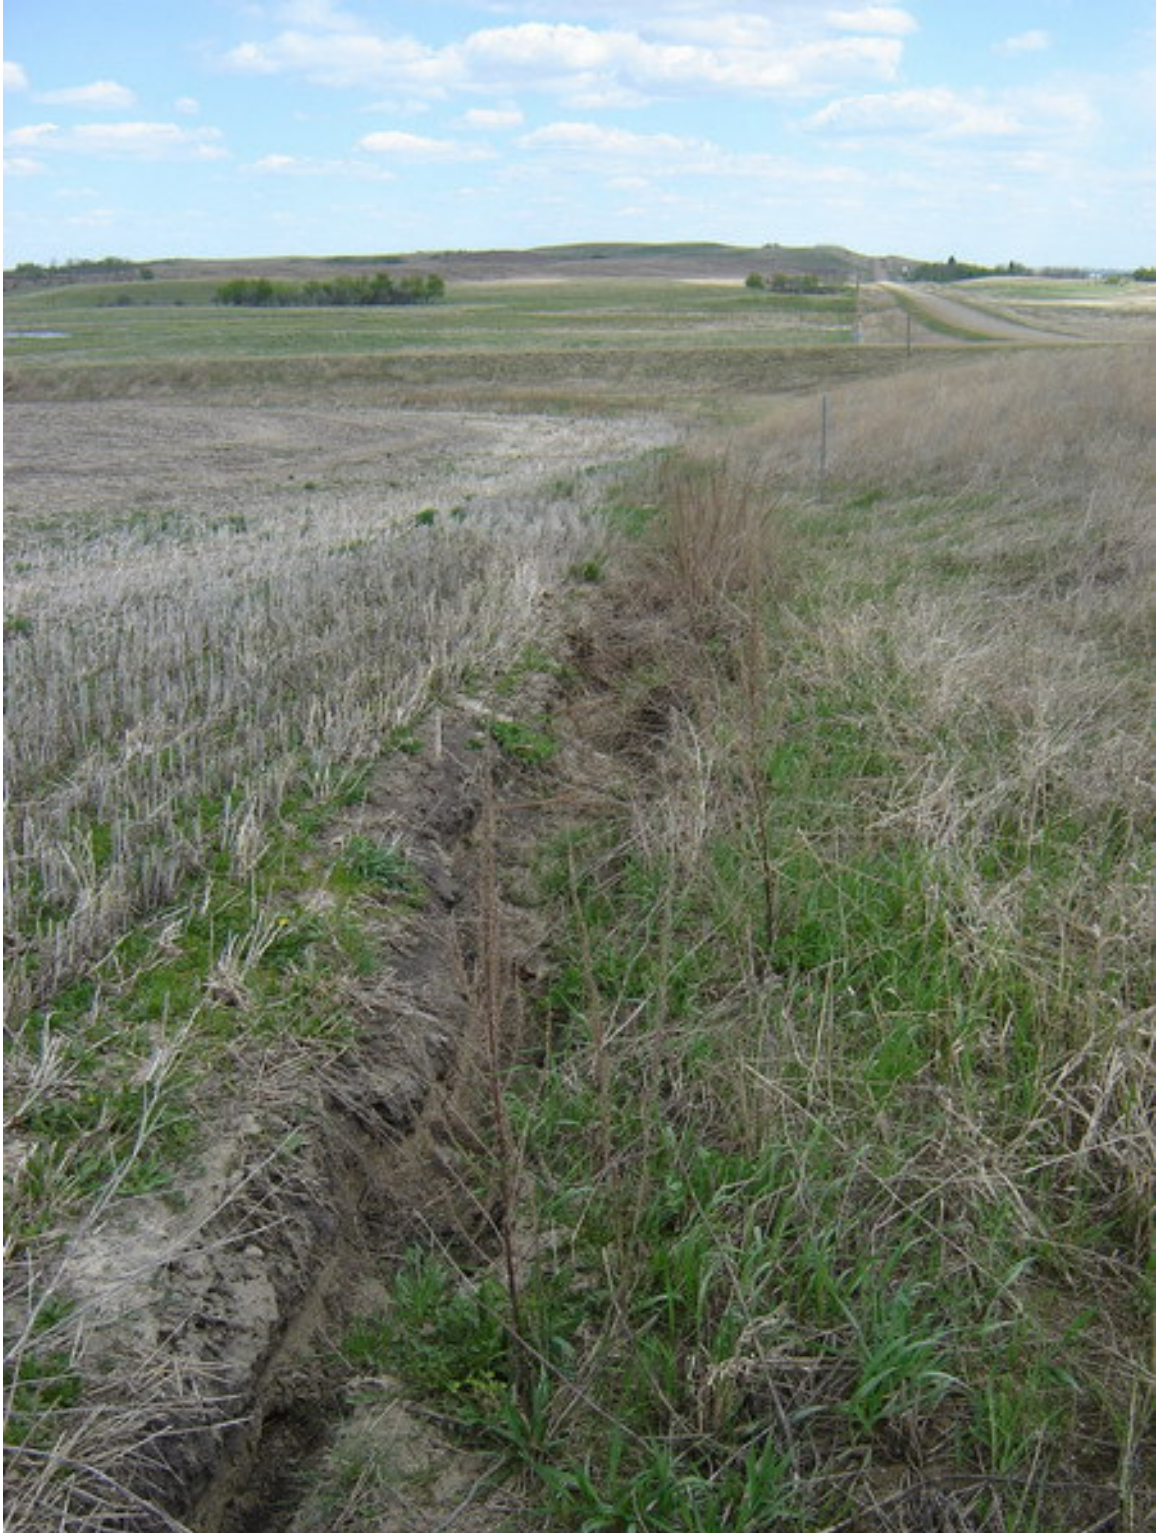
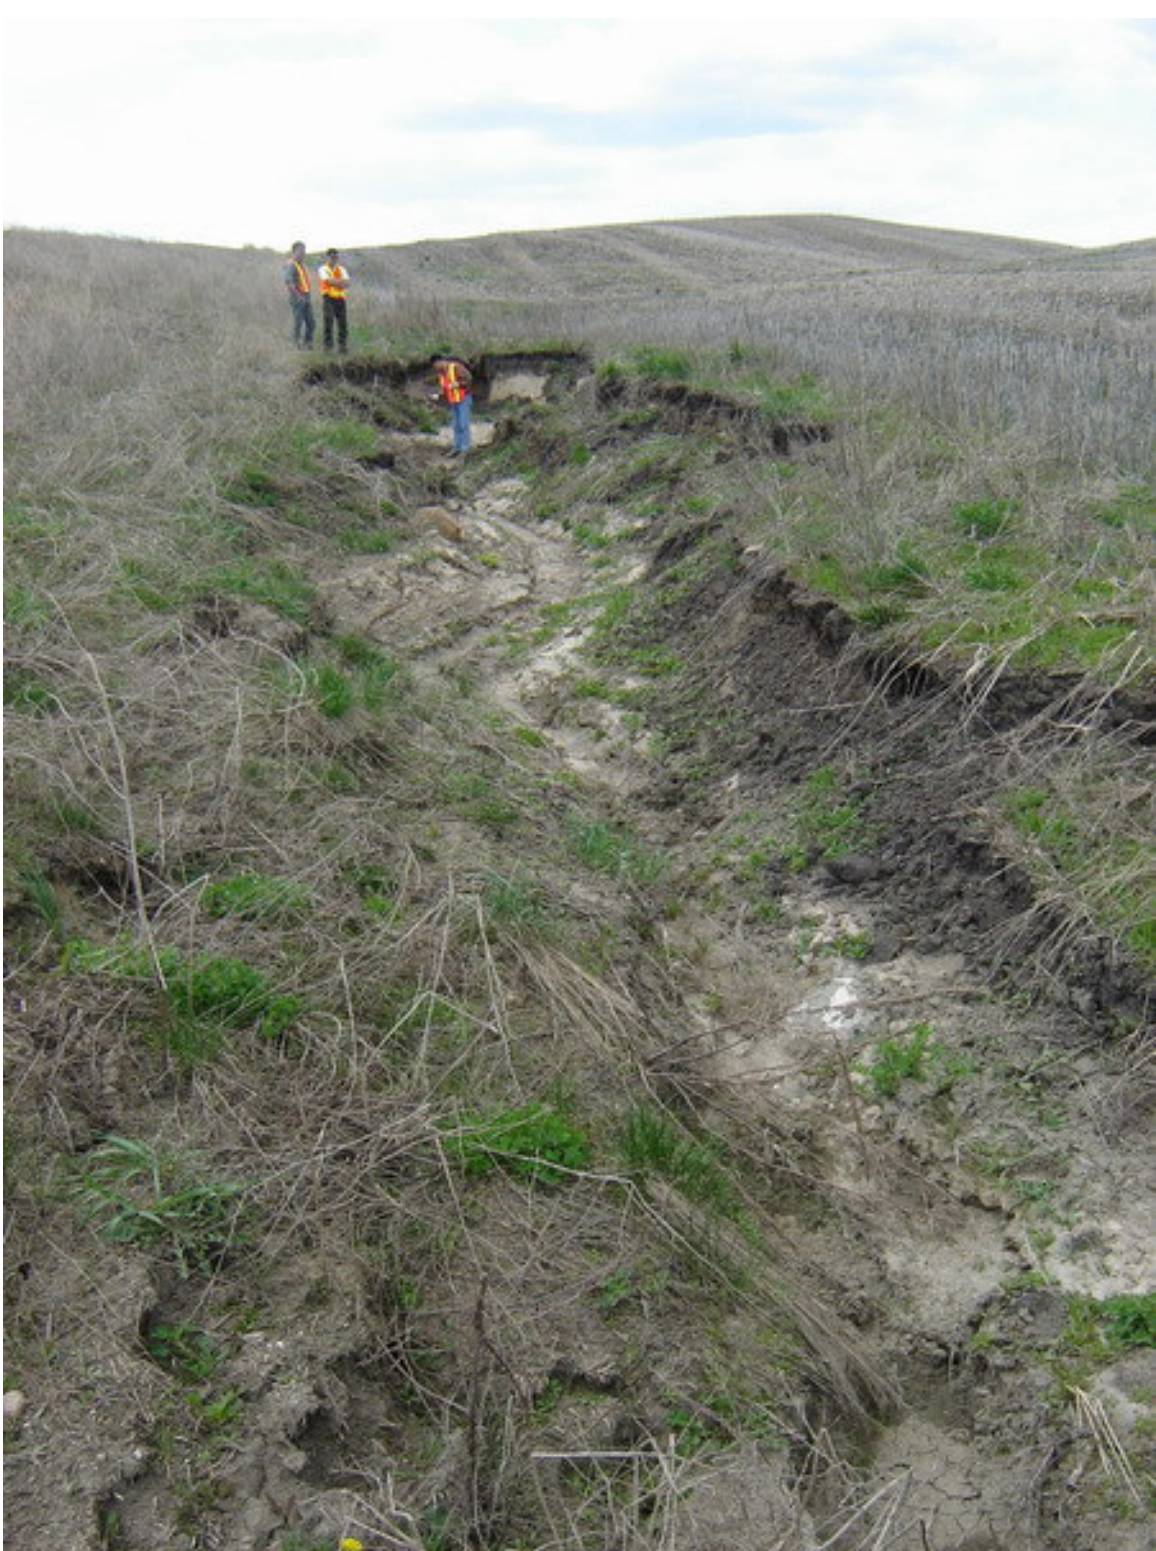
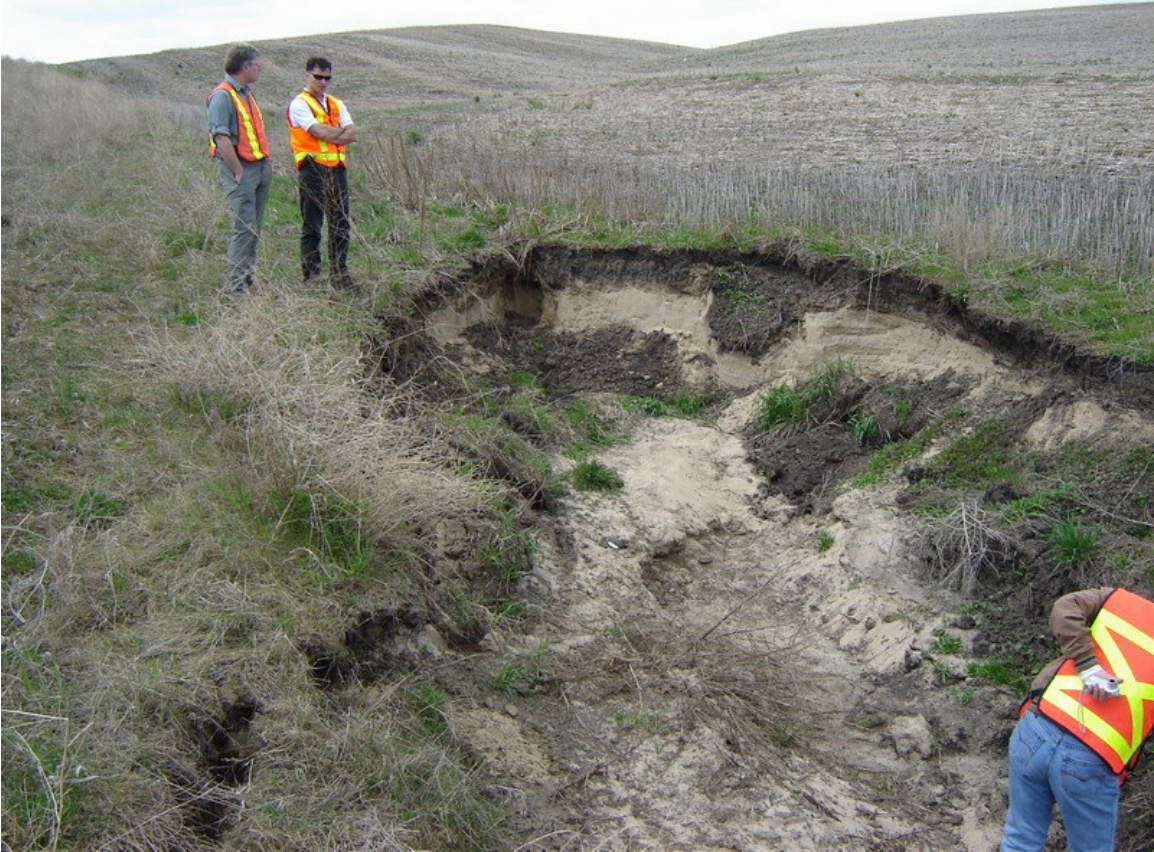
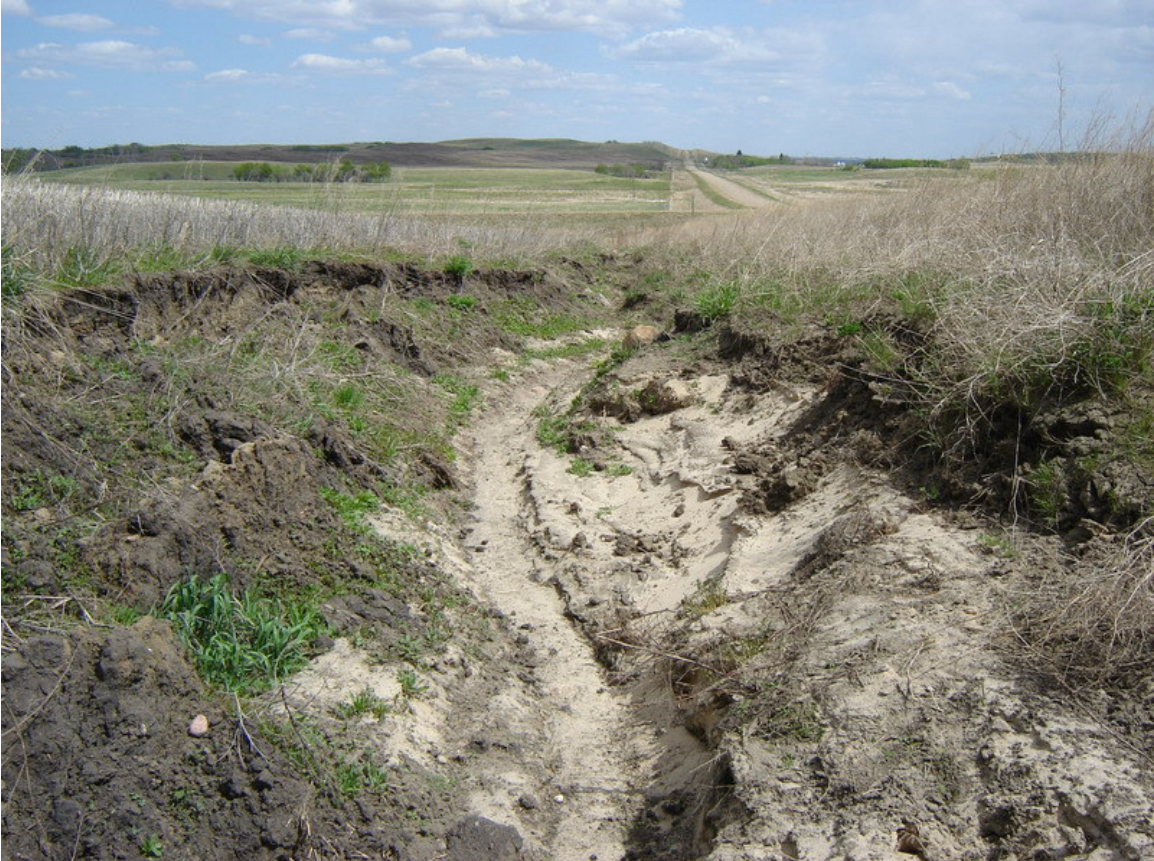
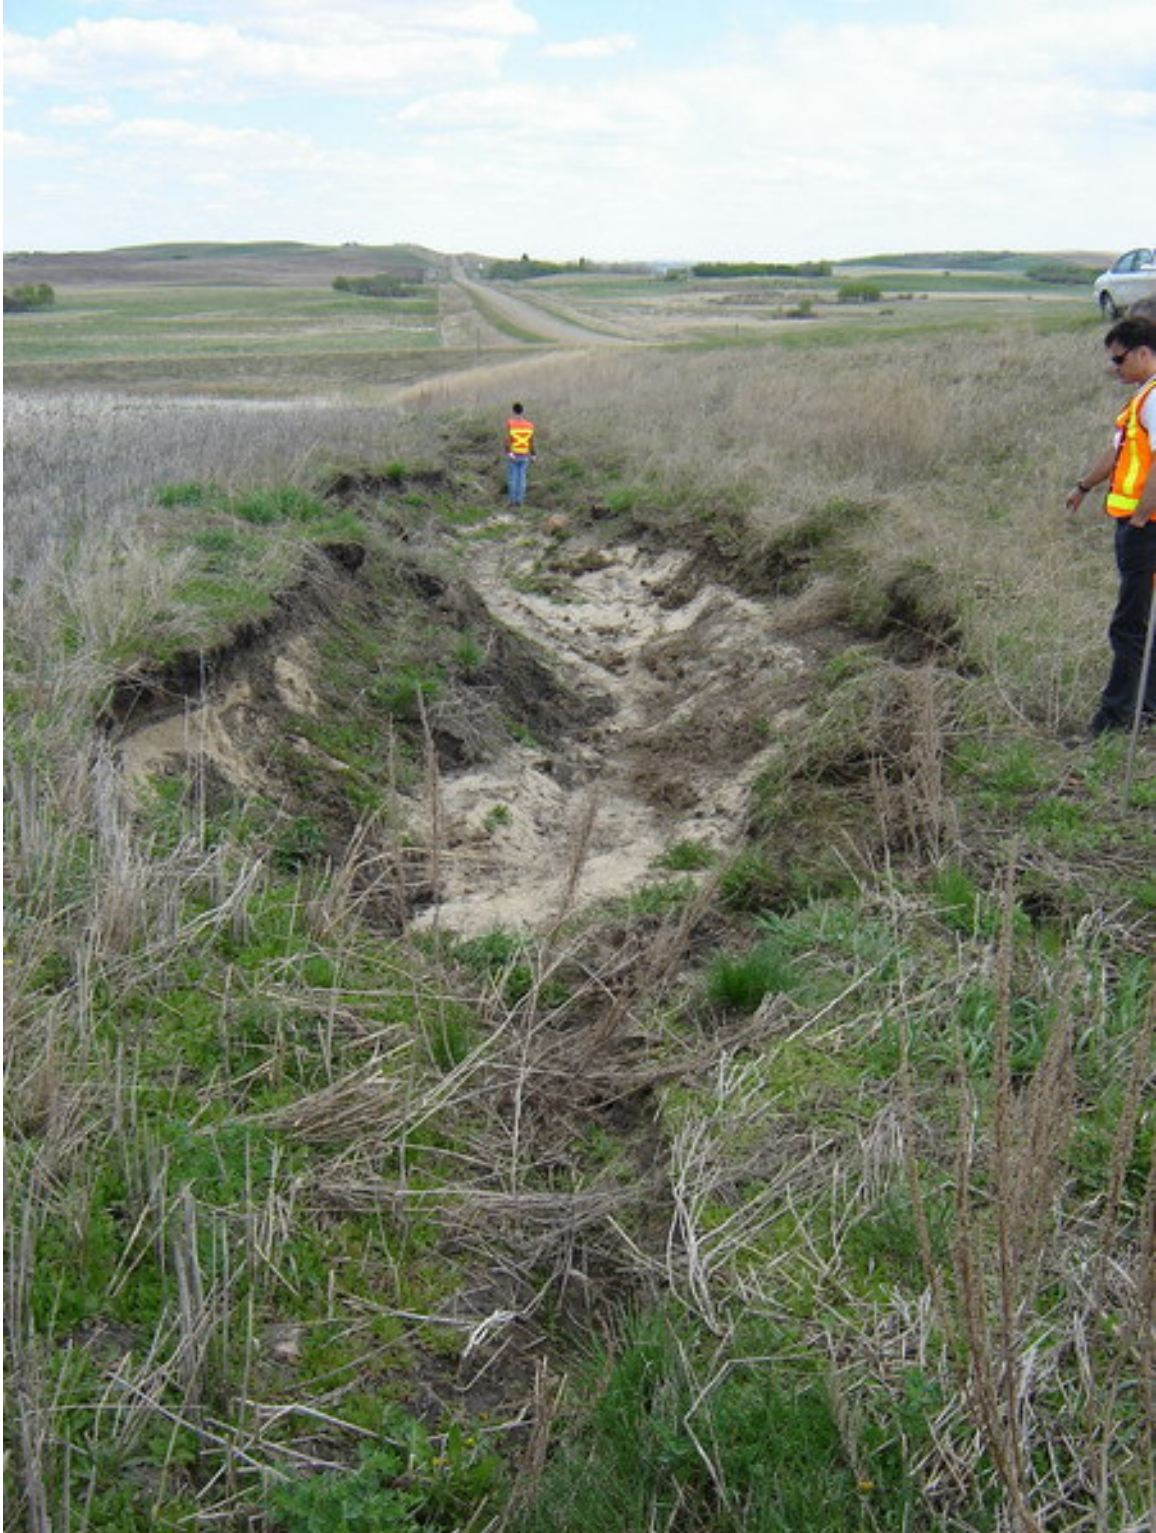
Site 2 (North Ditch of H614:02, near RR 4-4)

Refer to photo pages 5 – 9.

An erosion channel has formed on the north side of H614 in the ditch alongside a farmer's field. At the west end, the erosion is semi-circular (about 3 m wide, 1 m deep) and has exposed a uniform sand deposit under the topsoil. The channel extends for a length of about 50 m, becoming shallower to the east. The erosion channel is at least 10 m from the highway edge and does not represent a hazard to traffic.

It is recommended that the channel be backfilled with available fill and seeded.
